# PEST AND BUILDING PRE-PURCHASE REPORTS

# Inspection Report

## East Coast Building Solutions

**61 Daintree , Lennox Head, NSW, 2478**

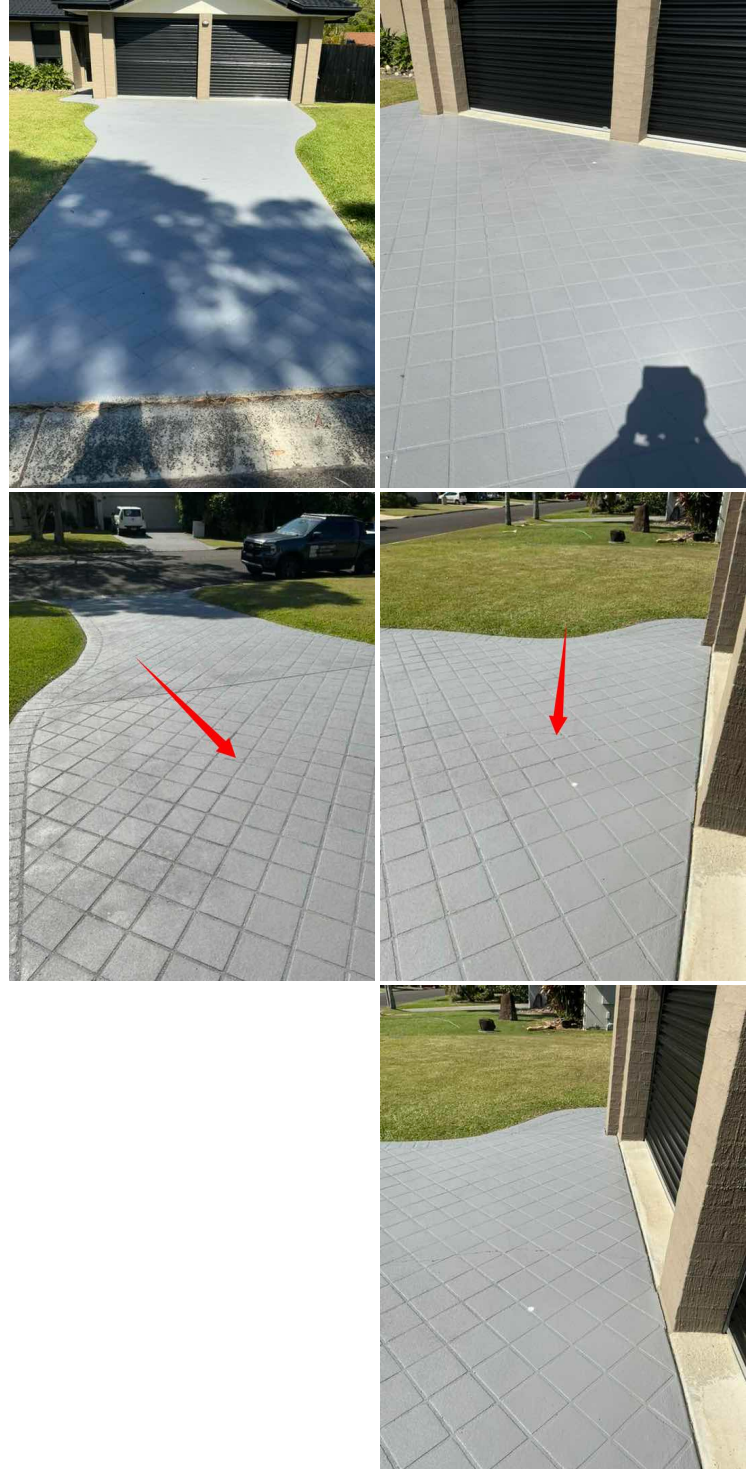
Common cracks were observed on the driveway. Whilst these cracks appeared to be typical at the time of inspection, we strongly recommend you monitor these cracks and if worsening occurs contact a concreter for further advice.

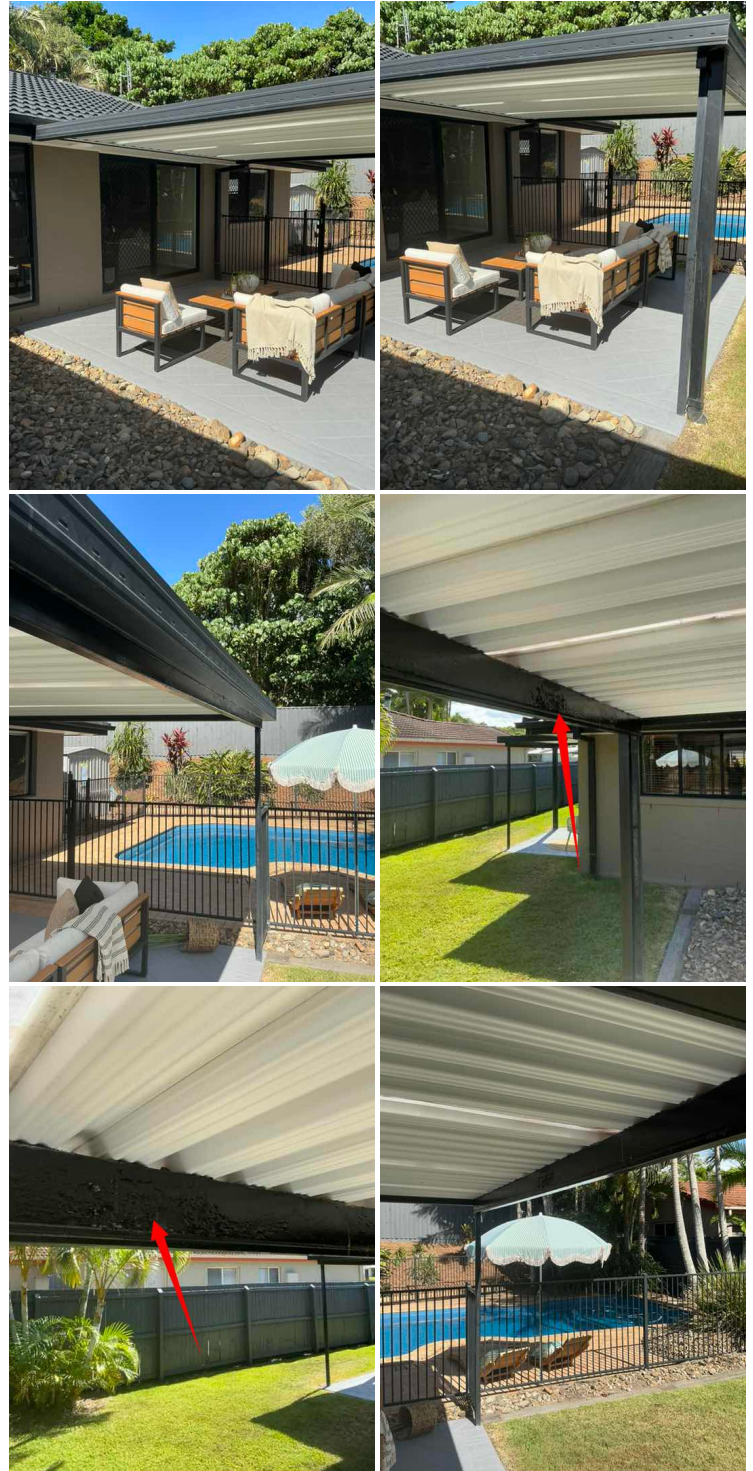
Visible sections of the Alfresco area are serviceable or in reasonable or condition for the age of this dwelling. Upon visual inspection, there appears to be corrosion on the metal beam. It is recommended to have a licensed tradesperson assess and treat the rust to prevent further deterioration. Consider applying a protective coating to extend the lifespan of the structure. Regular maintenance checks should be scheduled to monitor the condition of the metal components.

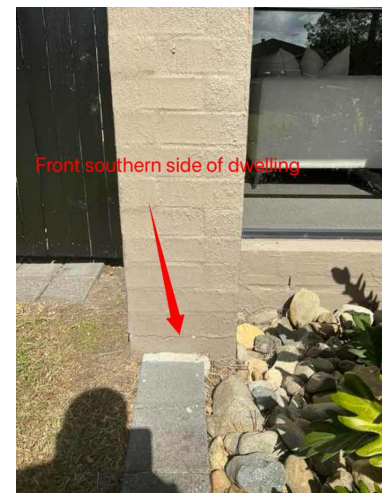
Upon visual inspection, the wall appears to have minor cracks and potential moisture exposure at the base. Recommend sealing cracks with appropriate filler and applying a waterproof sealant. Ensure proper drainage away from the wall to prevent further moisture issues. Consult a licensed tradesperson for a detailed assessment and repair.

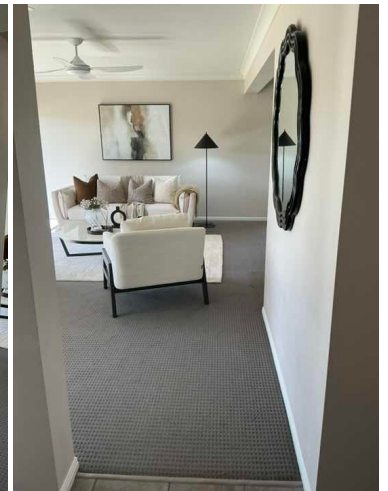
Upon visual inspection, the carpet shows signs of wear and possible damage near the window area. It is recommended to have a licensed flooring specialist assess and repair or replace the affected section to prevent further deterioration and ensure safety.

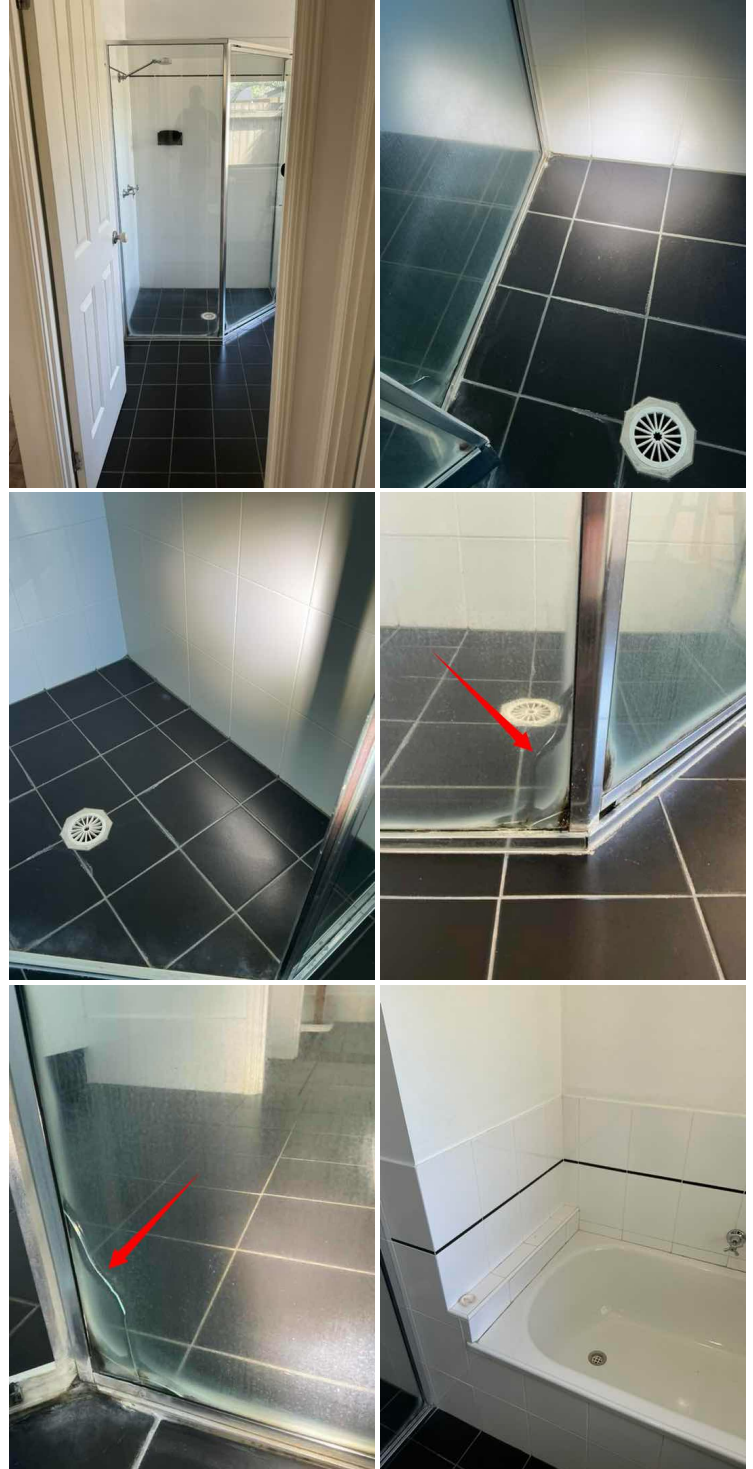
Upon visual inspection, the glass panel is cracked, posing a safety hazard. Immediate replacement by a licensed glazier is recommended to prevent injury and ensure structural integrity. Additionally, inspect the surrounding frame for any potential damage or misalignment that may have contributed to the crack.

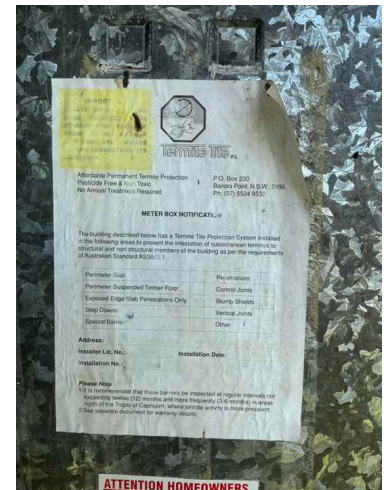
Yes, a durable notice was found in the meter-box during the inspection.
