# PEST AND BUILDING PRE-PURCHASE REPORTS

# Inspection Report

## East Coast Building Solutions

**245 Hutley Drive , Lennox Head, NSW, 2478**

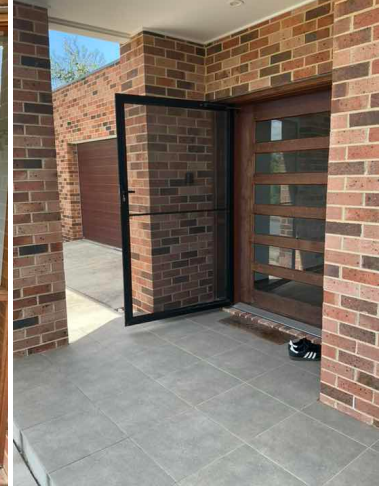
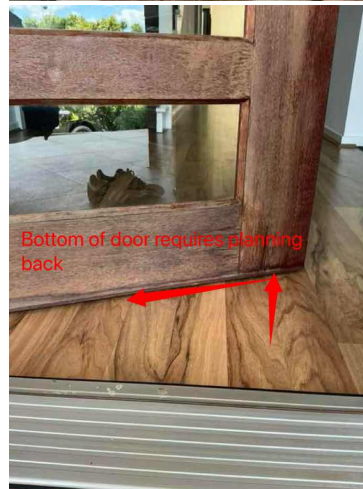
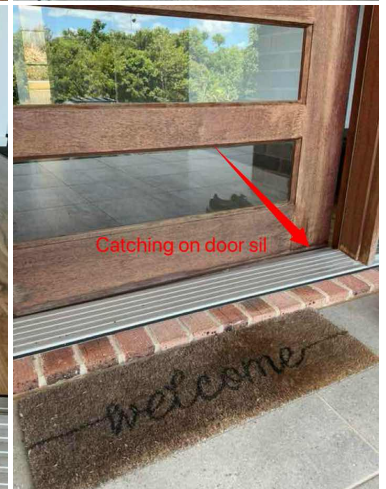
#### Front Entry Doors

Upon visual inspection, the wooden door appears well-maintained with no visible defects. The glass panels are intact, and the door frame shows no signs of damage. Ensure regular maintenance to preserve the wood finish and check for any potential weather-related wear. Consider consulting a licensed tradesperson for routine inspections to maintain optimal condition. Recommend planing bottom of door for full functionality

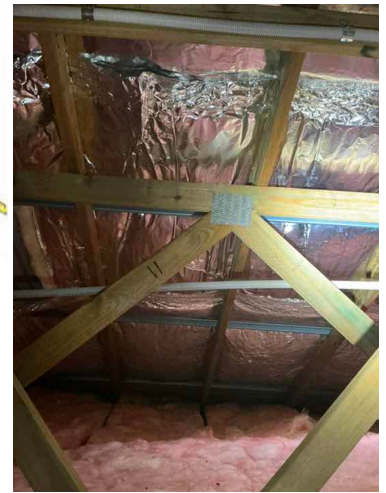
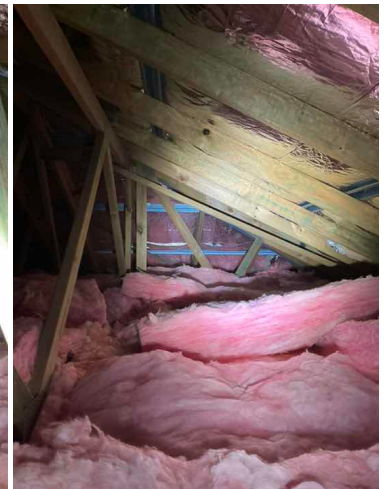
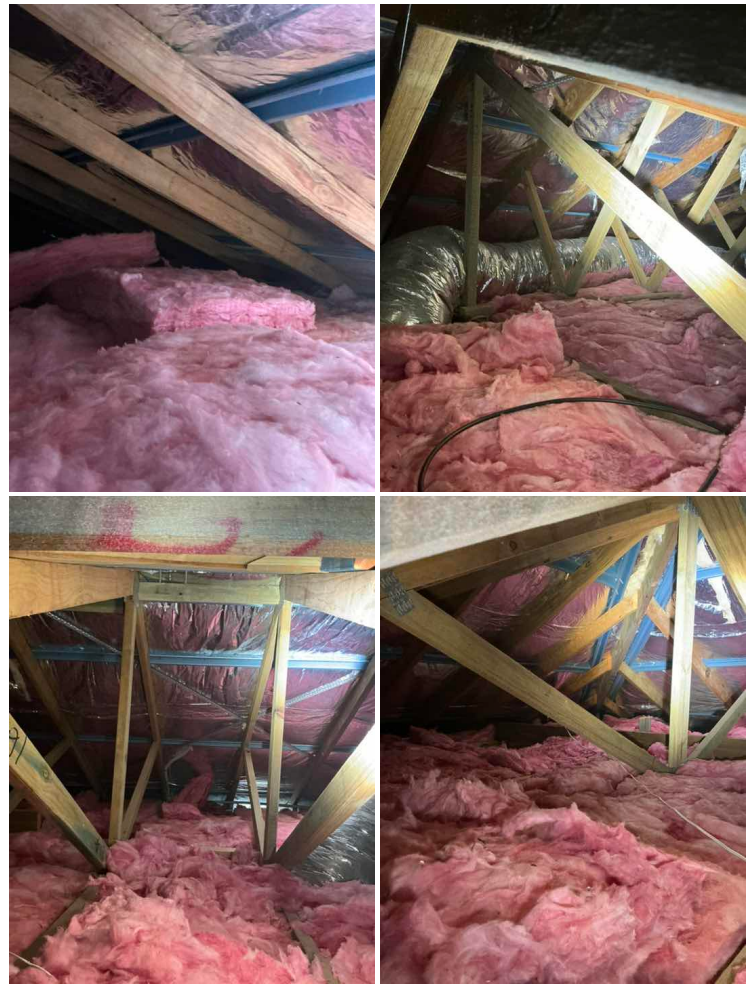
There is heating and/or cooling ducting present in the roof space. This is preventing a full inspection from being undertaken. It is strongly recommended that full access be gained as it could be harbouring timber pest activity, damage or defects.

There is insulation present in the roof space/void. This is preventing a full inspection of ceiling joists from being undertaken. It is strongly recommended that full access be gained as it could be harbouring timber pest activity, damage or defects.

Viewed from out side due to restricted entry. No comment can be made regarding condition

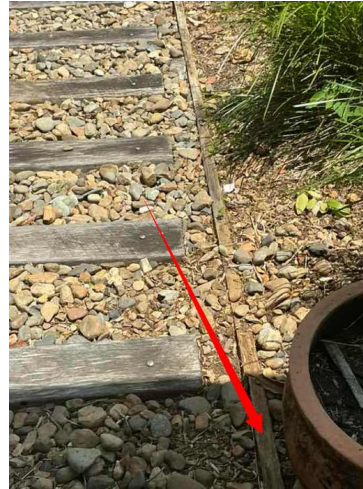
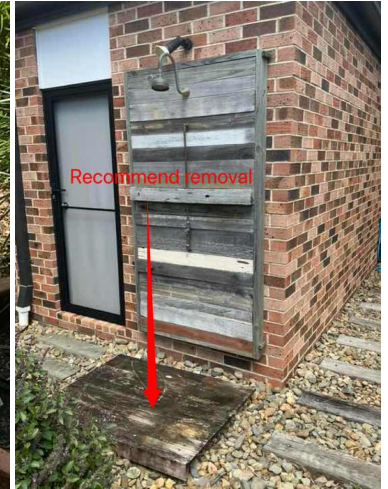
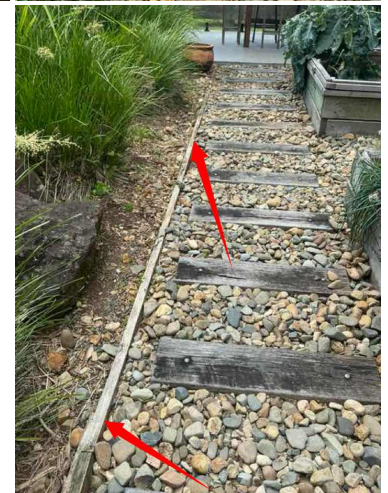
Yes: please read this report in its entirety.  
Recommend removal of Timbers throughout the back yard. Potential cause for termite infestation
