# Building and Pest Report

## 2/102 Killarney Cres, Skennars Head

# Inspection Report

**2/102 Killarney Cr, Skennars Head, NSW, 2478**

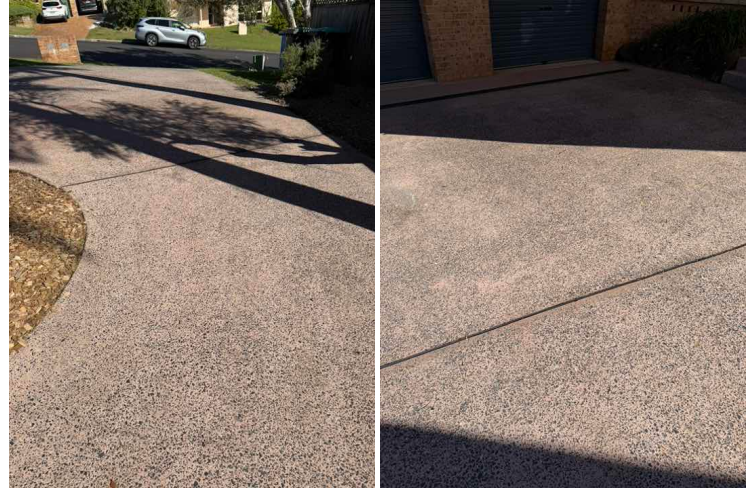
On visual inspection, the general condition of the driveway is serviceable.

Common cracks were observed on the driveway. Whilst these cracks appeared to be typical at the time of inspection, we strongly recommend you monitor these cracks and if worsening occurs contact a concreter for further advice.

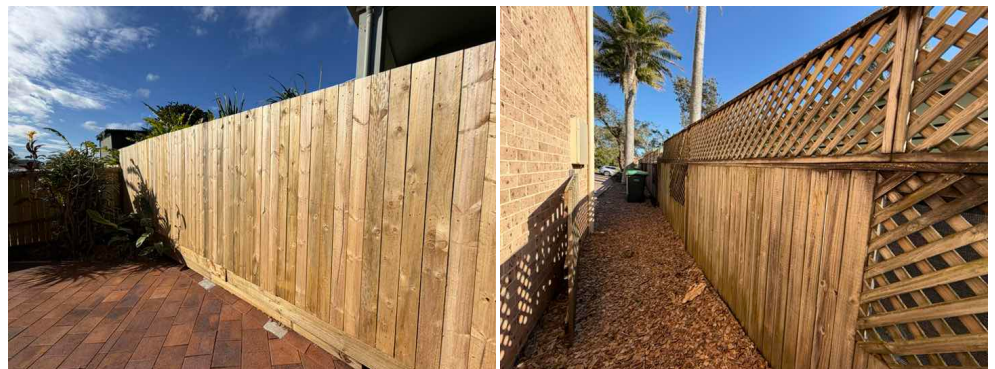
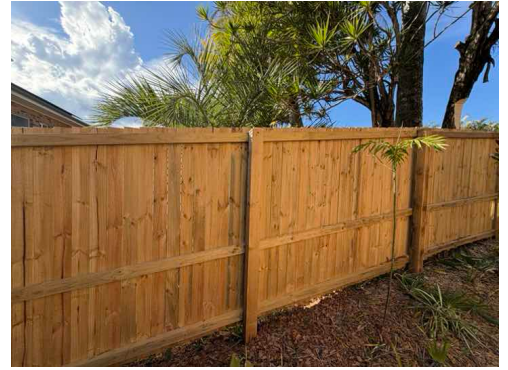
Of the visible areas, the general condition of the fences and gates is serviceable for the age of dwelling.

General age/damage/binding of gate/s components -

Recommendations: A qualified fencing contractor should be engaged for advice and recommendations.

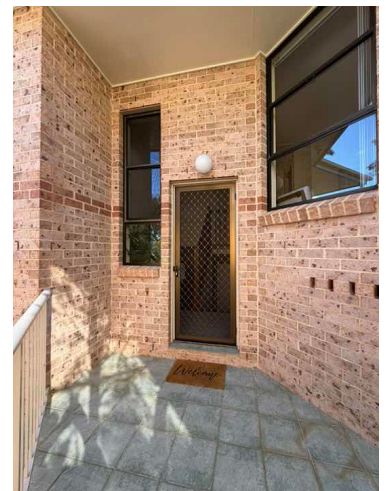
On Visual Inspection the external condition of the doors is serviceable.

General age/damage has occurred to door frame, face or components. Recommendations: A qualified carpenter should be engaged for advice and recommendations.

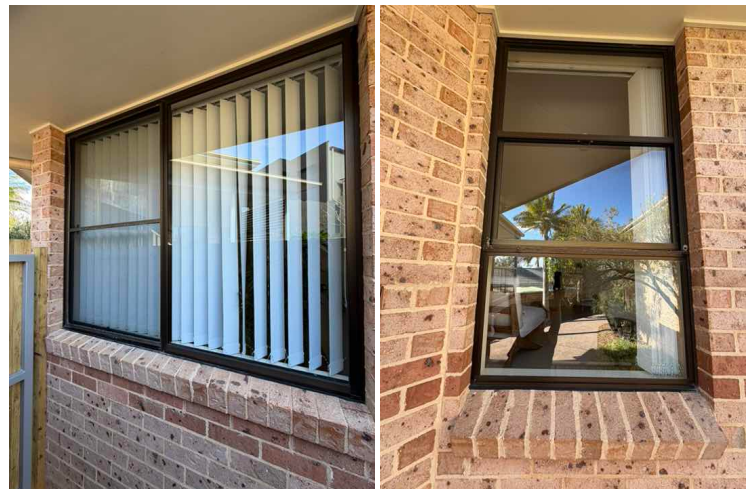
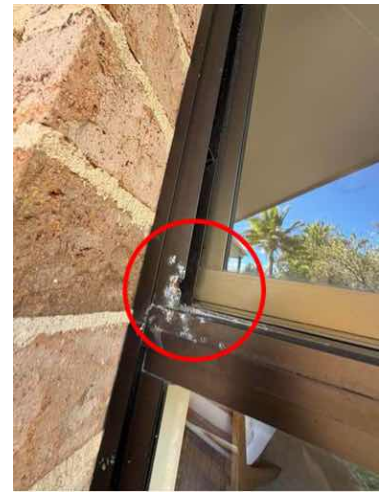
On visual inspection, the general condition of the windows is serviceable for the age.

Rust is evident in sections of the homes window framework. Some areas should be repaired. A suitably qualified tradesman should be engaged for advice and recommendations.

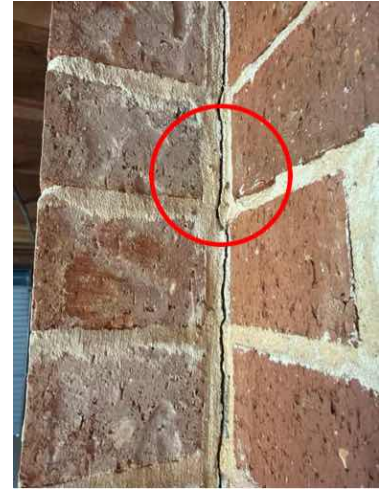
There appears to have been some settlement which has caused some cracking to the walls. These cracks are categorized as 0 to 2. This can also cause some doors to bind or be out of square. In the inspectors opinion these cracks are due to settlement, usually due to ground movement and subsequent movement to building materials can be expected. Any cracks should be monitored and if cracks increase in size, further investigation should be carried out by a structural engineer.

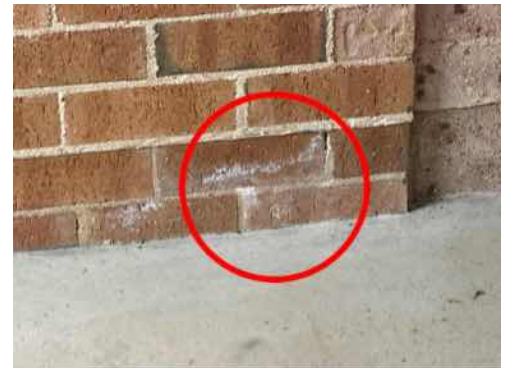
Rust in garage door frame noted - General repair required.

Upon visual inspection, rust was observed on the steel door frame, indicating potential structural compromise. Immediate action is recommended to prevent further deterioration. A suitably licensed tradesperson should remove rust, apply a rust-inhibiting primer, and repaint the frame. If corrosion is extensive, consider replacing the affected sections to ensure structural integrity and longevity. Regular maintenance checks are advised to prevent recurrence.

Moisture/damp detected. It is imperative that specialist advice be sought to obtain accurate diagnosis of the cause and extent of the damp problem and it is advised that you have assessed prior to purchasing the dwelling as can be quite costly if a damp proof course has to be reinstated.

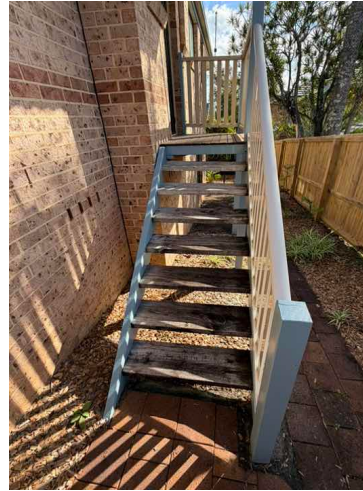
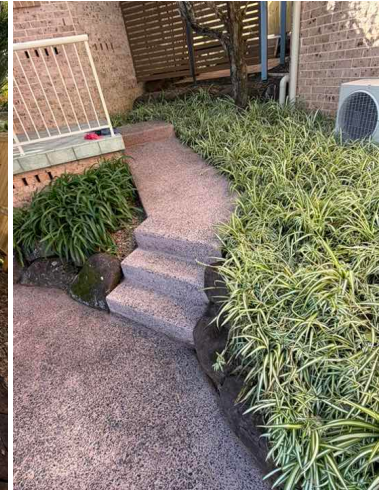
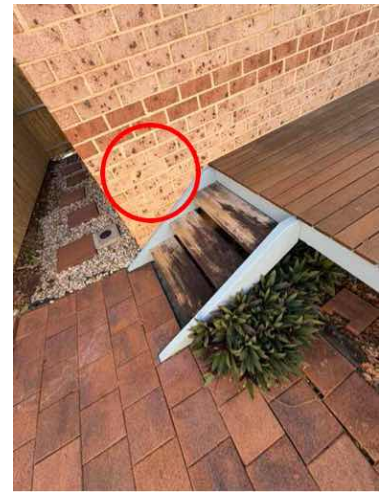
Timber fungal decay in sections of stair treads. This is a safety hazard and repair is required. A qualified carpenter should be engaged for advice and recommendations.

There are no rails on the stairs. This presents a fall risk. Have repaired immediately.

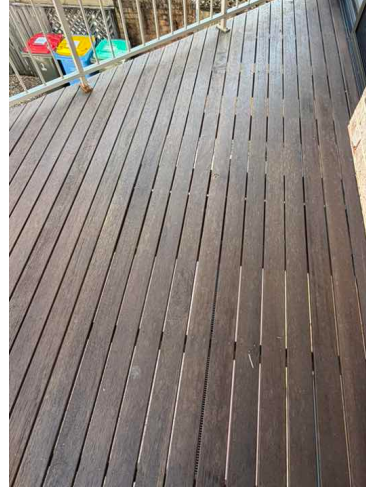
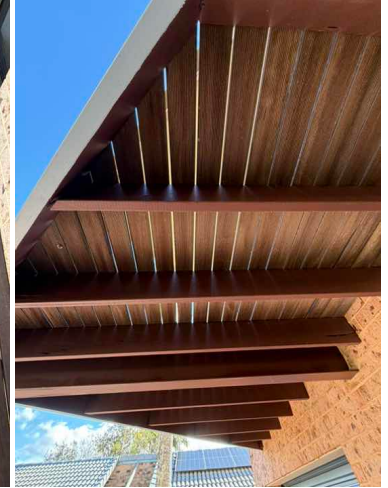
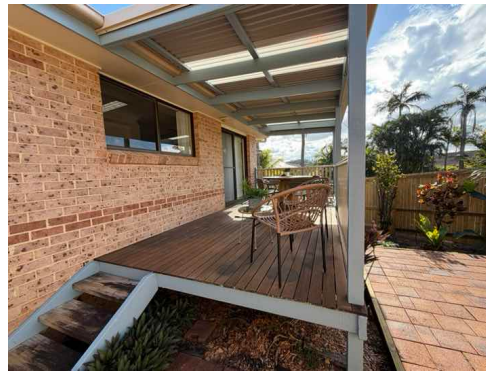
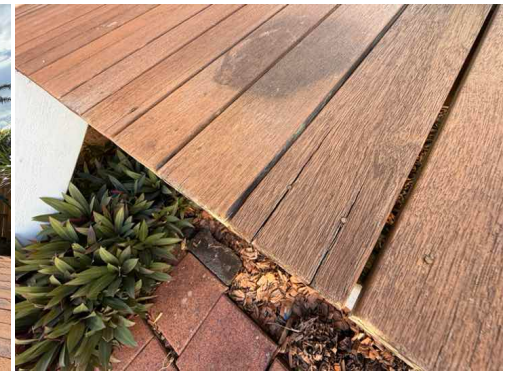
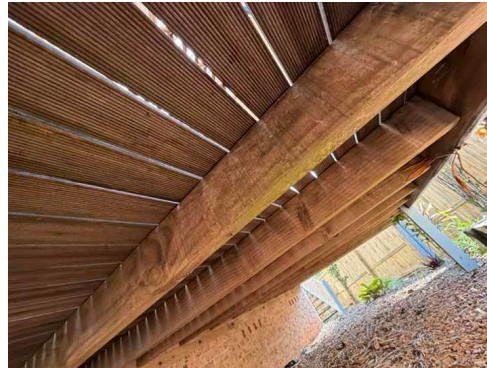
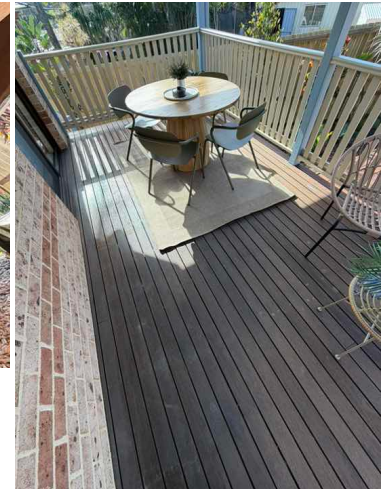
Moisture damage was observed on deck boards - Recommendations: Evaluation and repairs by a qualified decking contractor.

Decking board surfaces are weathered. We recommend cleaning and maintenance as needed.

Balustrade rail height- should be 1 m in height from deck/balcony/patio floor. In some circumstances this regulation was non-existent dependent on the age of the dwelling and technically there is no requirement to rectify. Recommendations: We strongly advise you rectify to comply for safety concerns.

Timber fungal decay in areas of balustrade and/or rails. A qualified carpenter should be engaged for advice and recommendations. This is a safety issue and requires immediate assessment.

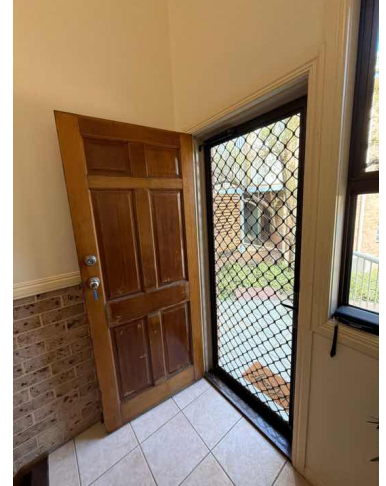
The doors are in serviceable condition with no notable defects observed. Upon visual inspection, moisture damage was identified in the living room ceiling, likely due to a roof leak. Recommend engaging a licensed roofer to assess and repair the roof to prevent further water ingress. Additionally, a licensed contractor should replace damaged ceiling materials and ensure proper ventilation to mitigate future moisture issues. Regular maintenance checks are advised to prevent recurrence.

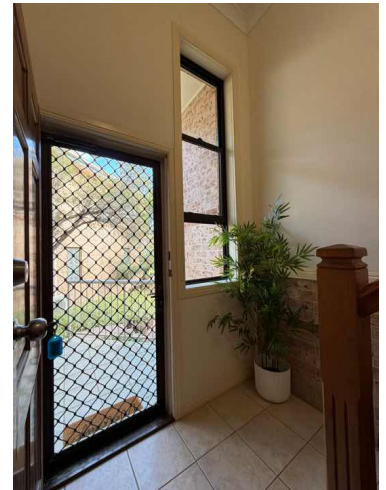
Typical cornice separation/detachment observed. I recommend you contact a qualified painter for repairs.

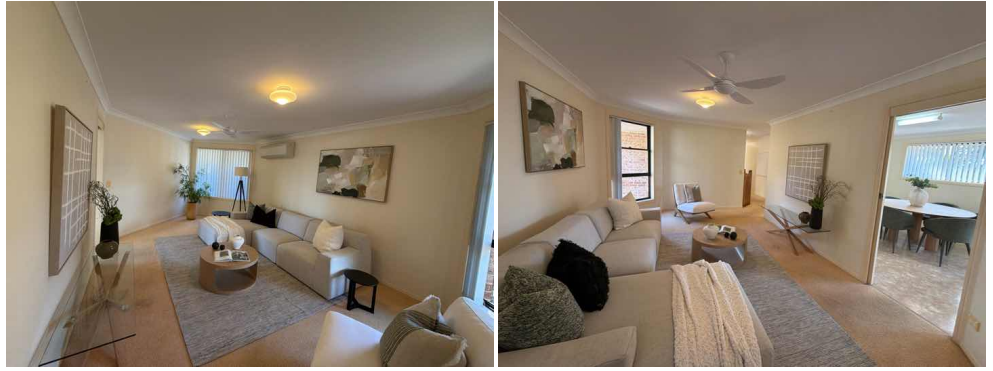
Typical cornice separation/detachment observed. I recommend you contact a qualified painter for repairs.

Stains observed - Steam cleaning may rectify stained areas but they appear entrenched.

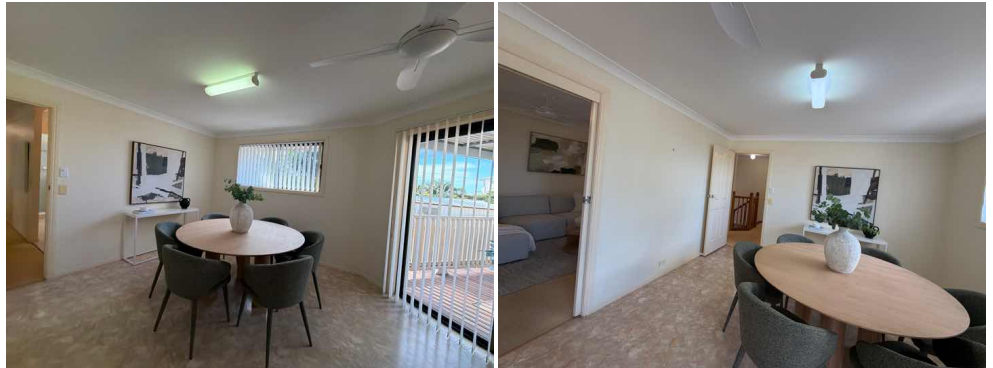
Upon visual inspection, moisture damage was observed at the bottom of the door, likely due to inadequate sealing or exposure to water. It is recommended to replace or repair the affected door section and improve weatherproofing. Ensure proper sealing and consider installing a door sweep or threshold to prevent future moisture intrusion. Consult a licensed tradesperson for assessment and repairs.

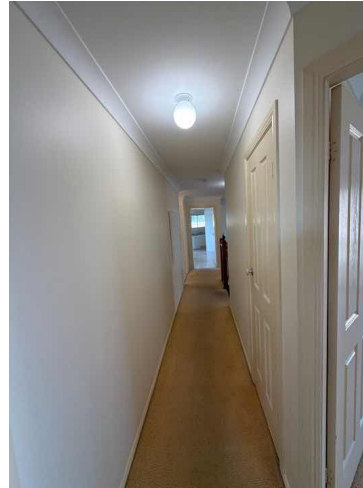
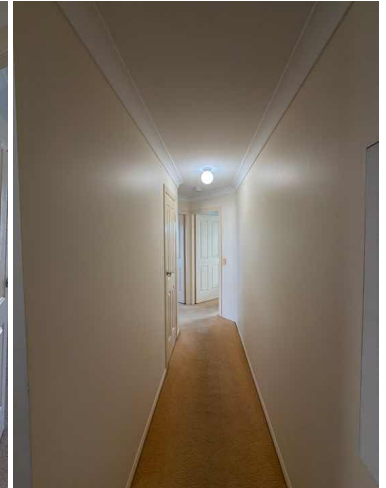
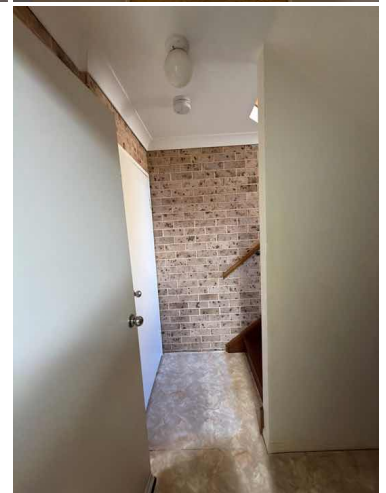
General carpet deterioration. Replacement may be required A qualified carpet layer should be engaged.

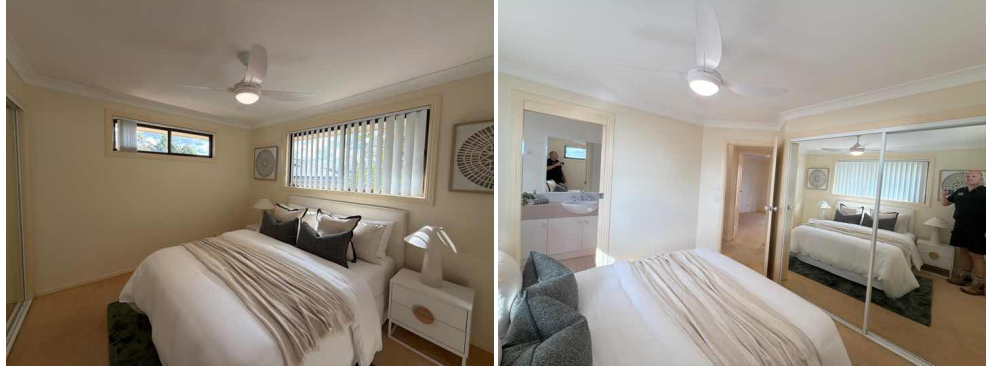
Door lock hardware is loose possibly damaged. Maintenance as required.

Upon visual inspection, moisture damage was observed at the bottom of the door, likely due to inadequate sealing or exposure to water. It is recommended to replace or repair the affected door section and improve weatherproofing. Ensure proper sealing and consider installing a door sweep or threshold to prevent future moisture intrusion. Consult a licensed tradesperson for assessment and repairs.

Stains observed - Steam cleaning may rectify stained areas but they appear entrenched.

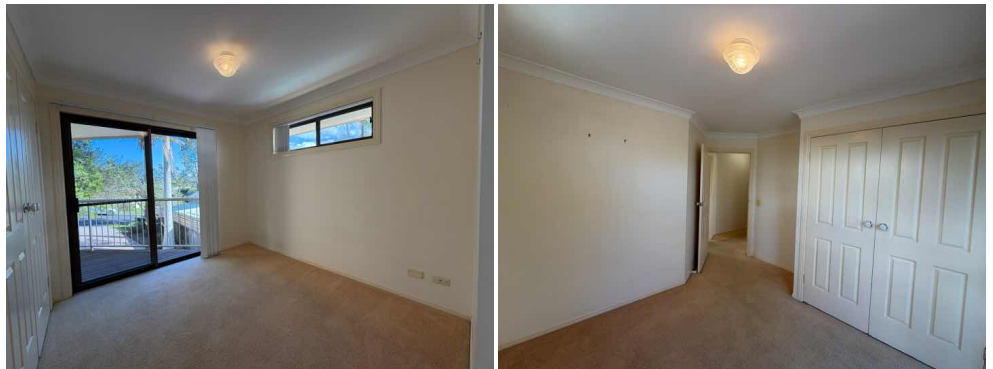
Upon visual inspection, moisture damage was observed at the bottom of the door, likely due to inadequate sealing or exposure to water. It is recommended to replace or repair the affected door section and improve weatherproofing. Ensure proper sealing and consider installing a door sweep or threshold to prevent future moisture intrusion. Consult a licensed tradesperson for assessment and repairs.

General age wear deterioration - The window frame/components showed evidence of ageing and wear. General maintenance works required.

General carpet deterioration. Replacement may be required A qualified carpet layer should be engaged.

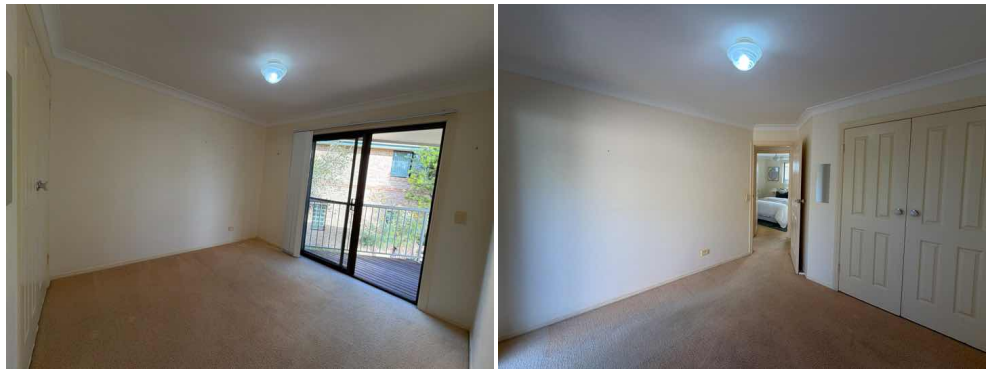
Upon visual inspection, moisture damage was observed at the bottom of the door, likely due to inadequate sealing or exposure to water. It is recommended to replace or repair the affected door section and improve weatherproofing. Ensure proper sealing and consider installing a door sweep or threshold to prevent future moisture intrusion. Consult a licensed tradesperson for assessment and repairs.

Typical cornice separation/detachment observed. I recommend you contact a qualified painter for repairs.

General age wear deterioration - The window frame/components showed evidence of ageing and wear. General maintenance works required.

General carpet deterioration. Replacement may be required A qualified carpet layer should be engaged.

Stains observed - Steam cleaning may rectify stained areas but they appear entrenched.

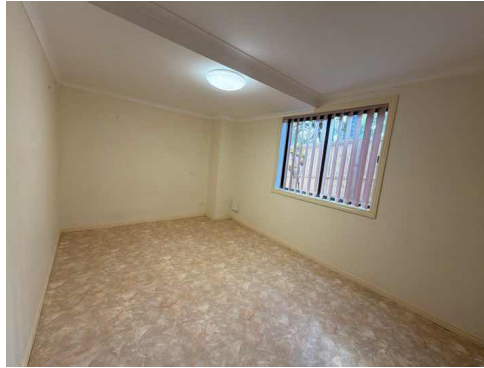
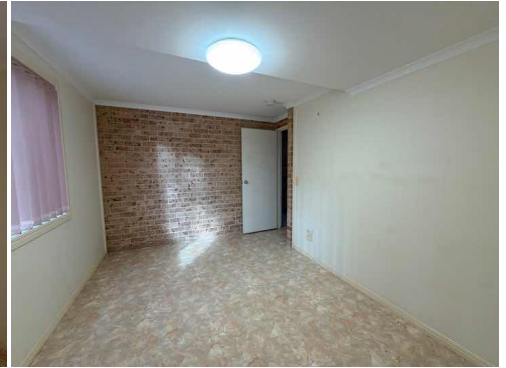
Door stop should be fitted - Wall damage from door handle impacting wall lining has occurred. I recommend you contact a qualified painter for repairs.

Typical cornice separation/detachment observed. I recommend you contact a qualified painter for repairs.

Settlement Cracks Noted. These are typical and generally patch and paint will suffice, however we recommend monitor these cracks and if become wider or longer, you will need to contact a structural engineers to assess. High moisture levels detected indicating rising damp. there can be other causes such as water ponding against the wall or poor drainage in that particular area. Rising damp in one area of the dwelling may mean that other sections of the dwelling may be affected and not yet visible. Contact a specialist in this field for repairs and advice. We recommend getting a quote prior to a decision to purchase as this can be very expensive to rectify.

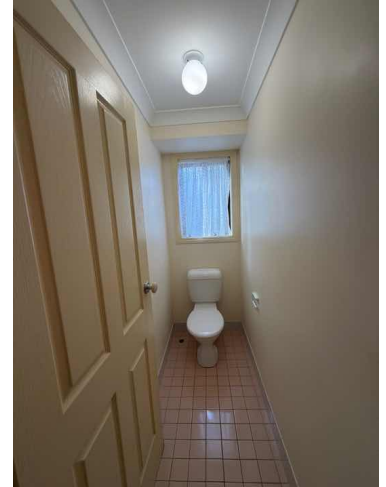
Door / frame deterioration - General age/damage has occurred to door frame, face or components.

Cornice separation. I recommend you contact a licensed plasterer for repairs.

Settlement Cracks Noted . These are typical and generally patch and paint will suffice, however Monitoring these cracks advised for 12 months and if become wider or longer, you will need to contact a structural engineers to assess.

No exhaust fan is installed - Recommend having one installed.

Recommendations: A qualified carpenter should be engaged for advice and recommendations.

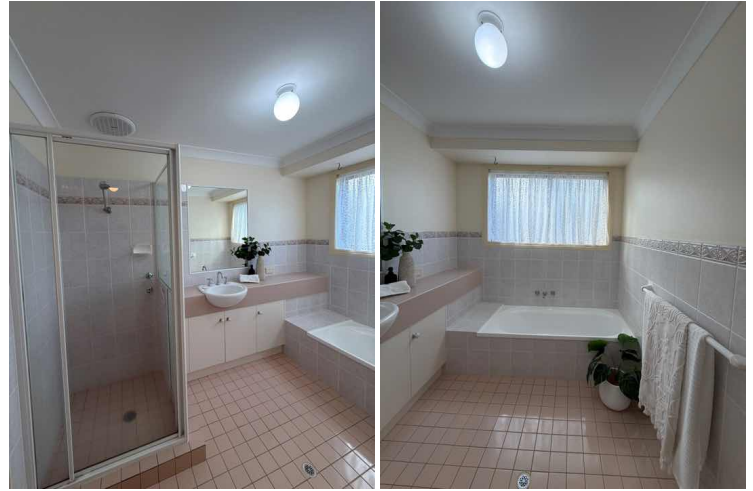
Door / frame deterioration - General age/damage has occurred to door frame, face or components.  
Recommendations: A qualified carpenter should be engaged for advice and recommendations.

Cornice separation. I recommend you contact a licensed plasterer for repairs.

Deteriorated grout noted. This should be repaired as this will lead to water ingress under the tiles causing uplifting and possible water penetration.

Cracked tile/s noted. This can cause extensive floor and floor frame damage and is conducive to termite infestation if water is leaking through the cavity. A qualified tiler should be engaged for advice and recommendations.

The vanity mirror is desilvering at edges. Replacement recommended.

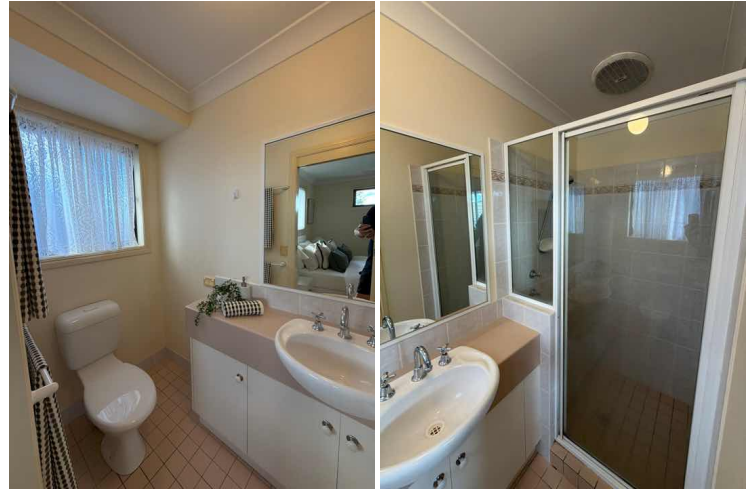
Door / frame deterioration - General age/damage has occurred to door frame, face or components.  
Recommendations: A qualified carpenter should be engaged for advice and recommendations.

Cornice separation. I recommend you contact a licensed plasterer for repairs.

Settlement Cracks Noted . These are typical and generally patch and paint will suffice, however Monitoring these cracks advised for 12 months and if become wider or longer, you will need to contact a structural engineers to assess.

Shower head is leaking. Replacement recommended.

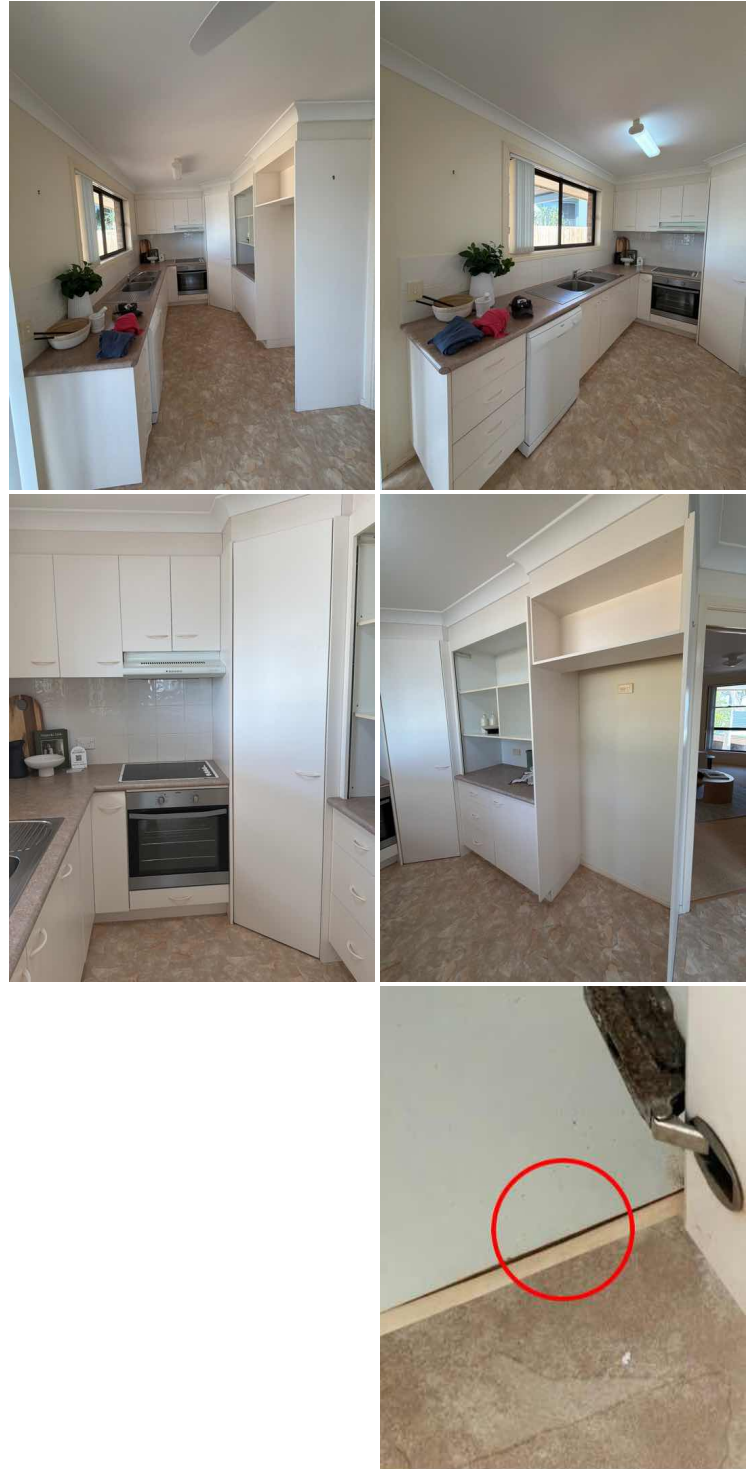
Cornice separation. I recommend you contact a licensed painter for repairs.

There is a leak from the tap head. Have checked by a plumber

Adjustment to cabinet doors required, in some instance hinges may need to be replaced.

Damage was noted to the cabinets, contact a joinery company for repairs

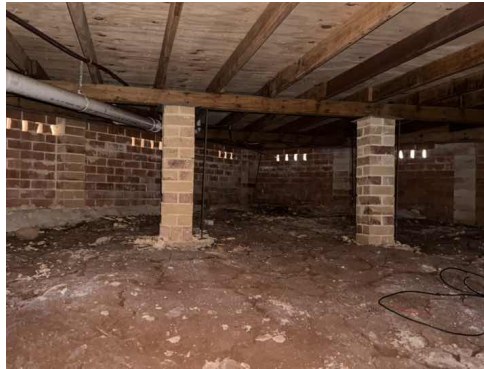
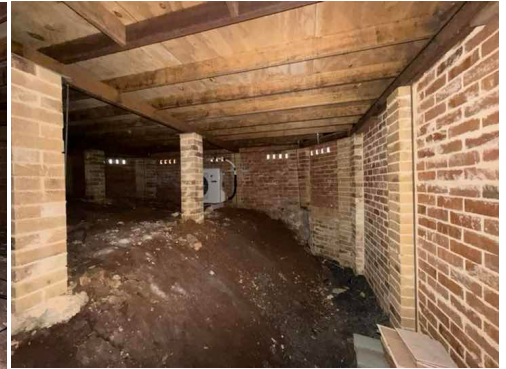
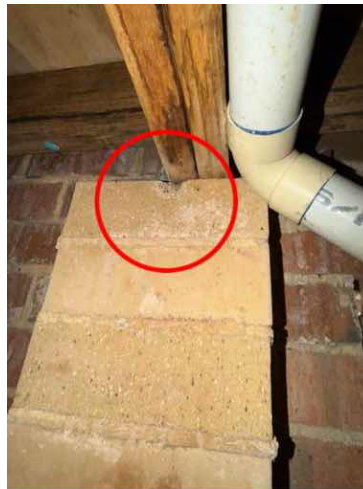
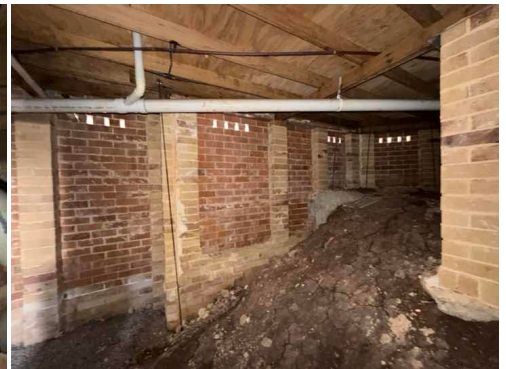
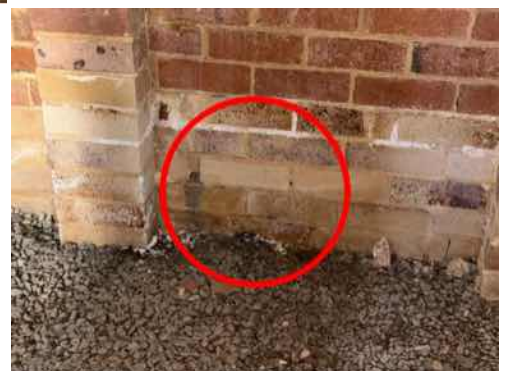
Upon visual inspection, signs of rising damp were observed on the external wall, including discoloration and peeling paint. To address this issue, it is recommended to improve drainage around the foundation and install a damp-proof course.

Ant caps are either missing or not installed. The purpose of ant capping is to prevent concealed termite entry by forcing the termites build mud tunnels around the visible sections of the ant capping enabling detection during a pest inspection. Ant caps will not prevent the entry of termites to a structure however, correctly fitted ant caps will assist in early detection.

Additionally, repair any damaged plaster and repaint with a breathable exterior paint. Ensure all gutters and downspouts are functioning properly to prevent water accumulation.
