PEST AND BUILDING PRE-PURCHASE REPORTS

Inspection Report

37 Montwood Dr, Lennox Head, NSW, 2478

Pest And Building Inspection

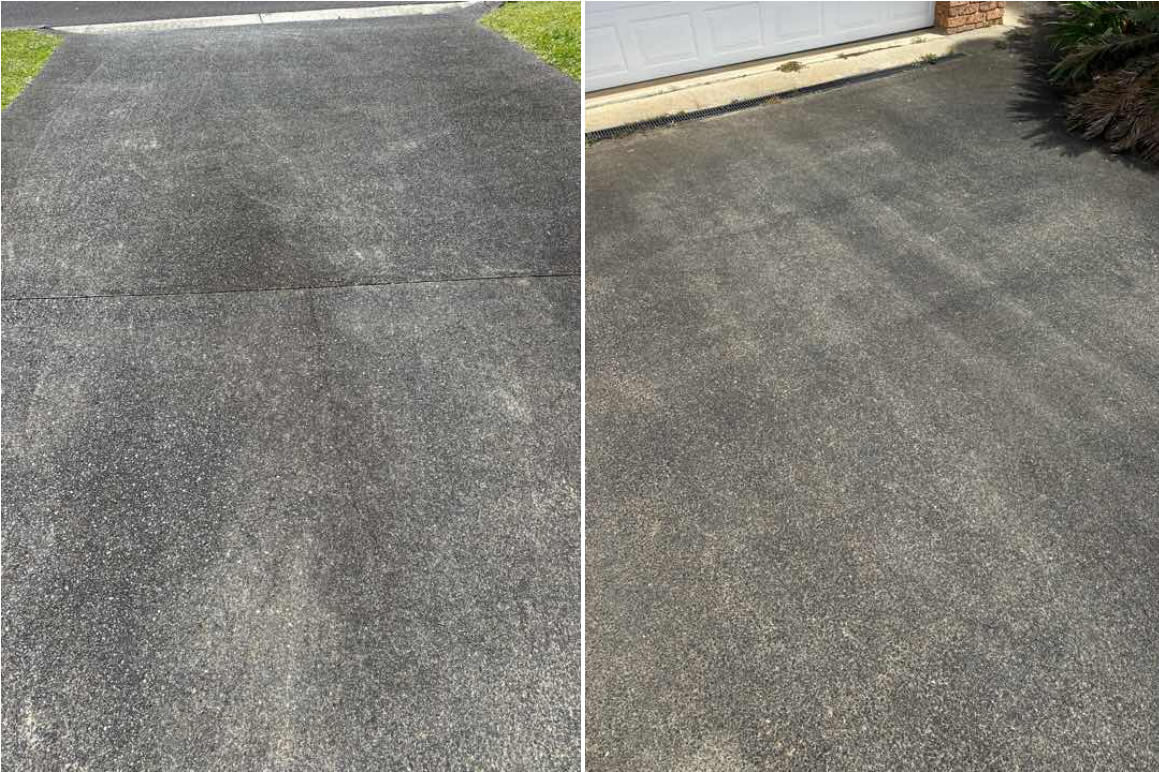
Common cracks were observed on the driveway. Whilst these cracks appeared to be typical at the time of inspection, we strongly recommend you monitor these cracks and if worsening occurs contact a concreter for further advice.

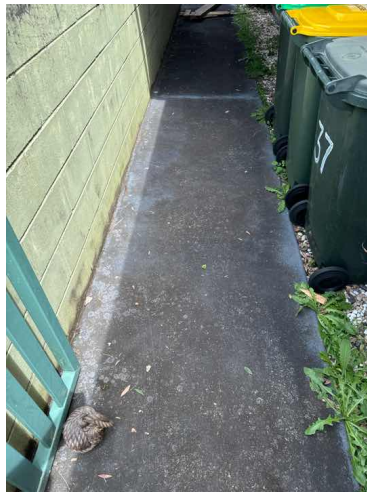
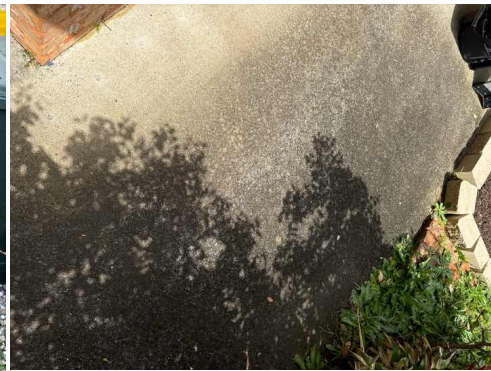
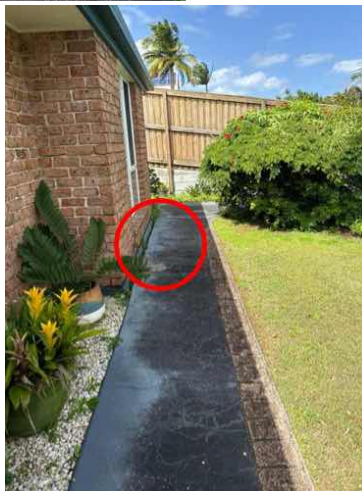
Common cracks and settlement were observed on paths. Whilst these cracks appeared to be typical at the time of inspection, we strongly recommend you monitor these cracks and if worsening occurs contact a concreter for further advice.

Surface raised and settled in some areas. This can cause water ponding. Relaying recommended.

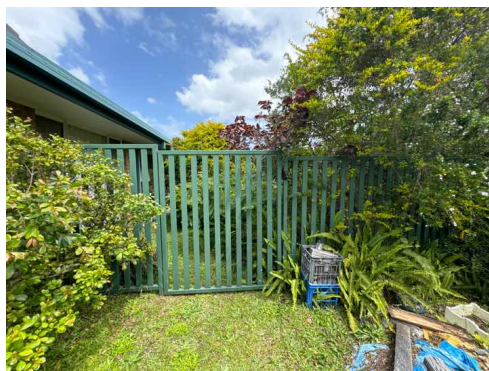
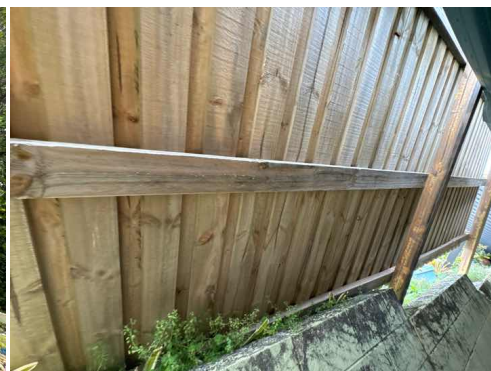
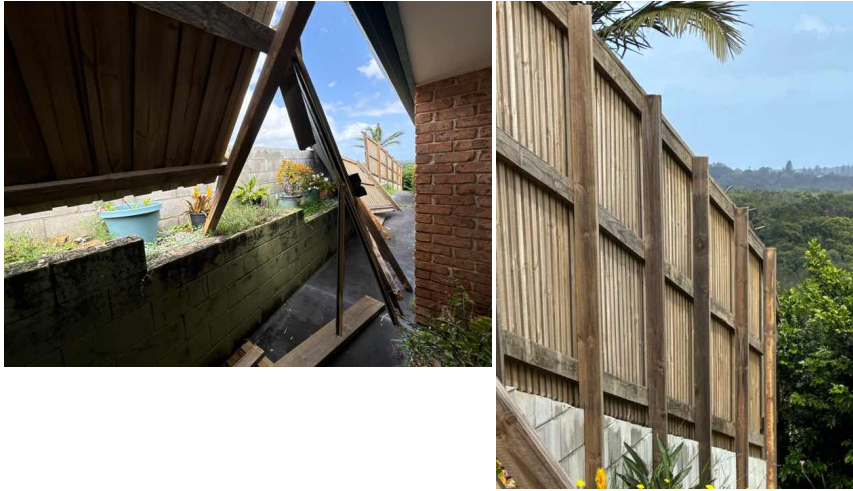
Damaged fence from recent storms

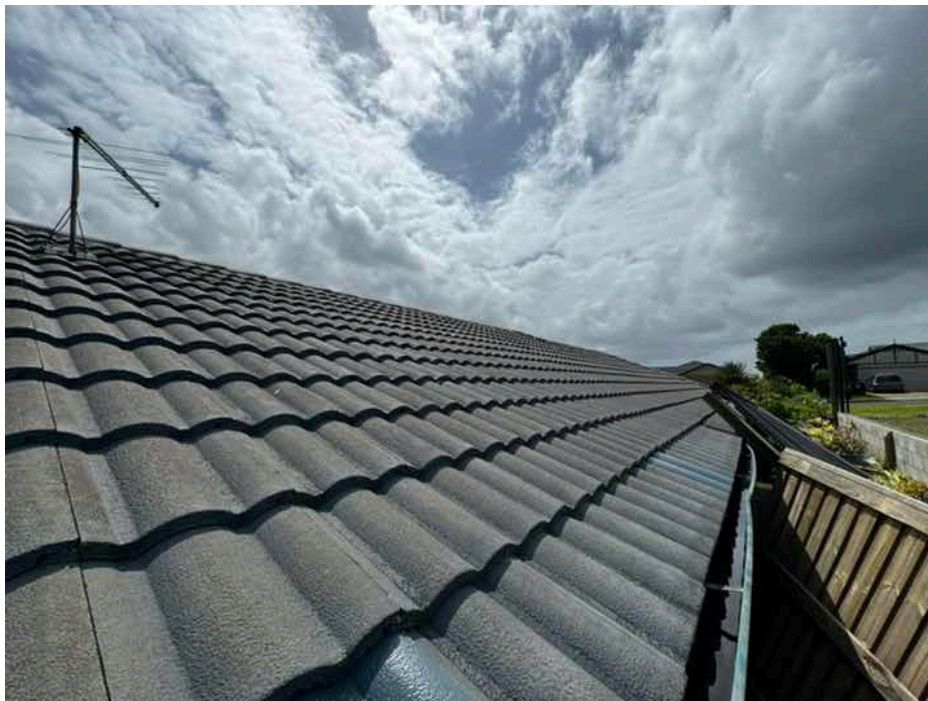
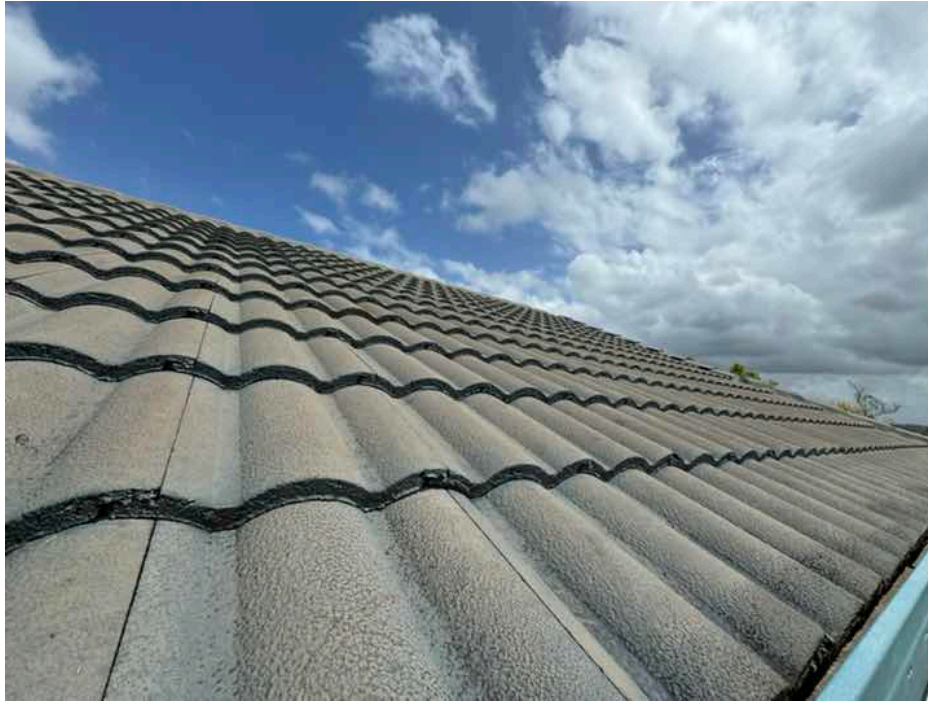
Minor damage from recent storm.

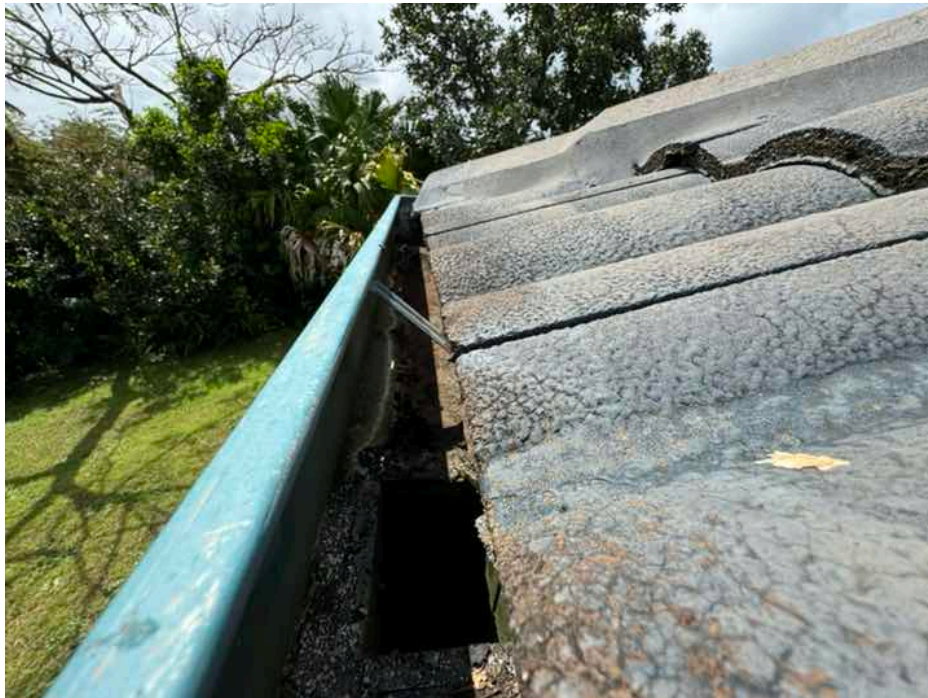
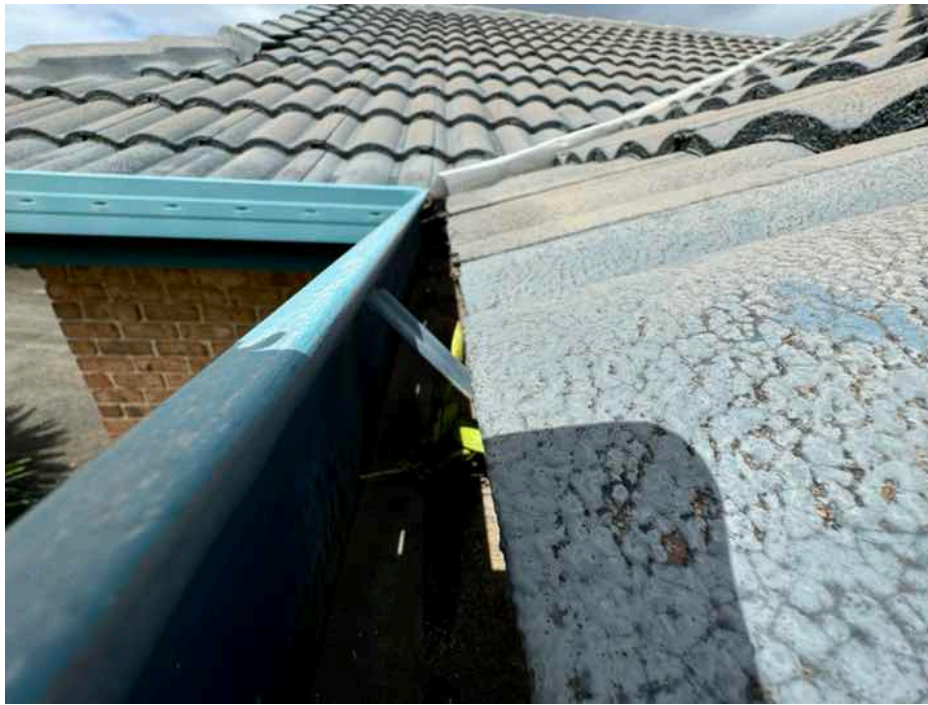
There is evidence of leaking gutters. Contact a roof plumber for advice and repairs.

Gutter surface rust in sections- the rust is yet to penetrate and repairs/sealing may be an option. A qualified roof plumber should be engaged for advice and recommendations.

Minor Damage From Recent Storm

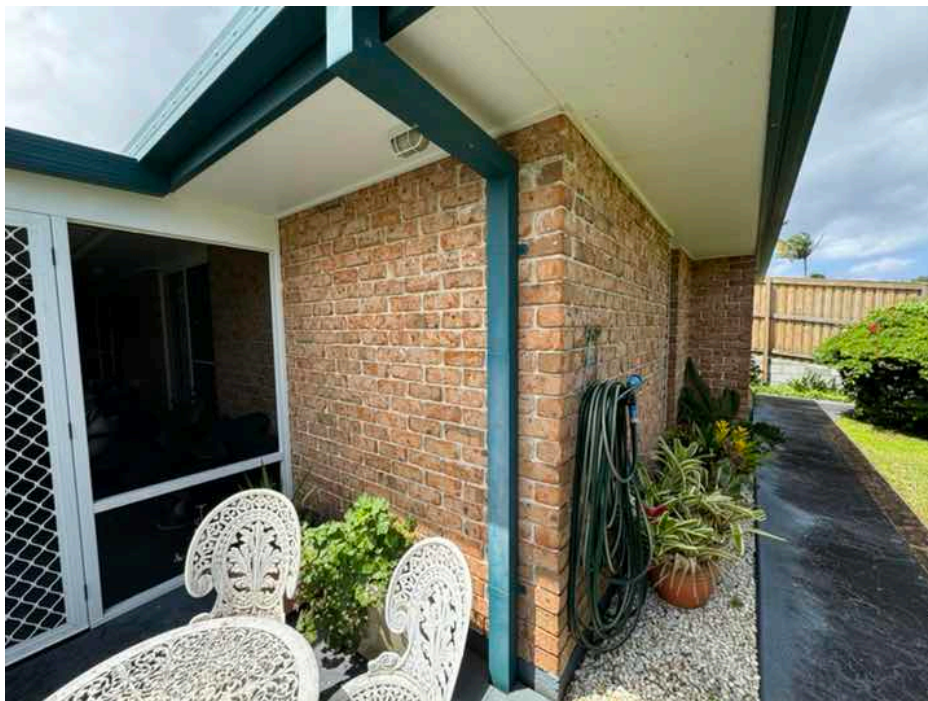
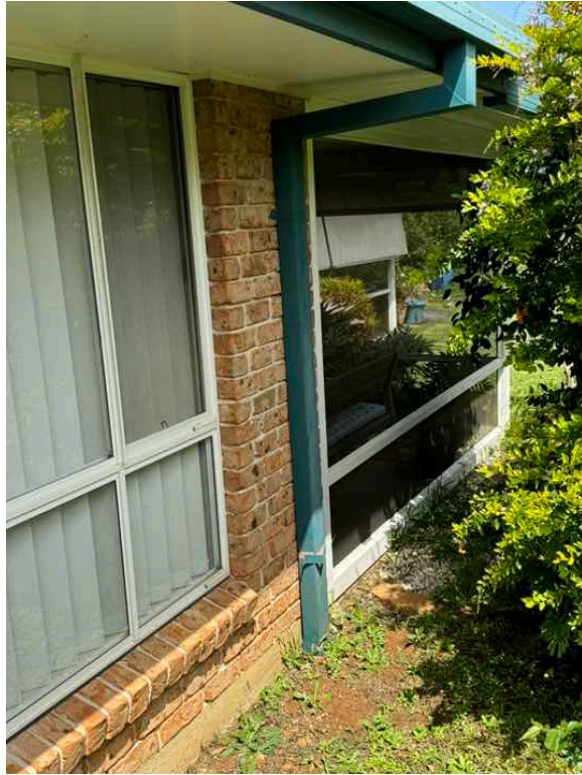
The downpipe/s wall clips is detached or missing. Although minor and easily rectifiable, we recommend a licensed roof plumber be engaged for repairs.

Leaking downpipe joints visible. This can be conducive to termite infestation and cause water damage to cladding over time. A qualified roof plumber should be engaged to repair.

Minor downpipe rust visible. A qualified plumber should be engaged for advice and recommendations.

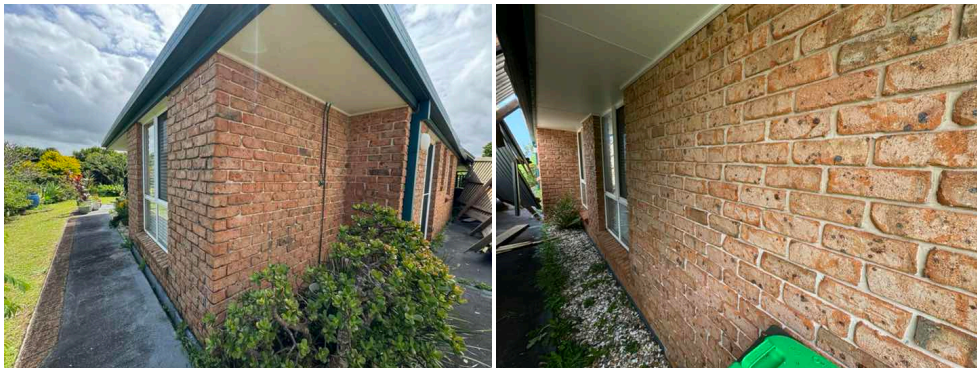
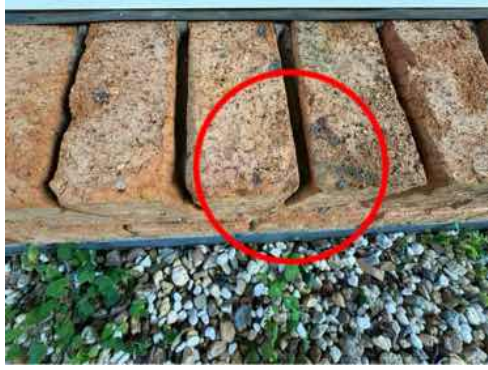
Mortar erosion between the brickwork is eroded. Contact a qualified bricklayer for repairs.

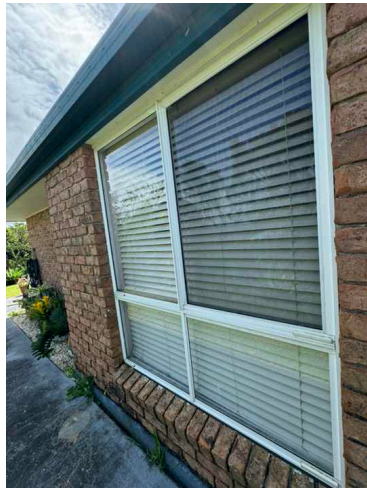
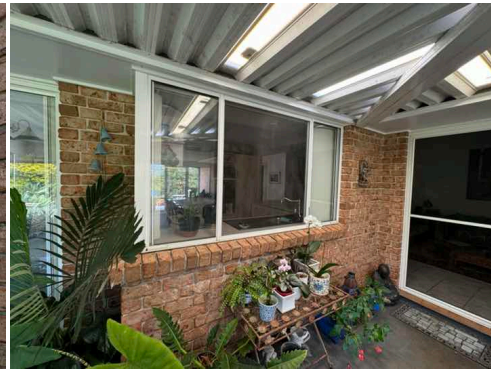
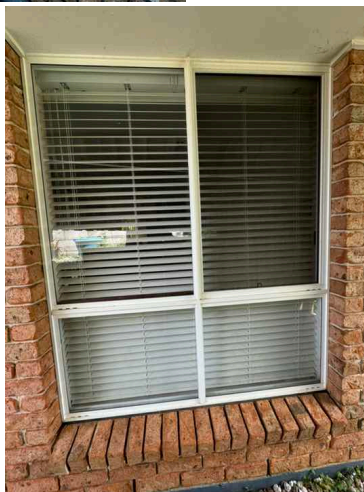
Cracked window pane. A qualified glazier should be engaged to repair.

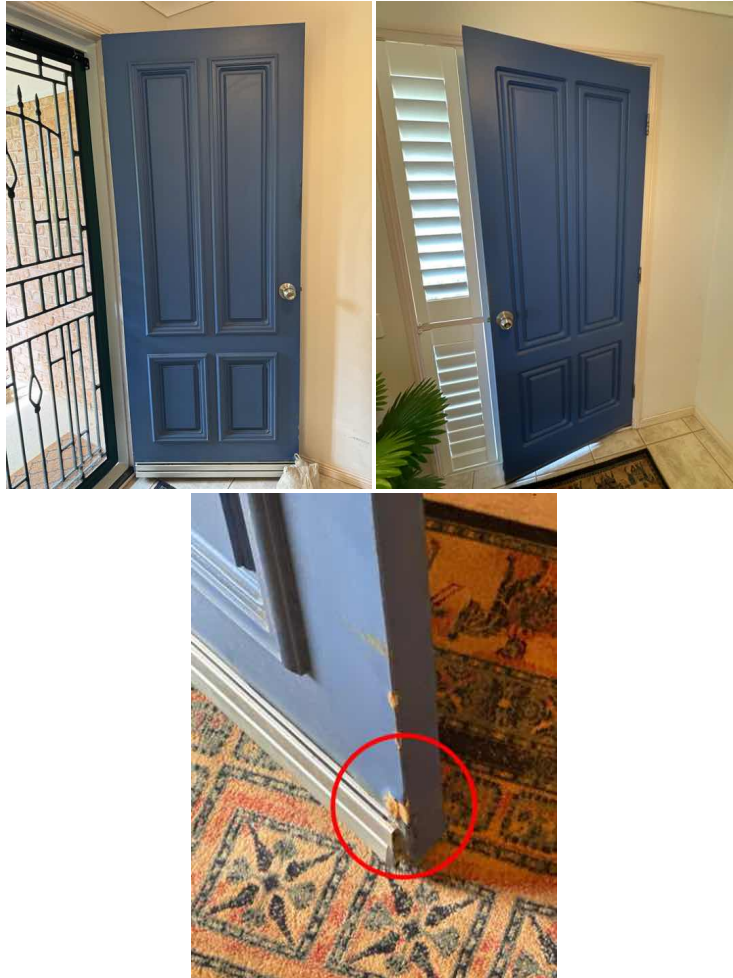
Damp damage to entry door/frame - It appear water has damaged / penetrated areas of the door/frame. I am not able to ascertain if this is still occurring and this can only be ascertained during heavy rainfall periods. If penetration occurs a qualified carpenter should be engaged for advice and recommendations re repair/sealing from weathering.

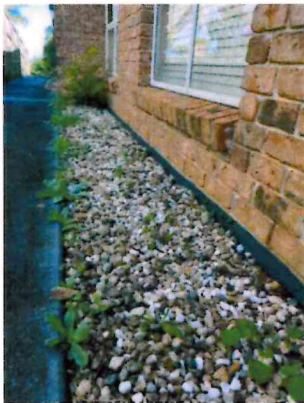
Showing exposed slab edge.

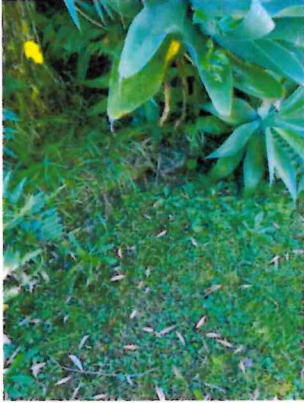
Timber garden edging which is conducive to termite attack.
