Regular Visual Termite Inspection Report in Accordance with AS 3660.2-2017

37 Montwood Drive

37 Montwood Drive
Lennox Head NSW 2478

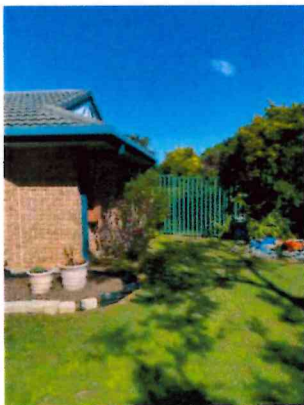
Showing side of dwelling.

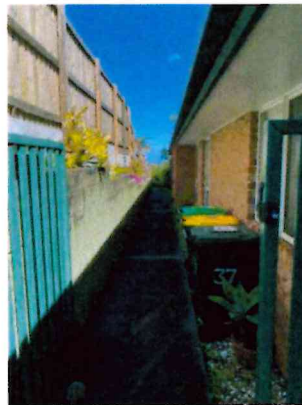
Showing side of dwelling.

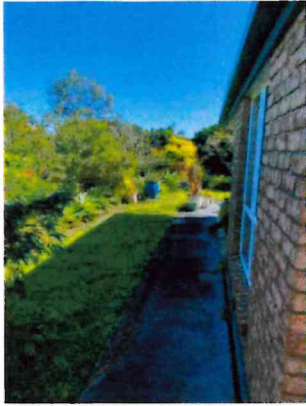
Showing rear of dwelling.

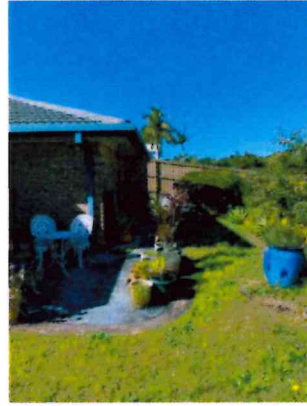
Showing rear of dwelling.

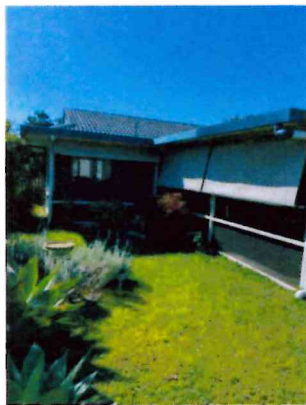
Showing rear of dwelling.

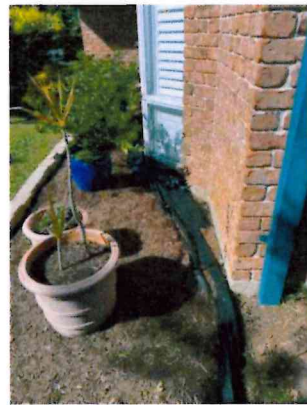
Showing newly exposed slab edge in front garden.

Inspection Zone Type: Concrete Slab Edge Gardens at front that were covering slab edge have now been removed.

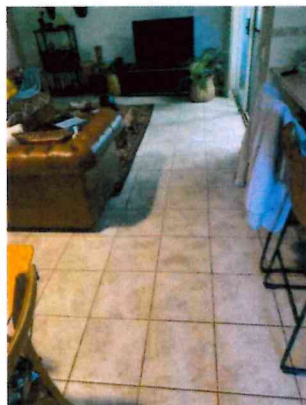
Showing internal flooring.

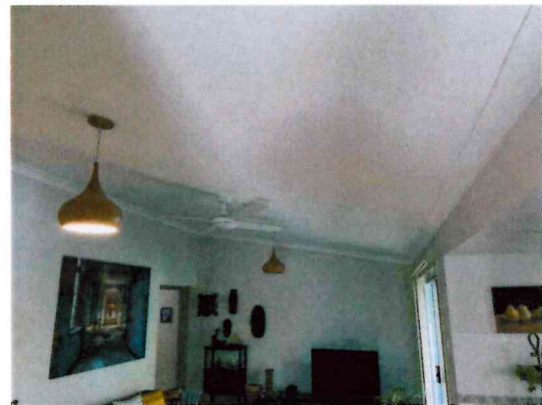
Showing internal roof structure.

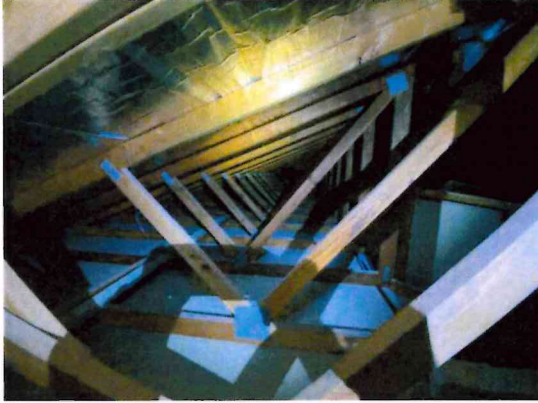
Showing inside roof void.

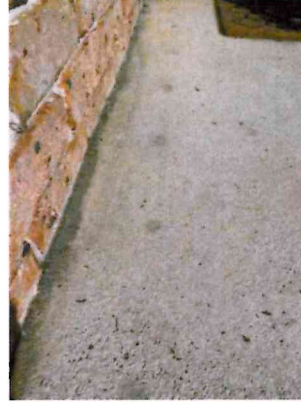
Shows drill holes indicating a previous treatment however no details available.

Drill Holes - External
Drill holes are visible in front and rear concrete areas which is evidence of a previous treatment however no details available.

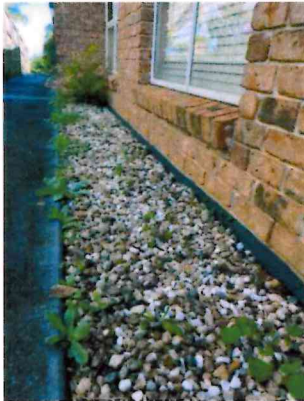
Showing exposed slab edge.

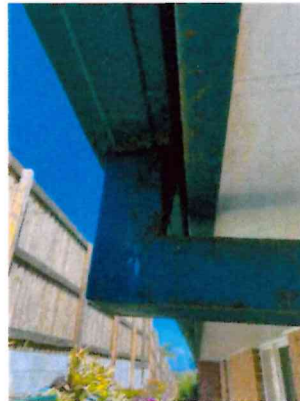
Water Leaks Present
IMPORTANT: The presence of conducive conditions is a termite management hazard as it increases the risk of termite activity at that location. The presence of areas providing potential for hidden termite entry into the structure increases the risk of undetected termite entry and potential termite damage occurring prior to the termite activity being identified or discovered.

This downpipe on the NE corner of the garage is badly rusted and leaking. Persistent leaks are a conducive condition for termites.

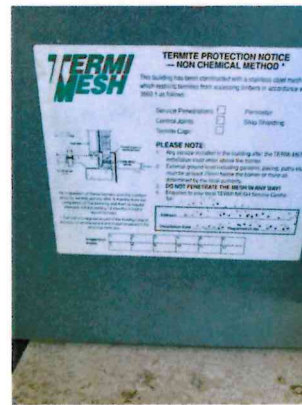
Pre-Construction

Electrical Meter Box

Preconstruction sticker.
