# Building and Pest Report

## 10 Kurrajong Crt East Ballina

| Report/Agreement # | 30102509452070 |
| Inspection Date: | 30 Oct 2025 |

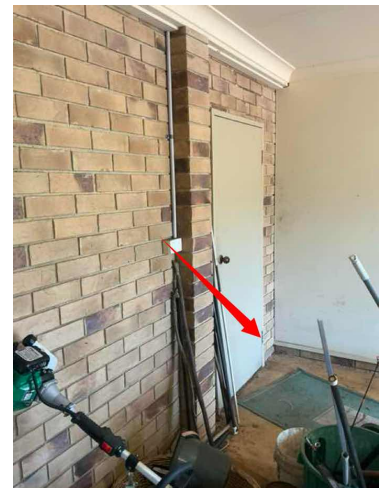
#1. Rust in garage door frame noted - General repair required.

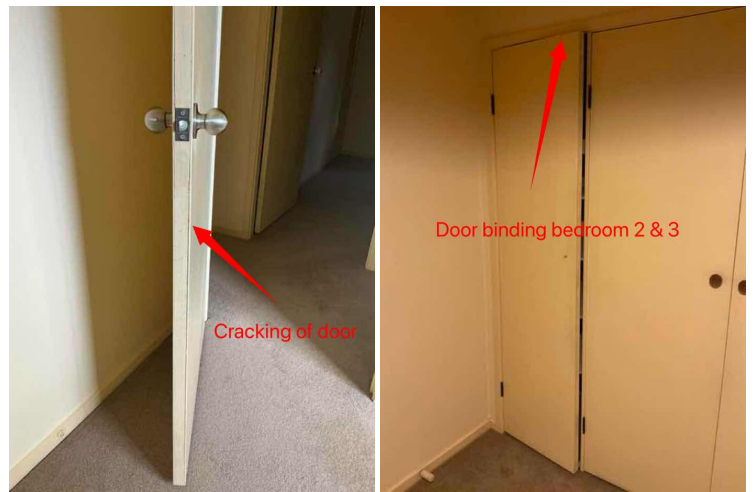
#3. Binding door - Doors that bind on the frame can relate to some differential settlement, frame movement, age, expansion, shrinkage or poor hanging. A qualified carpenter should be engaged for repairs.

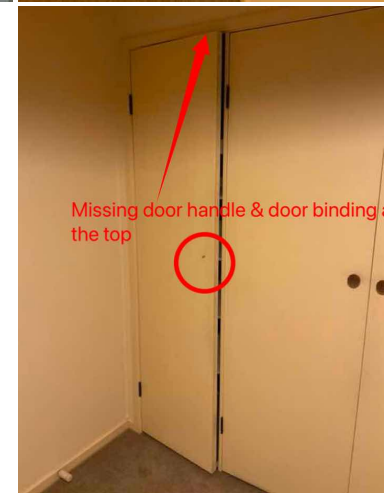
#4. Uneven / out of square door causing binding. A qualified carpenter should be engaged to refit.

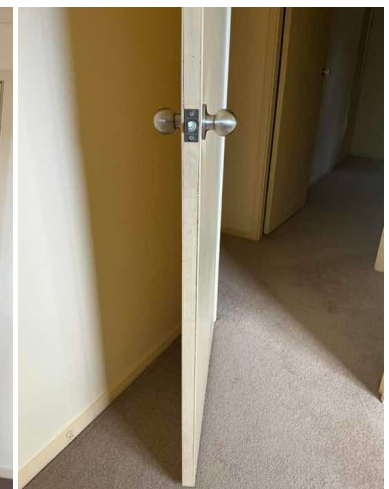
#5. Uneven / out of square door causing binding. A qualified carpenter should be engaged to refit.

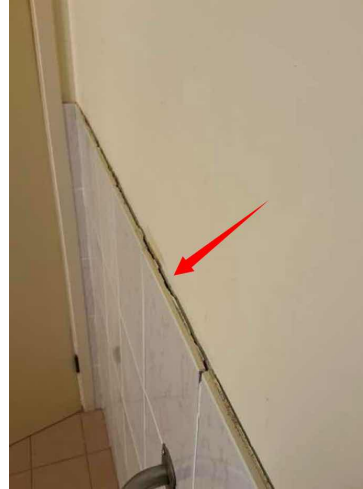
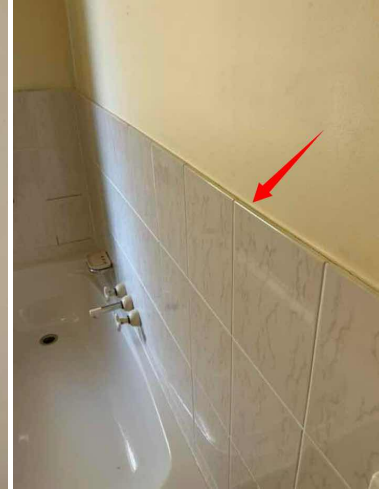
Upon visual inspection, there is a noticeable gap between the wall and the tiles, indicating potential structural movement or poor installation. It is recommended to consult a licensed tradesperson to assess and repair the gap, ensuring proper sealing and alignment to prevent moisture ingress and further damage.

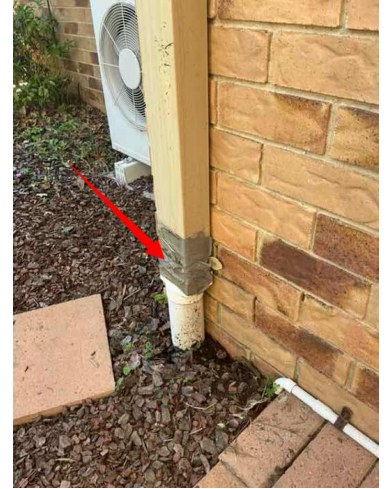
There was water leakage detected during the inspection from some downpipe joins. Consult a roof plumber for a scope of works and cost of repairs for the issue prior to contracts becoming binding.
