Building and Pest Report

33 Outrigger Rd, Lennox Head

Pest And Building Inspection

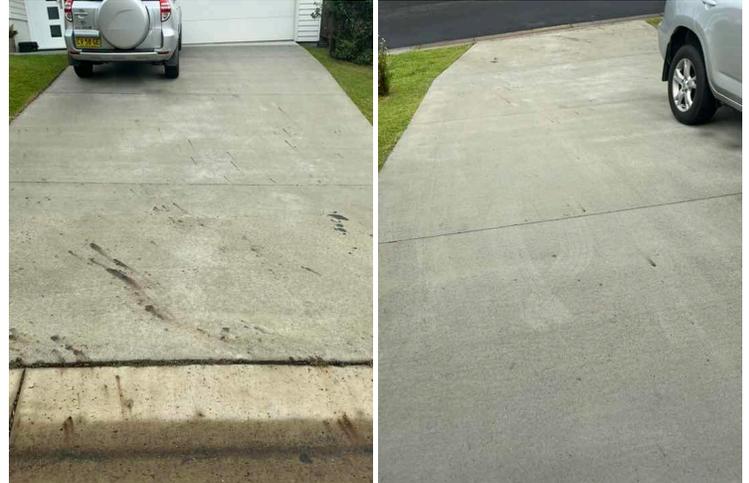
Driveway Condition

On visual inspection, the general condition of the driveway is serviceable.

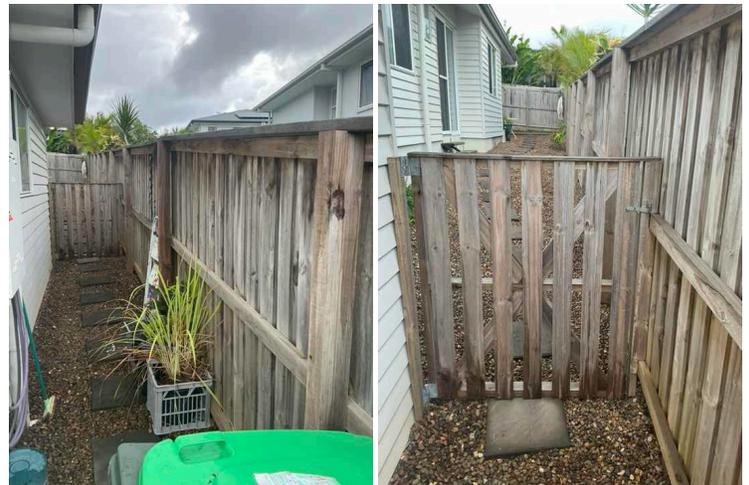
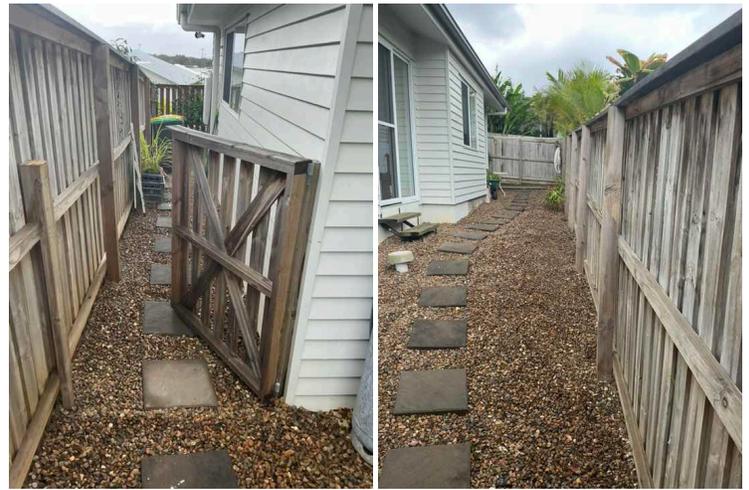
Overall Condition

Of the visible areas, the general condition of the fences and gates is serviceable for the age of dwelling.

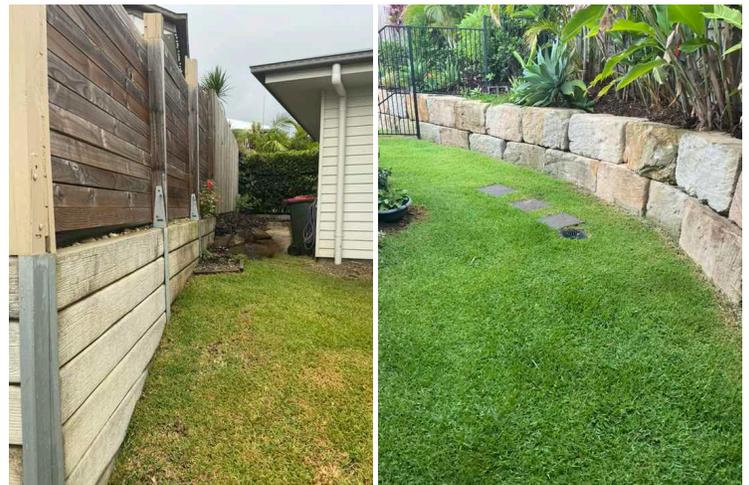
Retaining Walls

Of the visible areas, the general condition is serviceable or in reasonable condition for age of dwelling.

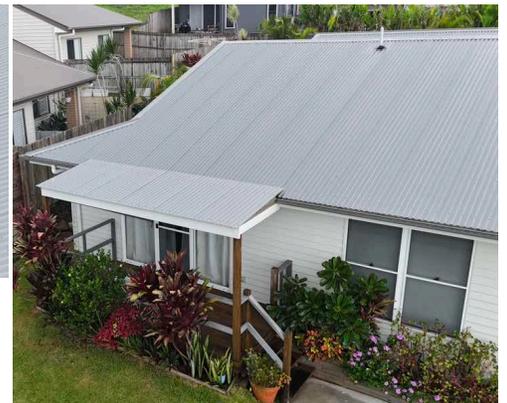
Of the visible areas, the general condition of the roof is in serviceable condition for the age.

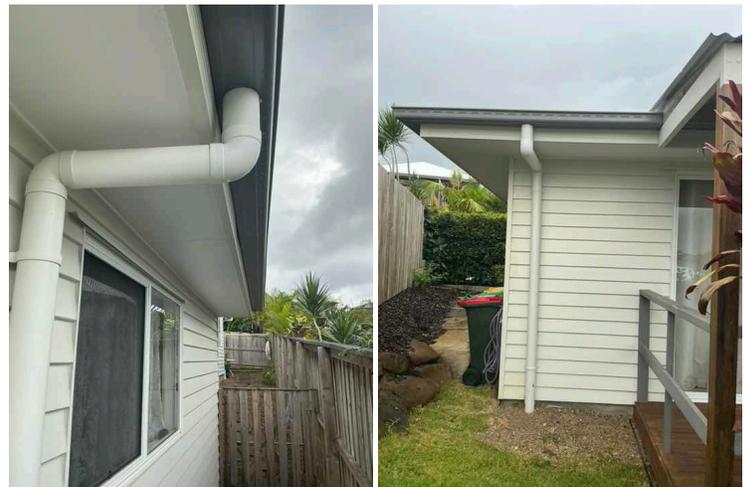
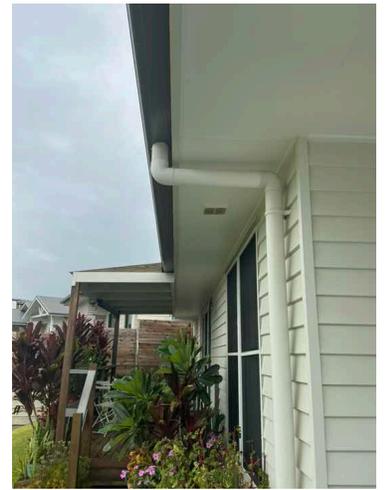
Downpipe Findings

On visual inspection no apparent defects were noted to the down pipes and are considered serviceable, however no comment can be made with regard to blockages or connections to stormwater or functionality in the absence of rain. Note: Periodic maintenance checks should be carried out for rust penetrations and leaks.

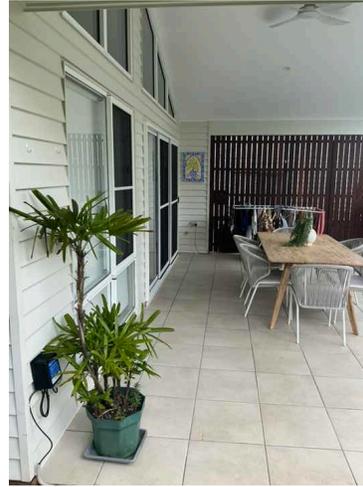
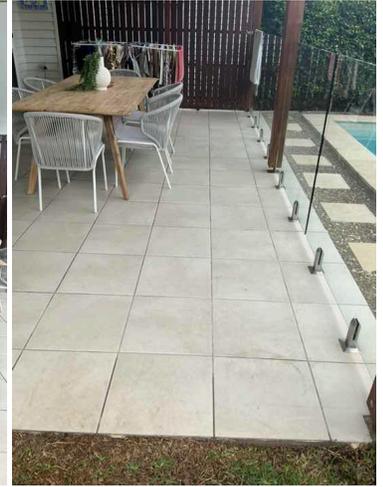
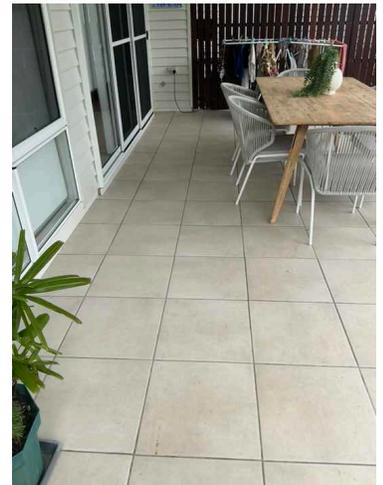
Visible sections of the Alfresco area are serviceable or in reasonable or condition for the age of this dwelling.

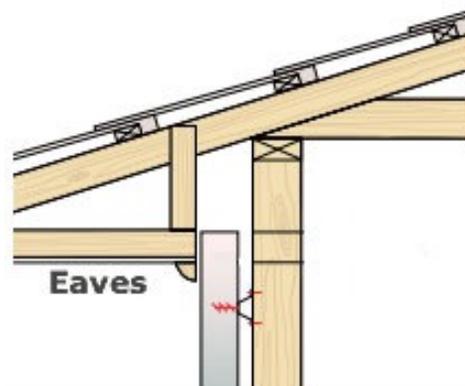
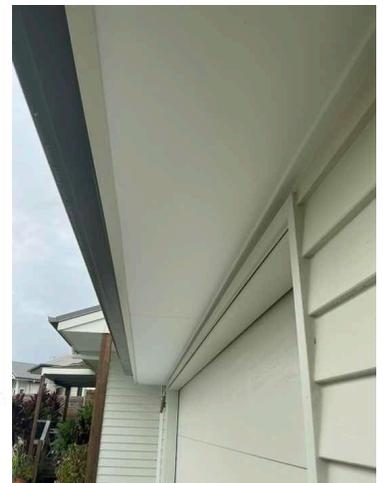
Eaves

The soffit lining (eaves) are in a serviceable condition with no notable defects.

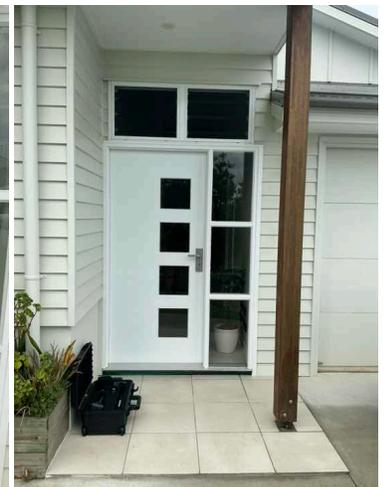
Entry Porch Area

The entry porch serviceable or in reasonable or condition for the age of this dwelling.

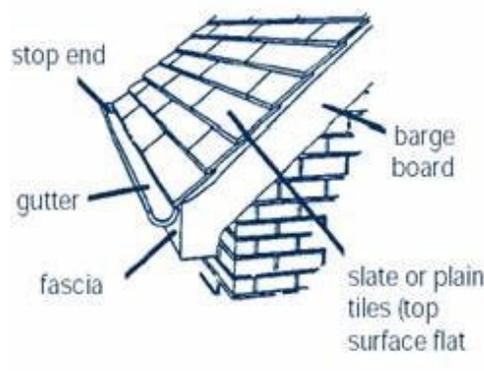
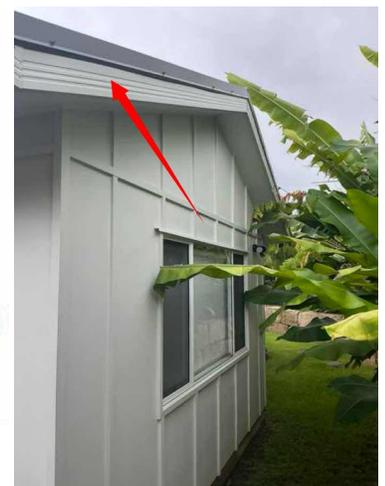
On visual inspection, the general condition of the fascia/barge boards is serviceable.

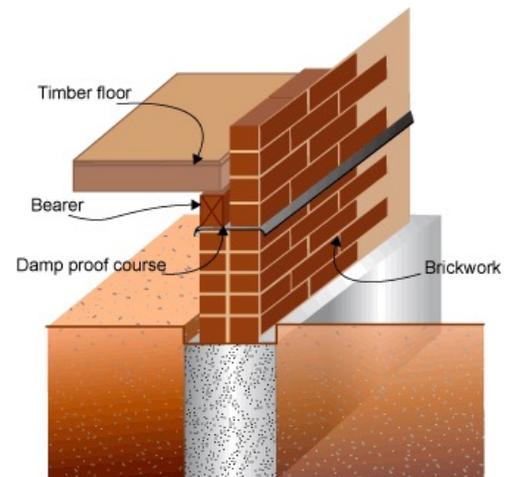
Damp Proof Course

A damp proof course (DPC) was noted.

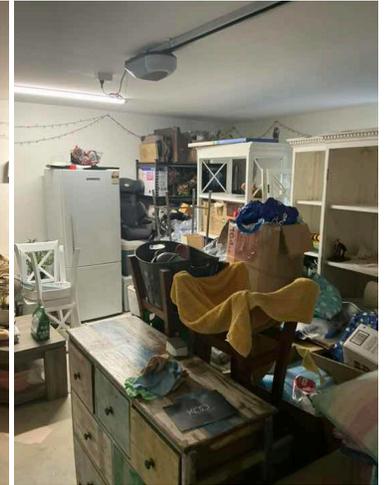
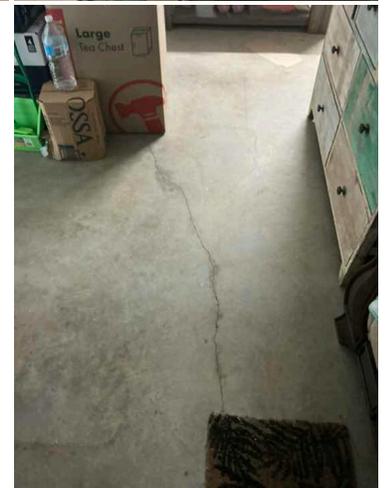
Areas Restricted

Stored items restricted a full and thorough inspection of this area. Defects may exist in the obstructed and inaccessible areas. It is strongly recommended that full access be granted to enable a thorough inspection as there may be timber pest activity, damage or defects. Note: Where vehicles and storage has restricted a full inspection it is advised that this area be cleared so a full and unobstructed inspection can be carried out.

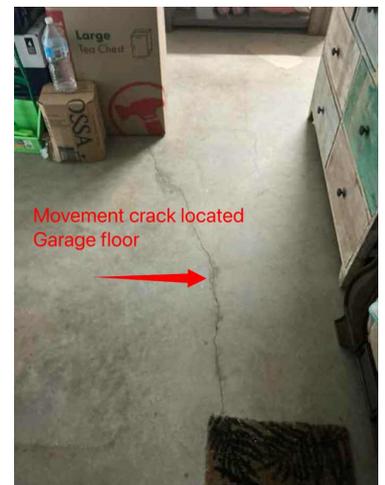
From the visible and accessible areas, the garage appears to be in a serviceable condition for the age of the property with no notable structural defects sighted.

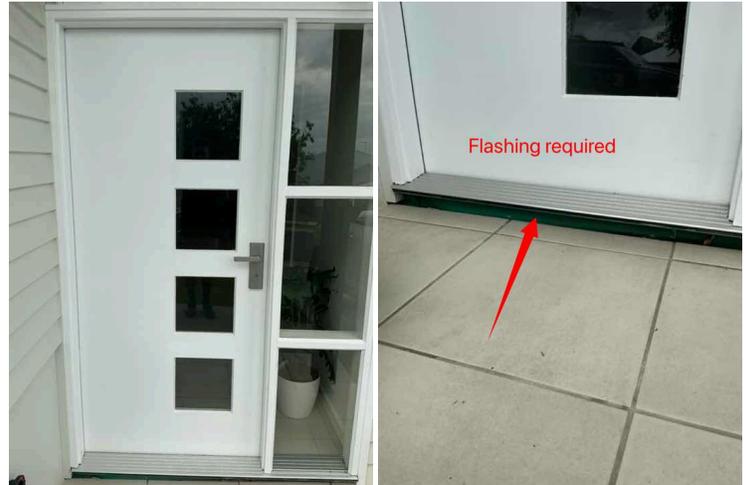
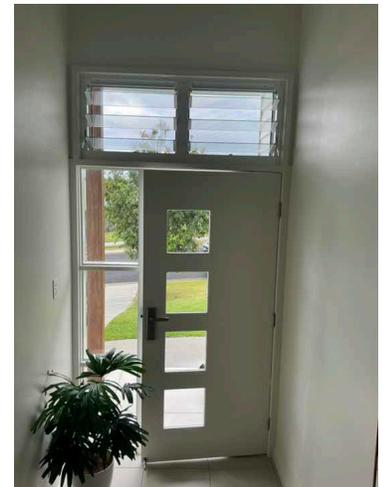
Front Entry Doors

Upon visual inspection, the door threshold appears misaligned, potentially allowing water ingress. Recommend a licensed carpenter to realign and seal the threshold to prevent moisture damage. Ensure proper sealing with weather-resistant materials to maintain structural integrity and energy efficiency.

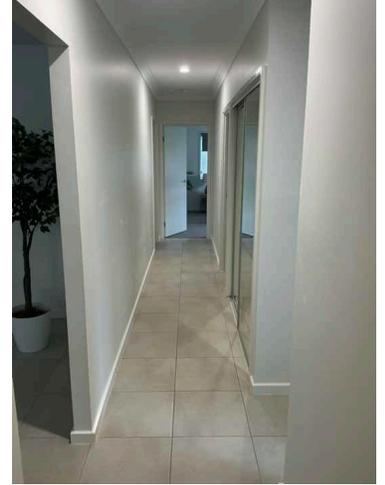
Hallway/s

From the visible and accessible areas, the hallway/s/ appears to be in a serviceable condition for the age of the property with no notable structural defects sighted.

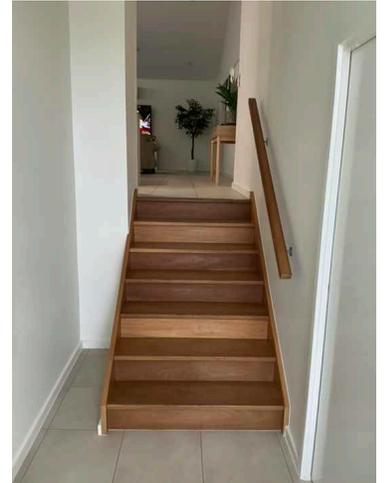
Internal Stair Case

The internal staircase and components appear to be in a serviceable condition for the age with no notable defects sighted.

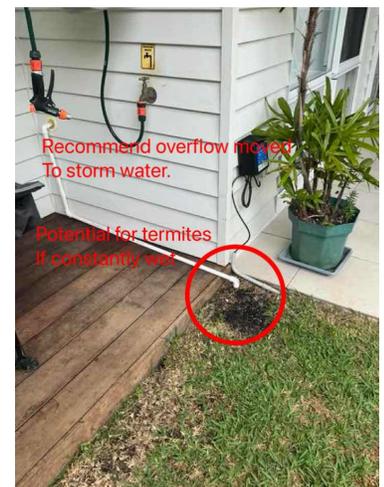
Was the Air Conditioner Sufficiently Drained

No - Divert A/C overflow away from the building perimeter.

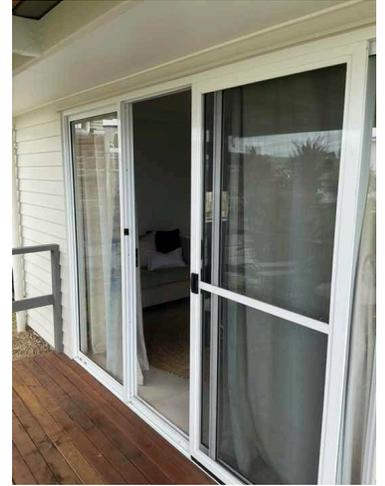
Front Entry Doors

The doors are in serviceable condition with no notable defects observed.

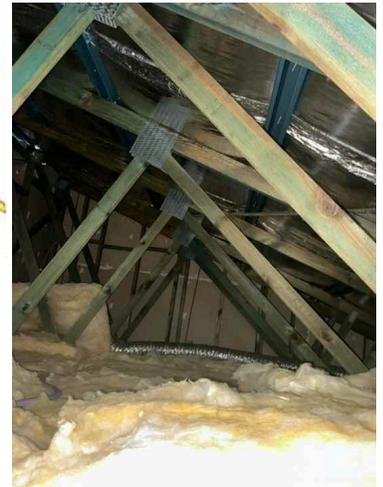
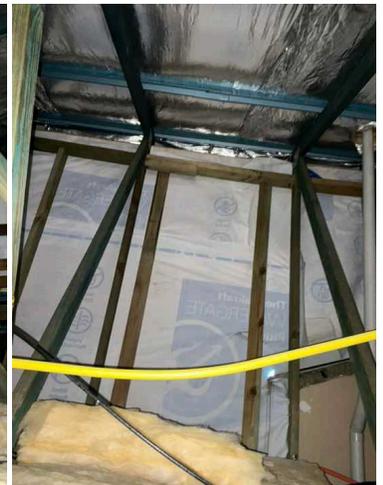
Roof Frame Type

The roof frame is a truss timber frame.
