Timber Pest Report

33 Outrigger Rd, Lennox Head

Visual Timber Pest Inspection and Report in Accordance with AS 4349.3-2010

Reference No: #31456

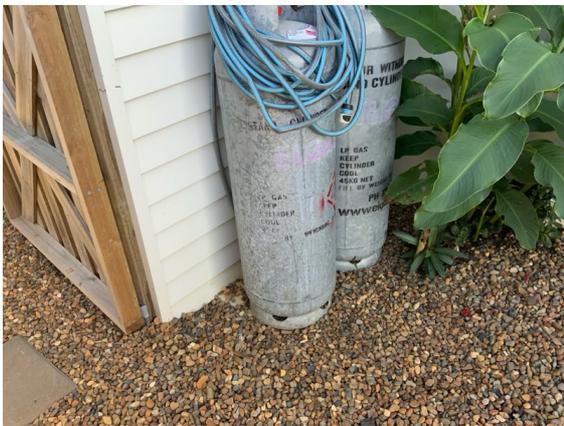
Timbers in ground and soil levels too high restricting visual inspection southern side.

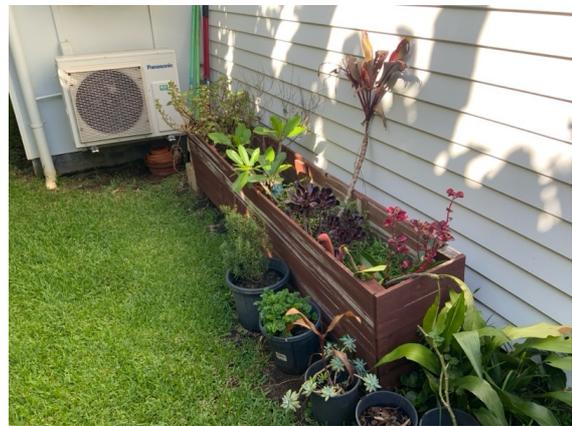
Garden restricting visual inspection

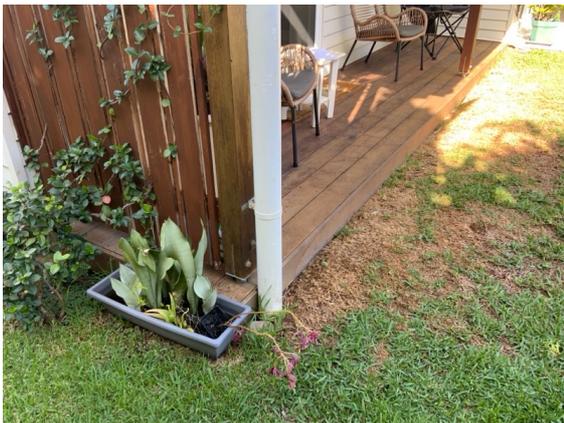
Deck timbers close to or in ground contact covering slab edge.

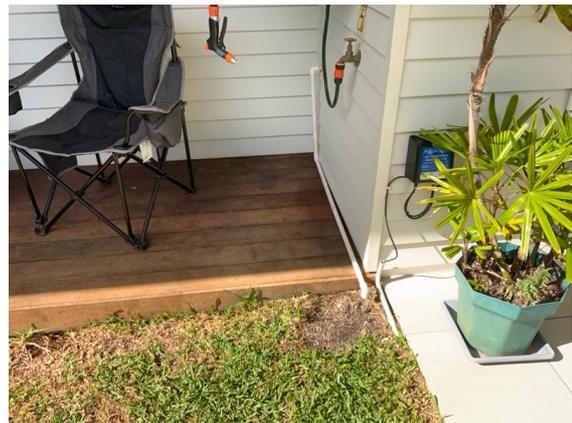
Aircon drain pipe needs diverting away from the house.

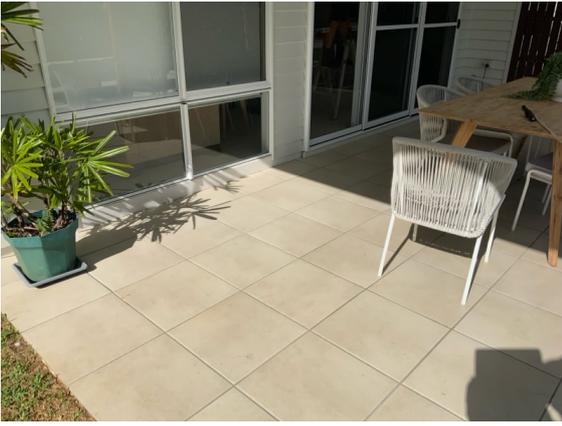
Slab edged covered by hard surface.

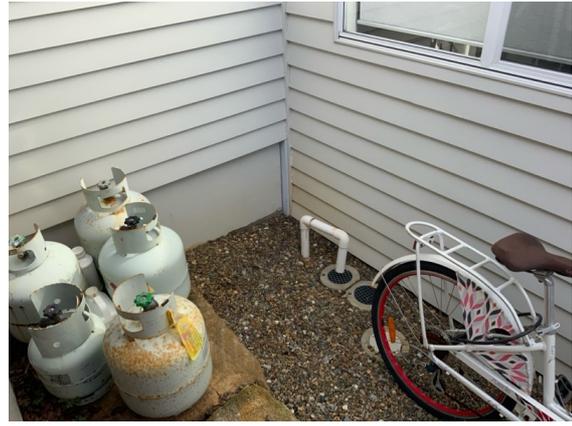
Timbers in ground and soil levels too high restricting visual inspection northern side back of granny flat.

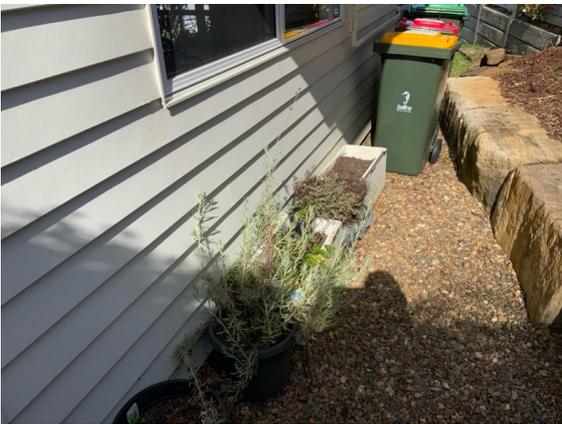
Stored items northern side restricting visual inspection.

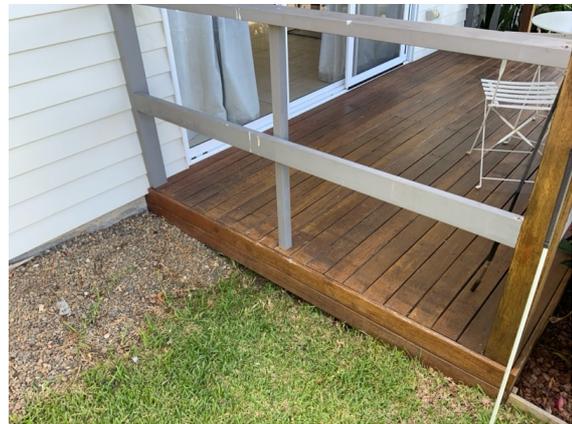
Timbers deck in ground at front of granny flat.

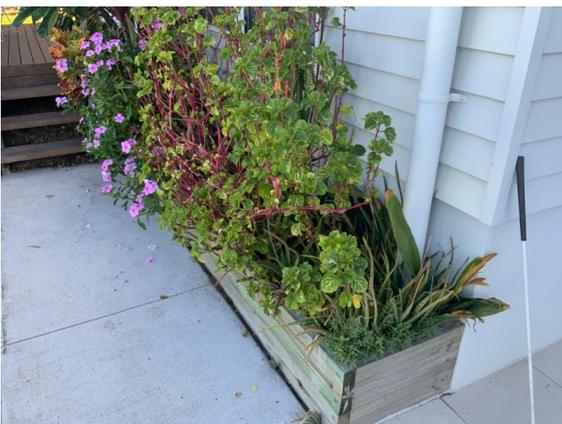
Front timber garden butting up to dwelling restricting visual inspection.

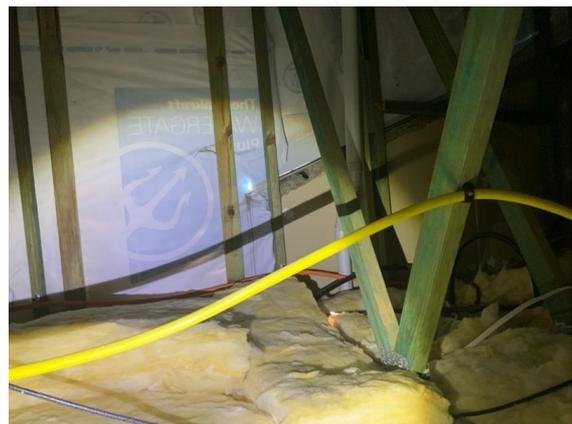
Leaking roof
Granny flat roof leak eastern side.

Roof leak, tare in sarking eastern side in granny flat.
