# Building and Pest Report

## 125a Montwood Drive Lennox Head

# BPI BUILDING & PEST INSPECTIONS

# BPI - INSPECTION REPORT

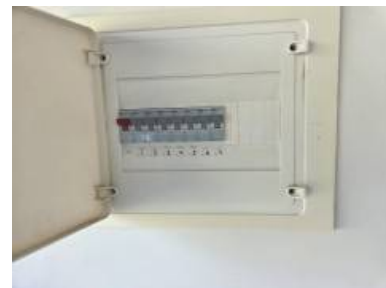
Whilst not an electrician, it appears that an electrical safety switch is present.

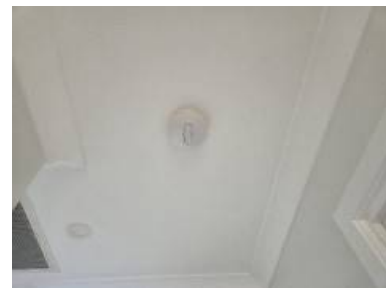
Present - Hall.

- Smoke alarms are noted but not tested, this is outside the scope of a standard building report & our expertise.
- *Pushing the "Test" button only verifies that there is power to the alarm (either a battery or hard wired to the house power) and not the operational workings of the alarm. The operational check is done by filling the sensor with smoke and is beyond the scope of this inspection.*
- A smoke alarm specialist should be consulted to test & advise on those installed or install new detectors / alarms if / where required.
- Any existing smoke alarms manufactured more than 10 years ago should be replaced with photoelectric smoke alarms which comply with Australian Standards (AS) 3786-2014.
- Battery operated smoke alarms should be checked routinely and the batteries changed frequently.

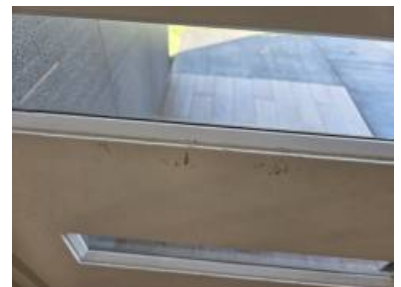
Paintwork to some doors requires touching up / repainting.

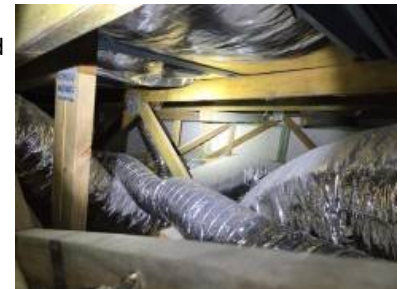
Inspection over the eaves was restricted due to the low pitch and construction allowing only a limited visual inspection from a distance of some areas to be carried out.

Clearance within sections of the roof was too low to allow body access. Outer top wall plates and framing timbers were not inspected due to the area being too low to allow body access. This allows only a limited visual inspection from a distance of some areas to be carried out.

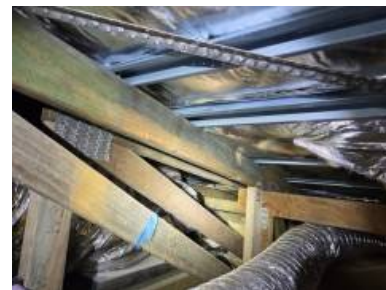
The roof framing is in satisfactory / typical condition for the age / construction date.

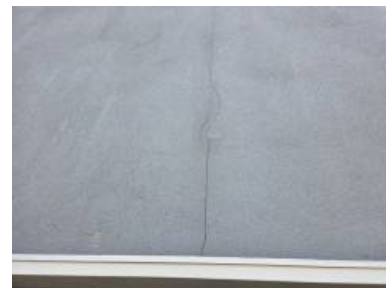
Hairline cracks to some rendered sheet joins over garage.

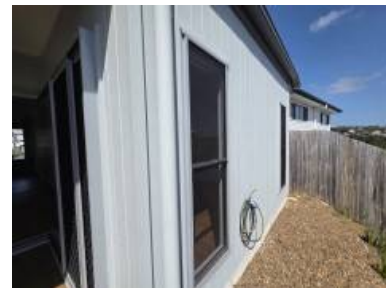
The external paintwork / finish to the external surfaces and timberwork is generally satisfactory. There are some sections / areas that require touching up / repainting.

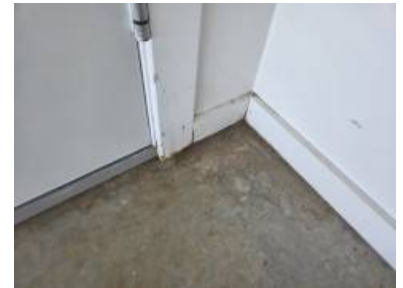
Condition:  
Past water penetration to around side door.

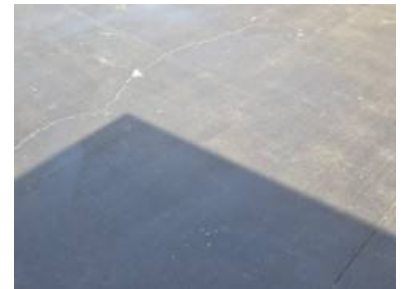
Some surface cracks to concrete slabs.
