# Building and Pest Report

## 21 Kellie-Ann Cres Lennox Head

| Inspection Date: | 31 Jan 2025 |

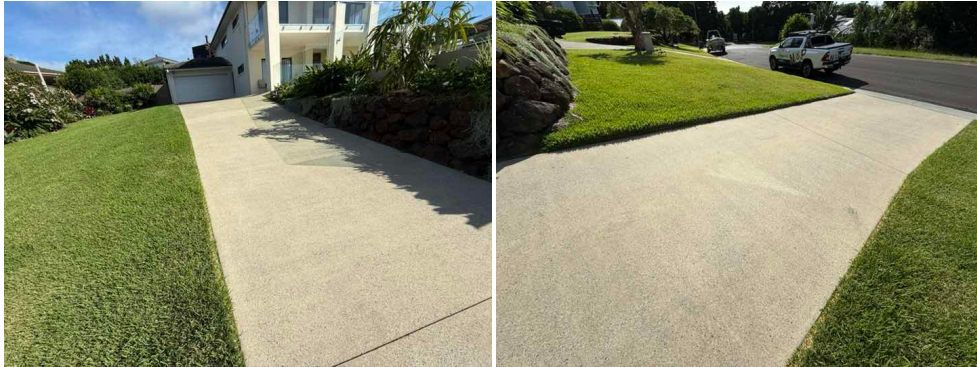
Common cracks were observed on the driveway. Whilst these cracks appeared to be typical at the time of inspection, we strongly recommend you monitor these cracks and if worsening occurs contact a concreter for further advice.

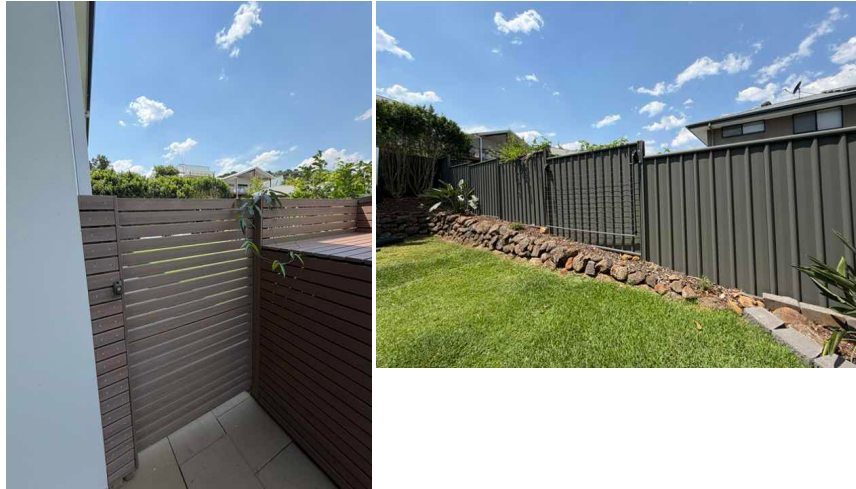
General age/damage/binding of gate/s components - Recommendations: A qualified fencing contractor should be engaged for advice and recommendations.

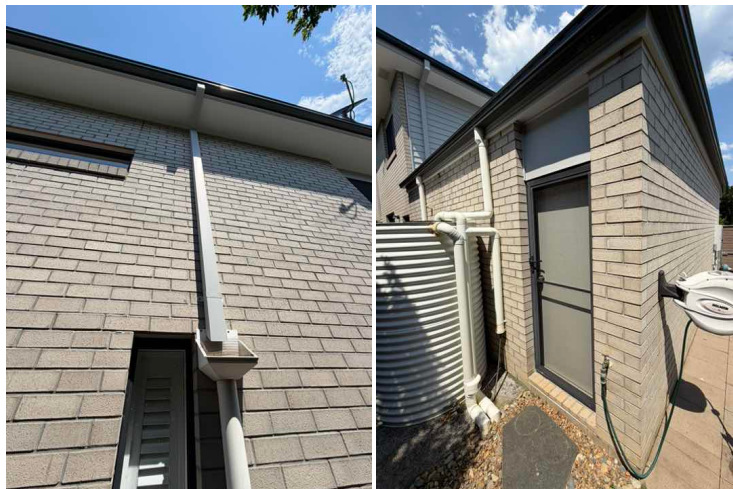
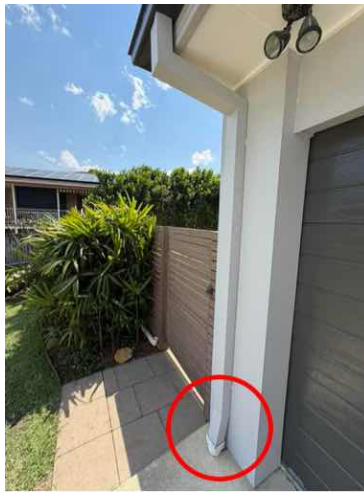
The downpipe base is damaged/cracked. This has the potential to cause leaking. Recommendations: A qualified plumber should be engaged for repairs.

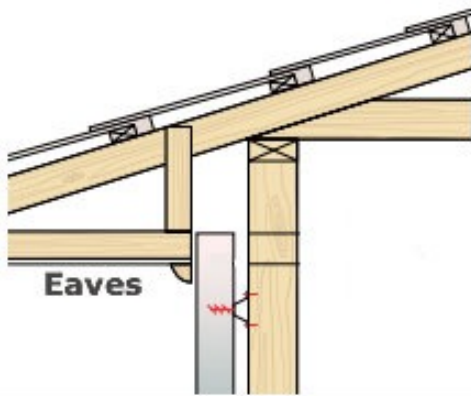
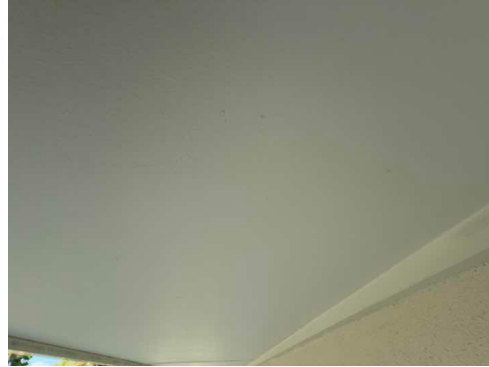
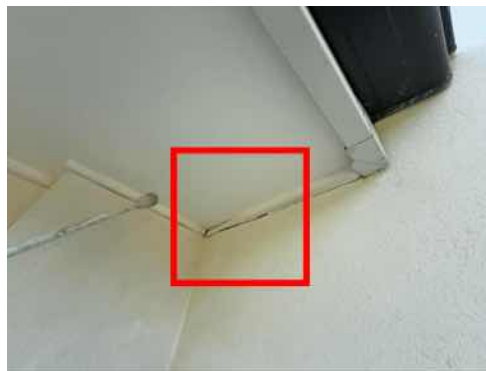
Quad deteriorated or detached. Contact a licensed carpenter for repairs.

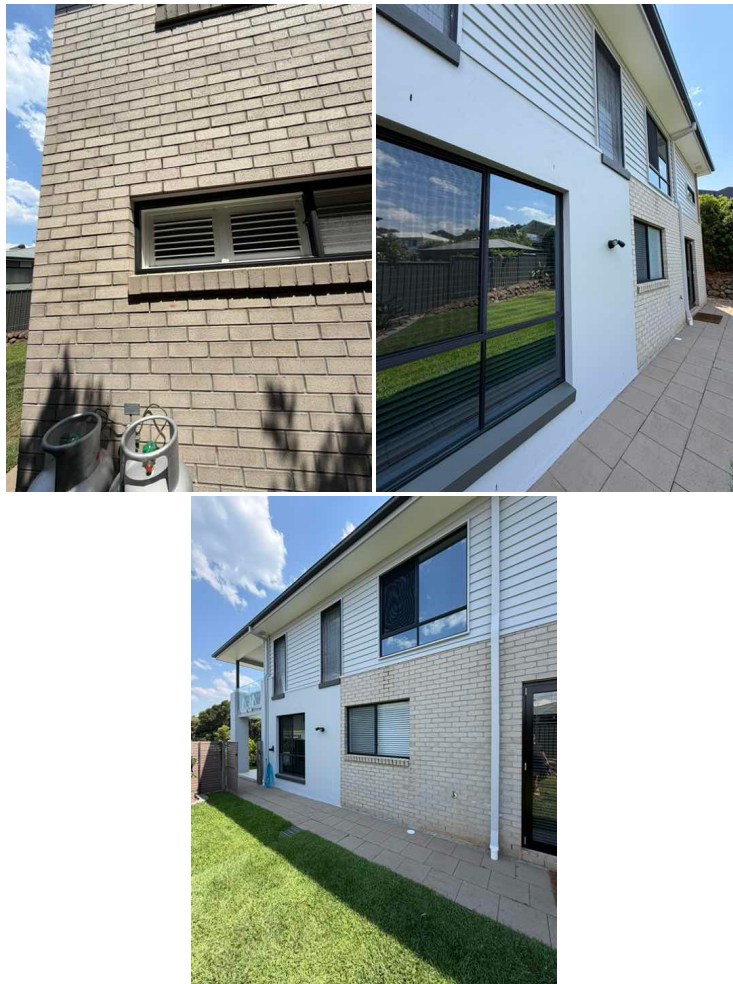
There appears to have been some settlement in the building which has caused some cracking to the walls. These cracks are categorized as 0 to 2. This can also cause some doors to bind or be out of square. In the inspectors opinion these cracks are due to settlement, usually due to ground movement and subsequent movement to building materials can be expected. Any cracks should be monitored and if cracks increase in size, further investigation should be carried out by a structural engineer.

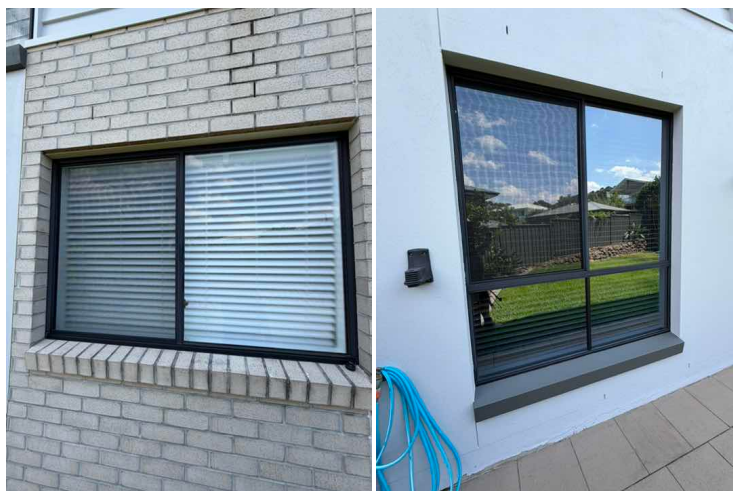
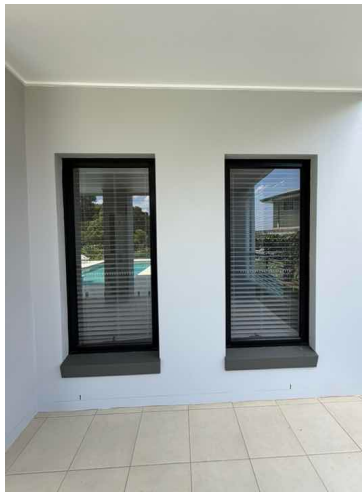
Minor Timber fungal decay is evident in sections of the window framework - Some areas should be replaced. A qualified carpenter should be engaged for advice and recommendations.

Damaged fly screen/s replace as required.

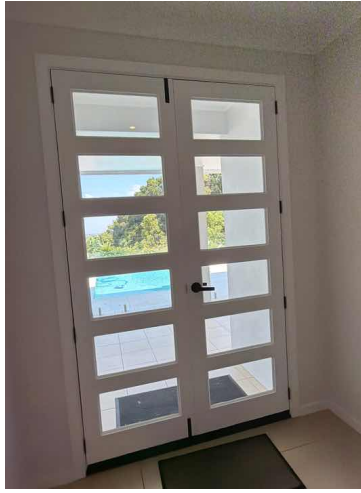
Binding entry door - Doors that bind on the frame can relate to some differential settlement, frame movement, age, expansion, shrinkage or poor hanging. A qualified carpenter should be engaged for repairs.

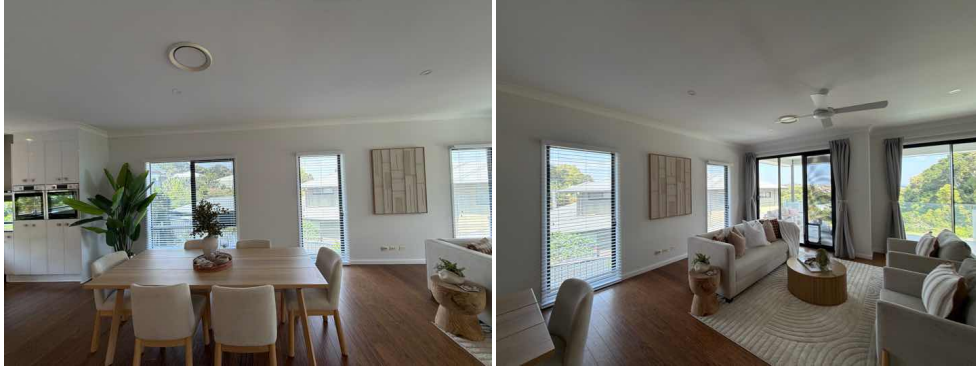
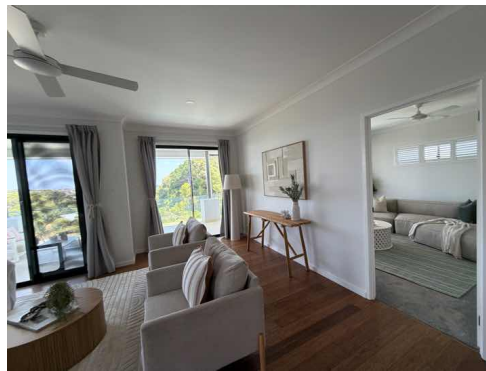
Typical cornice separation/detachment observed. I recommend you contact a qualified painter for repairs.

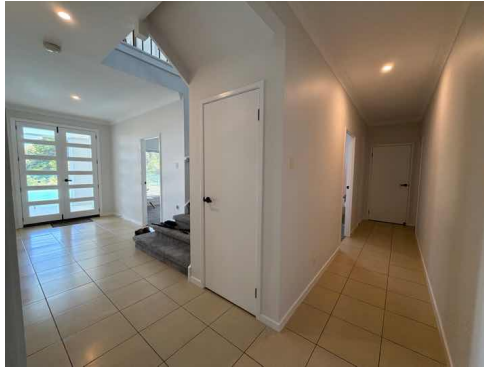
Ceiling stains - No moisture readings obtained. These may have been repaired however you will need to monitor after a prolonged period of rainfall. If leaking persists, a qualified plumber should be engaged for advice and recommendations. All water damaged plaster should be replaced.

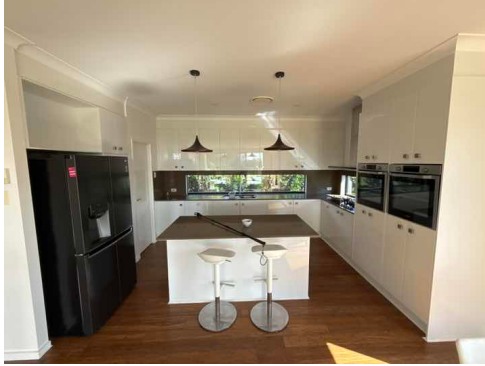
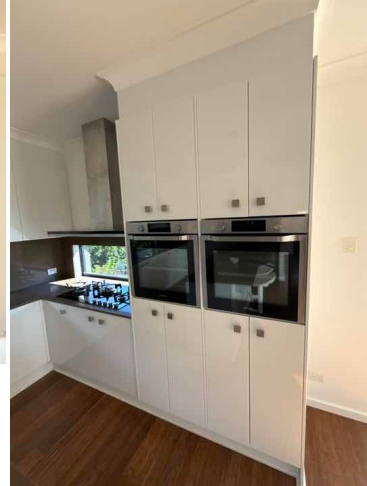
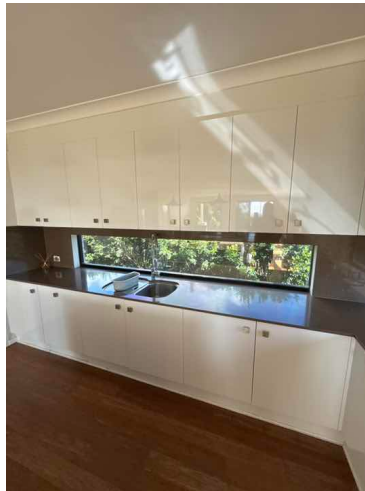
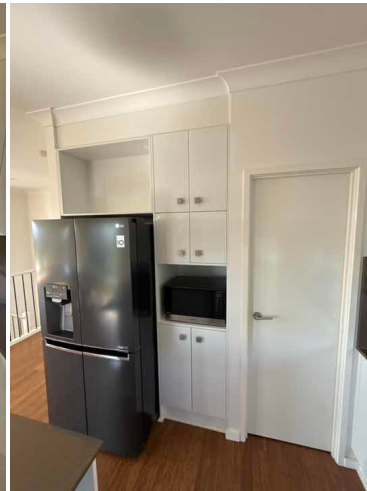
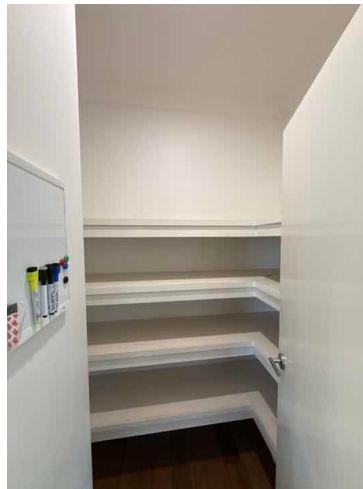
Adjustment to cabinet doors required, in some instance hinges may need to be replaced.
