Building and Pest Report

1/4 Chauvel Close Skennars Head

Pest And Building Inspection

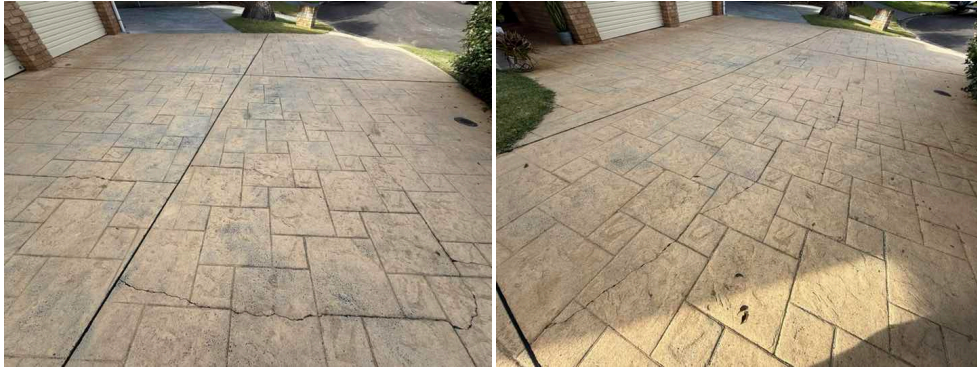
Driveway Condition

On visual inspection, the general condition of the driveway is serviceable.

Common cracks were observed on the driveway. Whilst these cracks appeared to be typical at the time of inspection, we strongly recommend you monitor these cracks and if worsening occurs contact a concreter for further advice.

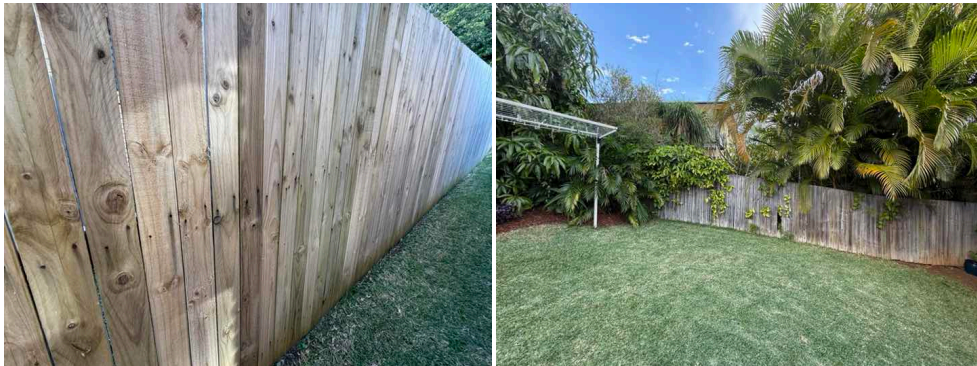
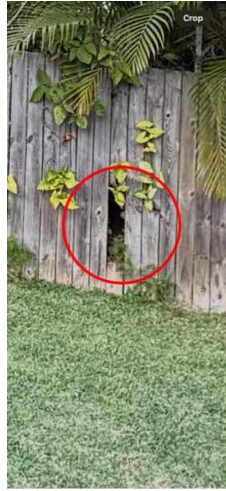
Fences & Gates

Of the visible areas, the general condition of the fences and gates is serviceable for the age of dwelling.

Fence rot/leaning. Repairs are required by a fencing contractor to avoid unsafe conditions.

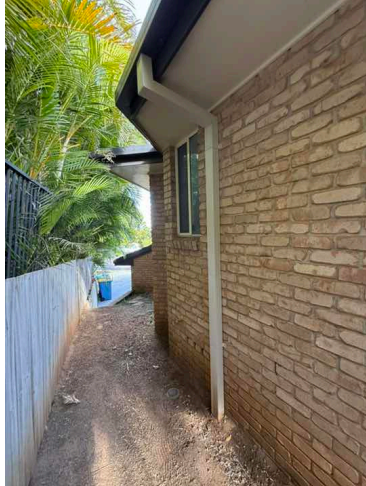
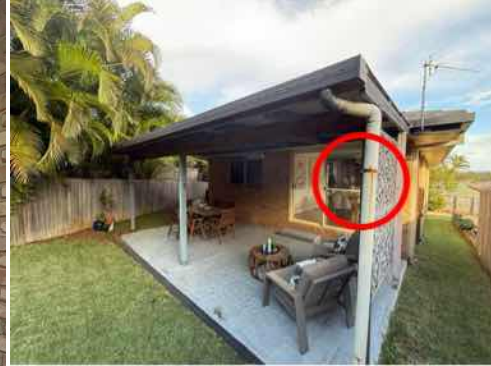
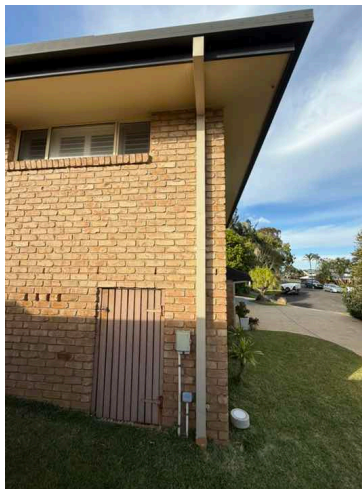
Downpipes

On visual inspection no apparent defects were noted to the down pipes and are considered serviceable, however no comment can be made with regard to blockages or connections to stormwater or functionality in the absence of rain. Note: Periodic maintenance checks should be carried out for rust penetrations and leaks.

The downpipe/s wall clips is detached or missing. Although minor and easily rectifiable, we recommend a licensed roof plumber be engaged for repairs.

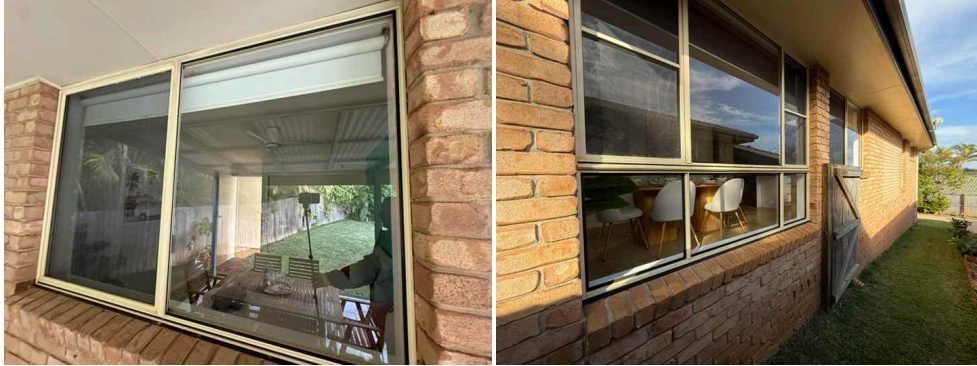
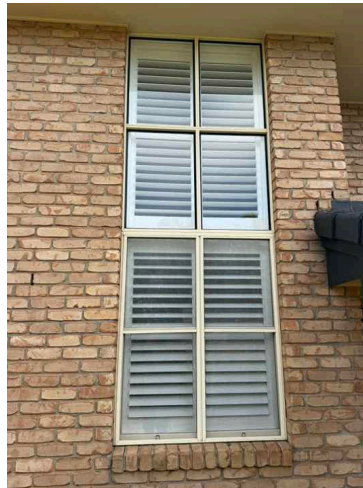
Windows

On visual inspection, the general condition of the windows is serviceable for the age.

Damaged fly screen/s replace as required.

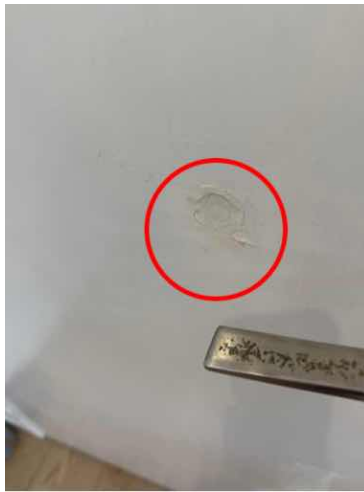
Door Findings

Impact damage observed. Repairs/Replacement recommended.

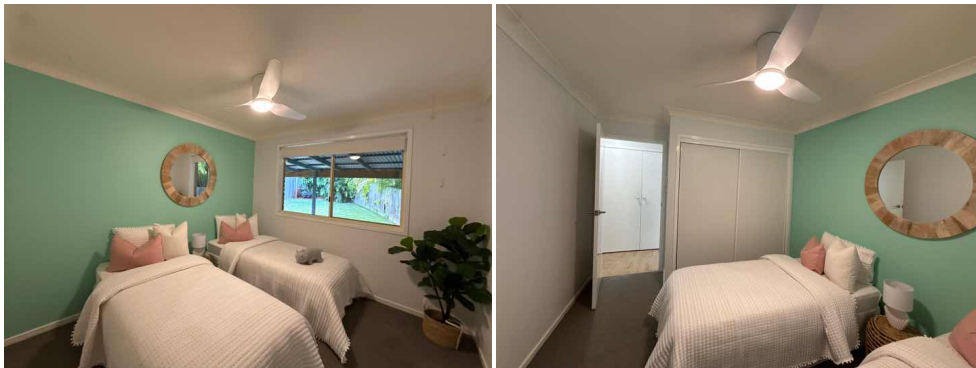
Squeaky floor boards noted. Re-fixing the floor boards may fix this issue.

From the visible and accessible areas, this bedroom appears to be in a serviceable condition for the age of the property with no notable structural defects sighted.

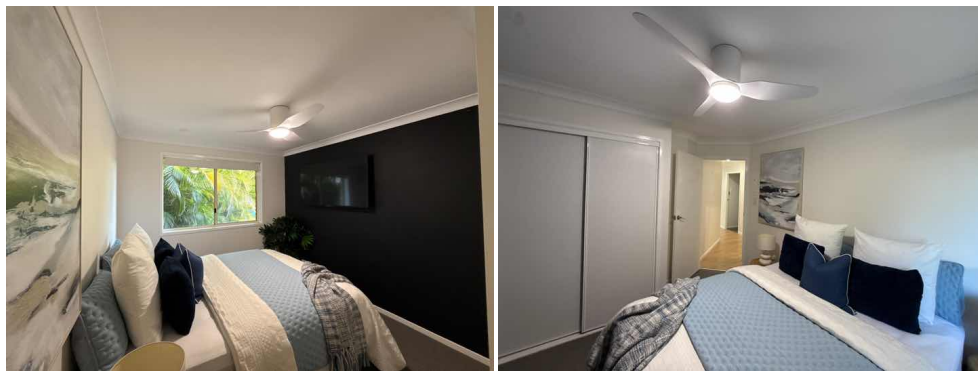
Door stop should be fitted - Wall damage from door handle impacting wall lining has occurred. I recommend you contact a qualified painter for repairs.

Typical cornice separation/detachment observed. I recommend you contact a qualified painter for repairs.

From the visible and accessible areas, this bedroom appears to be in a serviceable condition for the age of the property with no notable structural defects sighted.

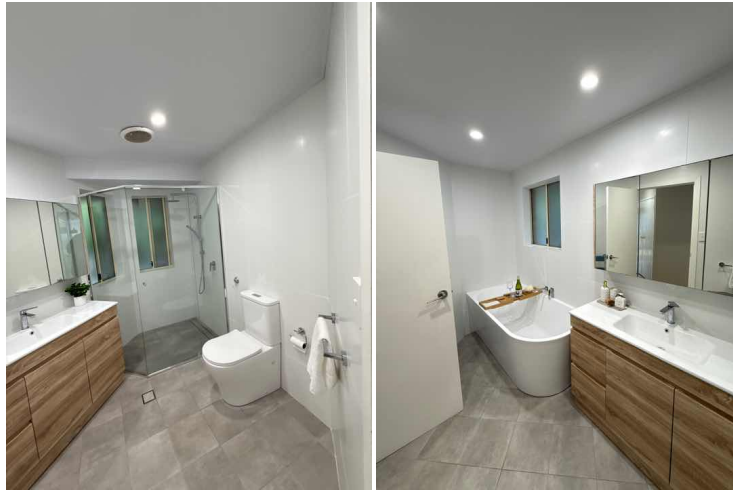
Typical cornice separation/detachment observed. I recommend you contact a qualified painter for repairs.

Of the visible areas, the general condition of this bathroom is serviceable or in reasonable condition for age of dwelling.

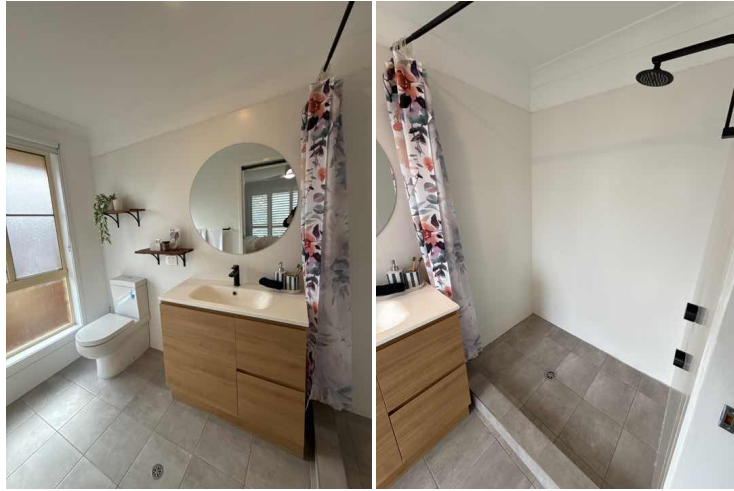
Binding/out of square door frame - This can relate to some differential settlement in the footings, frame movement, age, expansion, shrinkage and the like. A qualified carpenter should be engaged for advice and recommendations.

The vanity mirror is desilvering at edges. Replacement recommended.

Of the visible areas, the general condition of this bathroom is serviceable or in reasonable condition for age of dwelling.
