Building and Pest Report

1/35 Dress Circle Drive Lennox Head

Inspection Report

Pest And Building Inspection

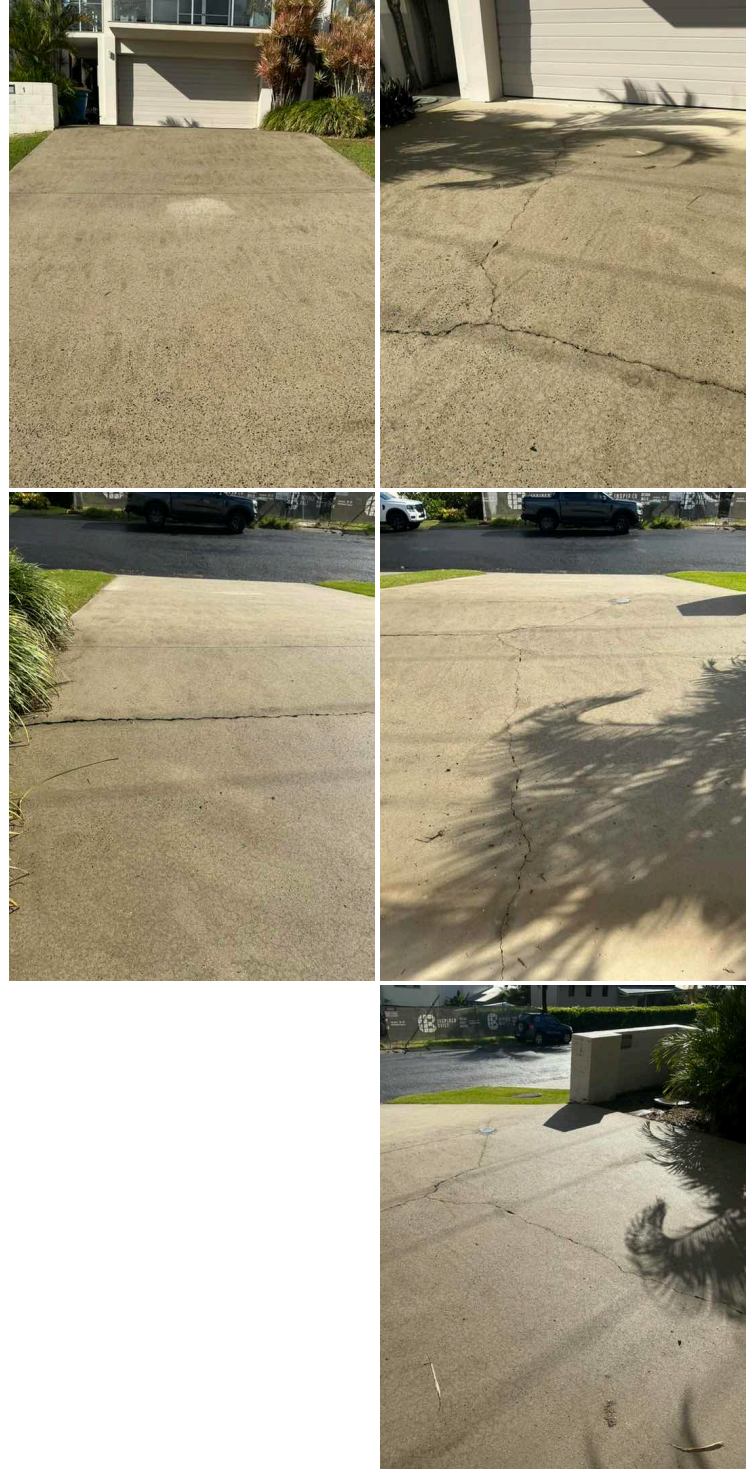
Common cracks were observed on the driveway. Whilst these cracks appeared to be typical at the time of inspection, we strongly recommend you monitor these cracks and if worsening occurs contact a concreter for further advice.

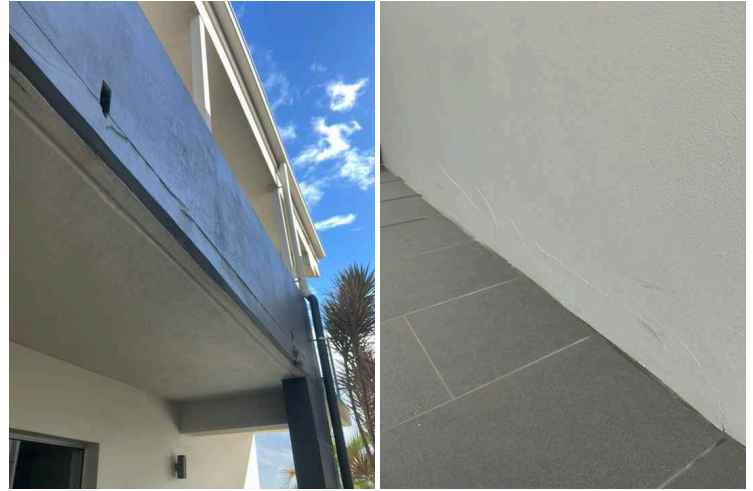
#1. There appears to have been some settlement in the building which has caused some cracking to the walls. These cracks are categorized as 0 to 2. This can also cause some doors to bind or be out of square. In the inspectors opinion these cracks are due to settlement, usually due to ground movement and subsequent movement to building materials can be expected. Any cracks should be monitored and if cracks increase in size, further investigation should be carried out by a structural engineer.

For clarification on the category of cracks please refer to Cracking of Building Elements in Section 2D of the Terms and Conditions contained in this report.
