# PEST AND BUILDING PRE-PURCHASE REPORTS

# BPI BUILDING & PEST INSPECTIONS

### INSPECTION ADDRESS

40 Byron Street  
Lennox Head

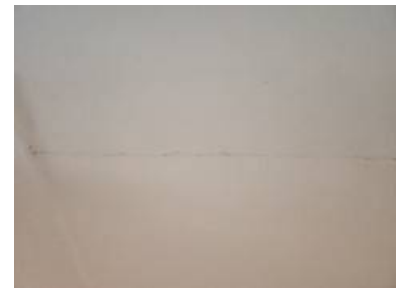
Minor crack to ceiling sheet join to Hallway.

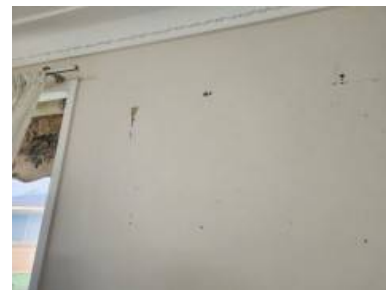
Some minor damage to wall sheeting requires touching up / repair / repainting.

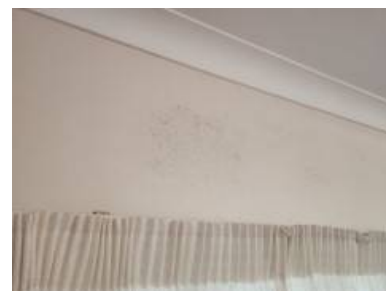
Mould to some walls in old garage.

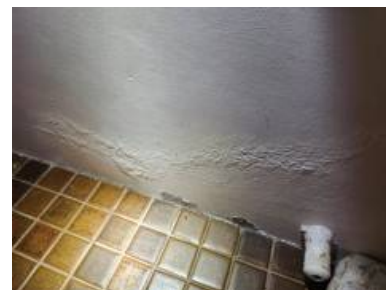
Signs of water penetration to back of laundry shower wall.

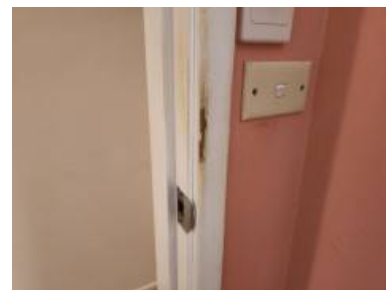
Some skirting and architraves require patching and painting.

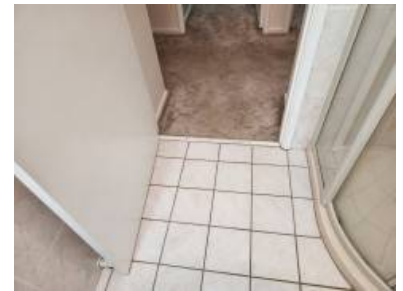
Squeaky flooring to some areas.

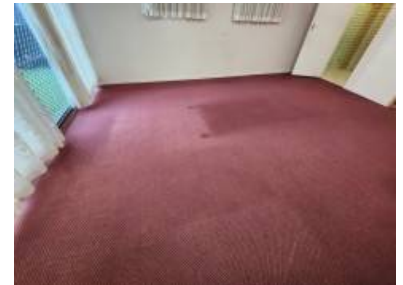
Slab levels vary.

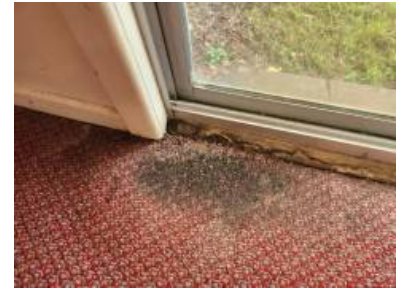
Some flooring shows signs of past water penetration / damage to Old garage door way.

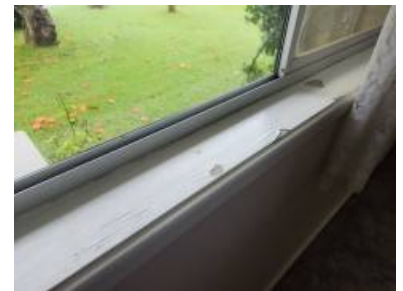
Some window reveals require repainting.

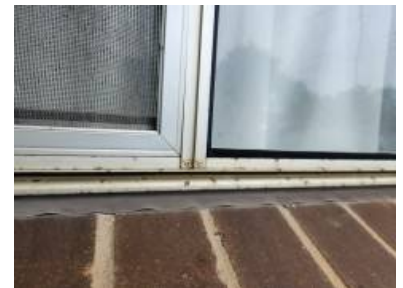
Various windows show evidence of corrosion and require maintenance / repair.

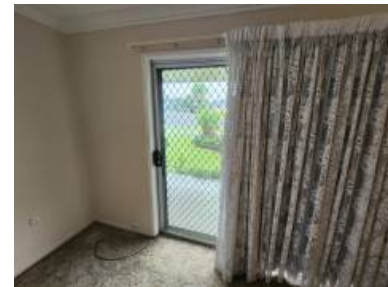
Some external slider rollers show signs of wear or are worn and require replacement.

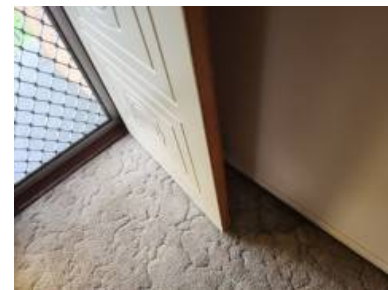
Some doors require new door stops / catches fitted to avoid damage / further damage to interior linings.

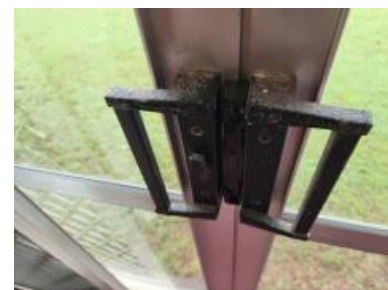
Signs of corrosion to some door handles.

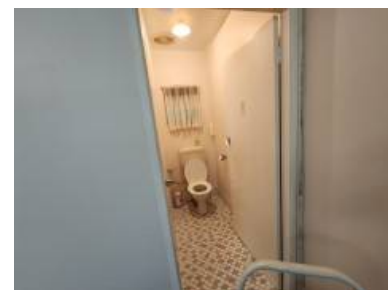
No lift off hinges present to the toilet door. This may comply with the date of construction however, this is a safety issue and therefore was included in this report. We recommend the installation of lift off hinges.

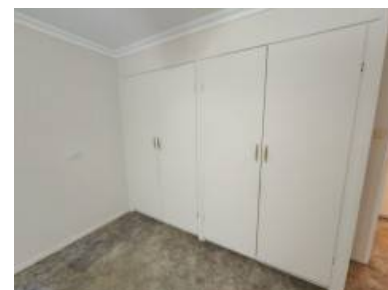
Some doors show signs of binding and require repair / adjustment.

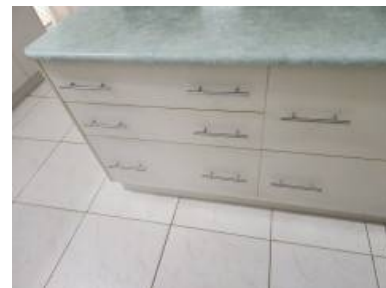
Some drawers require adjustment.

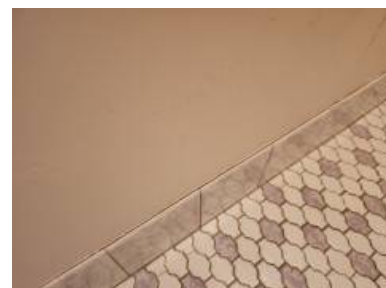
Skirting tiles are coming loose to laundry.

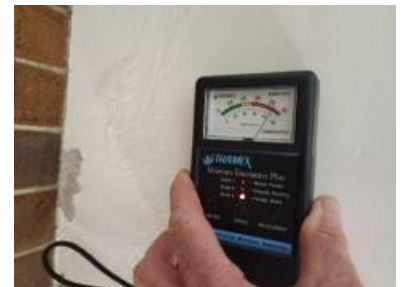
There are signs of high moisture levels in the walls adjacent to the laundry shower. I recommend that a plumber be engaged to inspect the taps / washers, conduct a compression check on the pipes. If not leaking pipes then I recommend engaging a shower sealer to reseal and water proof the shower floor and walls.

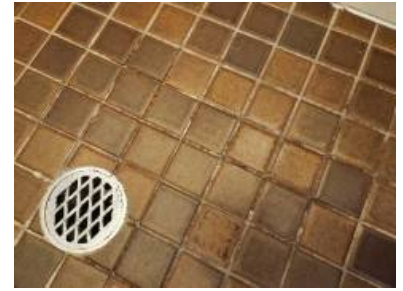
Some shower floor tiles require regrouting & resealing to Laundry.

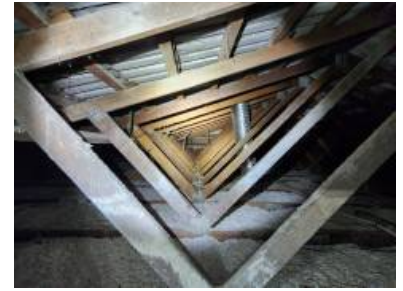
Older roof frames do not comply with current wind ratings. The roof framing is in satisfactory / typical condition for the age / construction date.

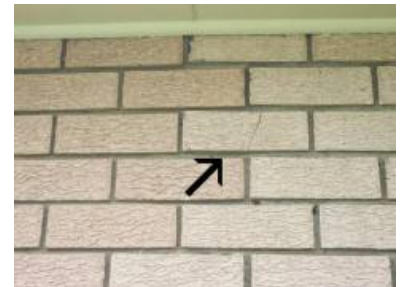
Minor cracks to brickwork above big sliding door southern wall.

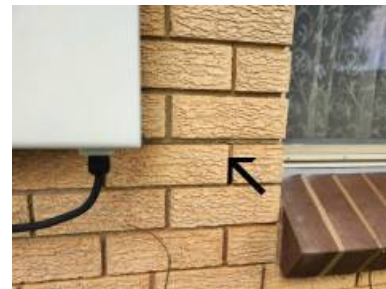
Mortar cracks to brickwork at Meter box.

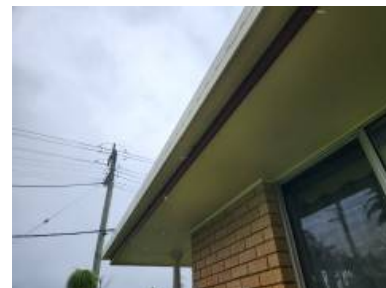
The external paintwork / finish to the external surfaces and timberwork is generally satisfactory. There are some sections / areas that require touching up / repainting.

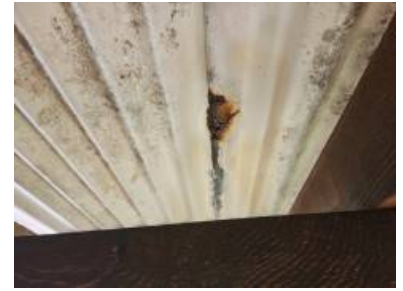
Rust to pergola roof sheets.

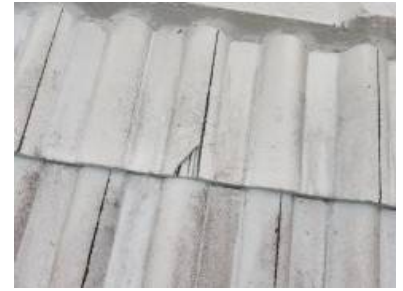
Some cracked corners and edges to roof tiles require resealing.

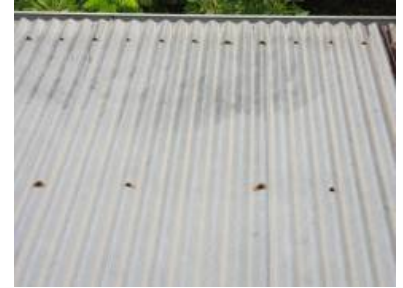
Some sheet roofing and flashings require major rectification and/or replacement. I recommend that a qualified roofer be engaged for further inspection and to quote the cost of rectification prior to making a purchase decision. Read the entire report. The tile roofing and flashings are in reasonably good condition.

Surface rust present at various rusted screw heads requires repair / painting with Killrust or better. Some sections of roof sheeting may require replacement. I recommend a qualified roofer / plumber be engaged to inspect the roof exterior and quote the cost of rectification prior to a purchase decision being made.

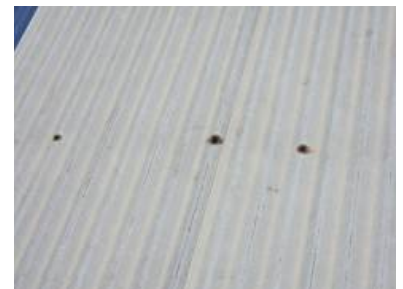
Some roofing screws show signs of rust and require replacement. Failure to do so may allow the rusted screws to cause rust to the roof sheeting.

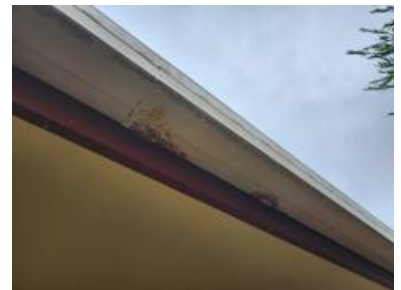
Some sections of guttering are rusted and require repair / painting with Killrust or better / replacement.

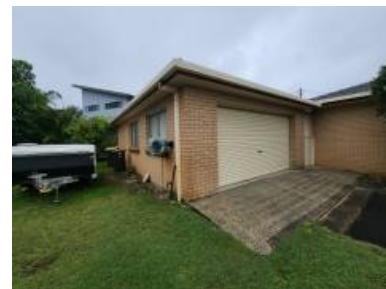
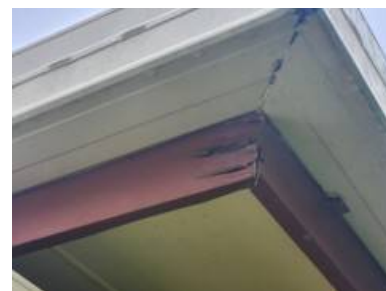
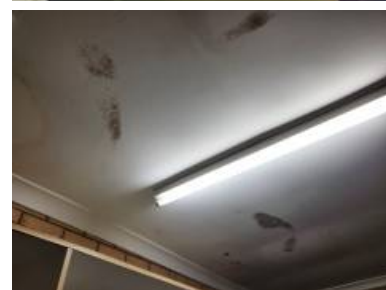
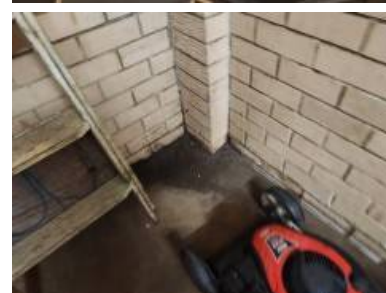
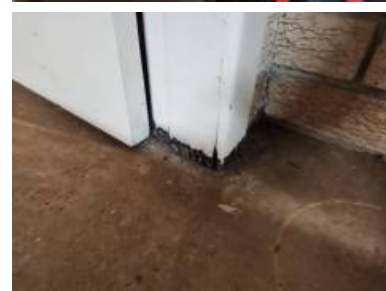
Fascias show signs of weather damage and requires repair.

Ceiling shows signs of old water damage and requires repair.

Back room of garage shows signs of water penetration and may need more drainage to the exterior.

Wood rot to door jamb bases.

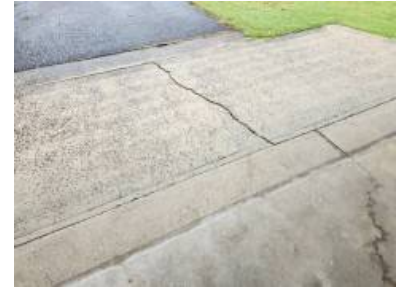
Some cracks to concrete slabs.
