# PEST AND BUILDING PRE-PURCHASE REPORTS

# Inspection Report

**76 Survey St Lennox Head , Lennox Head , NSW, 2478**

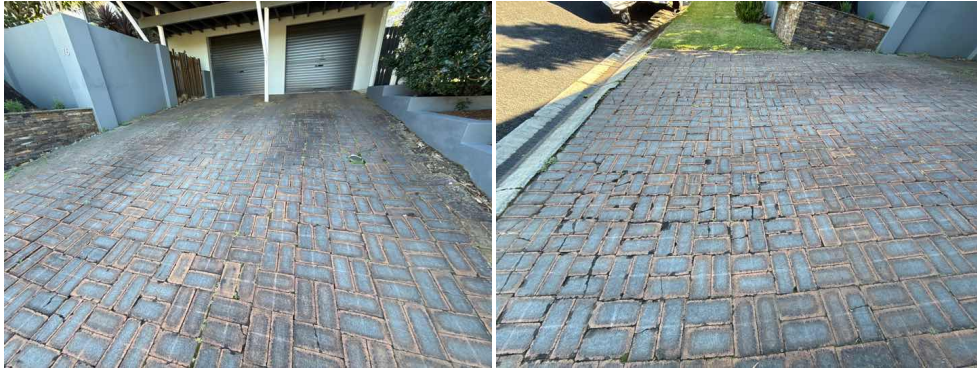
On visual inspection, the general condition of the driveway is serviceable.

Surface raised and settled in some areas. This can cause water ponding. Relaying recommended.

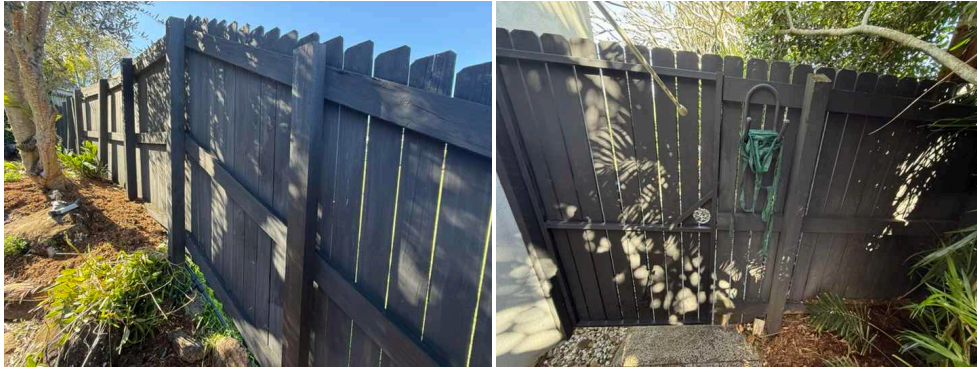
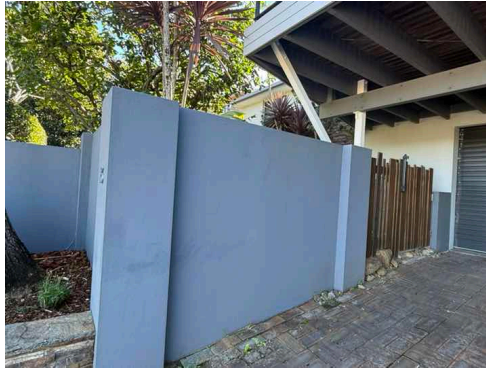
Of the visible areas, the general condition of the fences and gates is serviceable for the age of dwelling.

General age/damage/binding of gate/s components - Recommendations: A qualified fencing contractor should be engaged for advice and recommendations.

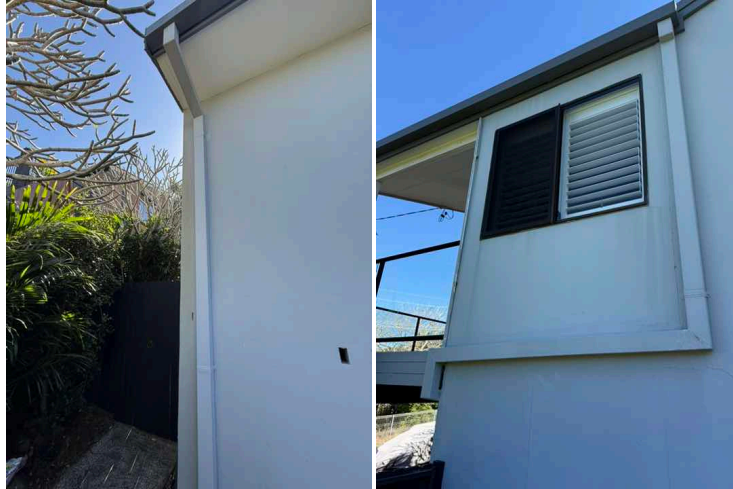
Rust penetrations observed to downpipe. Over time this has potential to cause differential settlement to the footings, cause rising damp and is also conducive to termite infestation. A qualified plumber should be engaged for advice and recommendations.

Minor downpipe rust visible. A qualified plumber should be engaged for advice and recommendations.

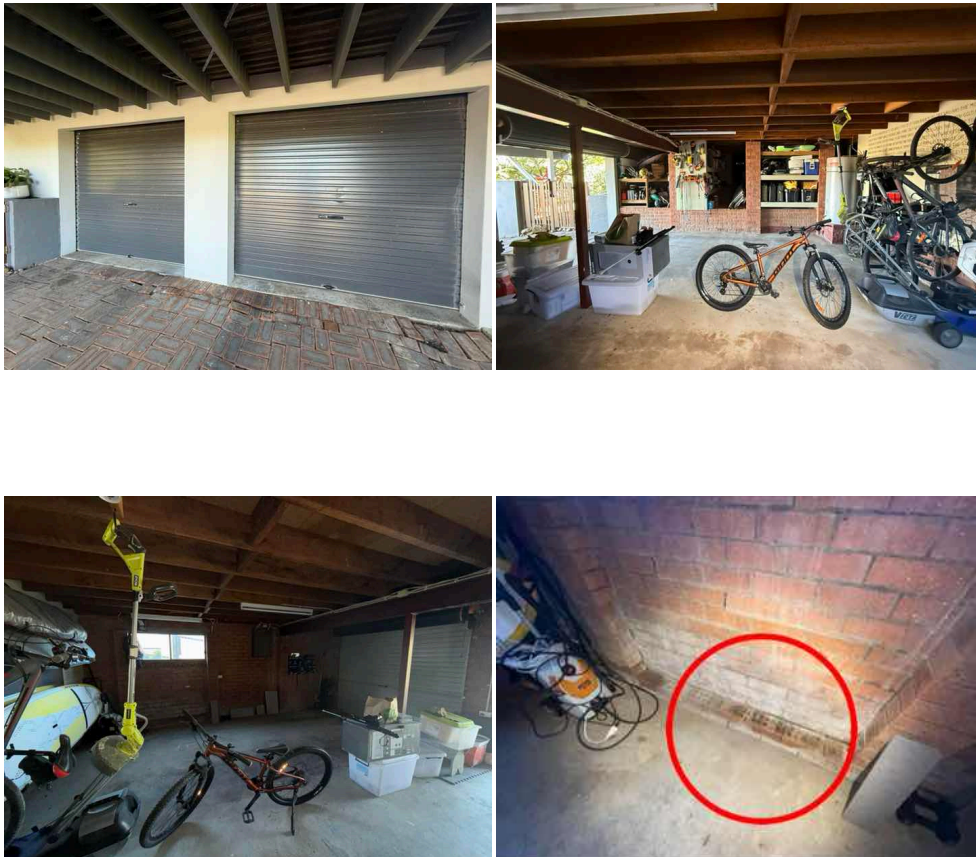
Stored items restricted a full and thorough inspection of this area. Defects may exist in the obstructed and inaccessible areas. It is strongly recommended that full access be granted to enable a thorough inspection as there may be timber pest activity, damage or defects. Note: Where vehicles and storage has restricted a full inspection it is advised that this area be cleared so a full and unobstructed inspection can be carried out.

From the visible and accessible areas, the garage appears to be in a serviceable condition for the age of the property with no notable structural defects sighted.

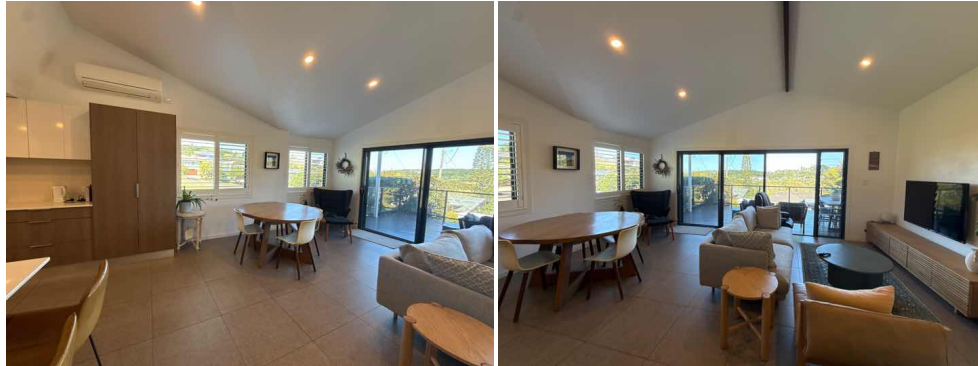
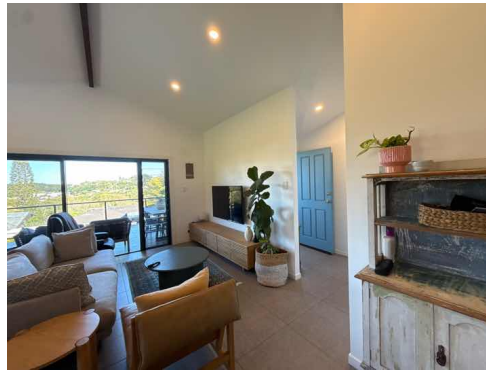
Settlement Cracks Noted. These are typical and generally patch and paint will suffice, however monitoring these cracks is advised for 12 months and if they become worse, further investigation by a suitably qualified professional is advised.

From the visible and accessible areas, this room appears to be in a serviceable condition for the age of the property with no notable structural defects sighted.

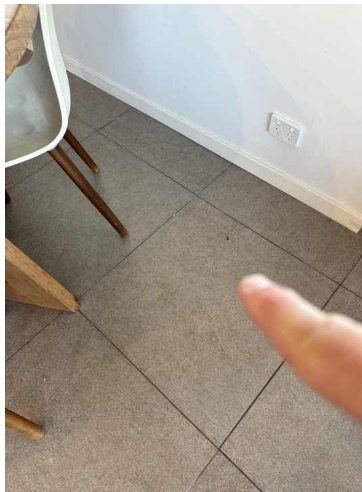
Settlement Cracks Noted. These are typical and generally patch and paint will suffice, however we recommend you monitor these cracks and if they become wider or longer, you will need to contact a structural engineers to assess.

Drummy/loose tiles observed. Tile lift and further deterioration likely. Contact a qualified tiler for repairs.

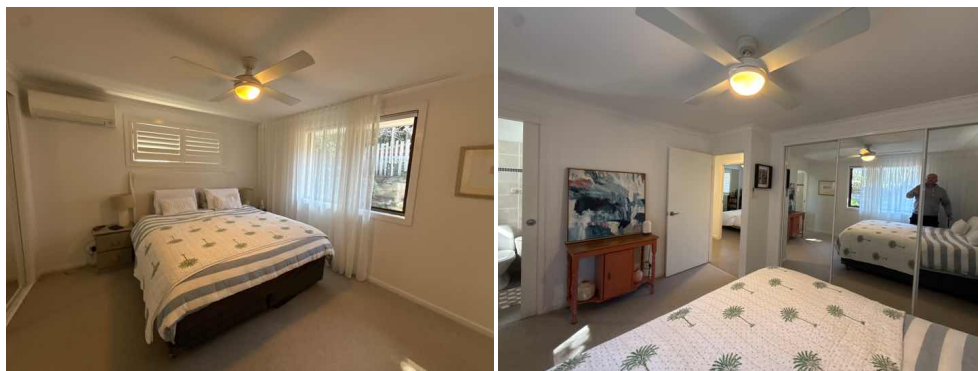
Settlement Cracks Noted. These are typical and generally patch and paint will suffice, however we recommend you monitor these cracks and if they become wider or longer, you will need to contact a structural engineers to assess.

From the visible and accessible areas, this bedroom appears to be in a serviceable condition for the age of the property with no notable structural defects sighted.

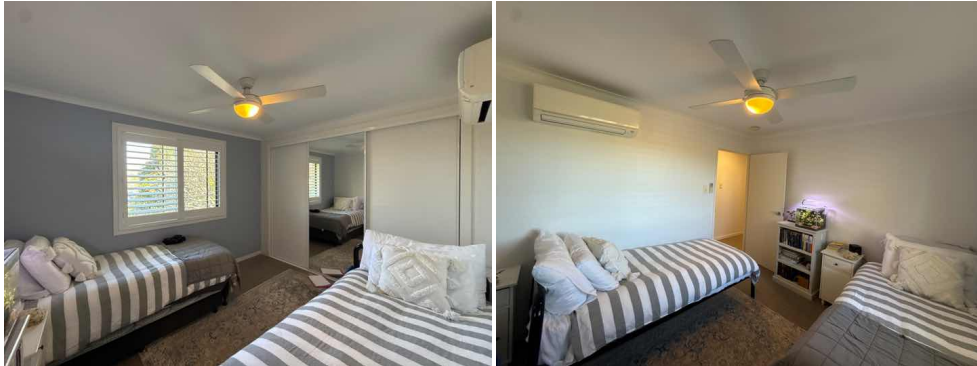
Typical cornice separation/detachment observed. I recommend you contact a qualified painter for repairs.

From the visible and accessible areas, this bedroom appears to be in a serviceable condition for the age of the property with no notable structural defects sighted.

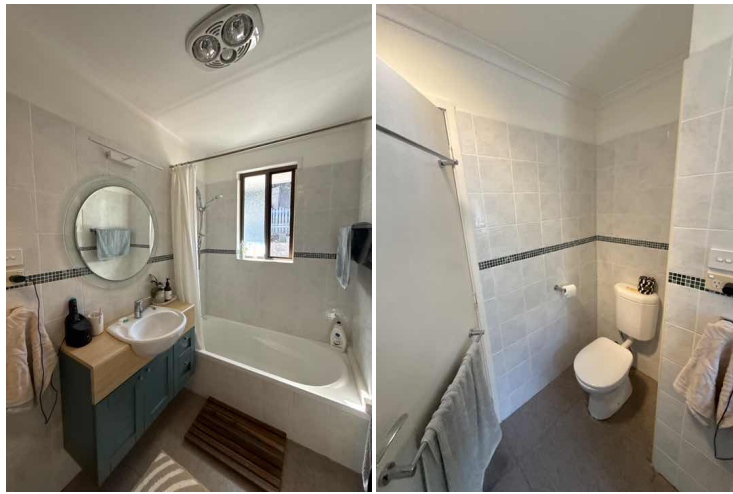
The shower screen door requires adjustment, maintenance or repair to operate properly.

Of the visible areas, the general condition of this bathroom is serviceable or in reasonable condition for age of dwelling.

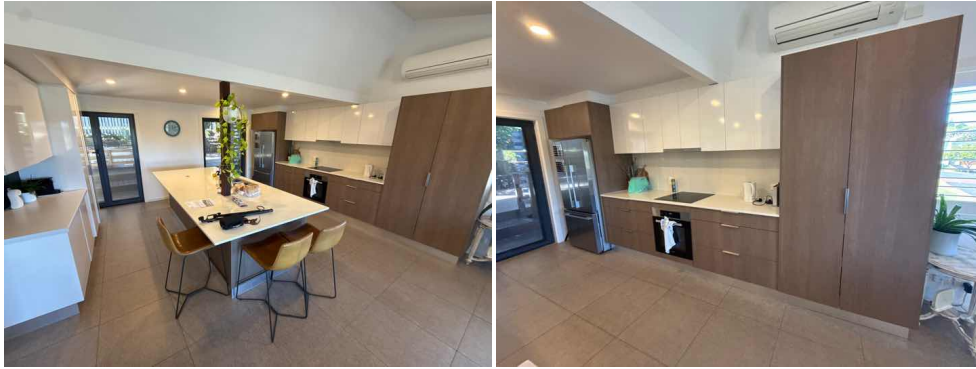
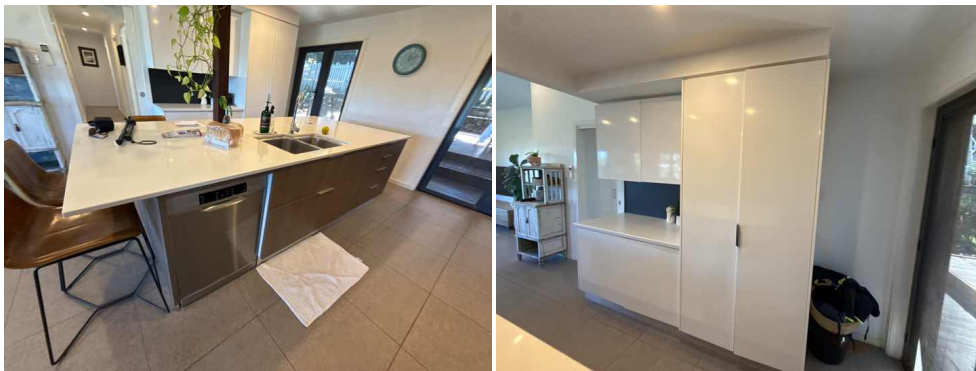
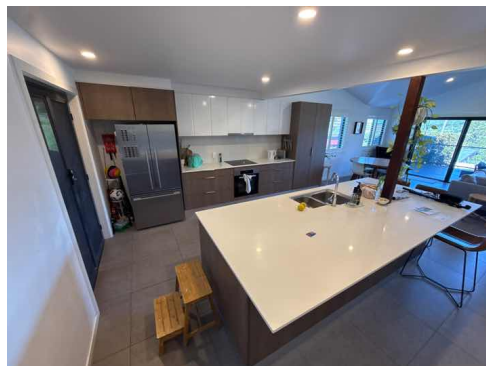
Of the visible areas, the general condition of the kitchen and pantry is serviceable or in reasonable condition for age of dwelling.

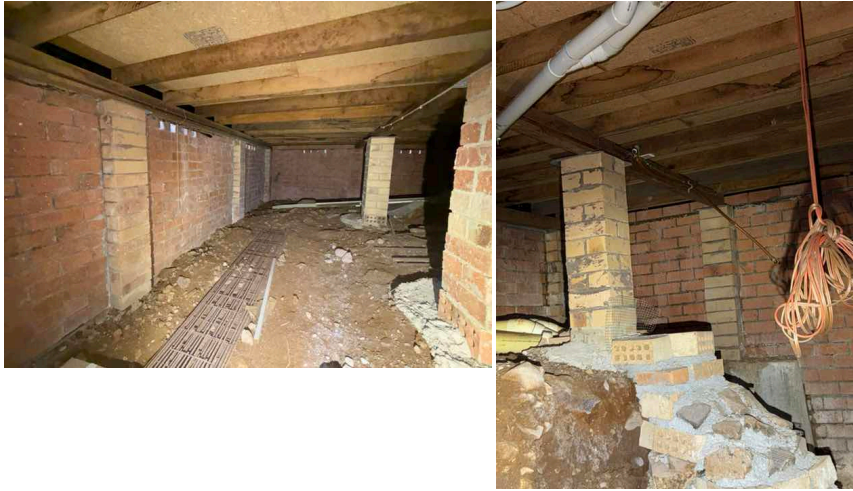
Of areas accessible and visible, the subfloor and components appeared to be in a serviceable condition.

Damp/Moisture damage noted. Possible failed water proof membrane to shower area. Reconstruction of this area may be the best option long term. Contact a licensed builder for further evaluation.

Rusted ant capping noted. Ant capping is not designed to prevent termite entry but to force the termites to reveal themselves by means of mud packing. Rusted, missing or defective ant capping will allow the termites to enter the building undetected. Contact a qualified brick layer for further advice
