# Building and Pest Report

## 8 Dune Avenue Skennars Head

| Inspection Date: | 06 Nov 2025 |

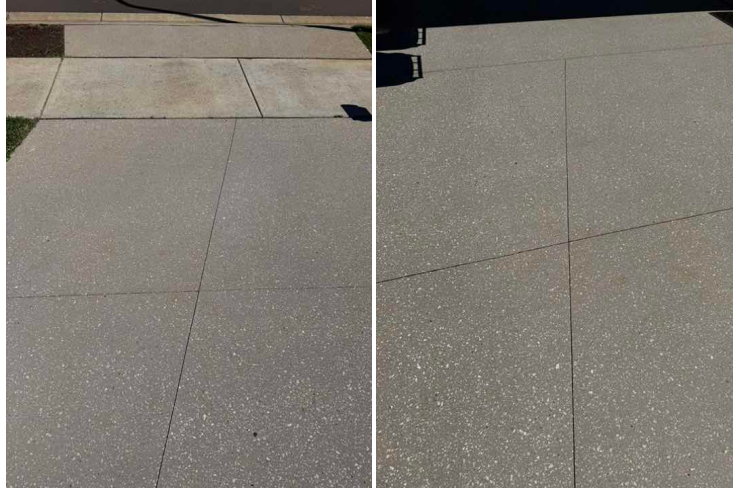
#### Driveway Condition

On visual inspection, the general condition of the driveway is serviceable.

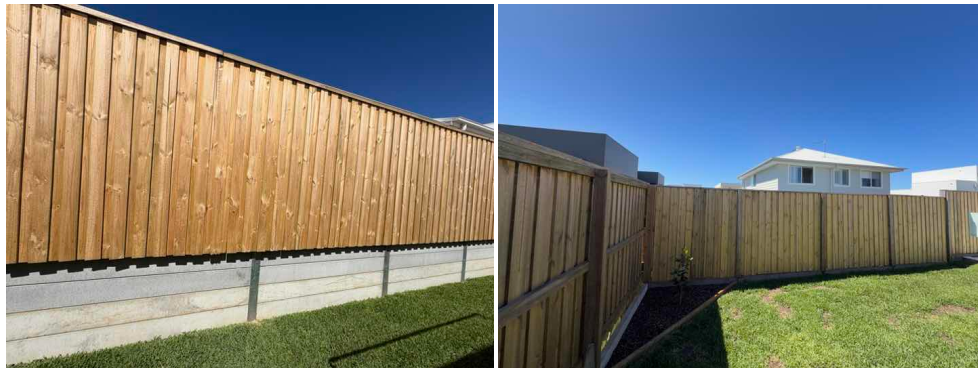
### Fences & Gates

Of the visible areas, the general condition of the fences and gates is serviceable for the age of dwelling.

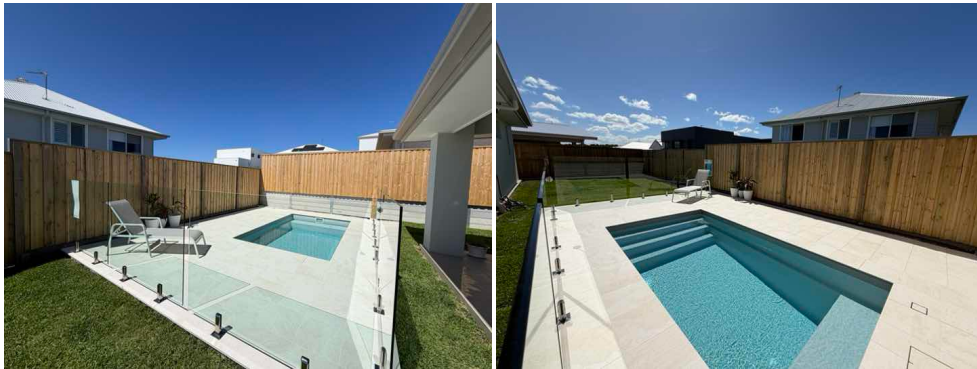
**Pool Fence & Signs****Pool Fence**

Pool fence and signage were sighted.

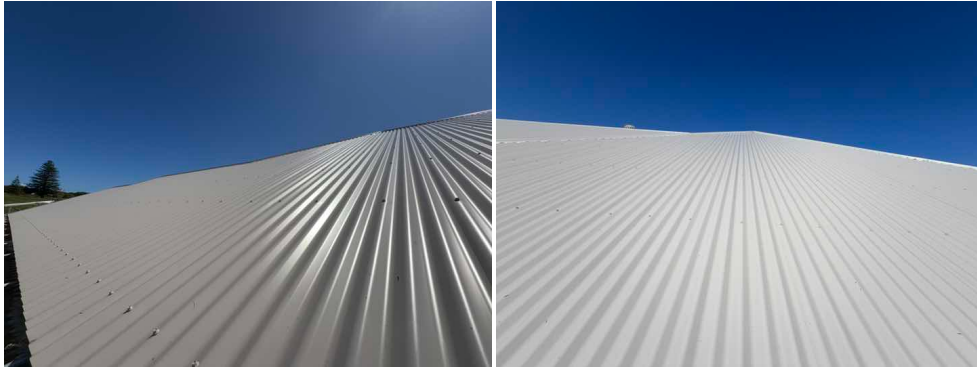
Of the visible areas, the general condition of the roof is in serviceable condition for the age.

Note: In the absence of rainfall there is no guarantee that the roof won't leak.

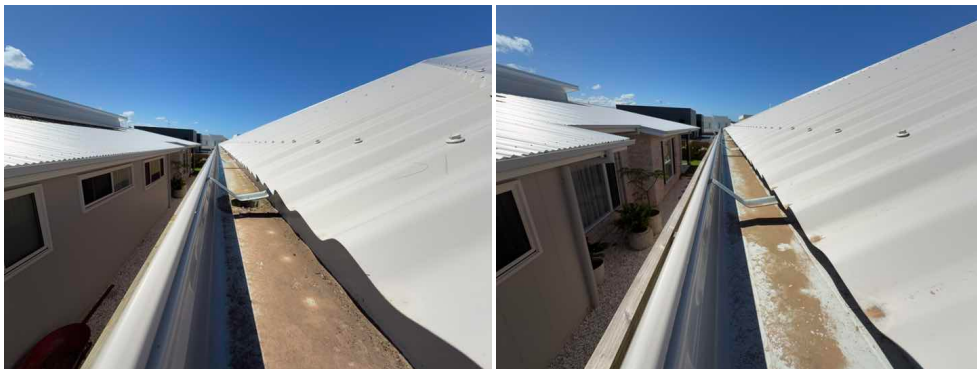
### Guttering

All visible and accessible of the physical nature of the guttering system appears to be in a serviceable condition with no apparent defects at the time of inspection. In the absence of prolonged rain fall efficiency of the guttering can not be assessed and you may find that further investigation or repairs maybe required. Note: Periodic maintenance checks should be carried out for rust penetrations and leaks.

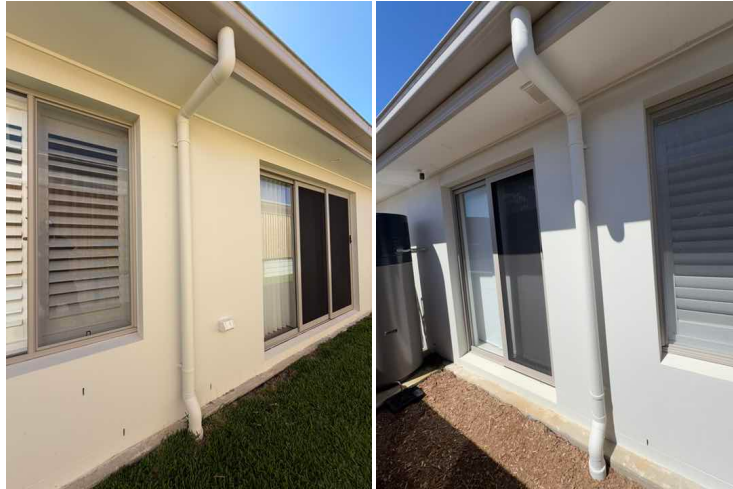
## **Downpipes**

On visual inspection no apparent defects were noted to the down pipes and are considered serviceable, however no comment can be made with regard to blockages or connections to stormwater or functionality in the absence of rain. Note: Periodic maintenance checks should be carried out for rust penetrations and leaks.

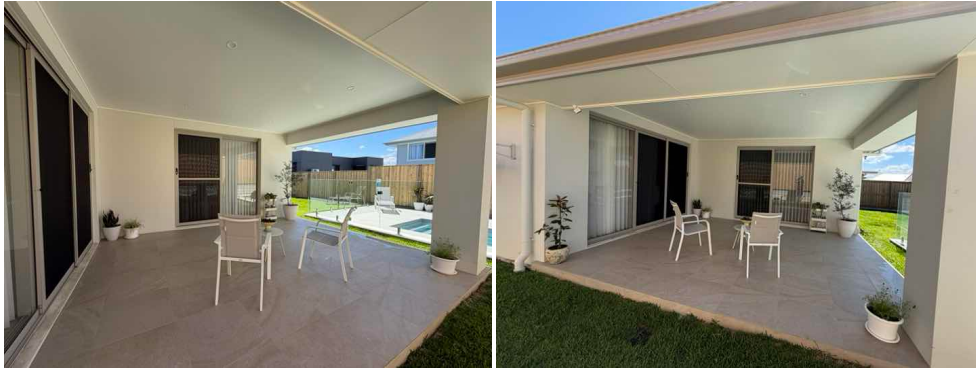
Visible sections of the Alfresco area are serviceable or in reasonable or condition for the age of this dwelling.

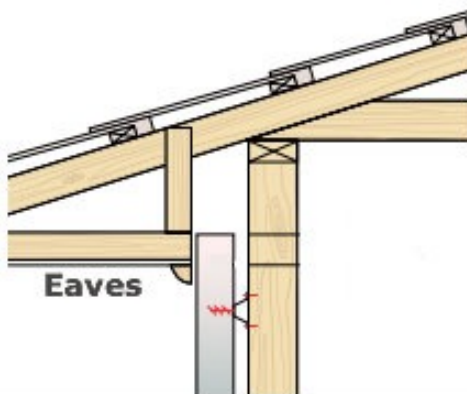
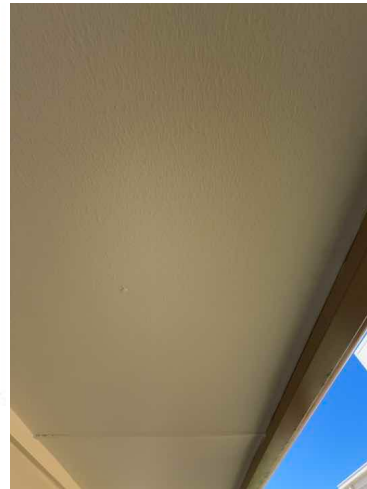
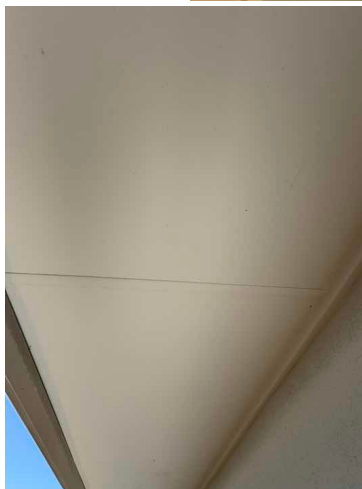
### Eaves

The soffit lining (eaves) are in a serviceable condition with no notable defects.

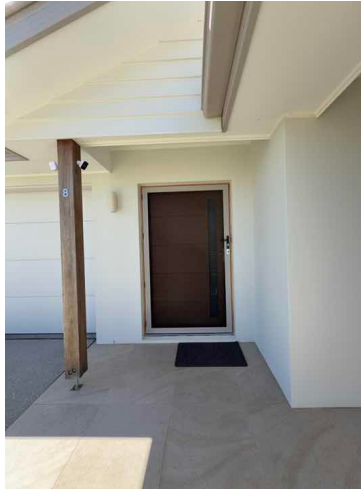
## **Entry Porch Area**

The entry porch serviceable or in reasonable or condition for the age of this dwelling.

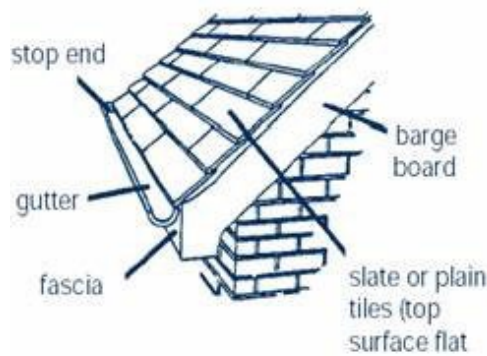
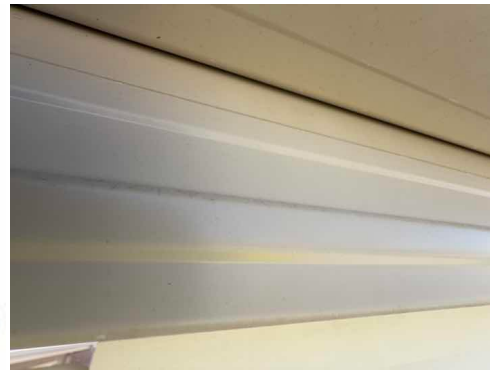
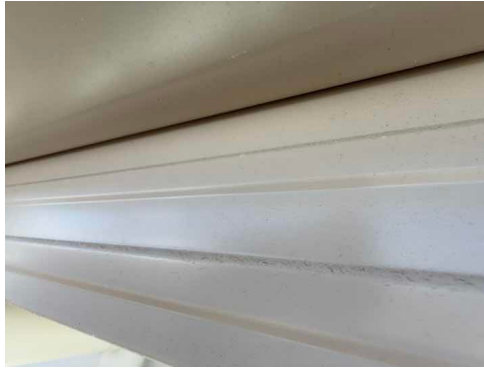
On visual inspection, the general condition of the fascia/barge boards is serviceable.

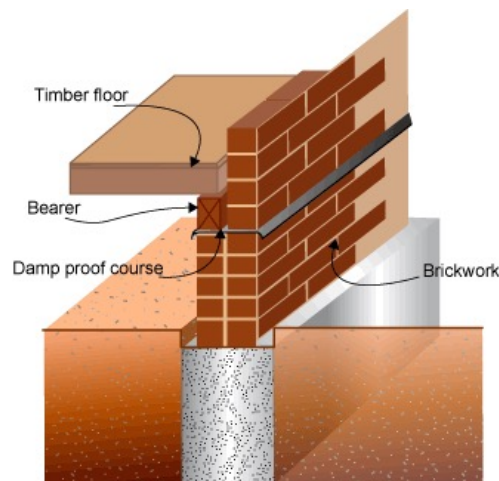
### **Damp Proof Course**

A damp proof course (DPC) was noted.

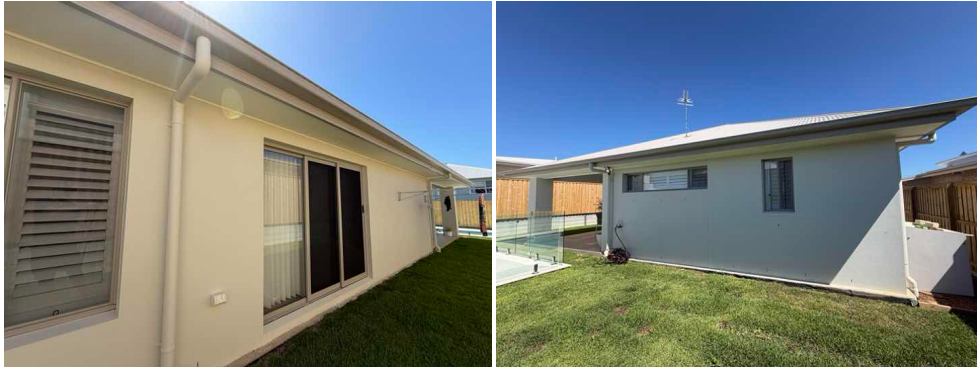
## **Walls**

On visual inspection, the general condition of the exterior walls is serviceable for the age.

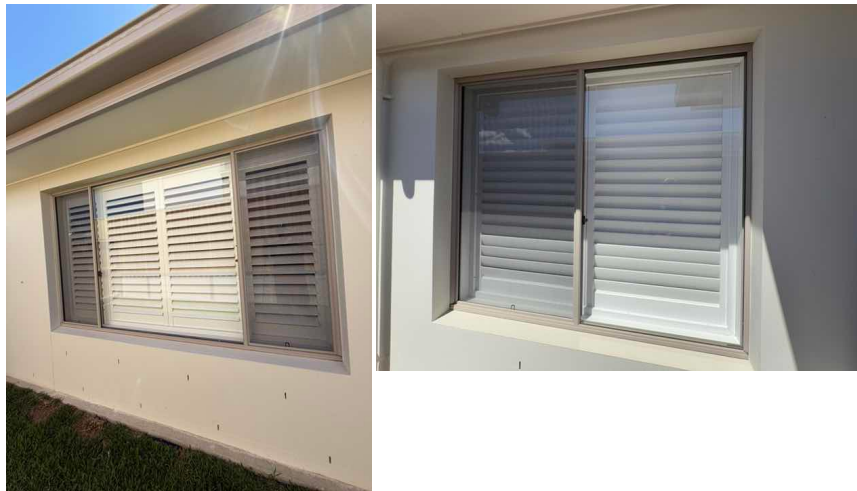
## Windows

On visual inspection, the general condition of the windows is serviceable for the age.

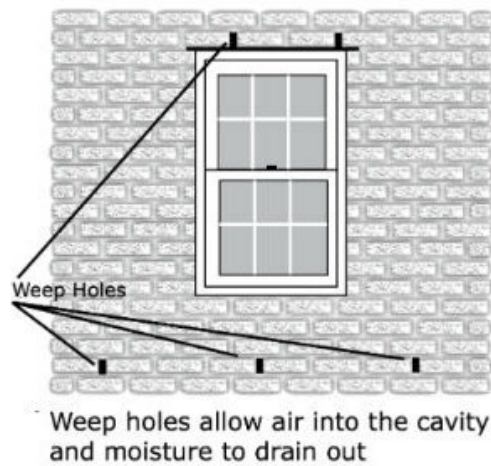
## Weep Holes and Ventilation

The weep holes are unobstructed .

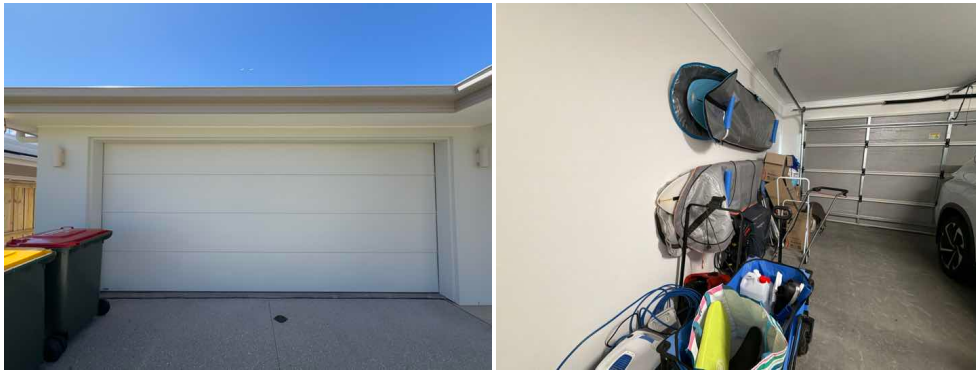
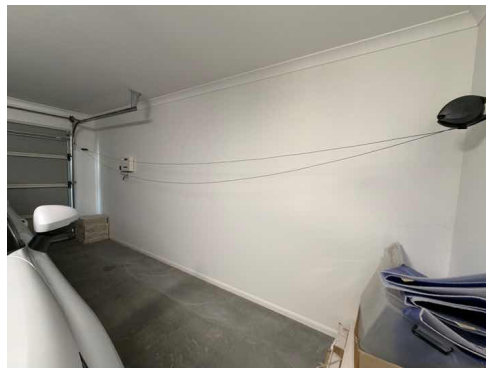
## GARAGE - CARPORT

Stored items restricted a full and thorough inspection of this area. Defects may exist in the obstructed and inaccessible areas. It is strongly recommended that full access be granted to enable a thorough inspection as there may be timber pest activity, damage or defects. Note: Where vehicles and storage has restricted a full inspection it is advised that this area be cleared so a full and unobstructed inspection can be carried out.

From the visible and accessible areas, the garage appears to be in a serviceable condition for the age of the property with no notable structural defects sighted.

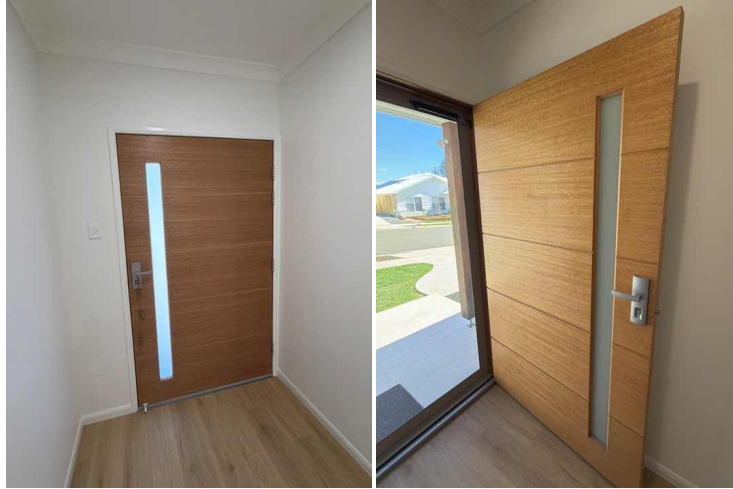
#### **Front Entry Doors**

The doors are in serviceable condition with no notable defects observed.

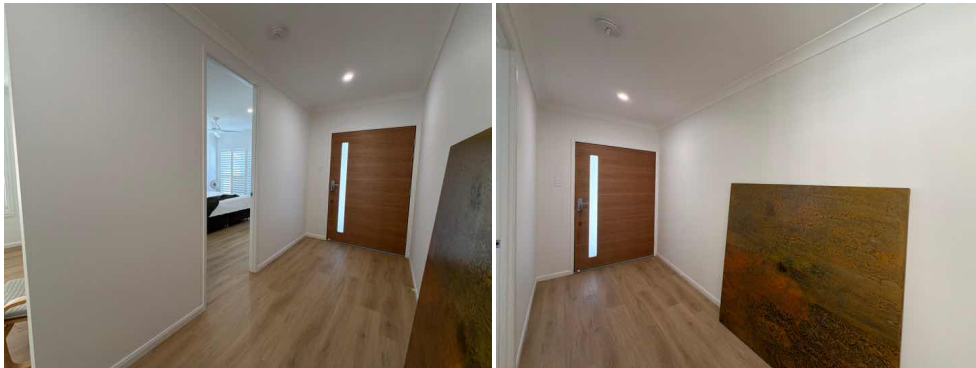
From the visible and accessible areas, this area appears to be in a serviceable condition for the age of the property with no notable structural defects sighted.

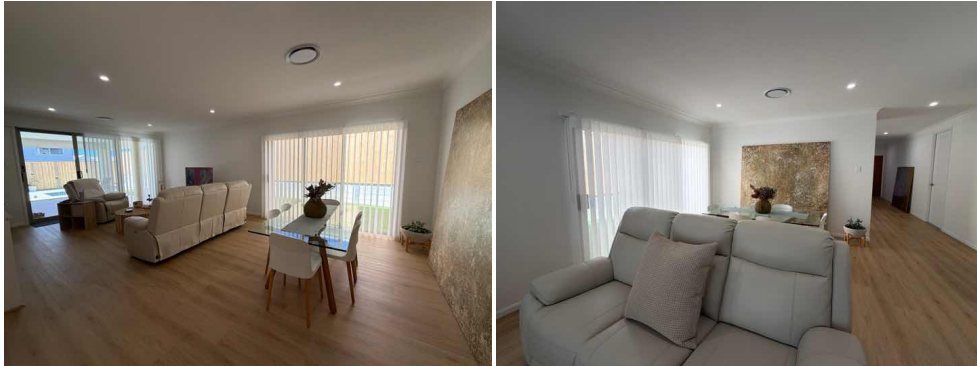
## **Combined Living & Dining**

From the visible and accessible areas, this room appears to be in a serviceable condition for the age of the property with no notable structural defects sighted.

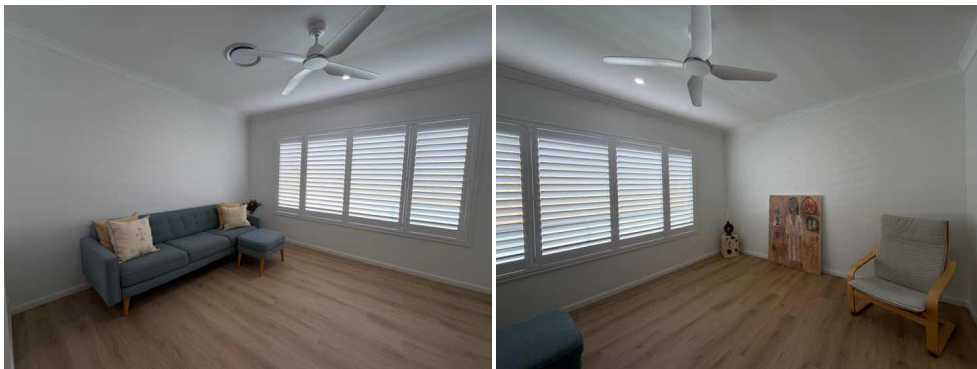
## **Home Theatre Room**

From the visible and accessible areas, this room appears to be in a serviceable condition for the age of the property with no notable structural defects sighted.

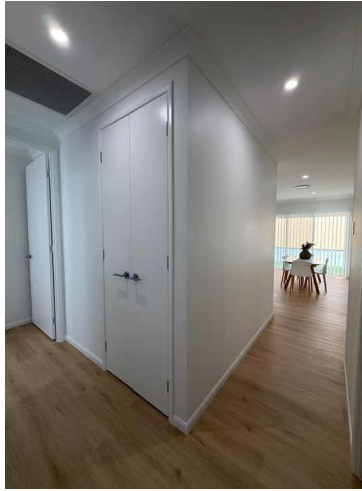
## **Hallway/s**

From the visible and accessible areas, the hallway/s/ appears to be in a serviceable condition for the age of the property with no notable structural defects sighted.

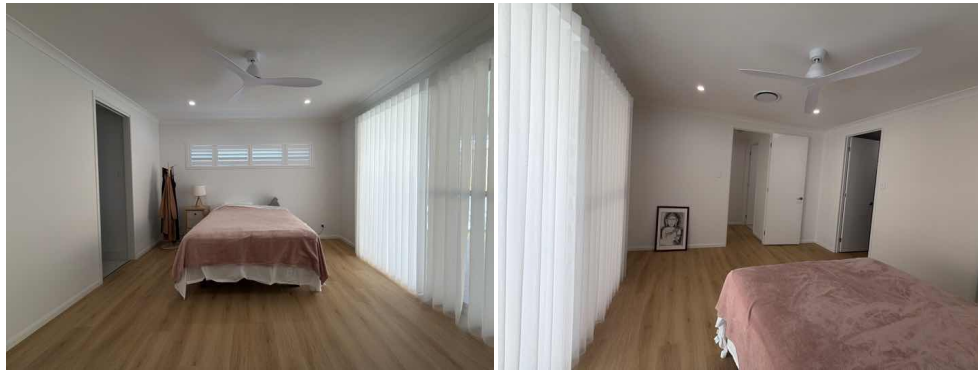
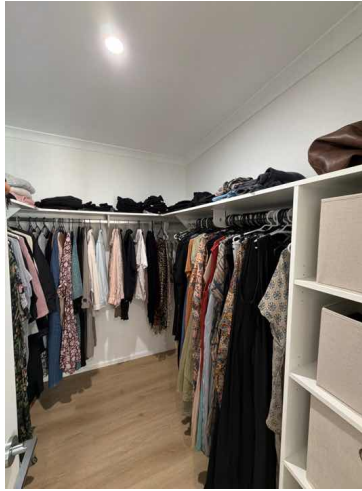
From the visible and accessible areas, this bedroom appears to be in a serviceable condition for the age of the property with no notable structural defects sighted.

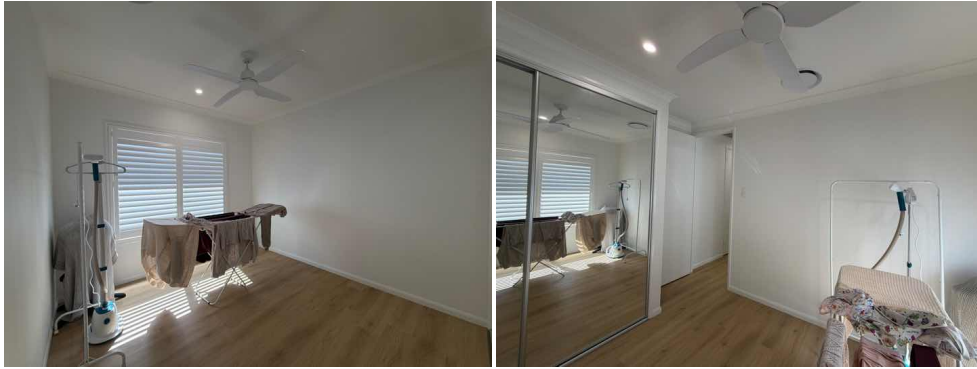
## **Bedroom 2**

From the visible and accessible areas, this bedroom appears to be in a serviceable condition for the age of the property with no notable structural defects sighted.

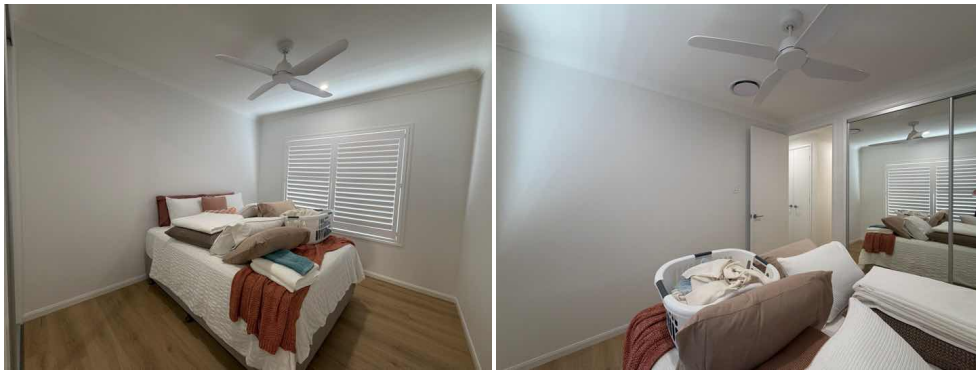
## **Bedroom 3**

From the visible and accessible areas, this bedroom appears to be in a serviceable condition for the age of the property with no notable structural defects sighted.

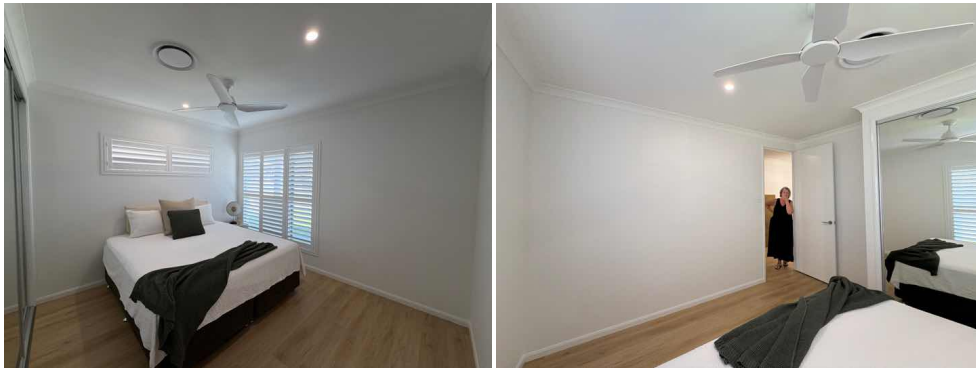
## **Bedroom 4**

From the visible and accessible areas, this bedroom appears to be in a serviceable condition for the age of the property with no notable structural defects sighted.

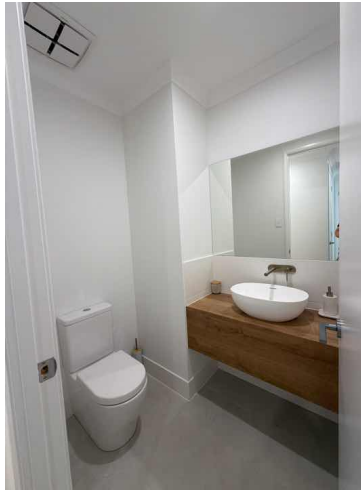
Of the visible areas, the general condition of this bathroom is serviceable or in reasonable condition for age of dwelling.

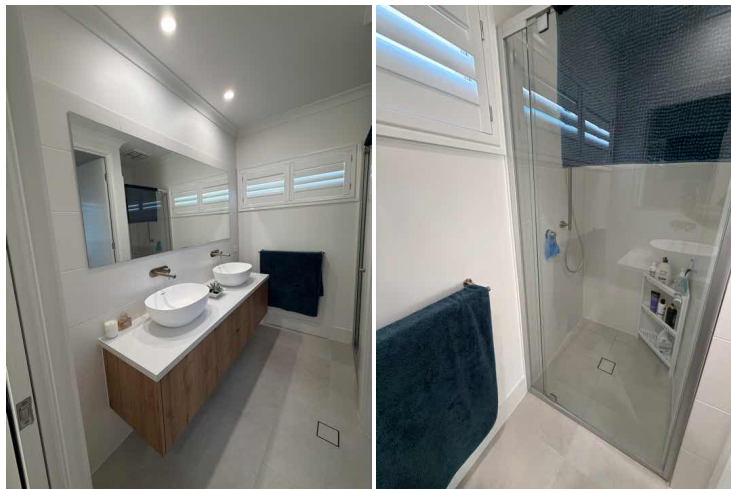
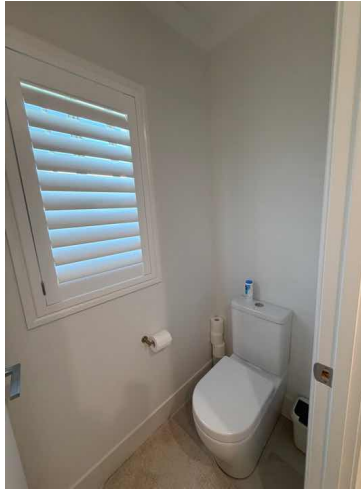
### Bathroom 1

Of the visible areas, the general condition of this bathroom is serviceable or in reasonable condition for age of dwelling.

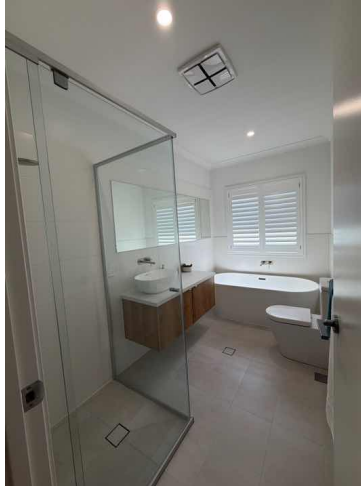
Of the visible areas, the general condition of this bathroom is serviceable or in reasonable condition for age of dwelling.

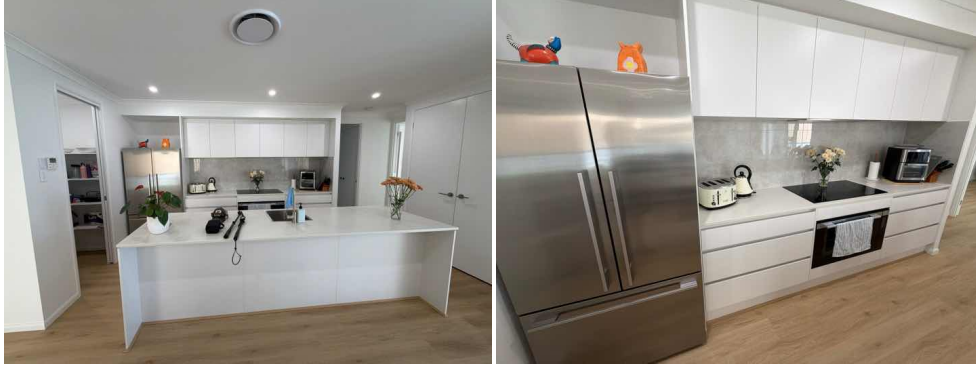
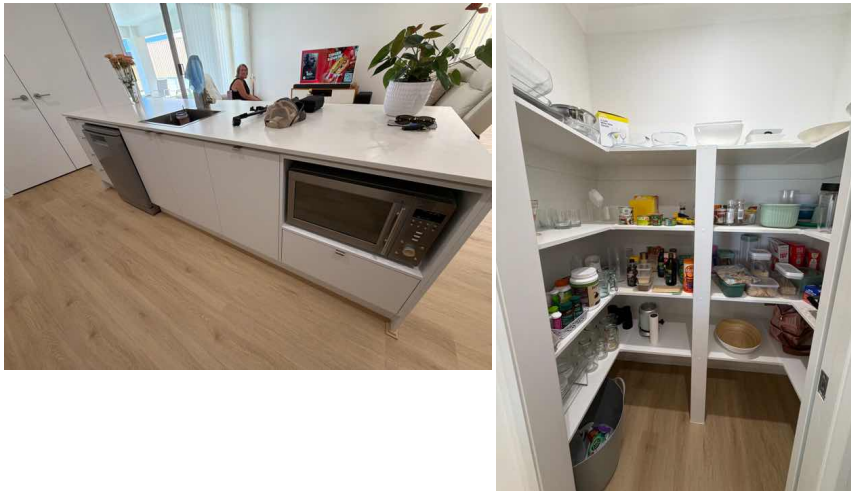
Of the visible areas, the general condition of the kitchen and pantry is serviceable or in reasonable condition for age of dwelling.

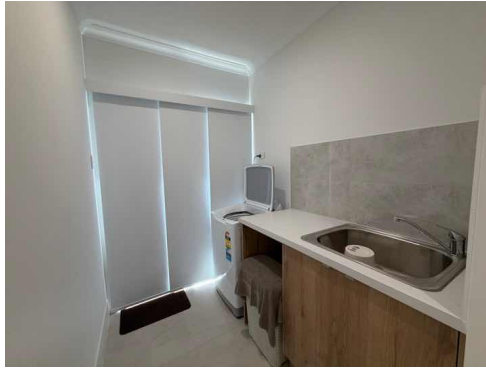
Of the visible areas, the general condition of the laundry is serviceable or in reasonable condition for age of dwelling.
