# Building and Pest Report

## 39A Fox Valley Way Lennox Head

# **BPI BUILDING & PEST INSPECTIONS**

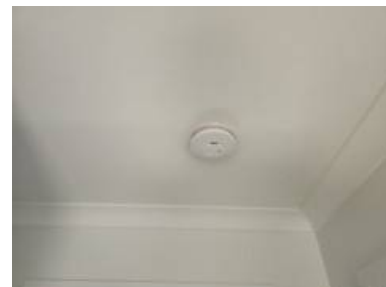
Present - Hall.

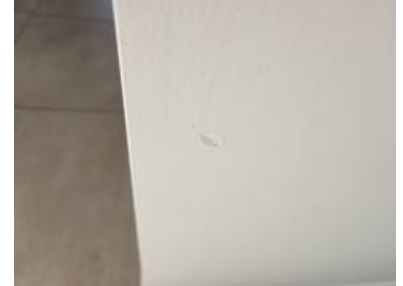
**Cracking / Defective Lining**  
Some minor damage to wall sheeting requires touching up / repair / repainting.

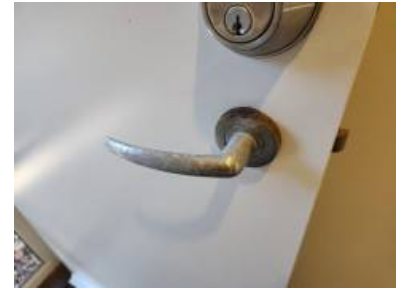
Signs of rust to laundry door handle.

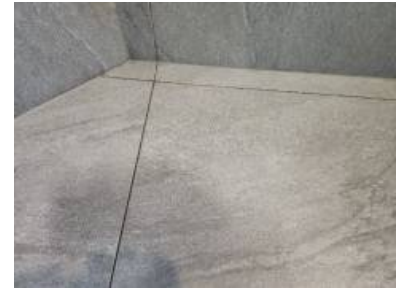
Some Ensuite & Bathroom floor tiles require regrouting & resealing.

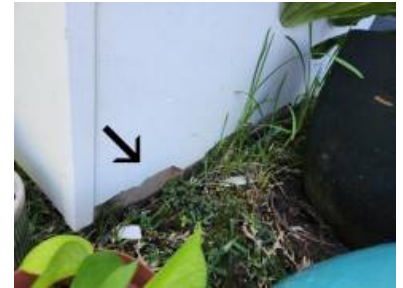
Base of 1 cladding board is damaged out side of ensuite bathroom.

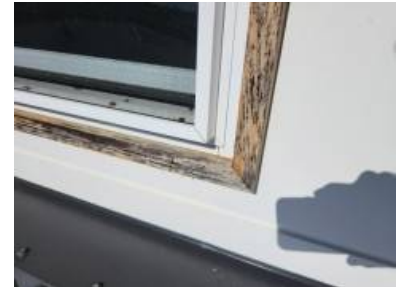
Some highlight window architraves require sanding and resealing.

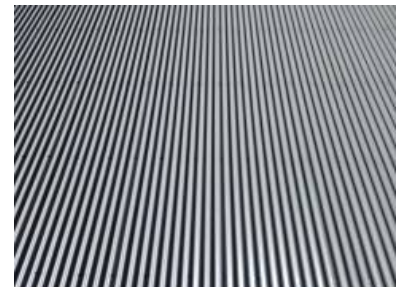
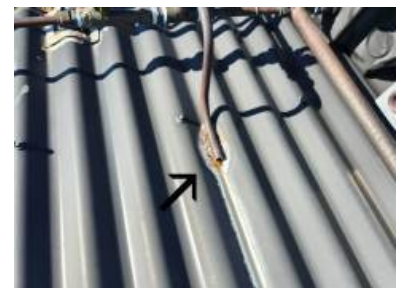
Hotwater overflow pipe is leaking onto roof causing 1 sheet to rust, I recommend repairing with kill rust and repainting.

Also install hose on pipe and direct into down pipe to stop further damage.

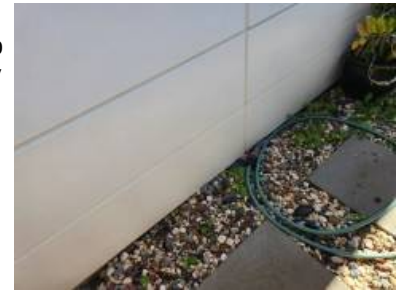
- Ensure that the exposed slab edges to the perimeter of the residence are exposed by at least 75mm clearance as they are physical / visual termite barriers. If the slab edges are covered by things such as gardens, soil, paths or stored goods, they may allow concealed termite entry.

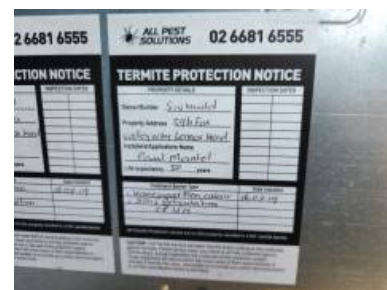
A termite barrier / treatment notice in the Meter Box / Kitchen Cupboard indicates that a reticulation system is present to the perimeter of the residence. This system was installed in 2019.
