Building and Pest Report

24 Morton Way Skennars Head

Report/Agreement #	230525085709465
Inspection Date:	23 May 2025
Inspection Time:	08:57 am

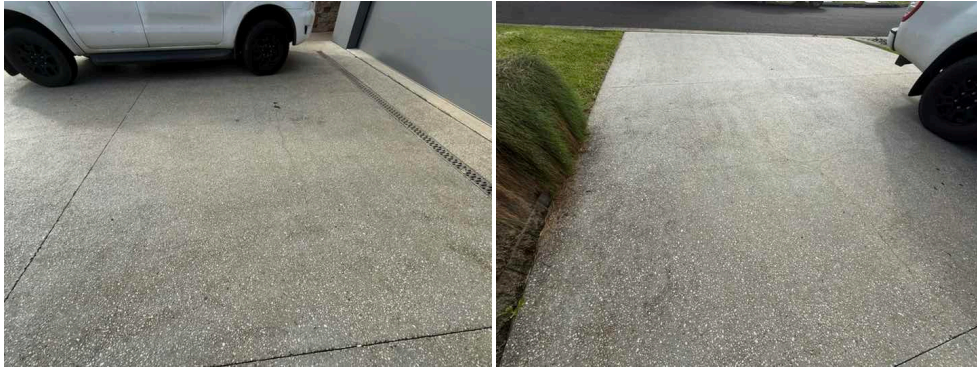
Driveway Condition

On visual inspection, the general condition of the driveway is serviceable.

Common cracks were observed on the driveway. Whilst these cracks appeared to be typical at the time of inspection, we strongly recommend you monitor these cracks and if worsening occurs contact a concreter for further advice.

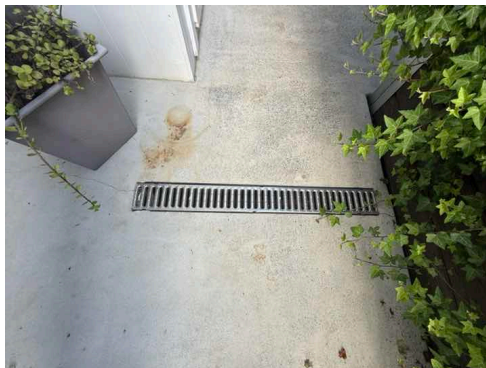
Pathways Condition

The paths around the home are in a serviceable condition for the age of this dwelling with no major defects visible.

Common cracks and settlement were observed on paths. Whilst these cracks appeared to be typical at the time of inspection, we strongly recommend you monitor these cracks and if worsening occurs contact a concreter for further advice.

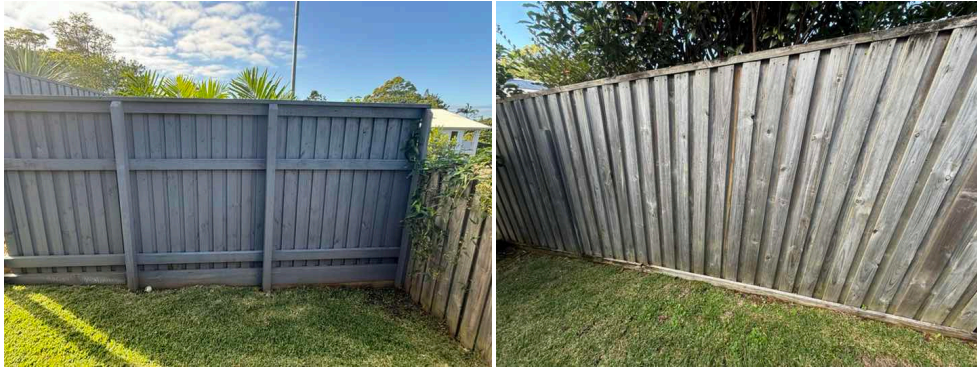
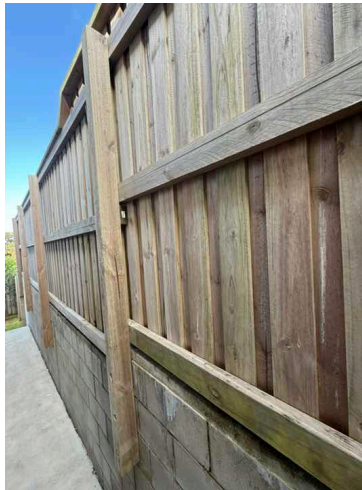
Overall Condition

Of the visible areas, the general condition of the fences and gates is serviceable for the age of dwelling.

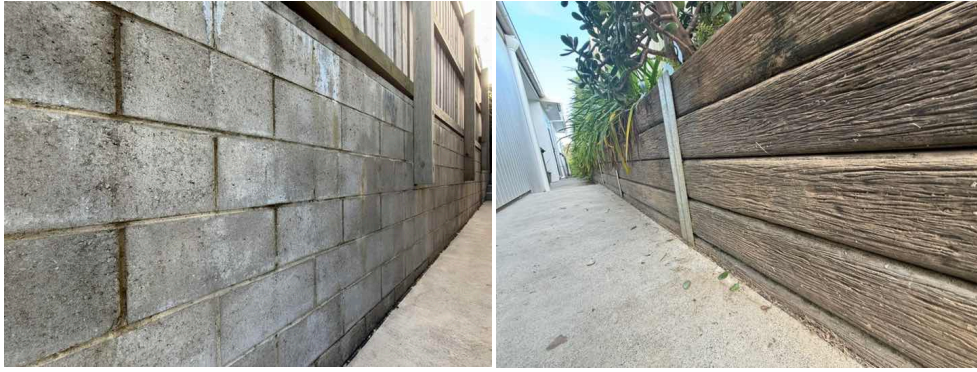
Retaining Walls

Of the visible areas, the general condition is serviceable or in reasonable condition for age of dwelling.

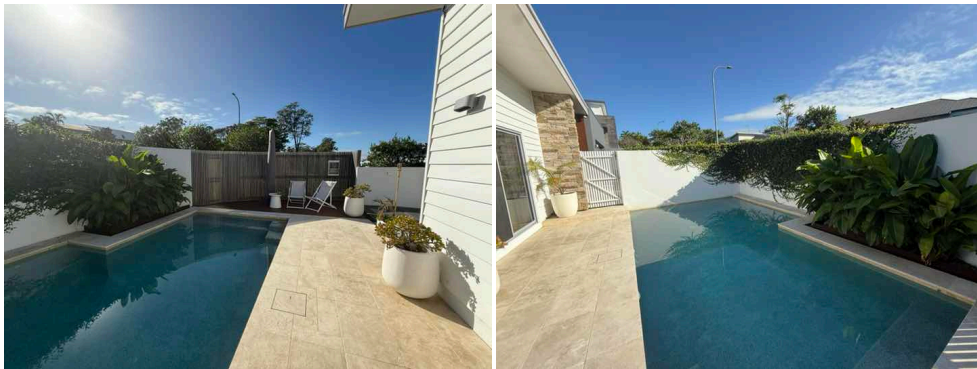
Pool Fence

Pool fence and signage were sighted.

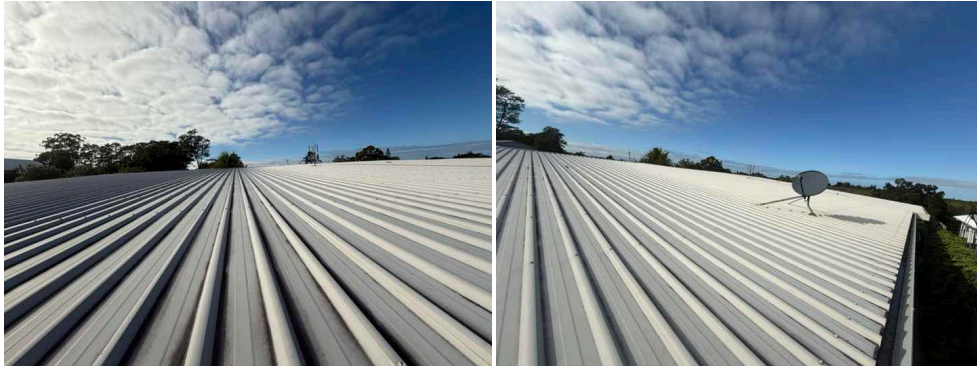
Of the visible areas, the general condition of the roof is in serviceable condition for the age.

Note: In the absence of rainfall there is no guarantee that the roof won't leak.

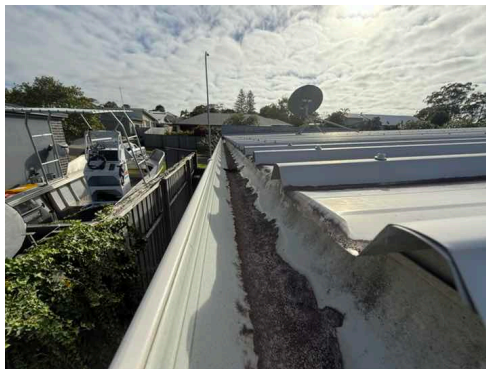
Guttering

All visible and accessible of the physical nature of the guttering system appears to be in a serviceable condition with no apparent defects at the time of inspection. In the absence of prolonged rain fall efficiency of the guttering can not be assessed and you may find that further investigation or repairs maybe required. Note: Periodic maintenance checks should be carried out for rust penetrations and leaks.

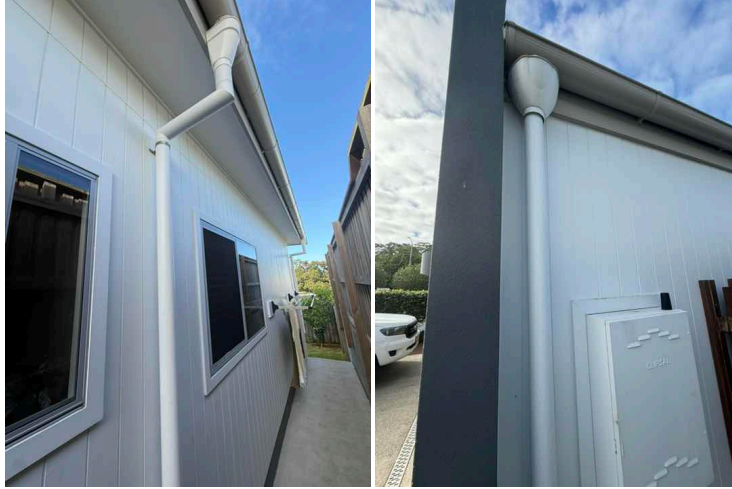
Downpipes

On visual inspection no apparent defects were noted to the down pipes and are considered serviceable, however no comment can be made with regard to blockages or connections to stormwater or functionality in the absence of rain. Note: Periodic maintenance checks should be carried out for rust penetrations and leaks.

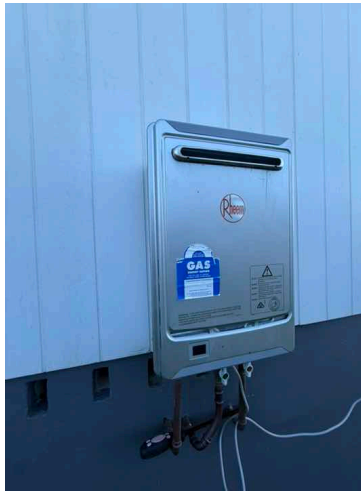
System Make

The hot water system appears to be in a serviceable condition. No specific tests other than running the hot water from a tap was carried out. No determination has been made as to the suitability or adequacy of the hot water system in relation to capacity or otherwise.

The make of the hot water unit is rheem.

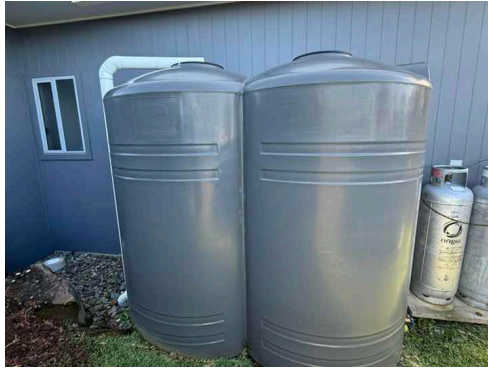
On Visual Inspection the water tank appears serviceable, but should be checked by a qualified plumber.

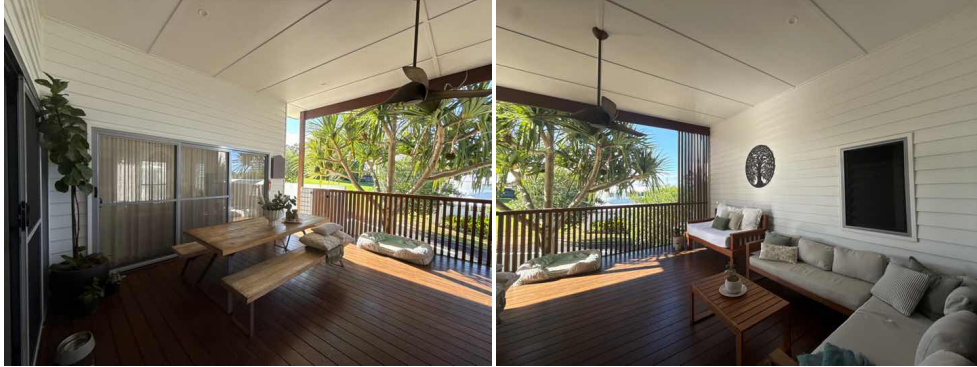
Visible sections of the Alfresco area are serviceable or in reasonable or condition for the age of this dwelling.

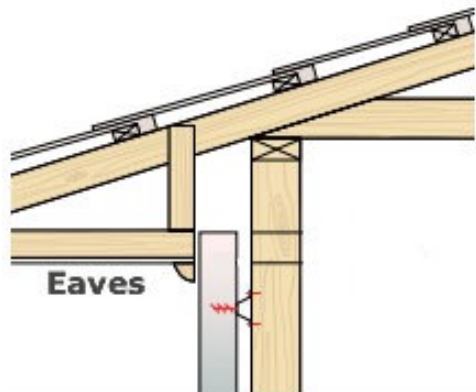
Eaves

The soffit lining (eaves) are in a serviceable condition with no notable defects.

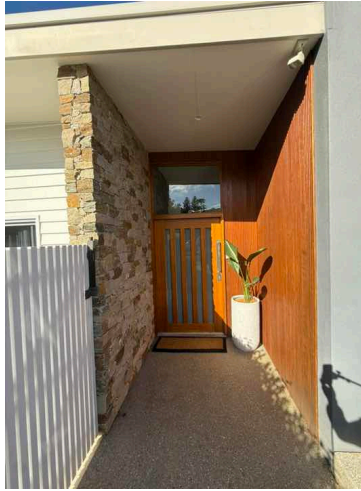
Entry Porch Area

The entry porch serviceable or in reasonable or condition for the age of this dwelling.

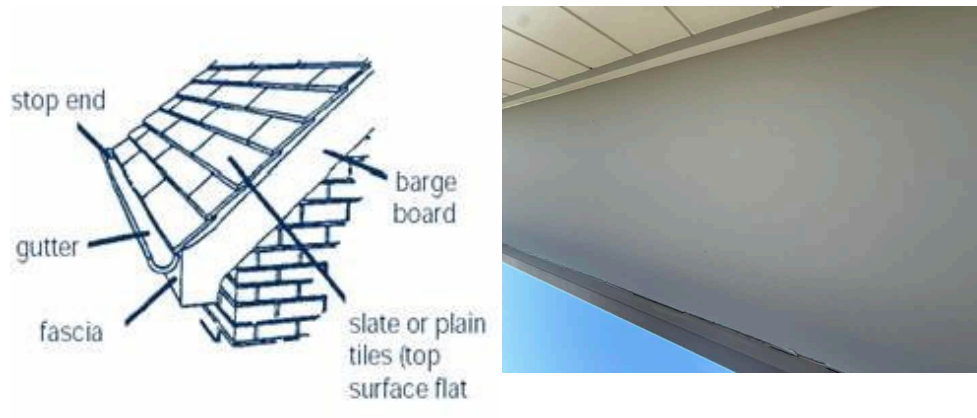
On visual inspection, the general condition of the fascia/barge boards is serviceable.

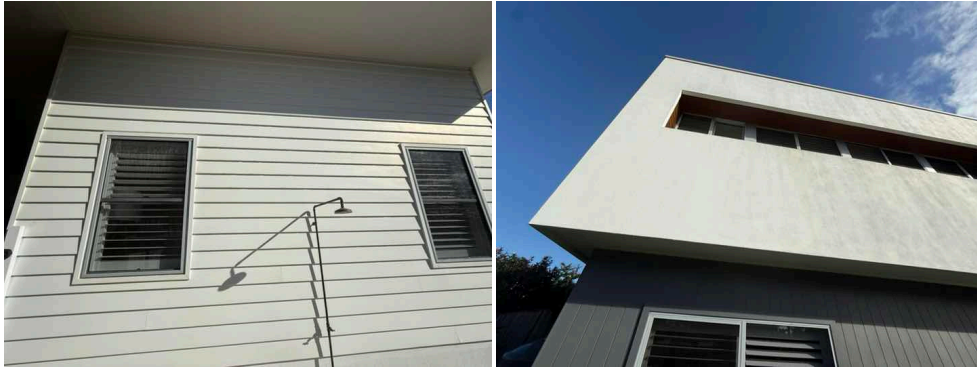
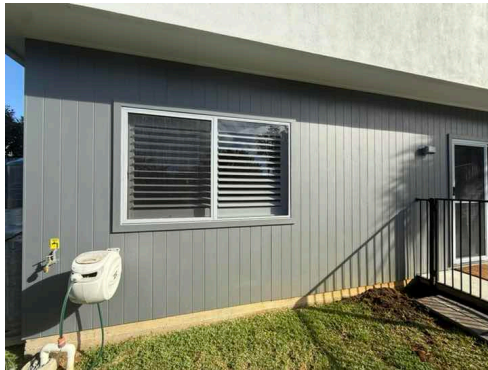
Walls

Fibrous cement sheeting. Some fibro may contain asbestos, we recommend that you organise a asbestos inspection to this dwelling prior to a decision to purchase.

On visual inspection, the general condition of the exterior walls is serviceable for the age.

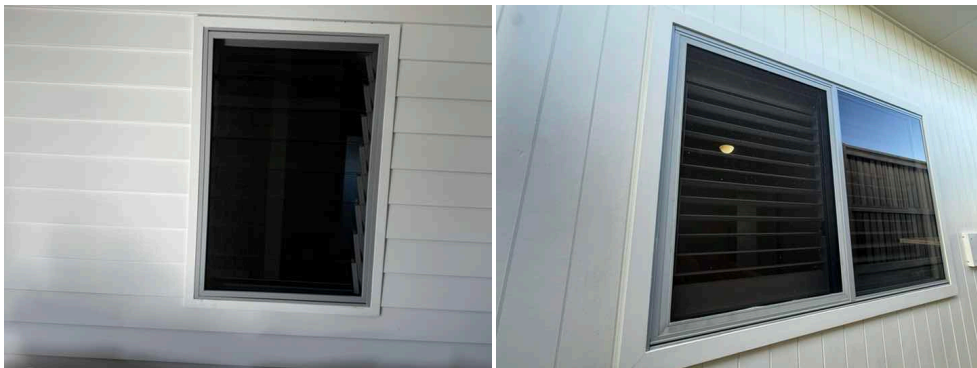
Windows

On visual inspection, the general condition of the windows is serviceable for the age.

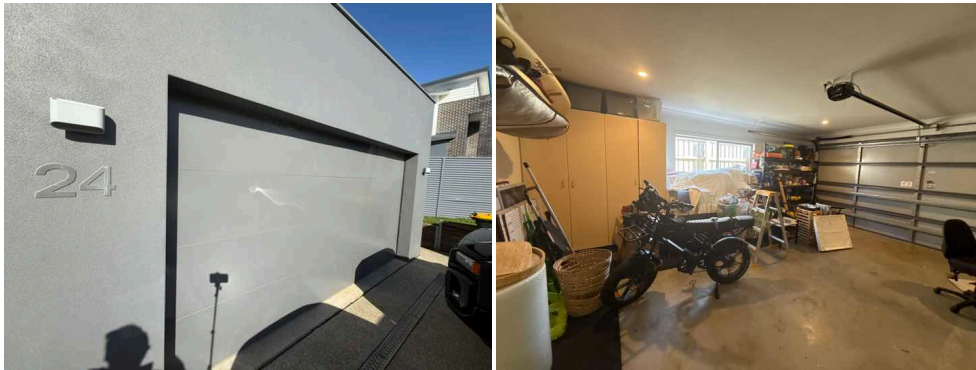
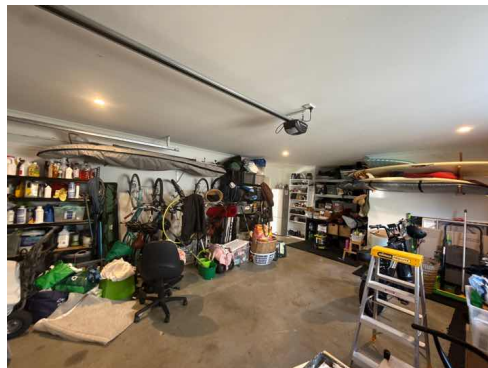
GARAGE - CARPORT

Stored items restricted a full and thorough inspection of this area. Defects may exist in the obstructed and inaccessible areas. It is strongly recommended that full access be granted to enable a thorough inspection as there may be timber pest activity, damage or defects. Note: Where vehicles and storage has restricted a full inspection it is advised that this area be cleared so a full and unobstructed inspection can be carried out.

From the visible and accessible areas, the garage appears to be in a serviceable condition for the age of the property with no notable structural defects sighted.

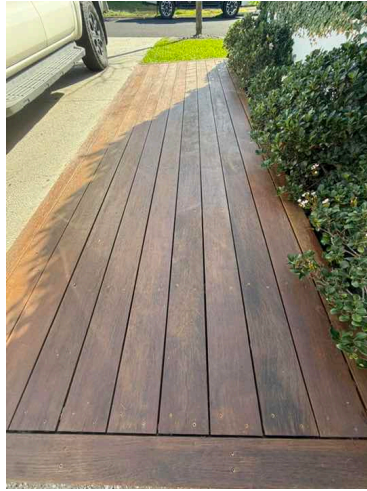
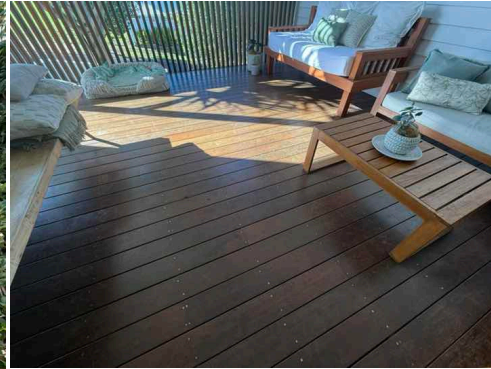
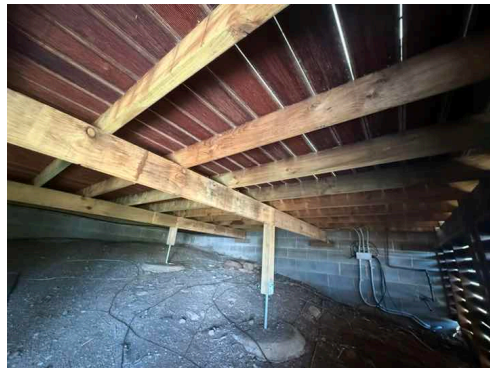
Of areas visible, the decking appears to be in a serviceable condition.

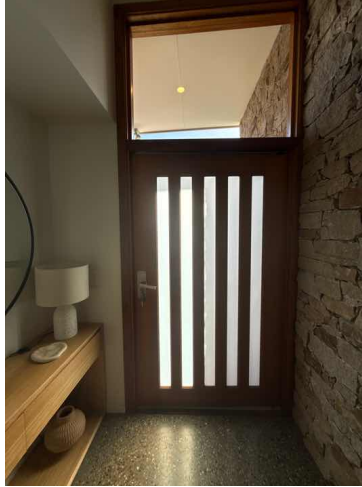
Front Entry Doors

The doors are in serviceable condition with no notable defects observed.

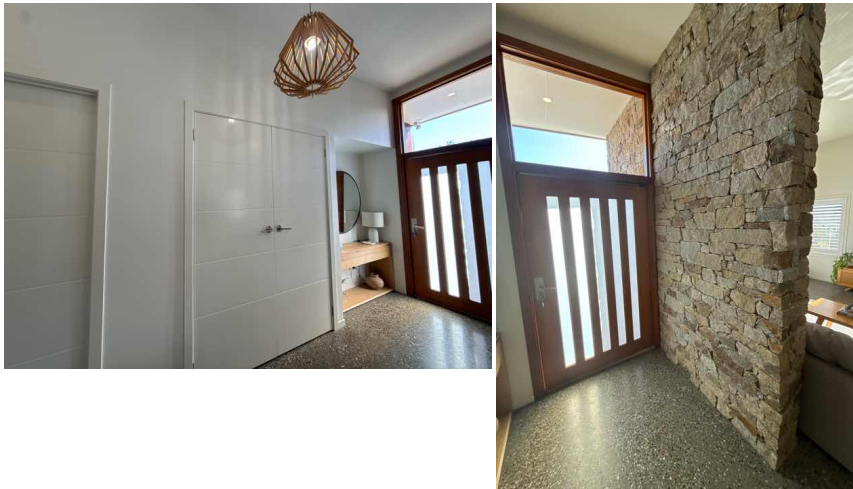
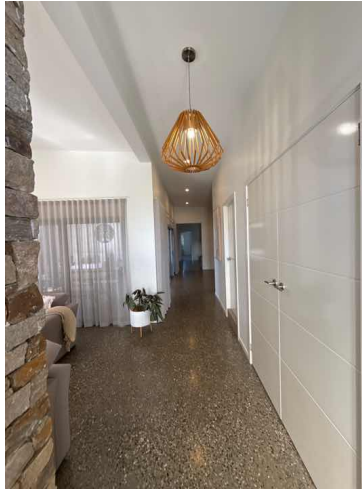
From the visible and accessible areas, this area appears to be in a serviceable condition for the age of the property with no notable structural defects sighted.

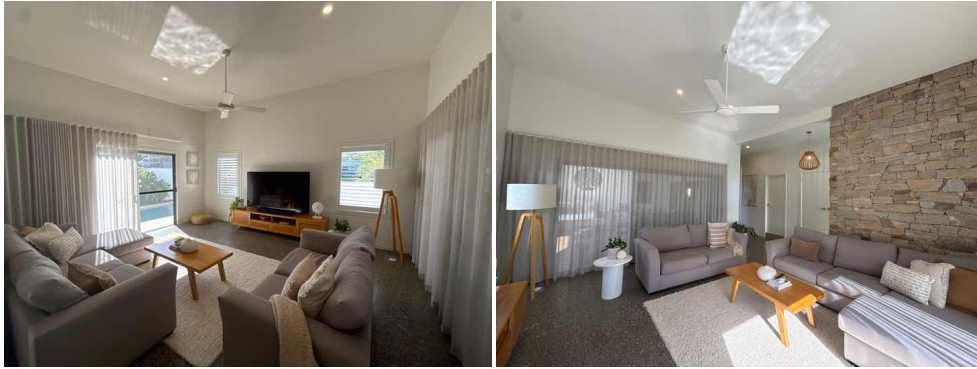
Living Room

From the visible and accessible areas, this room appears to be in a serviceable condition for the age of the property with no notable structural defects sighted.

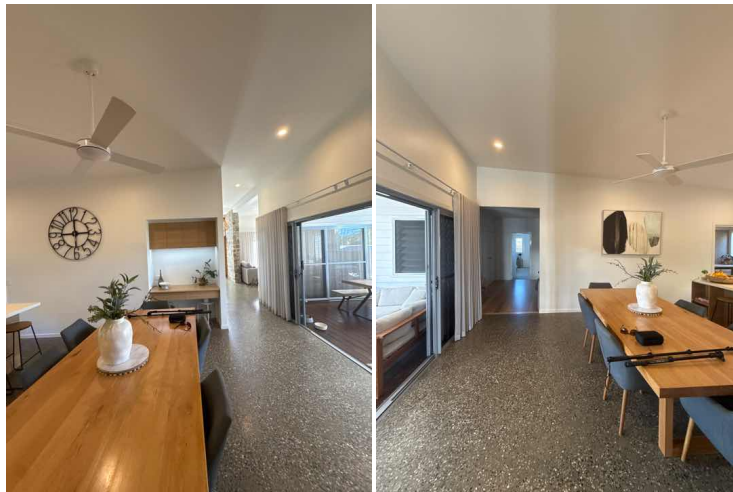
Dining Room

From the visible and accessible areas, this room appears to be in a serviceable condition for the age of the property with no notable structural defects sighted.

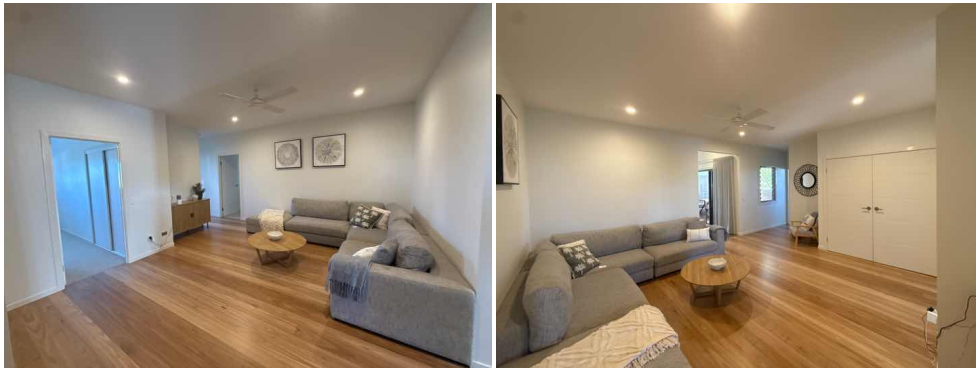
Family Room

From the visible and accessible areas, this room appears to be in a serviceable condition for the age of the property with no notable structural defects sighted.

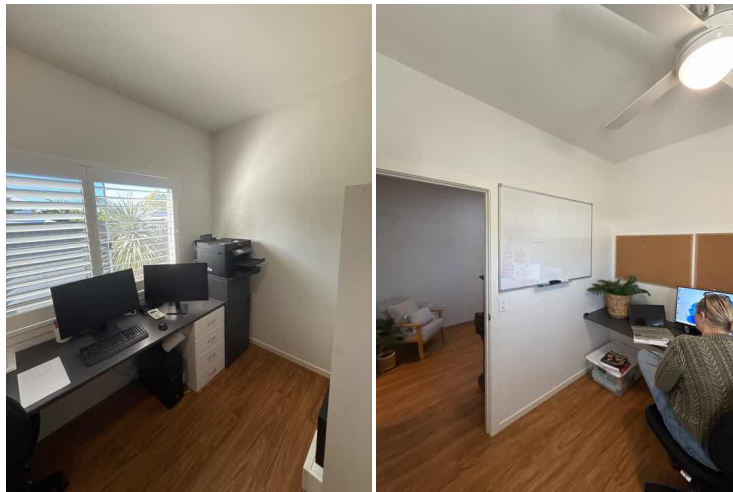
Study

From the visible and accessible areas, this room appears to be in a serviceable condition for the age of the property with no notable structural defects sighted.

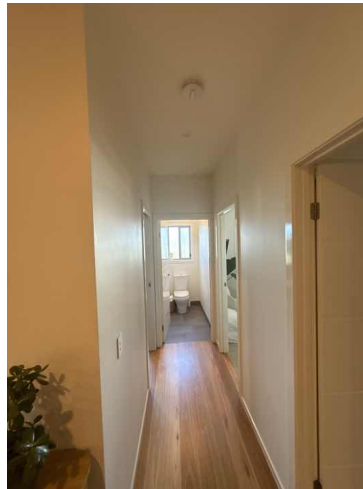
Hallway/s

From the visible and accessible areas, the hallway/s/ appears to be in a serviceable condition for the age of the property with no notable structural defects sighted.

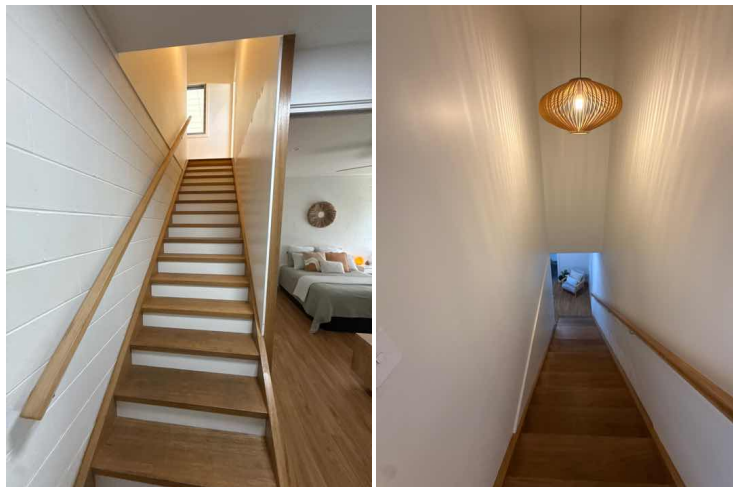
Internal Stair Case

The internal staircase and components appear to be in a serviceable condition for the age with no notable defects sighted.

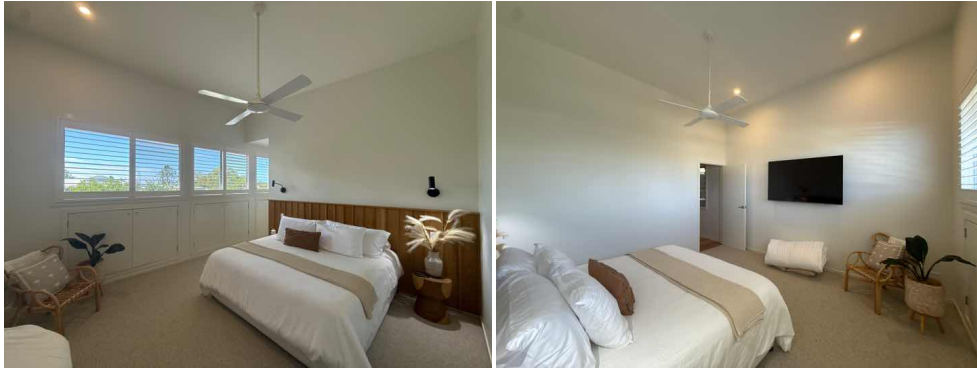
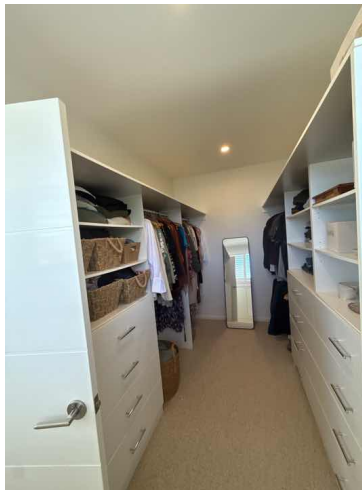
From the visible and accessible areas, this bedroom appears to be in a serviceable condition for the age of the property with no notable structural defects sighted.

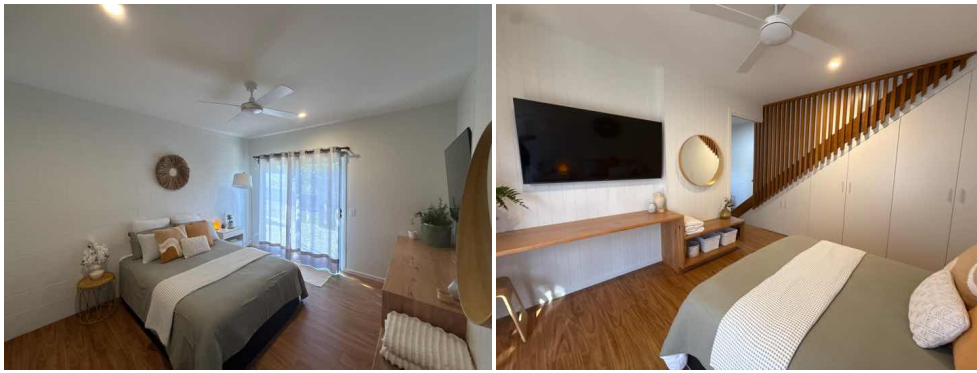
Bedroom 2

From the visible and accessible areas, this bedroom appears to be in a serviceable condition for the age of the property with no notable structural defects sighted.

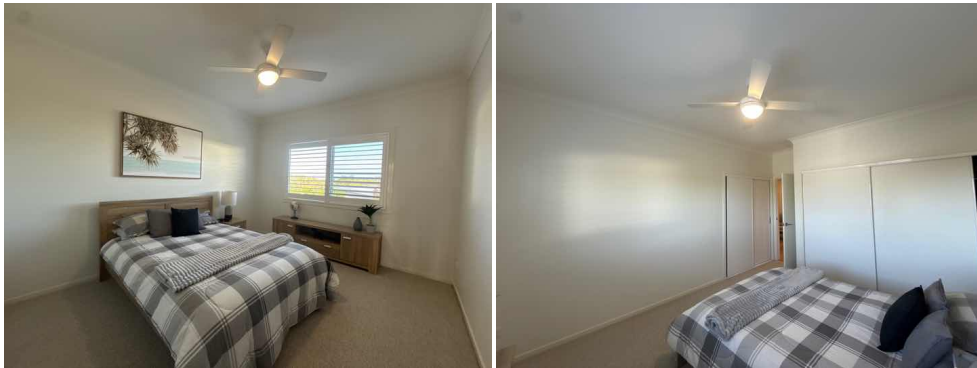
Bedroom 3

From the visible and accessible areas, this bedroom appears to be in a serviceable condition for the age of the property with no notable structural defects sighted.

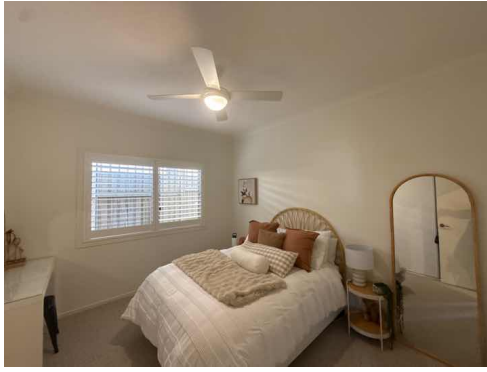
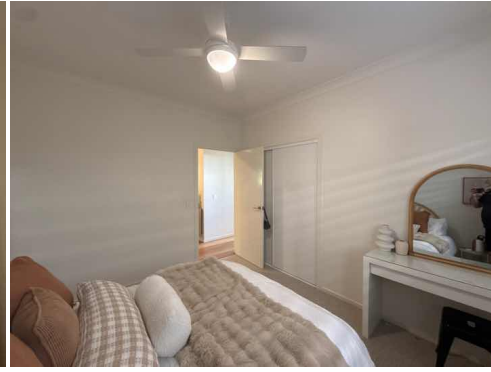
Bedroom 4

From the visible and accessible areas, this bedroom appears to be in a serviceable condition for the age of the property with no notable structural defects sighted.

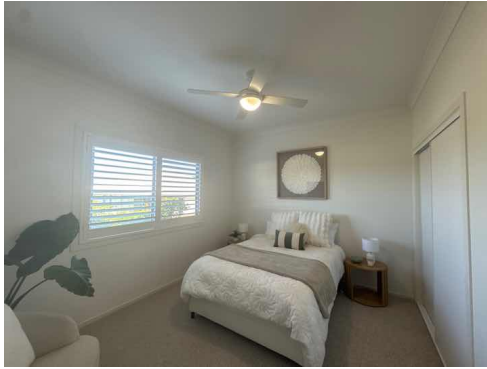
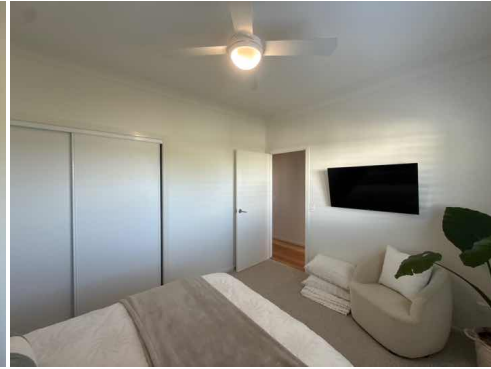
Bedroom 5

From the visible and accessible areas, this bedroom appears to be in a serviceable condition for the age of the property with no notable structural defects sighted.

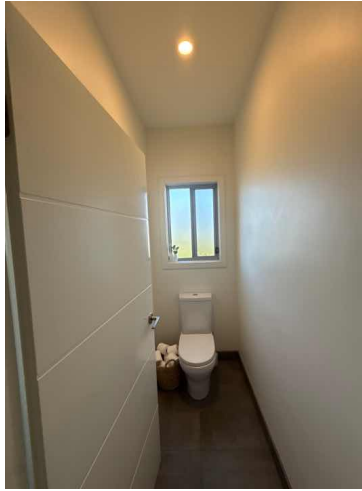
Of the visible areas, the general condition of this bathroom is serviceable or in reasonable condition for age of dwelling.

No exhaust fan is installed - Recommend having one installed.

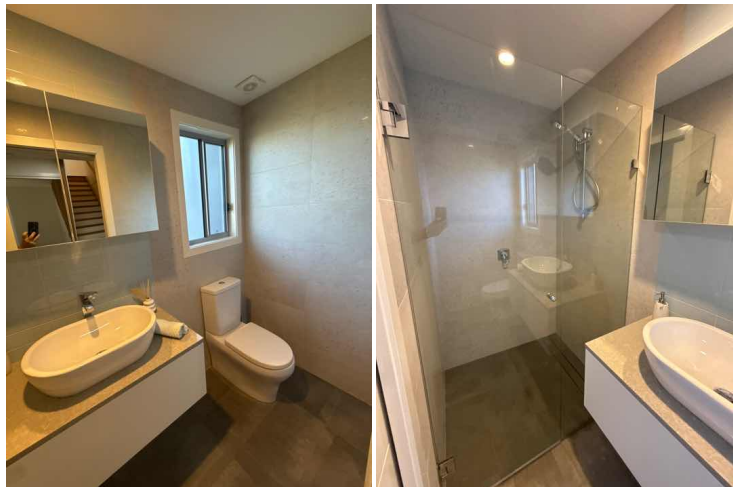
Of the visible areas, the general condition of this bathroom is serviceable or in reasonable condition for age of dwelling.

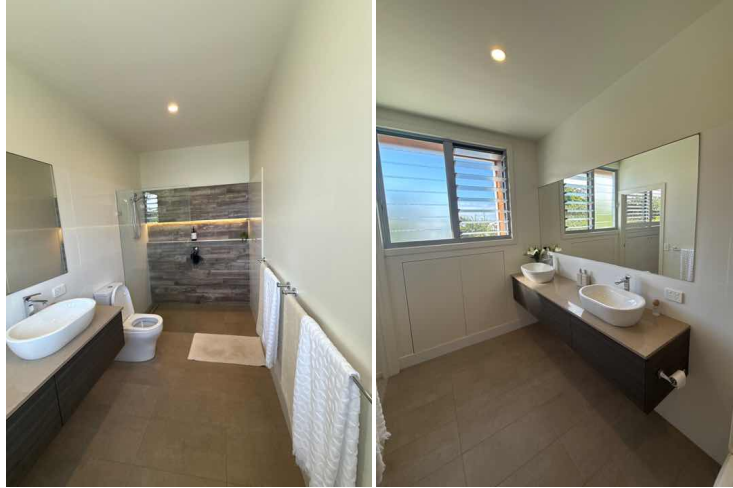
Of the visible areas, the general condition of this bathroom is serviceable or in reasonable condition for age of dwelling.

No exhaust fan is installed - Recommend having one installed.

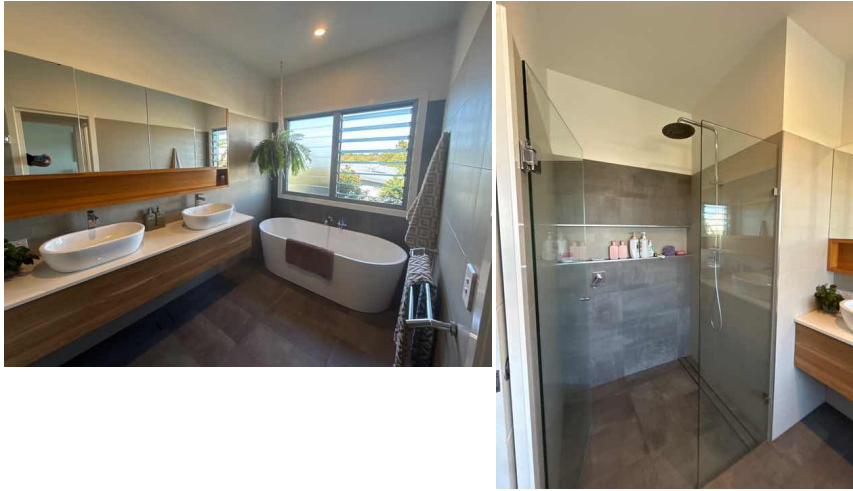
Of the visible areas, the general condition of this bathroom is serviceable or in reasonable condition for age of dwelling.

The vanity mirror is desilvering at edges. Replacement recommended.

No exhaust fan is installed - Recommend having one installed.

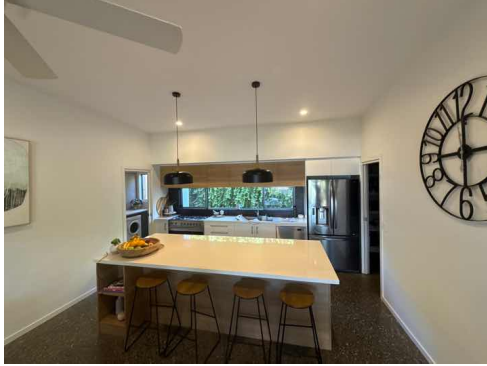
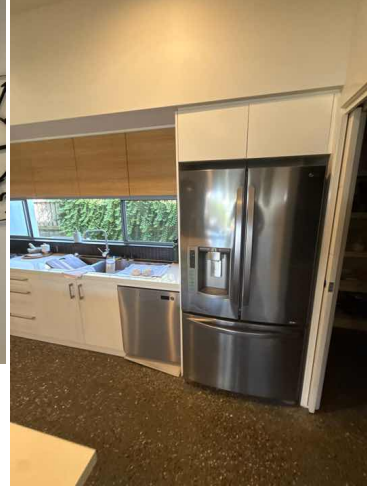
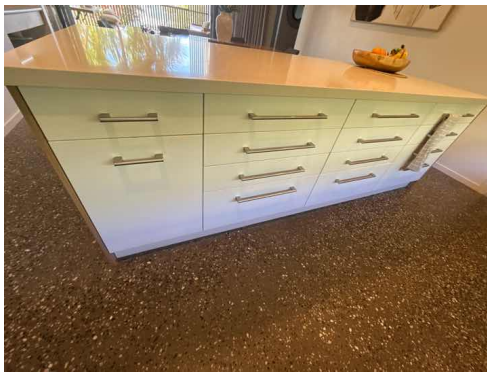
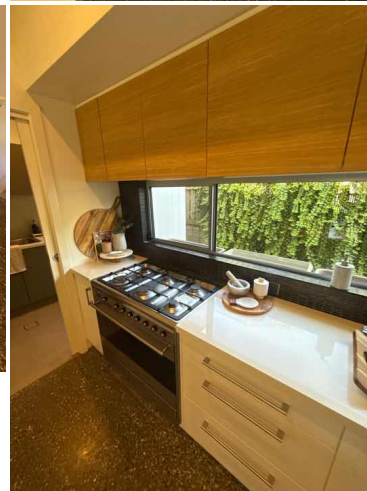
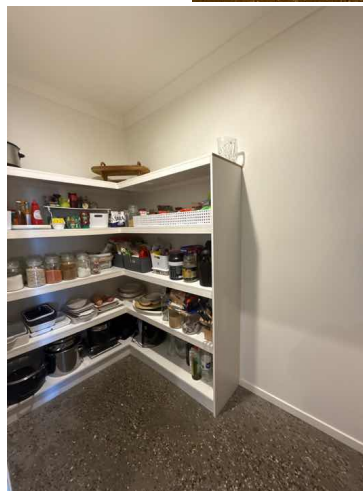
Of the visible areas, the general condition of the kitchen and pantry is serviceable or in reasonable condition for age of dwelling.

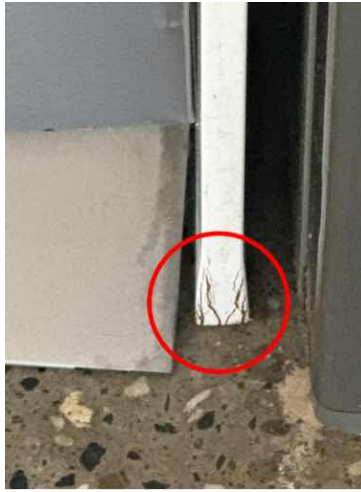
Cupboards And Bench Tops

These components appear to be in a serviceable condition

Adjustment to cabinet doors required, in some instance hinges may need to be replaced.

Damage was noted to the cabinets, contact a joinery company for repairs

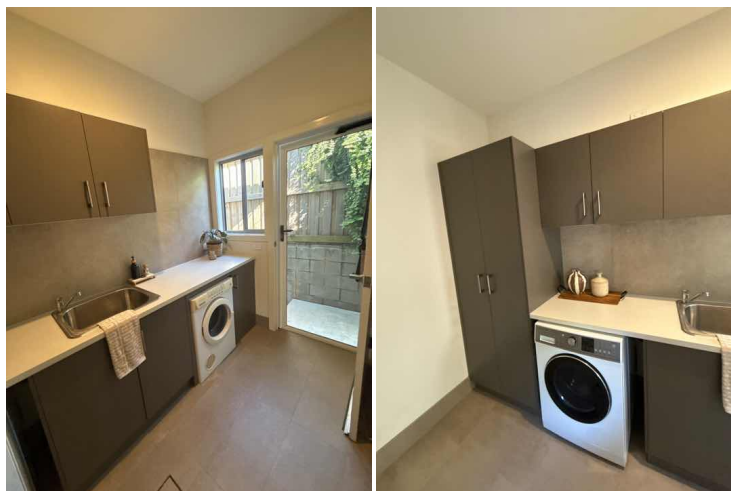
Laundry

Of the visible areas, the general condition of the laundry is serviceable or in reasonable condition for age of dwelling.

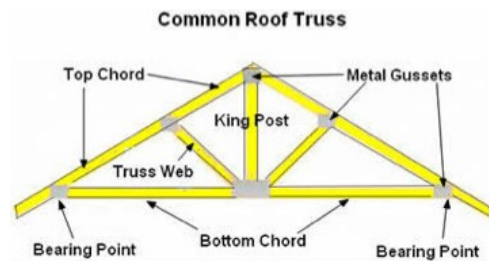
Roof Frame Type

The roof frame is a truss timber frame.

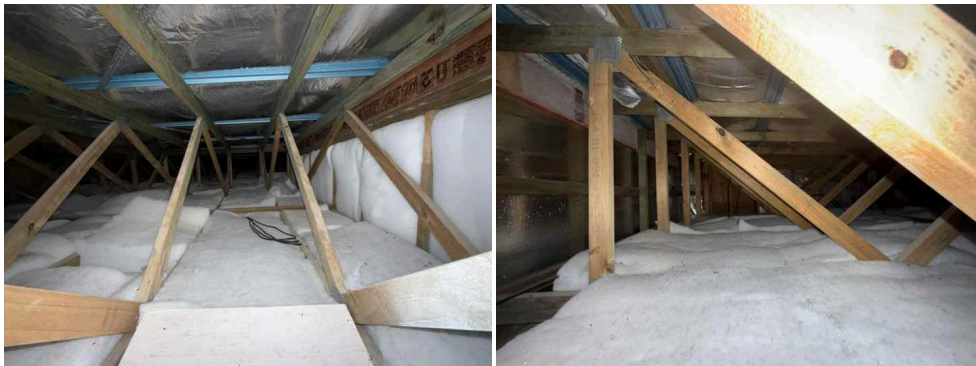
Visible sections of the roof void is in a serviceable condition for age of this dwelling.

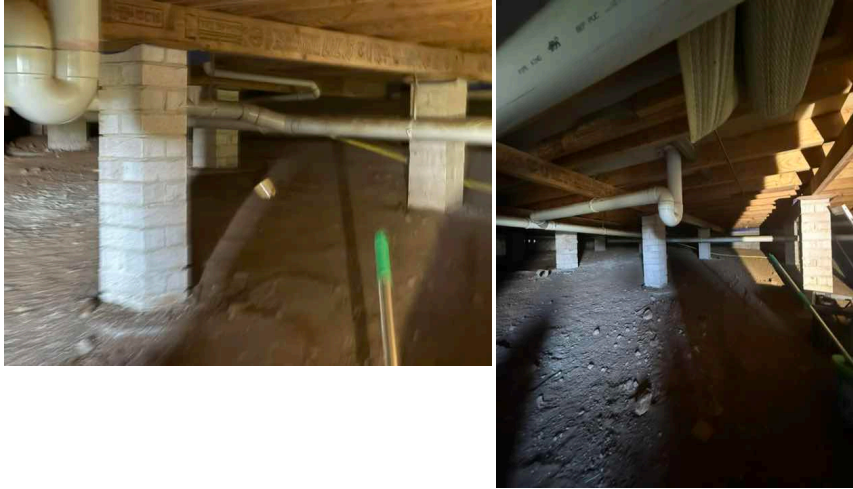
Of areas accessible and visible, the subfloor and components appeared to be in a serviceable condition.

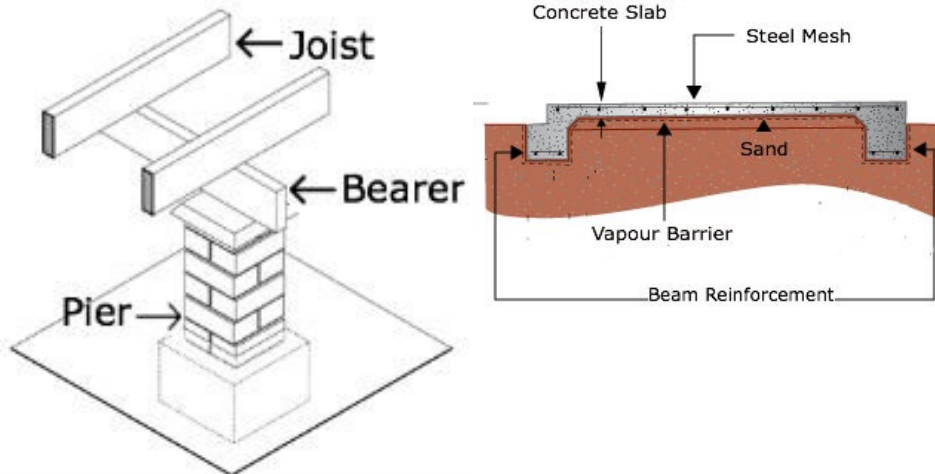
Slab on ground construction.

Footings are brick piers with timber bearers and joists.
