Building and Pest Report

8 Granite Street Lennox Head

Pest And Building Inspection

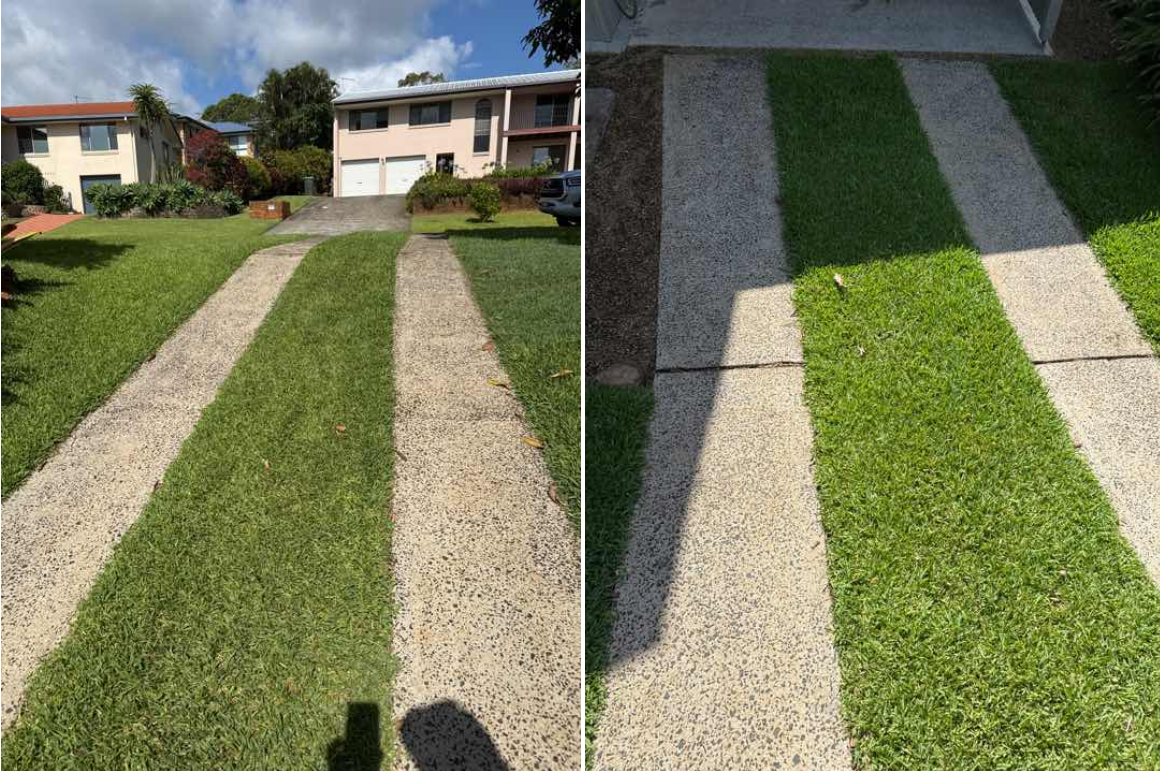
Driveway Condition

On visual inspection, the general condition of the driveway is serviceable.

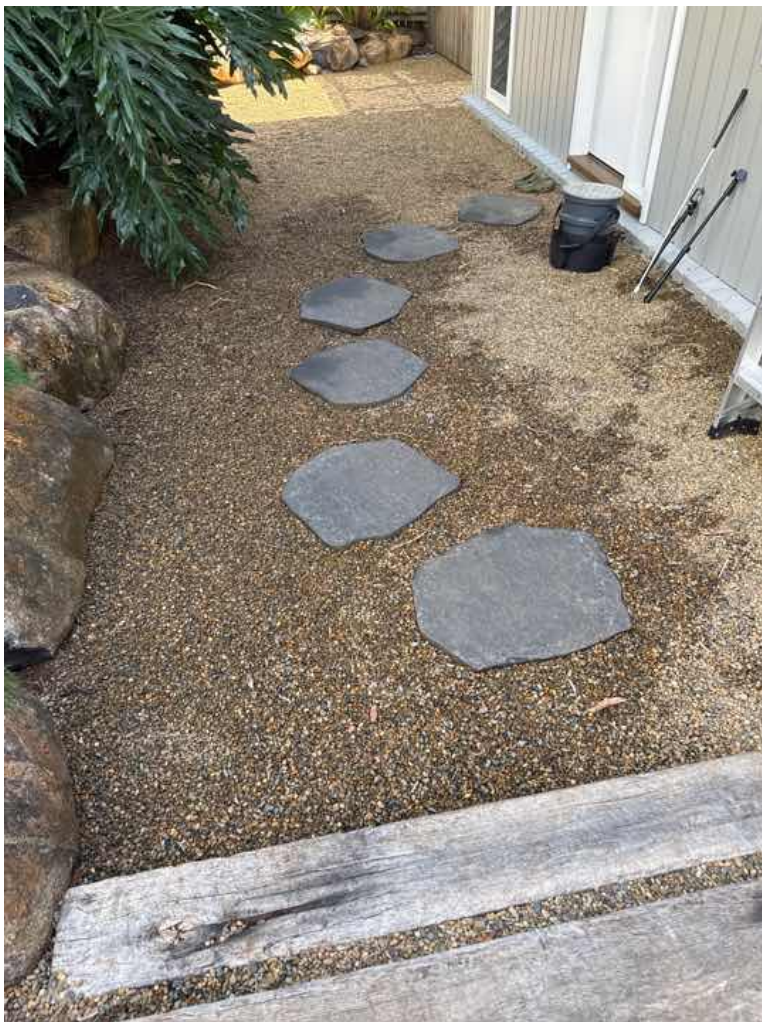
Pathways Condition

The paths around the home are in a serviceable condition for the age of this dwelling with no major defects visible.

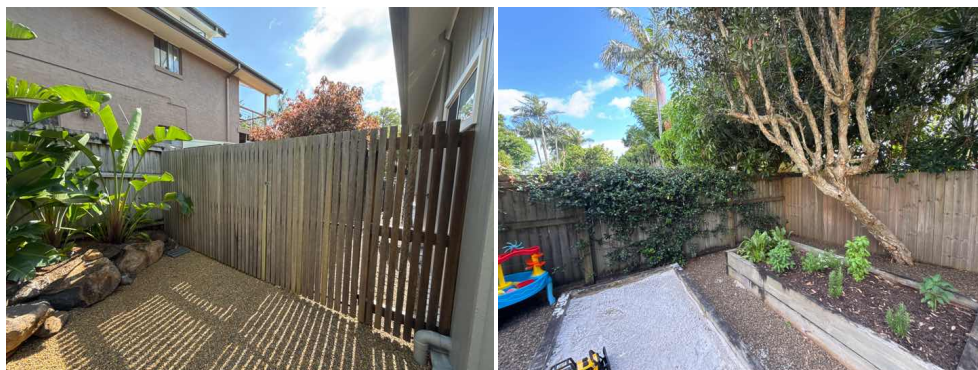
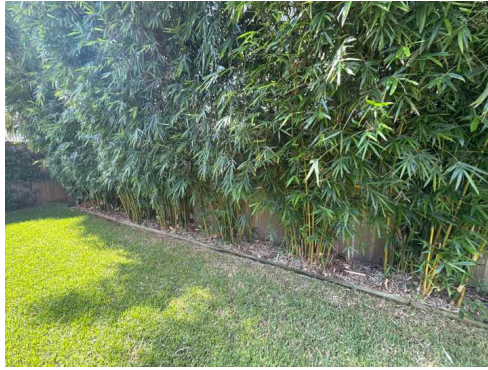
Fences & Gates

Of the visible areas, the general condition of the fences and gates is serviceable for the age of dwelling.

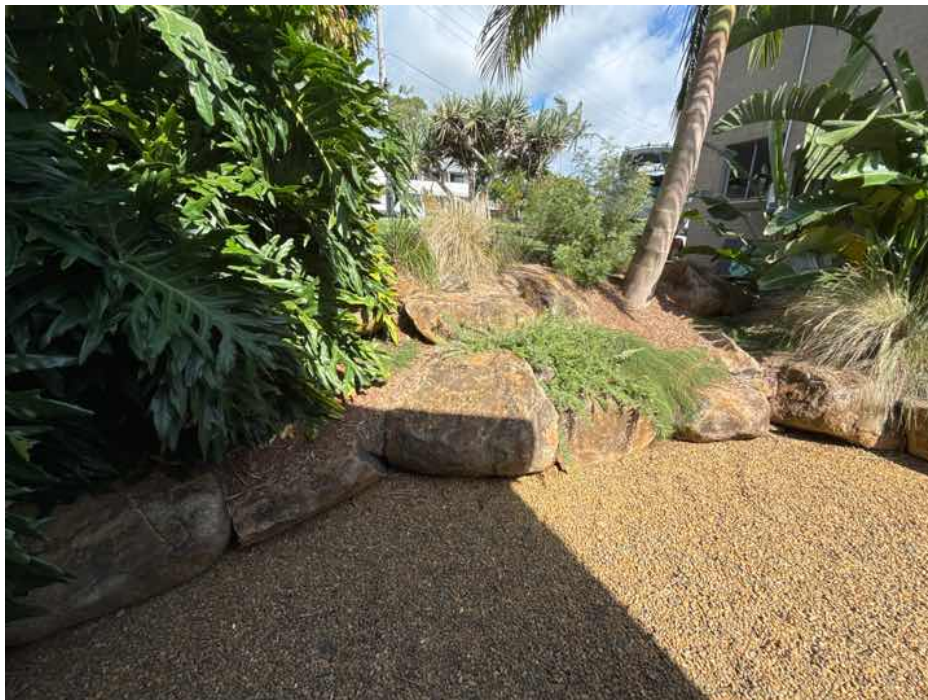
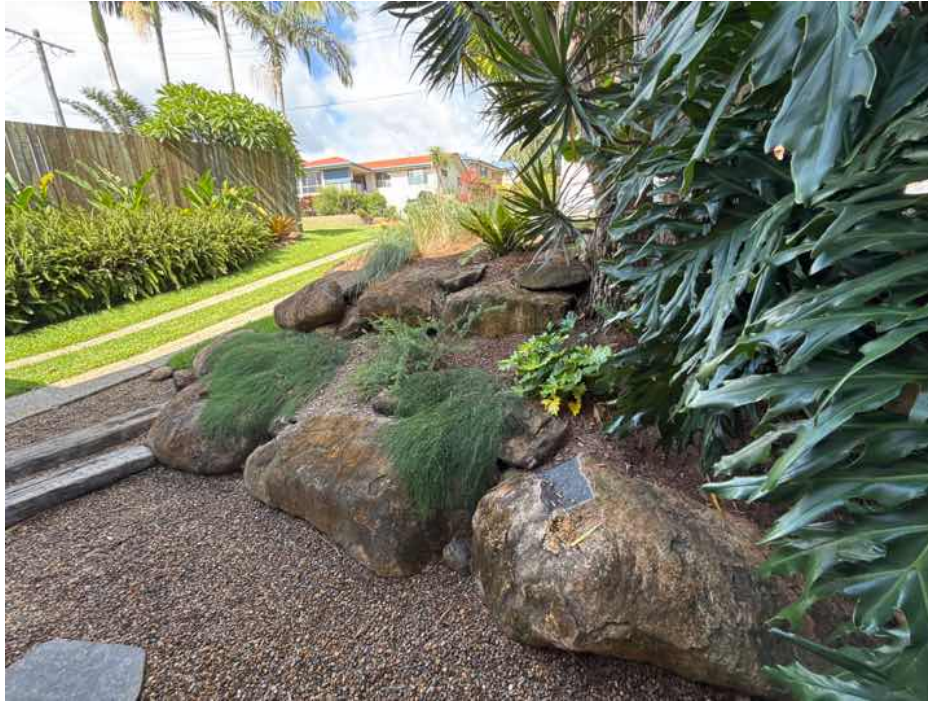
Surface Drainage

There was no visible evidence of excess ponding or fall towards the property walls at the time of the inspection. Regardless, it is difficult to ascertain in dry conditions and it is therefore recommended that you assess same after a rainfall period to be able to sufficiently ascertain if any problems exist in this regard. If water is ponding around perimeter walls and paths or appears to be flowing into the footings/foundations you must have assessed by a qualified plumber or landscaper.

Recommend installing a drainage point under the tap to assist with drainage.

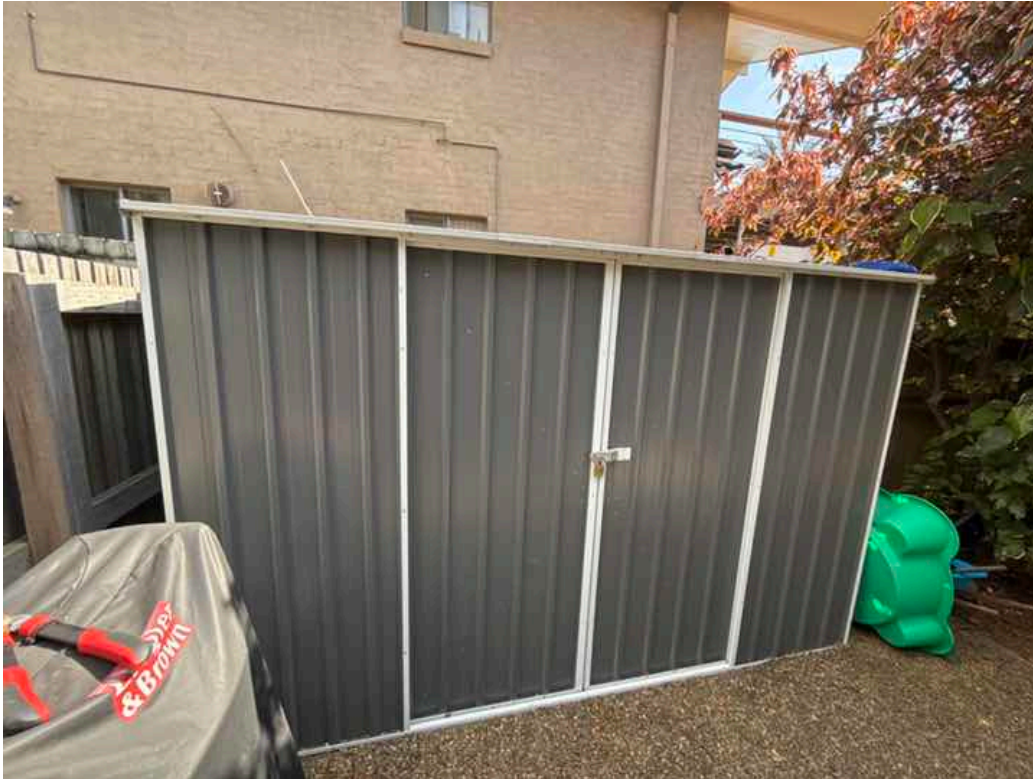
Shed Condition

The shed is in fair usable condition.

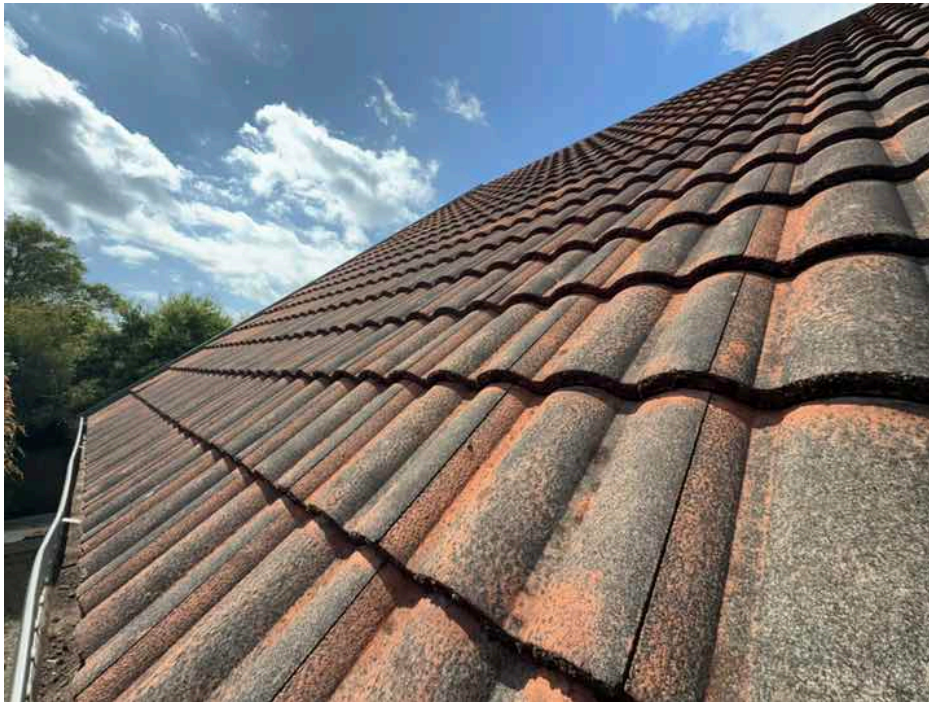
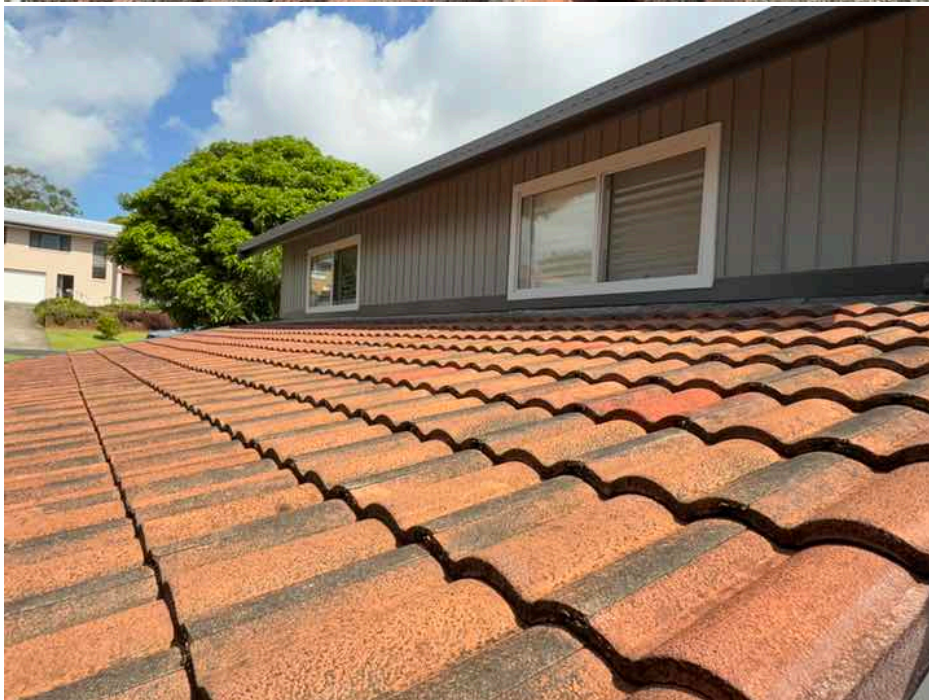
Roof Clad Condition

Visible section of The roof cladding appeared in a serviceable condition for the age of this dwelling. Annual maintenance inspection recommended.

Deterioration & ageing evident. I recommend you contact a roof restorer to clean, seal, and repoint the mortar.

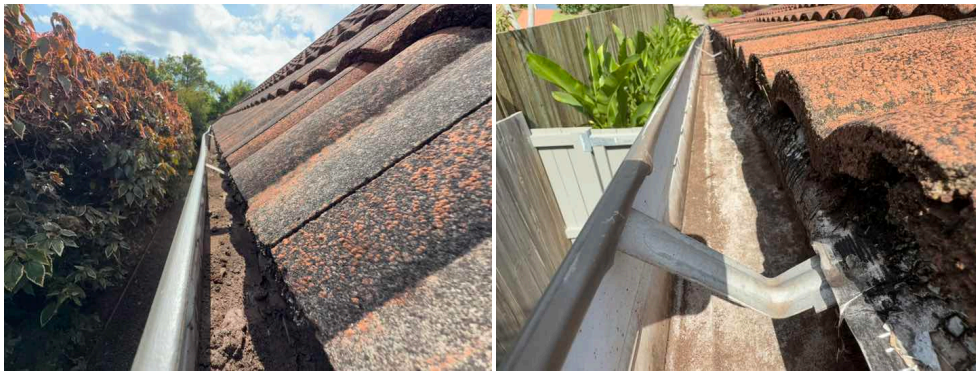
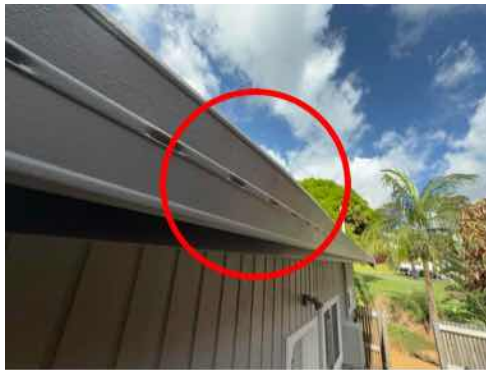
Impact/Denting damage observed. Replace as required.

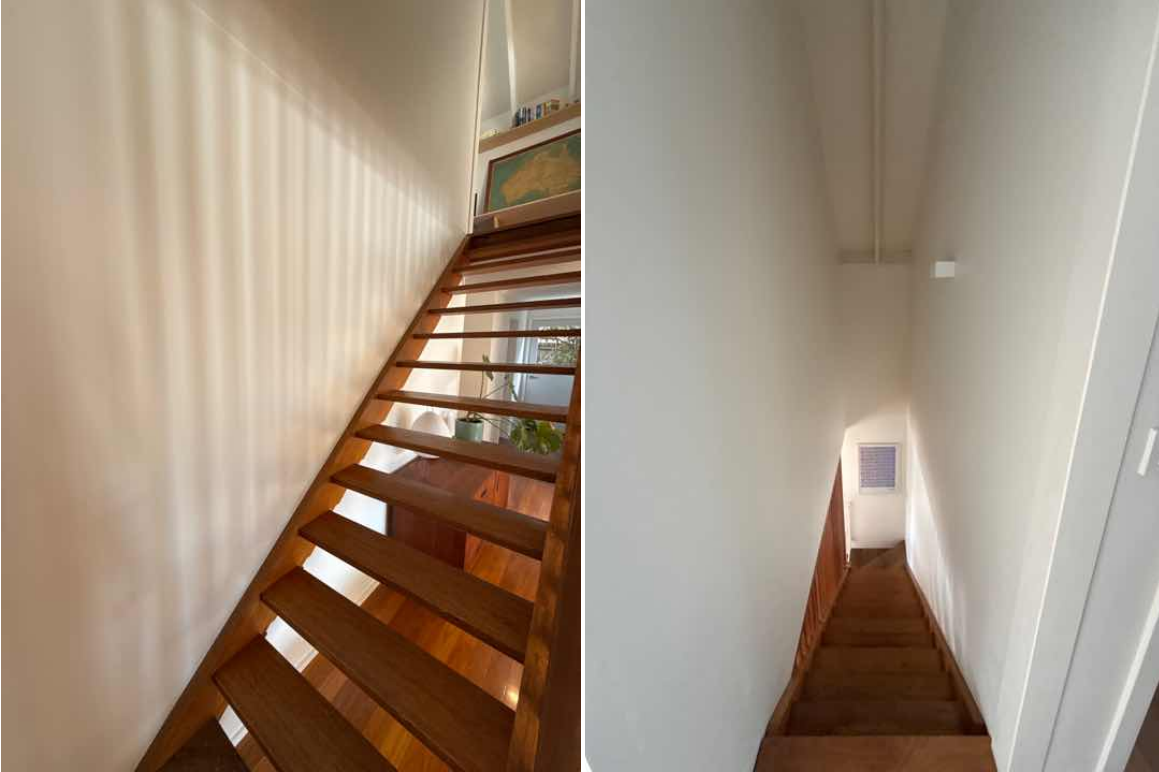
Internal Stair Case

The internal staircase and components appear to be in a serviceable condition for the age with no notable defects sighted.

No hand rail installed to the staircase. This is a building requirement and presents a safety hazard. Contact a qualified carpenter or builder for repairs prior to purchase.
