# Building and Pest Report

## 35 Kell Mather Dr Lennox Head

| Report/Agreement # | 12112512582274 |
| Inspection Date: | 12 Nov 2025 |

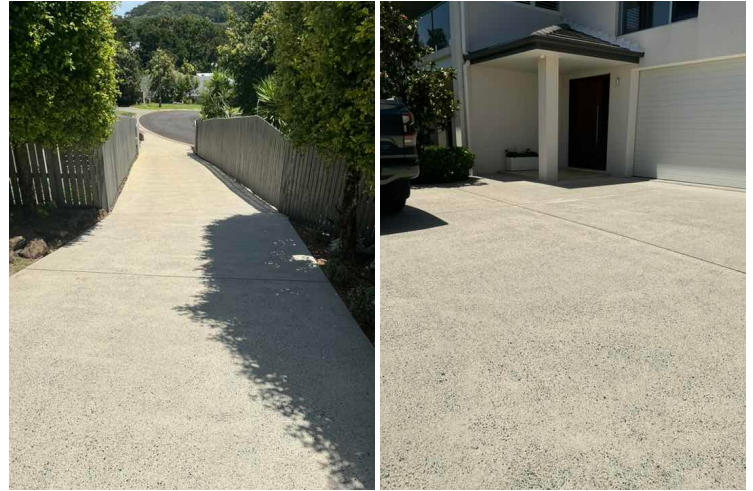
On visual inspection, the general condition of the driveway is serviceable.

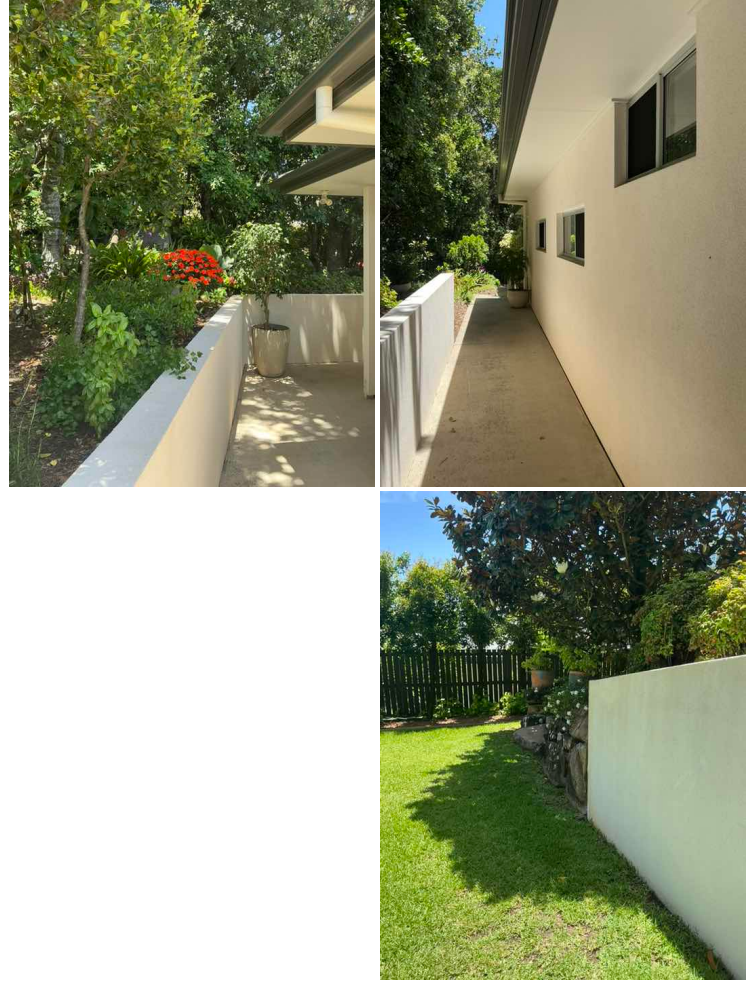
Of the visible areas, the general condition is serviceable or in reasonable condition for age of dwelling.

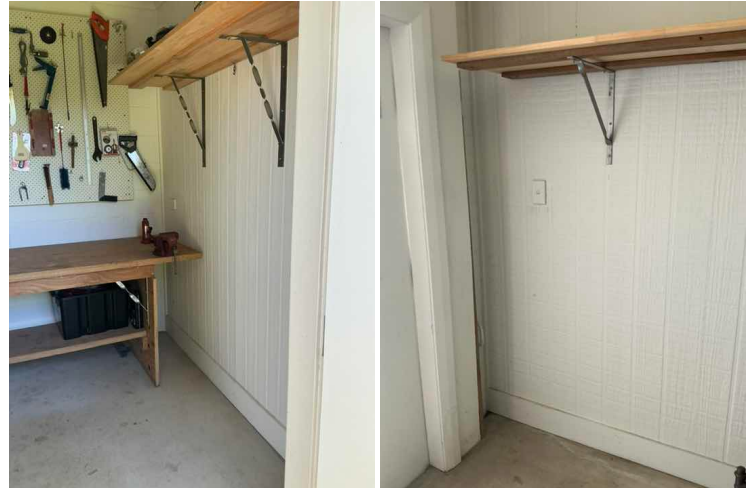
The shed is in fair usable condition.

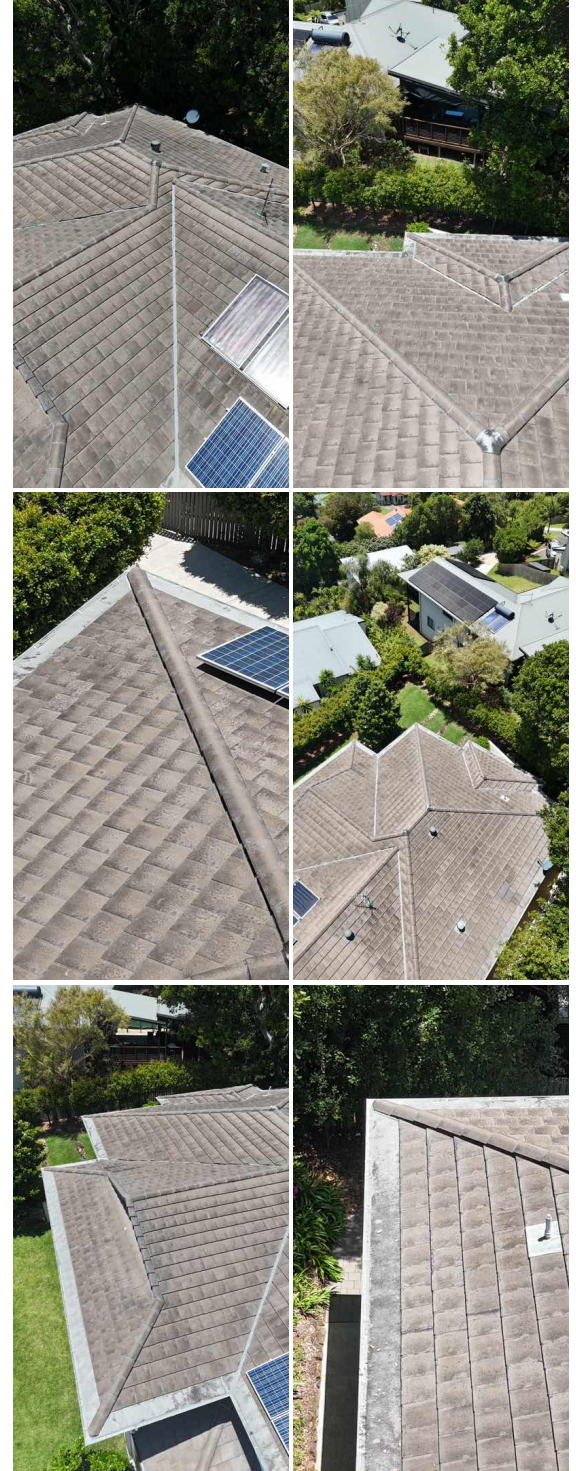
Of the visible areas, the general condition of the roof is in serviceable condition for the age.

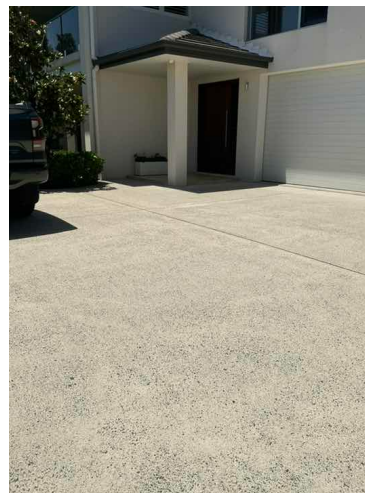
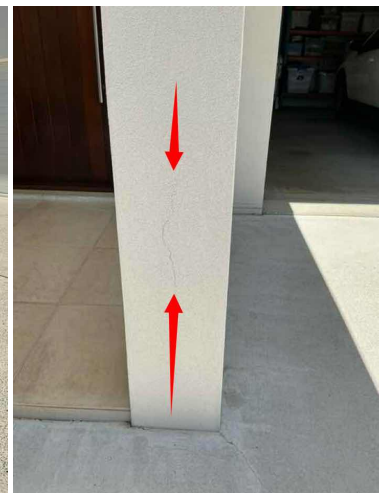
Upon visual inspection, a vertical crack is visible on the column. It is recommended to have a licensed tradesperson assess and repair the crack to prevent further deterioration. Sealing and repainting may be necessary to restore structural integrity and appearance.

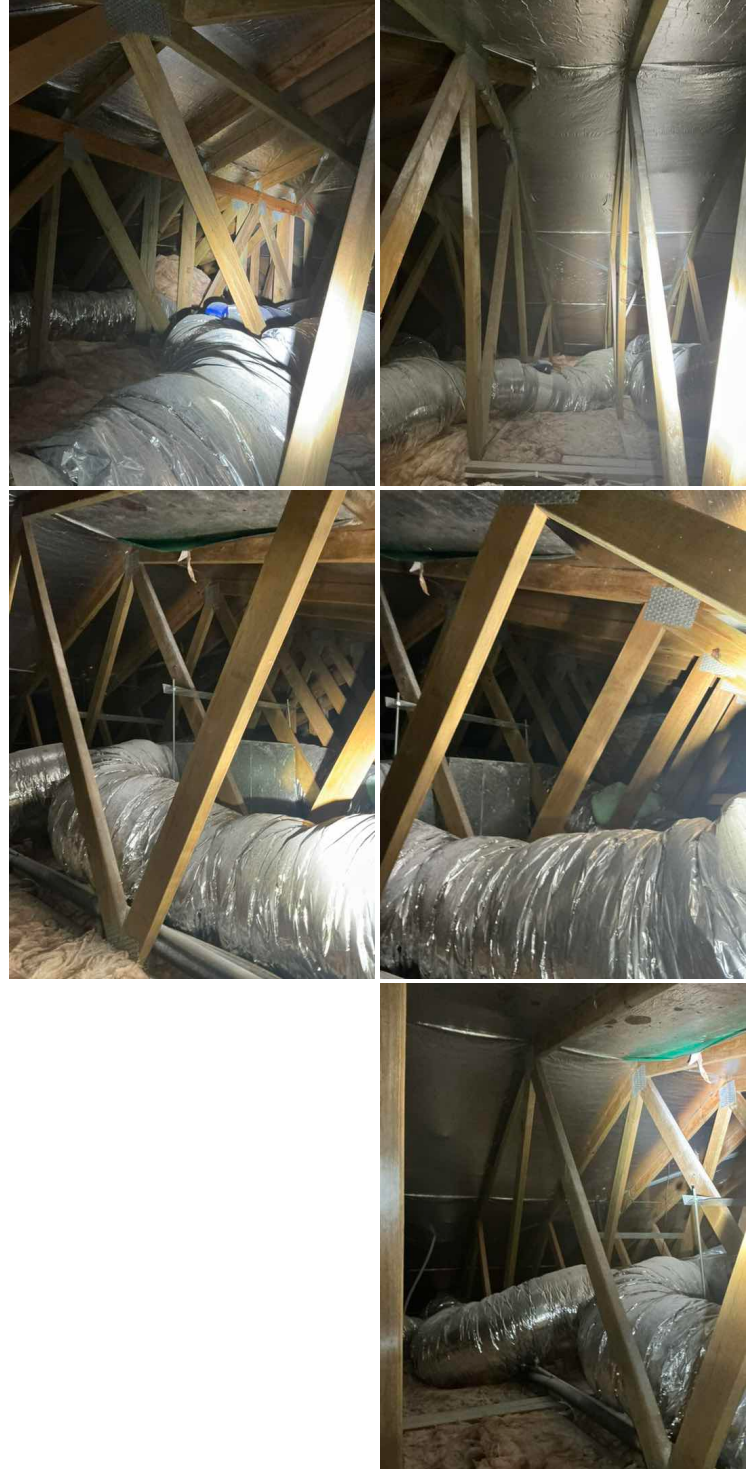
There is heating and/or cooling ducting present in the roof space. This is preventing a full inspection from being undertaken. It is strongly recommended that full access be gained as it could be harbouring timber pest activity, damage or defects.

There is insulation present in the roof space/void. This is preventing a full inspection of ceiling joists from being undertaken. It is strongly recommended that full access be gained as it could be harbouring timber pest activity, damage or defects.

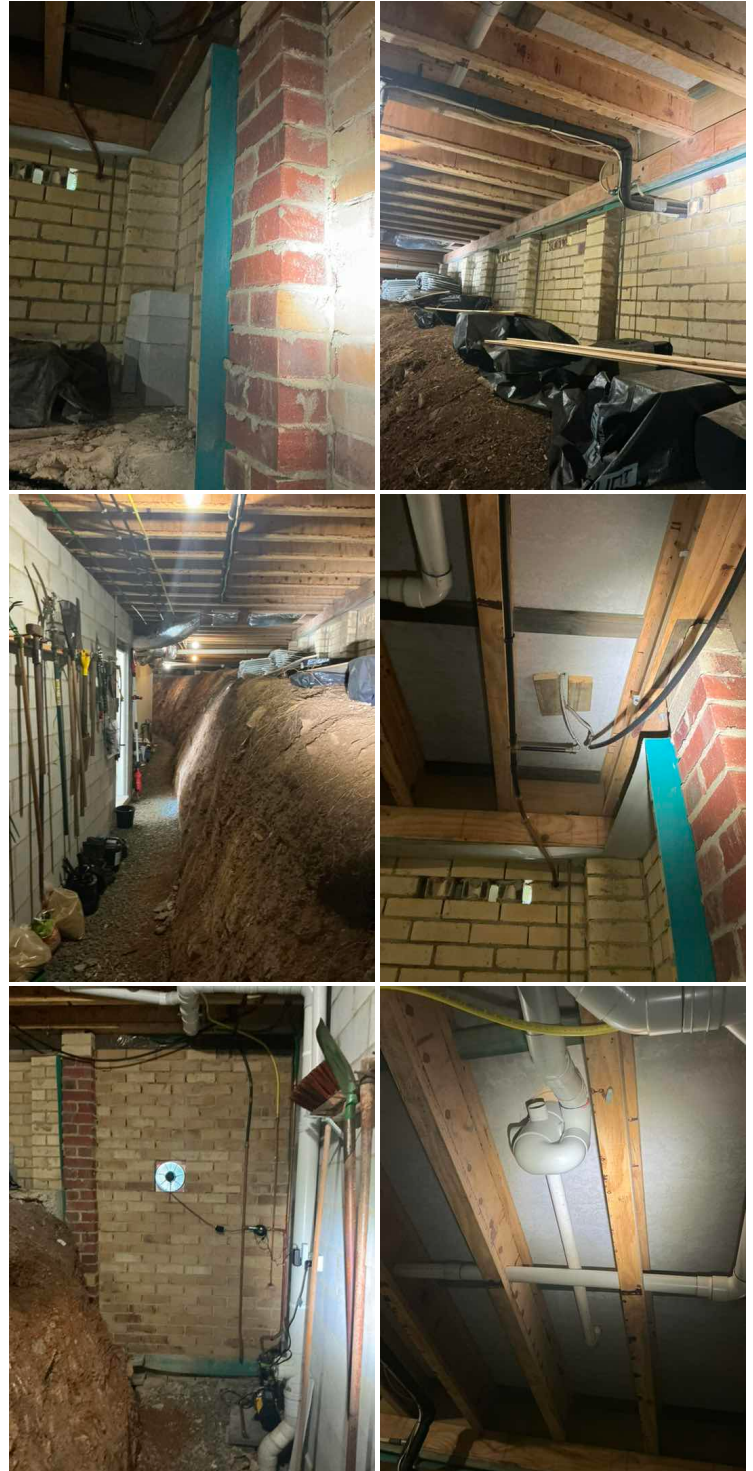
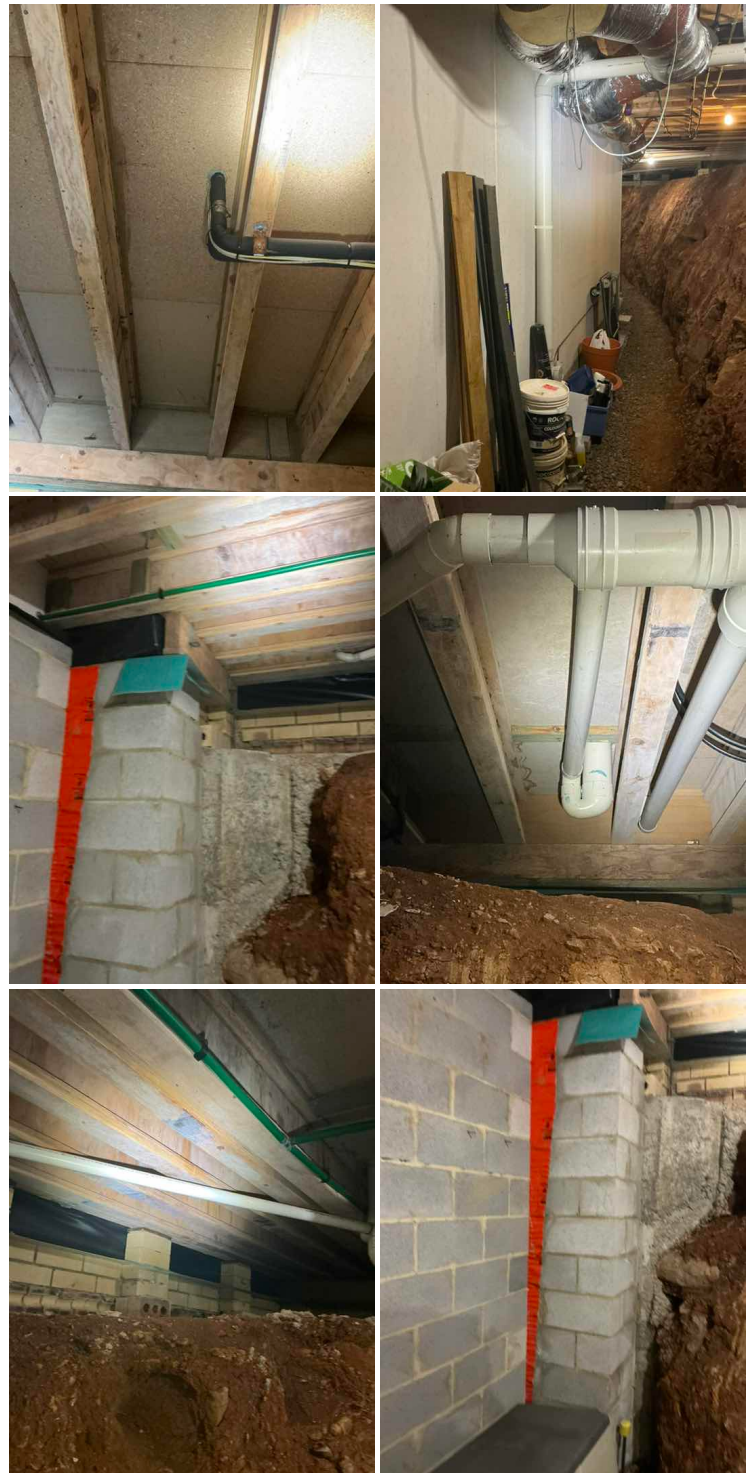
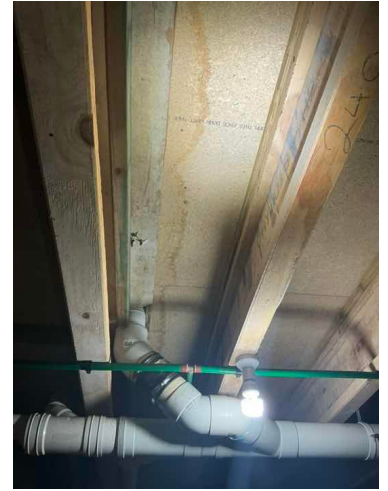
Upon visual inspection, water staining is evident on the ceiling, indicating a possible leak. Recommend engaging a licensed plumber to investigate and repair any plumbing issues. Additionally, a licensed builder should assess the structural integrity of the affected area to ensure no further damage occurs.

Past water penetration is present to sub floor timbers adjacent to the shower. Probable cause leaking shower recess. This situation appears to have been rectified.
