# Building and Pest Report

## 33 Karalauren Crt, Lennox Head

# Inspection Report

**33 Karalauren Crt , Lennox Head , NSW, 2478**

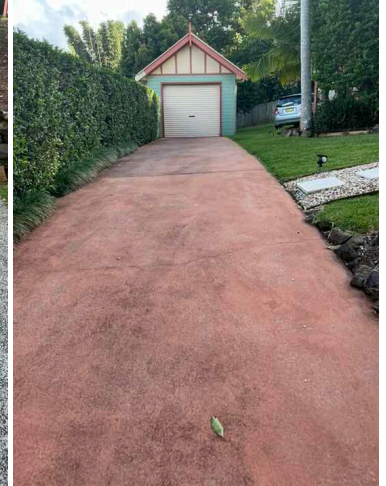
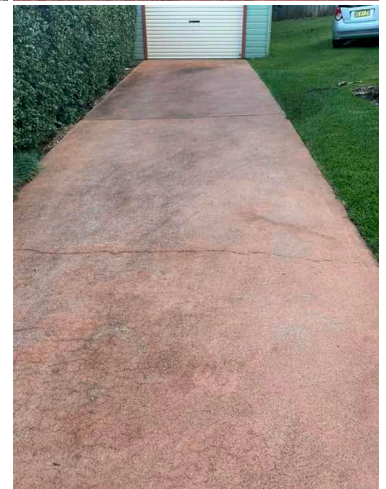
Common cracks were observed on the driveway. Whilst these cracks appeared to be typical at the time of inspection, we strongly recommend you monitor these cracks and if worsening occurs contact a concreter for further advice.

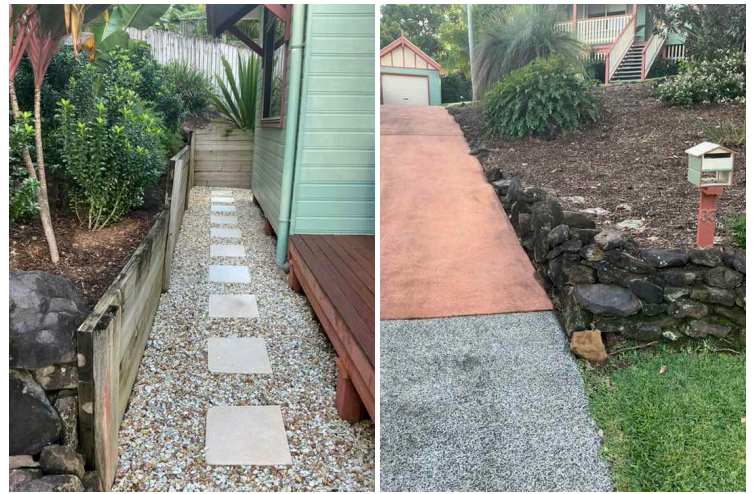
#1. Retaining wall leaning due to deterioration and age. A qualified brick layer should be engaged for advice and recommendations.

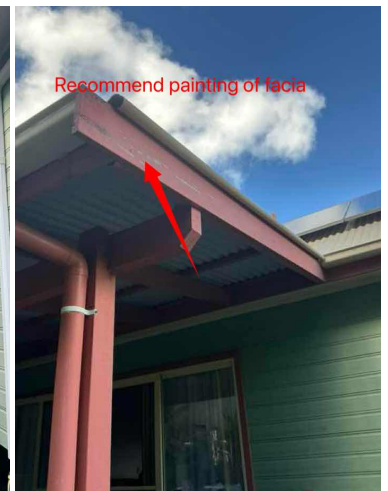
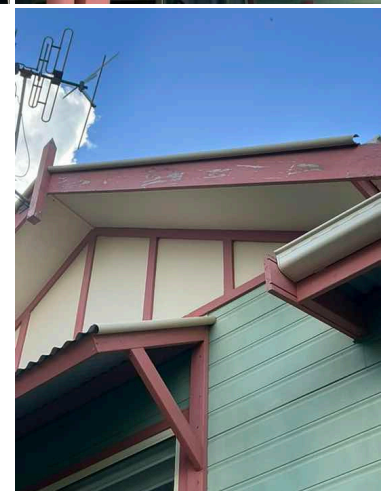
#2. Paint / finish was deteriorated in areas and is in need of maintenance - Sanding back affected areas and painting required.

Upon visual inspection, the fascia board shows signs of peeling paint, indicating potential weather exposure. Recommend sanding and repainting to protect the wood.

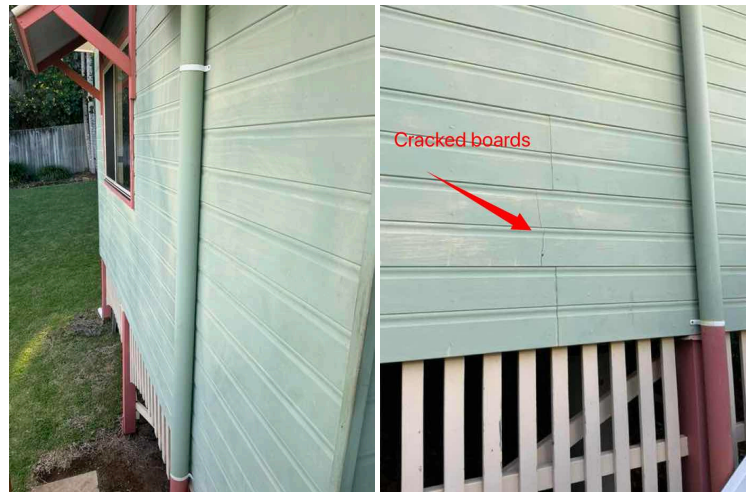
#3. Paneling/cladding damaged. Have a suitably qualified tradesman assess and repair.

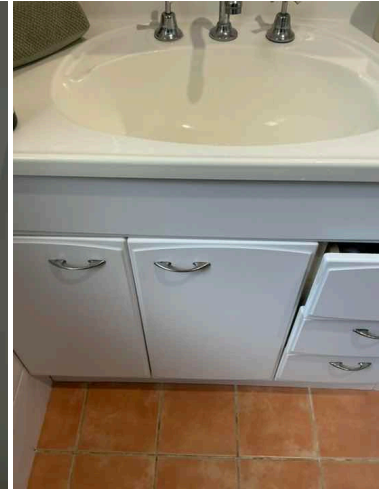
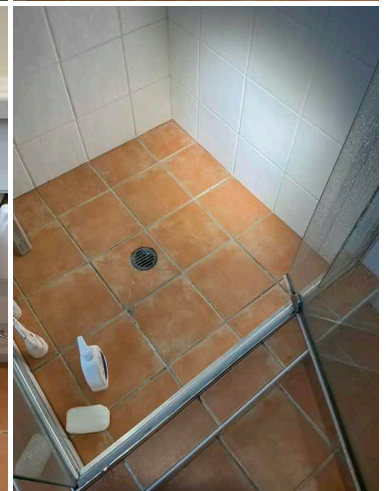
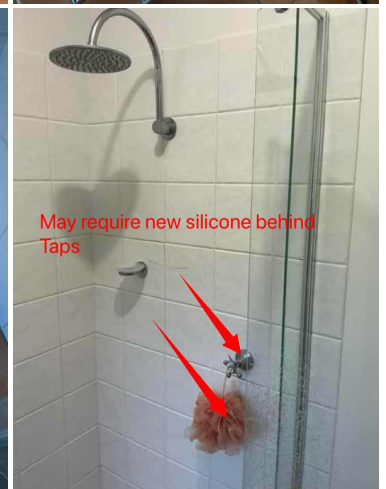
Upon visual inspection, there is water staining on the subfloor indicating a possible leak. It is recommended to have a licensed plumber inspect and repair the plumbing to prevent further water damage. Additionally, assess the surrounding materials for any signs of mold or rot and replace if necessary.

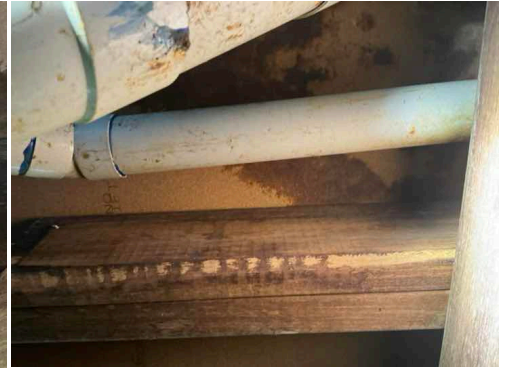
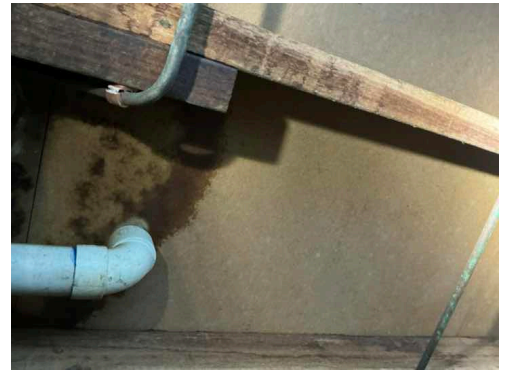
#4. Damp/Moisture damage noted. Possible failed water proof membrane to shower area. Reconstruction of this area may be the best option long term. Contact a licensed builder for further evaluation.

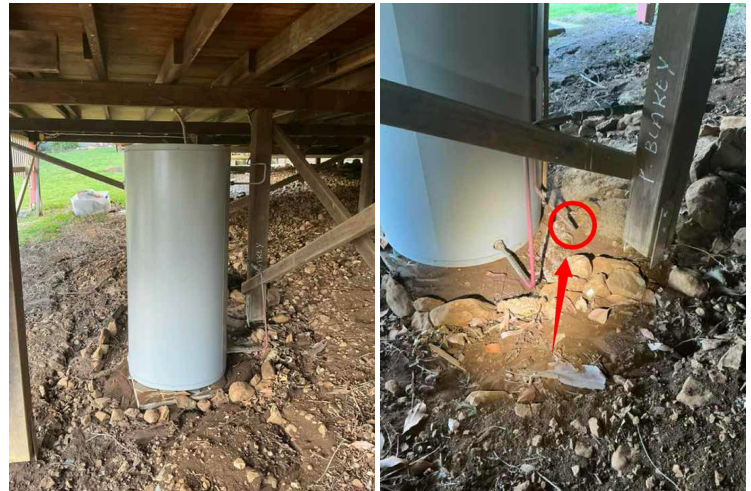
There was water leakage detected during the inspection from the hot water overflow. This should be diverted away from the dwellings walls or into a drain.
