# PEST AND BUILDING PRE-PURCHASE REPORTS

# Inspection Report

**13 Andrew Pl, Lennox Head, NSW, 2479**

Report/Agreement #	280325101850332
Inspection Date:	28 Mar 2025
Inspection Time:	10:18 am

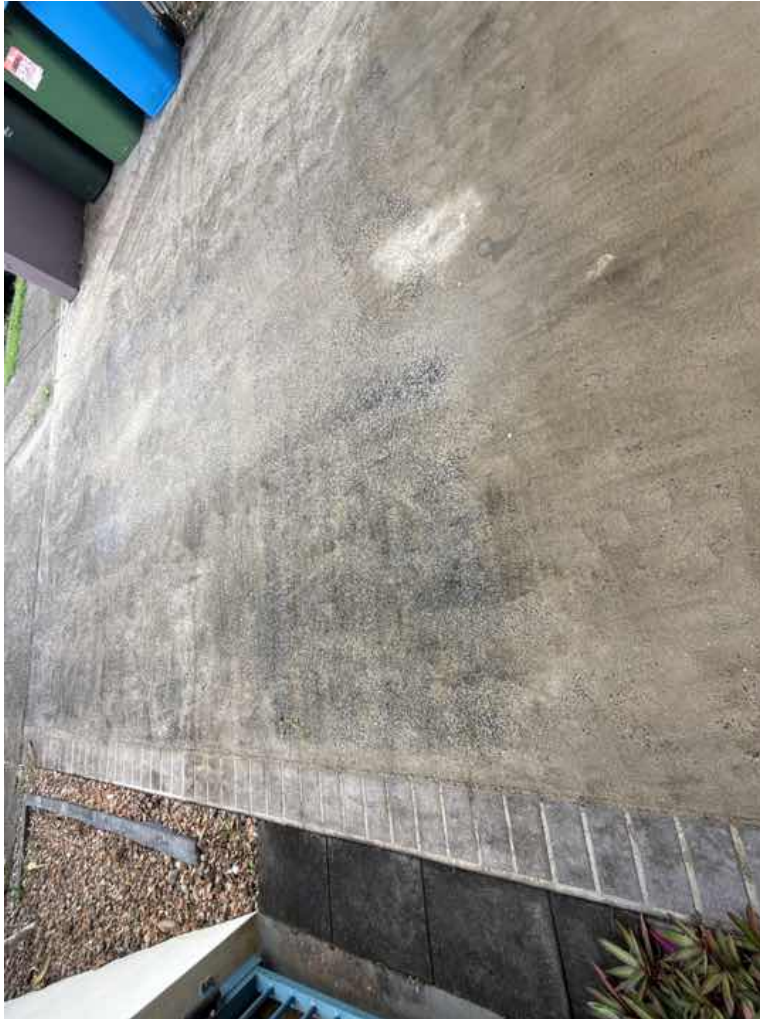
Common cracks were observed on the driveway. Whilst these cracks appeared to be typical at the time of inspection, we strongly recommend you monitor these cracks and if worsening occurs contact a concreter for further advice.

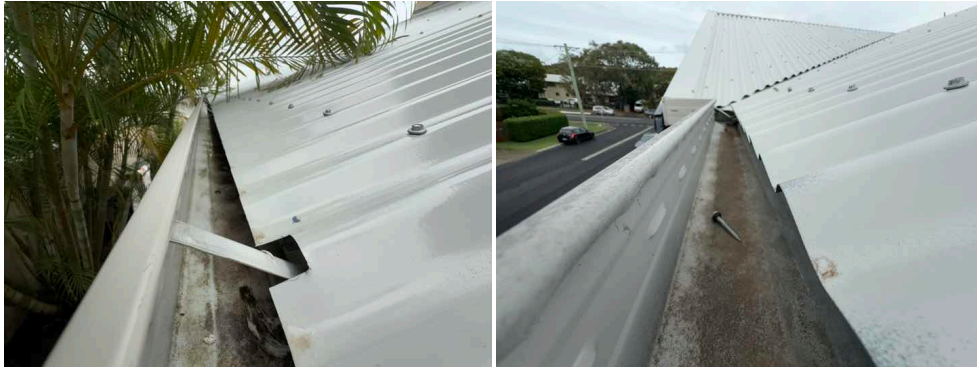
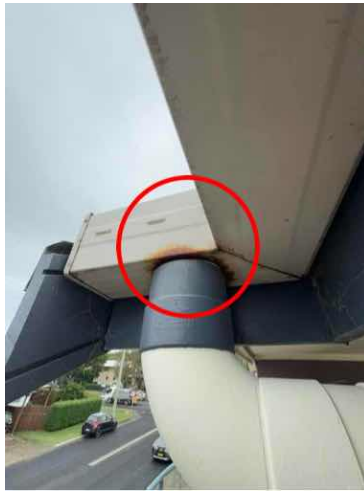
Gutter rust/penetrations- The guttering has excessive rust where leaking will occur. The gutters require replacement by a roof plumber.

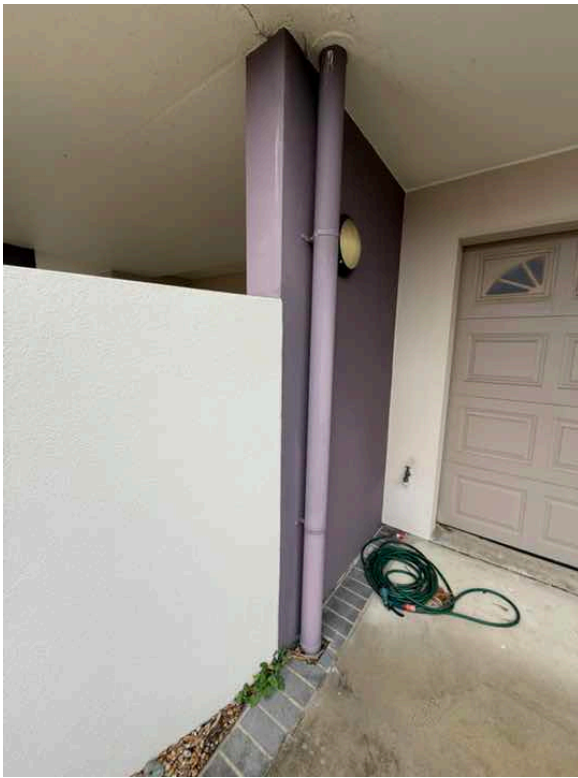
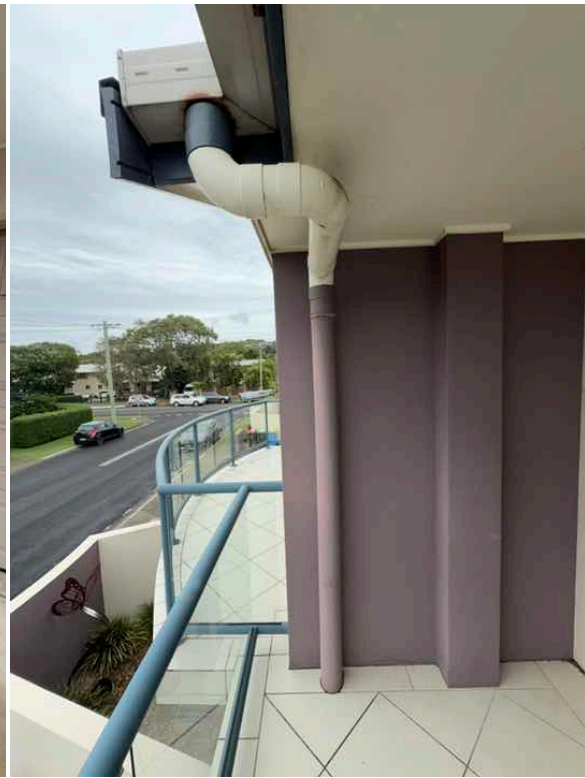
Rusty clips

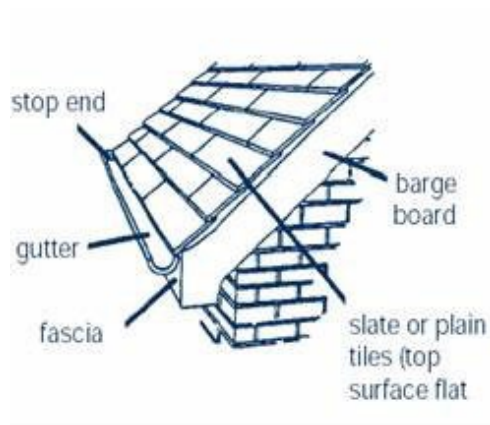
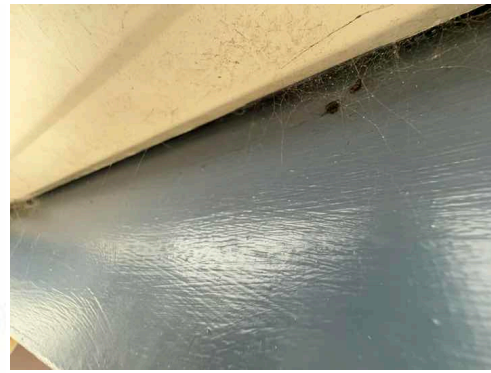
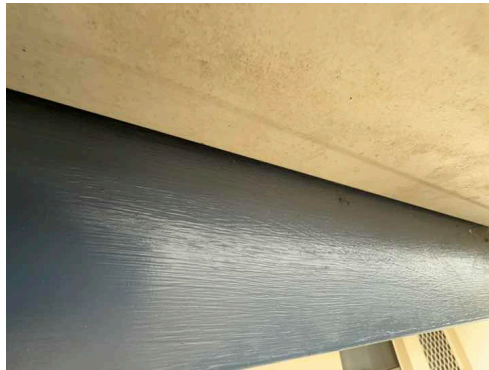
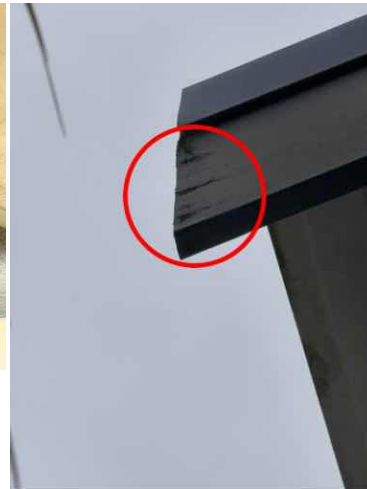
Timber fungal decay (rot) visible. Recommendations: A qualified carpenter should be engaged to replace all affected timbers.

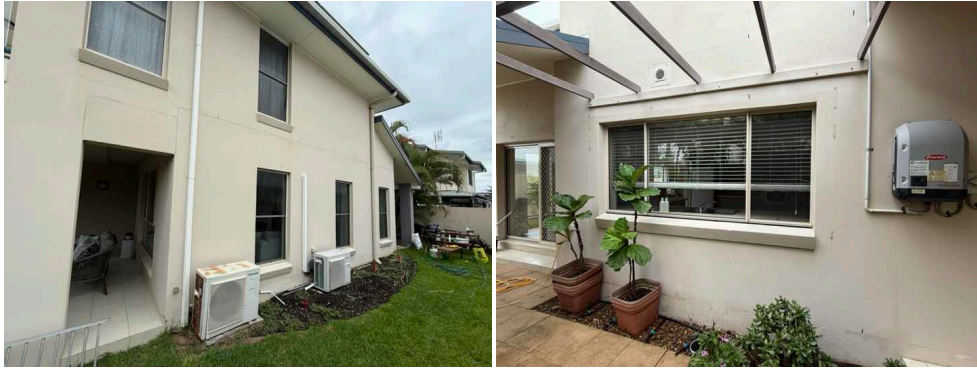
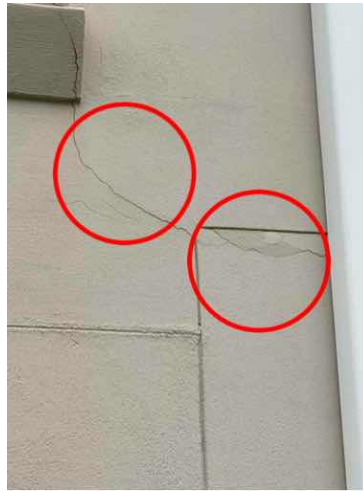
There appears to have been some settlement in the building which has caused some cracking to the walls. These cracks are categorized as 0 to 2. This can also cause some doors to bind or be out of square. In the inspector's opinion these cracks are due to settlement, usually due to ground movement and subsequent movement to building materials can be expected. Any cracks should be monitored and if cracks increase in size, further investigation should be carried out by a structural engineer.

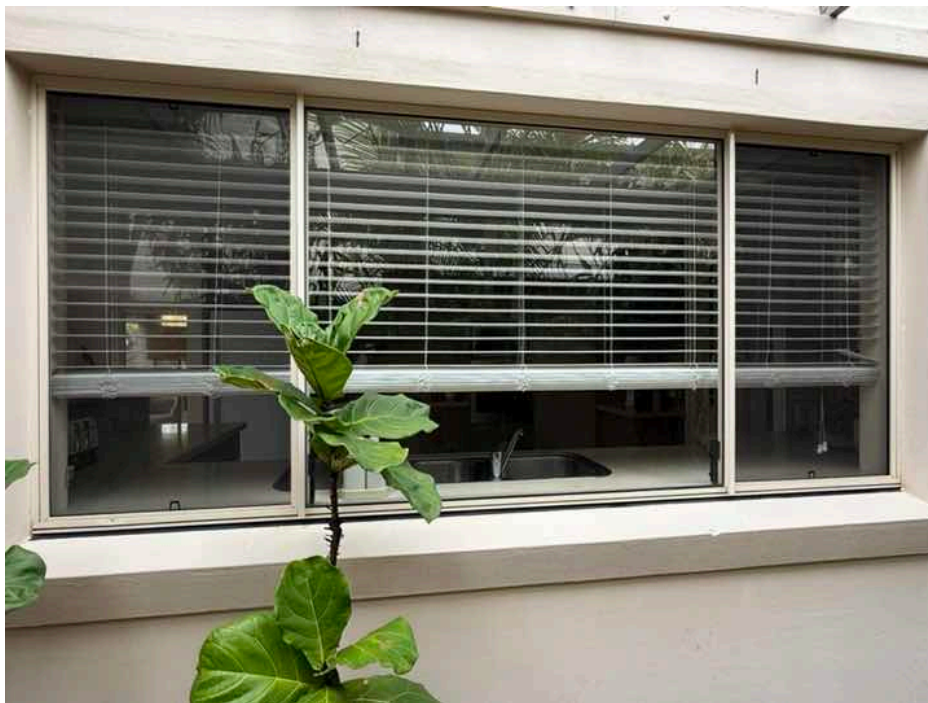
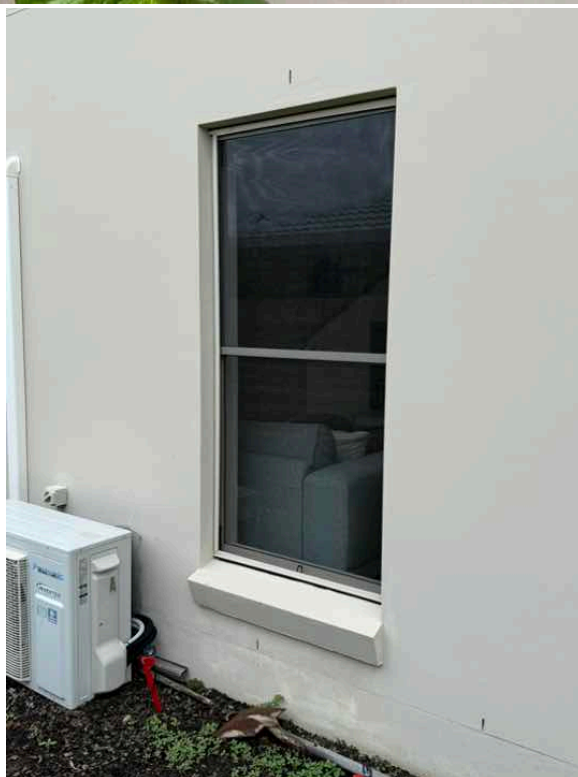
Damaged fly screen/s replace as required.

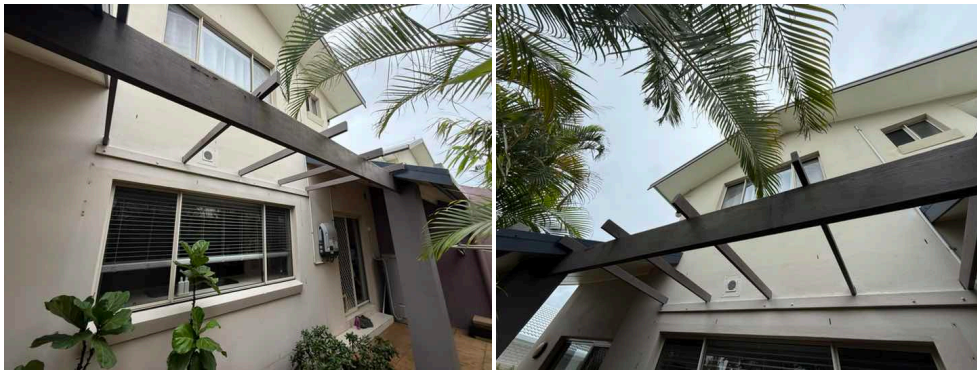
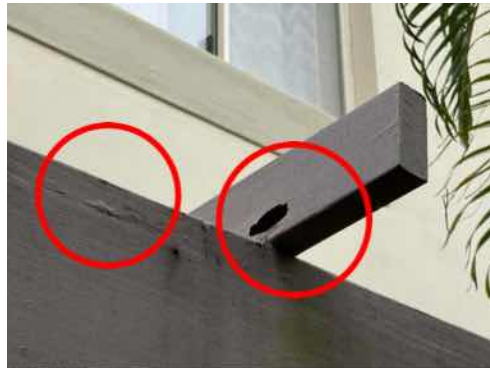
Timber fungal decay in the framework is visible. A qualified carpenter should be engaged for advice and recommendations.

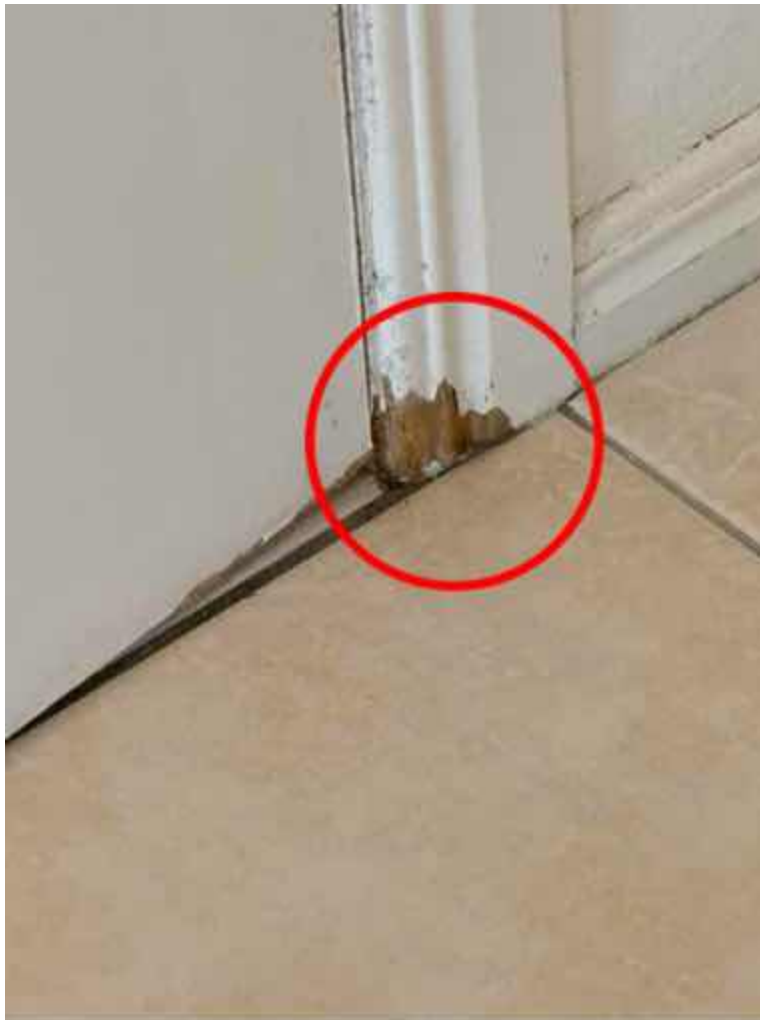
Skirting board damage/deterioration. A qualified carpenter should be engaged to replace.

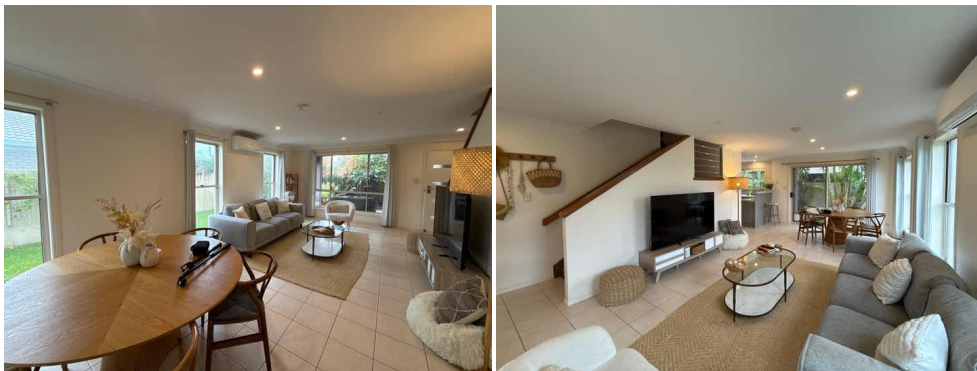
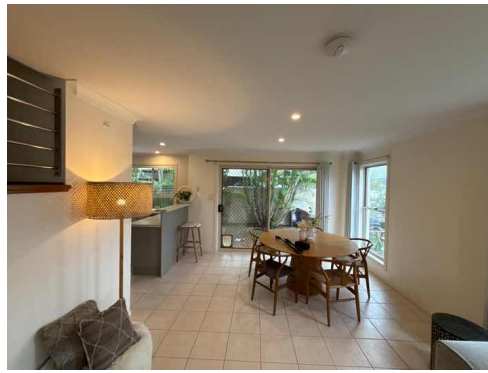
Drummy/loose tiles observed. Tile lift and further deterioration likely. Contact a qualified tiler for repairs.

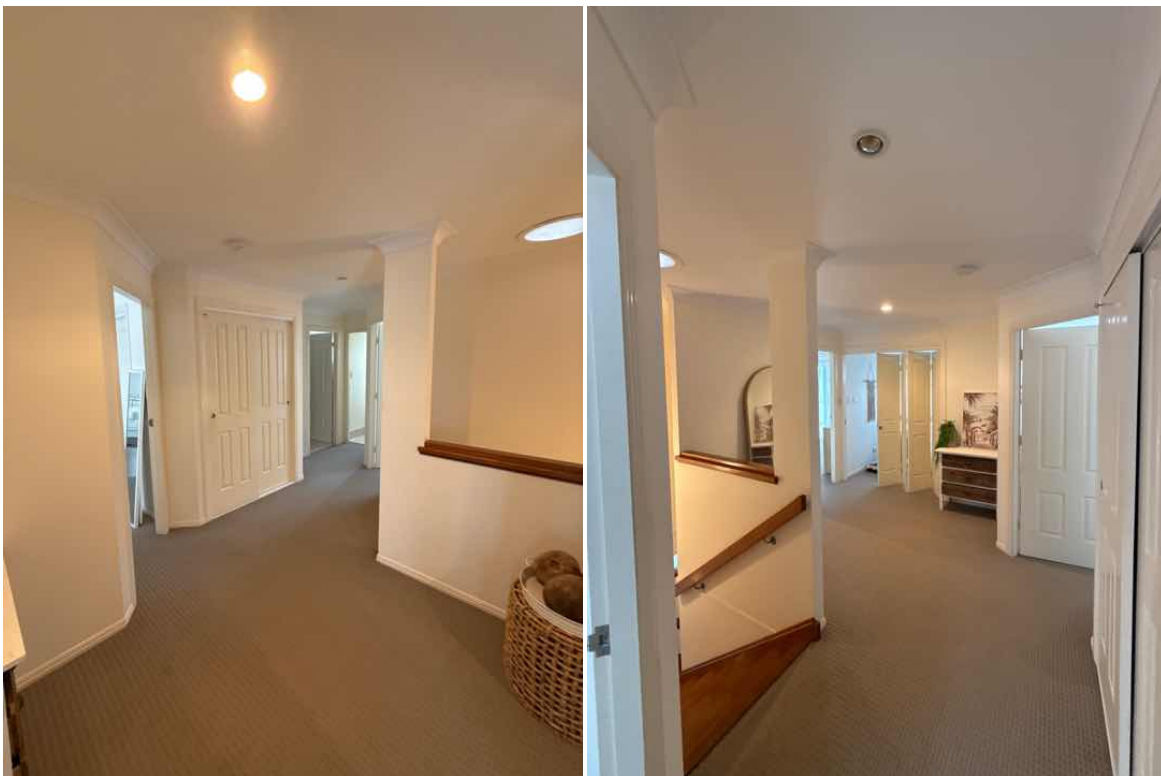
Stains observed - Steam cleaning may rectify stained areas but they appear entrenched.

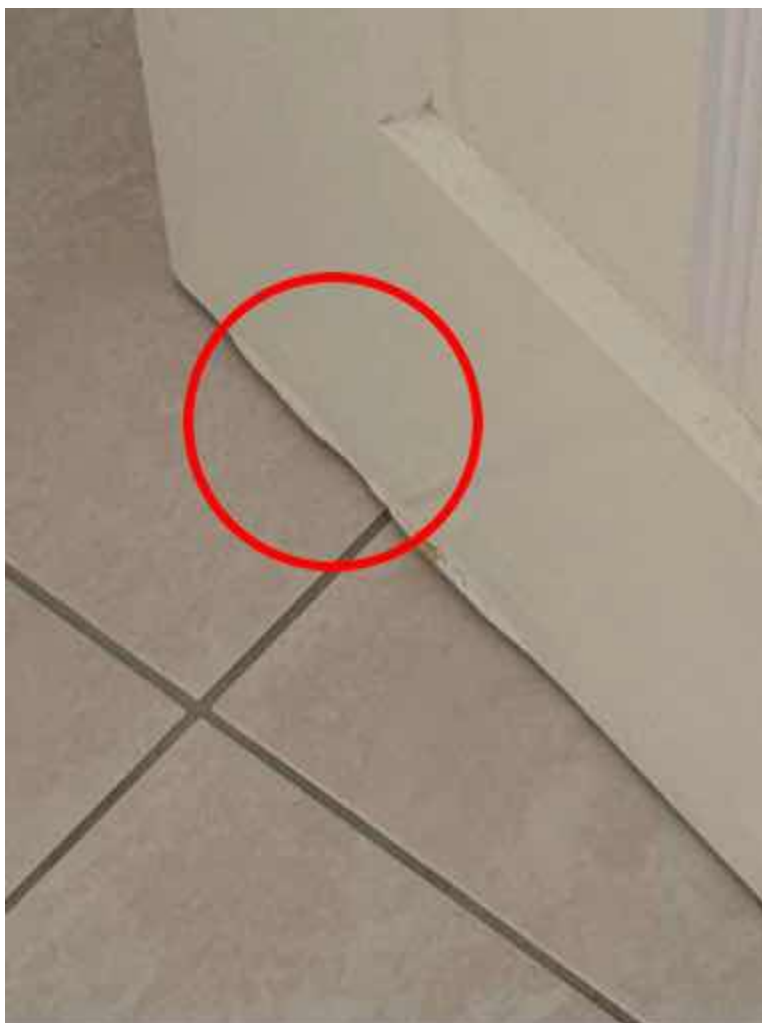
Water damaged door. Possible due to leak in bathroom. Replacement recommended.

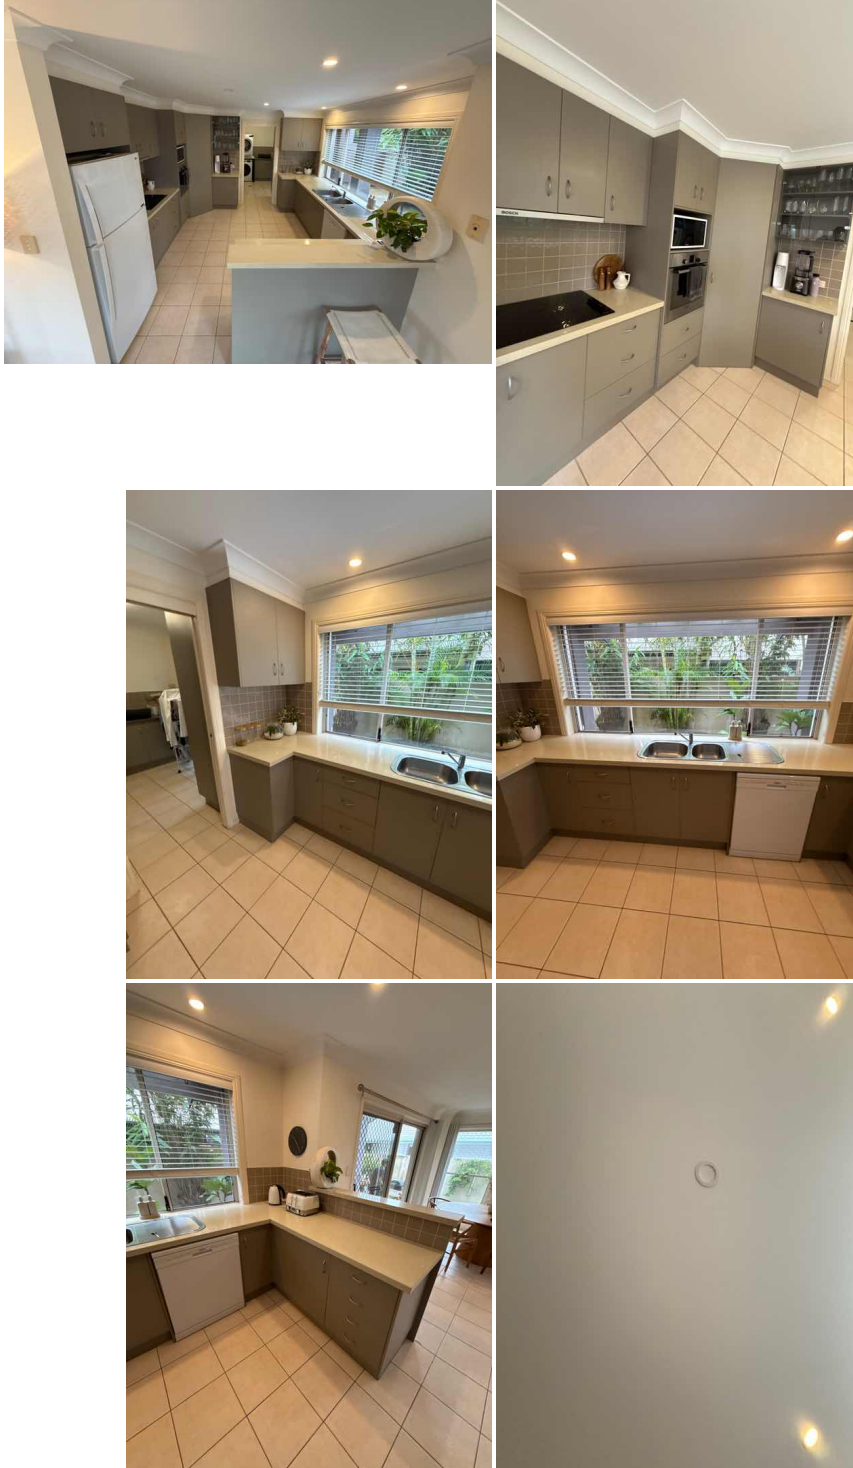
Some chipped and damaged tiled were noted. Replacement recommended by a qualified tiler

Minor cracks floor tiles. A qualified tiler should be engaged for repairs.

Drummy tiles noted. This needs to be repaired at the earliest as this has the potential to lead to many related issues such as damp, water ingress to other areas and cracked tiles. Contact a qualified tiler for repairs and recommendation.

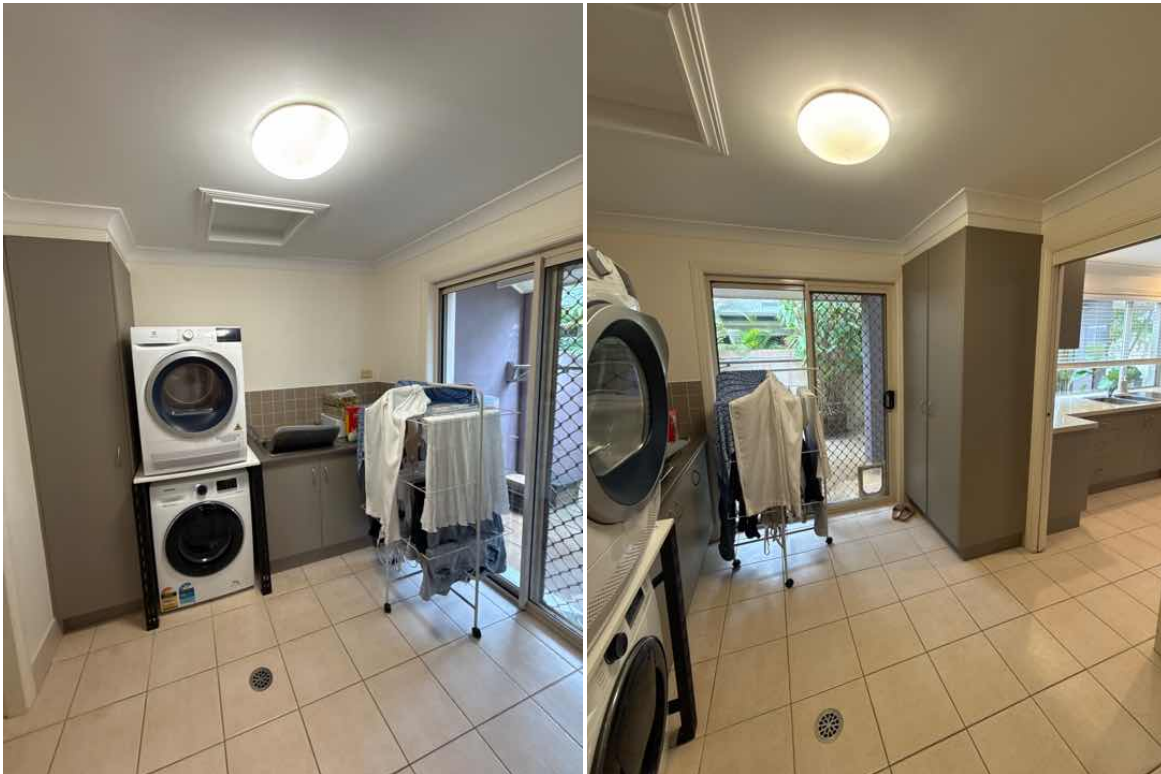
Drummy tiles noted. This needs to be repaired at the earliest as this has the potential to lead to many related issues such as damp, water ingress to other areas and cracked tiles. Contact a qualified tiler for repairs and recommendation.
