Building and Pest Report

2/28 Kell Mather Drive Lennox Head

Pest And Building Inspection

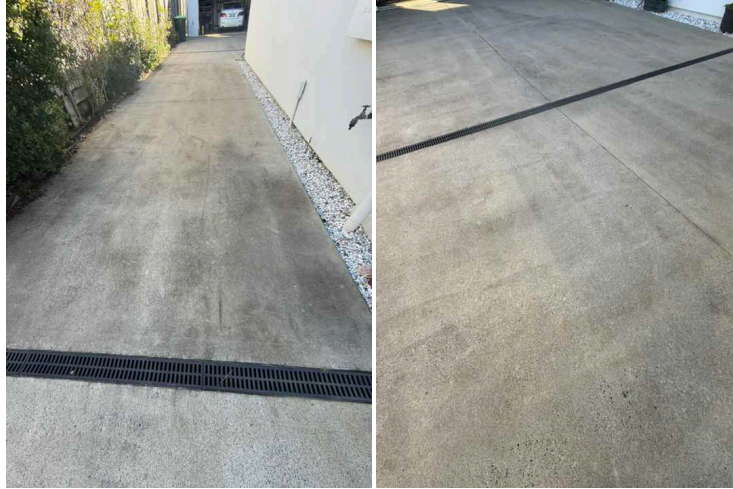
Driveway Condition

On visual inspection, the general condition of the driveway is serviceable.

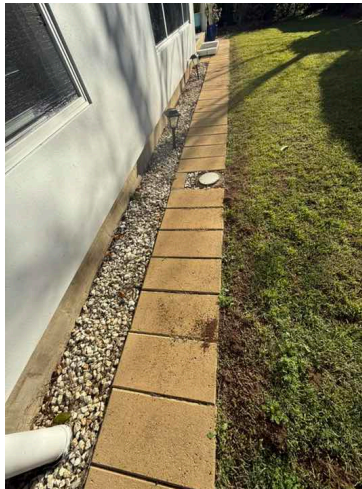
Pathways Condition

The paths around the home are in a serviceable condition for the age of this dwelling with no major defects visible.

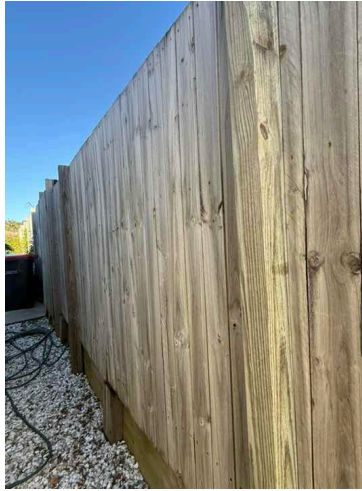
Overall Condition

Of the visible areas, the general condition of the fences and gates is serviceable for the age of dwelling.

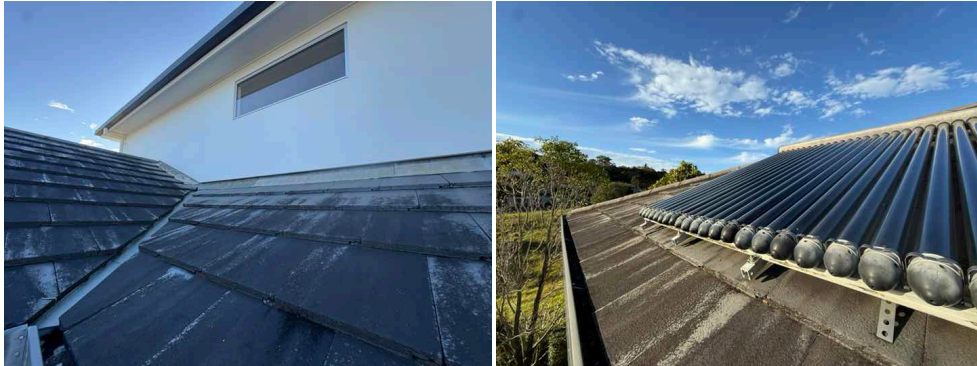
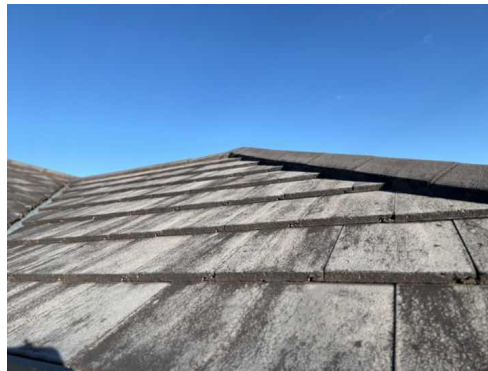
Overall Condition

Of the visible areas, the general condition of the roof is in serviceable condition for the age.

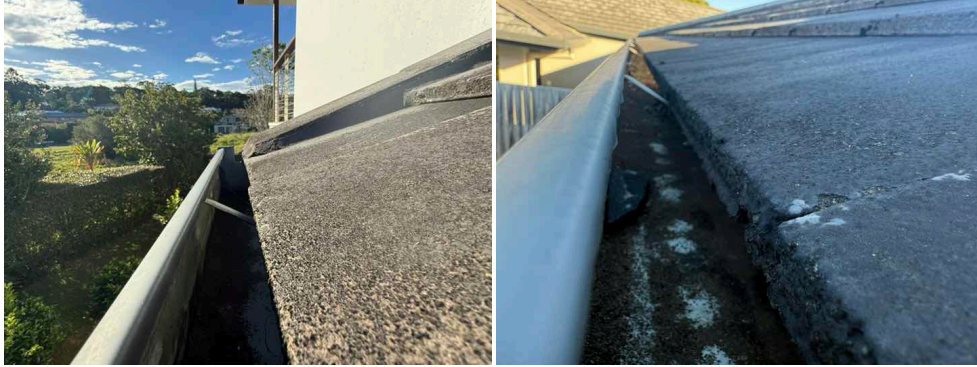
Gutter Findings

All visible and accessible of the physical nature of the guttering system appears to be in a serviceable condition with no apparent defects at the time of inspection. In the absence of prolonged rain fall efficiency of the guttering can not be assessed and you may find that further investigation or repairs maybe required. Note: Periodic maintenance checks should be carried out for rust penetrations and leaks.

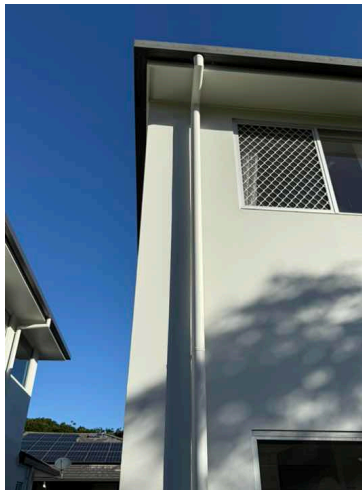
Downpipe Findings

On visual inspection no apparent defects were noted to the down pipes and are considered serviceable, however no comment can be made with regard to blockages or connections to stormwater or functionality in the absence of rain. Note: Periodic maintenance checks should be carried out for rust penetrations and leaks.

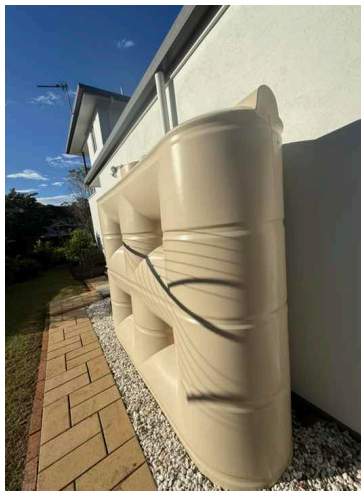
Water Tank Condition

On Visual Inspection the water tank appears serviceable, but should be checked by a qualified plumber.

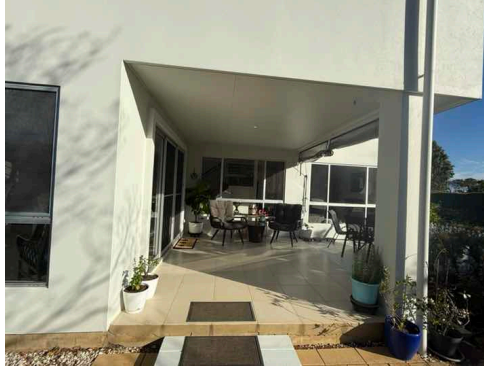
Visible sections of the Alfresco area are serviceable or in reasonable or condition for the age of this dwelling.

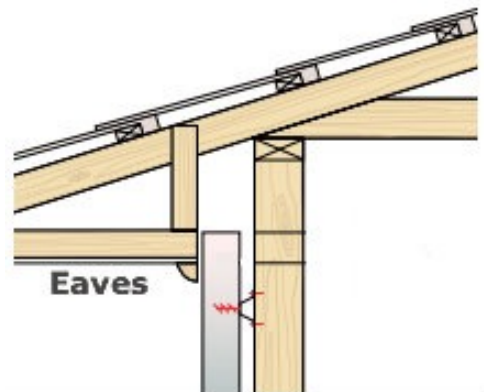
Eave Condition

The soffit lining (eaves) are in a serviceable condition with no notable defects.

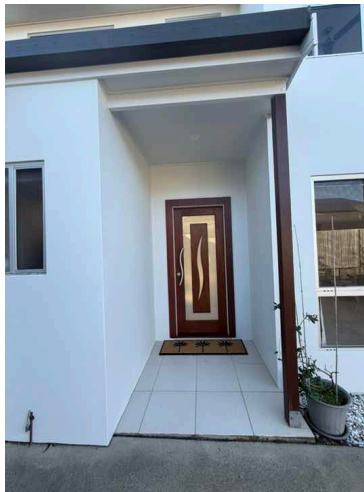
Entry Porch Area

The entry porch serviceable or in reasonable or condition for the age of this dwelling.

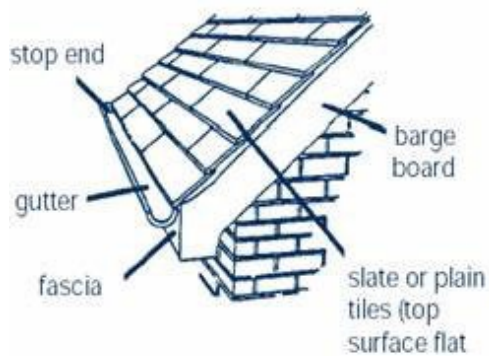
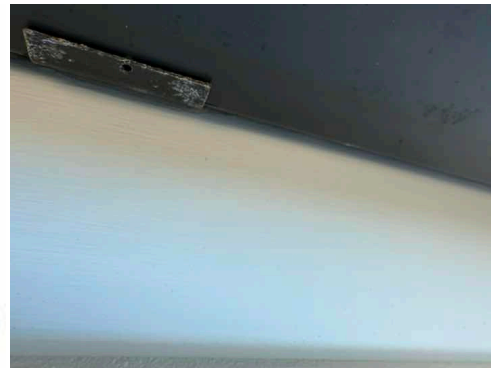
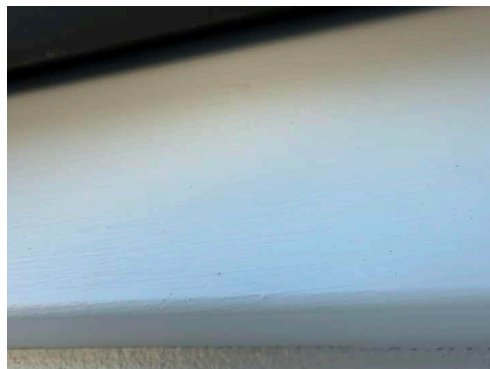
On visual inspection, the general condition of the fascia/barge boards is serviceable.

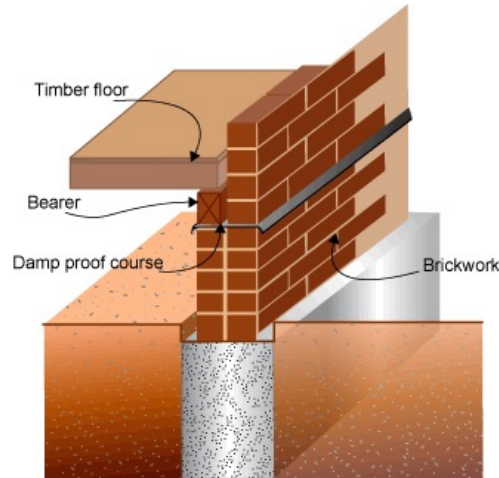
Damp Proof Course

A damp proof course is not visible or could not be visually identified. This may cause rising damp issues. Contact a specialist in this field to further investigate and make recommendation.

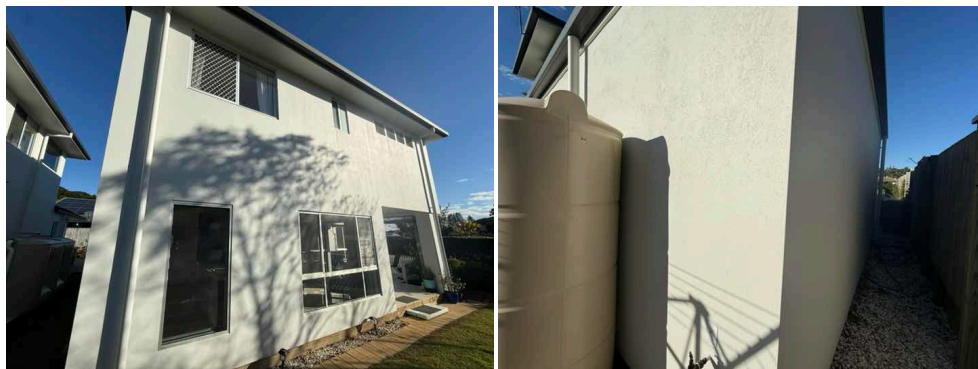
On visual inspection, the general condition of the exterior walls is serviceable for the age.

There appears to have been some settlement in the building which has caused some cracking to the walls. These cracks are categorized as 0 to 2. This can also cause some doors to bind or be out of square. In the inspectors opinion these cracks are due to settlement, usually due to ground movement and subsequent movement to building materials can be expected. Any cracks should be monitored and if cracks increase in size, further investigation should be carried out by a structural engineer.

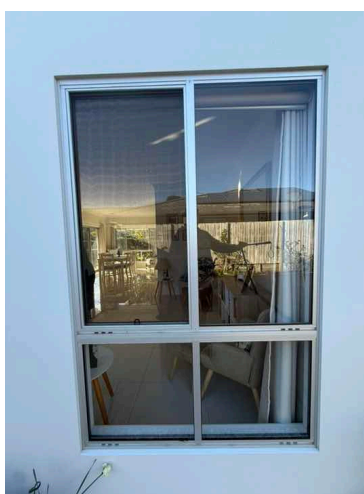
Overall Condition

On visual inspection, the general condition of the windows is serviceable for the age.

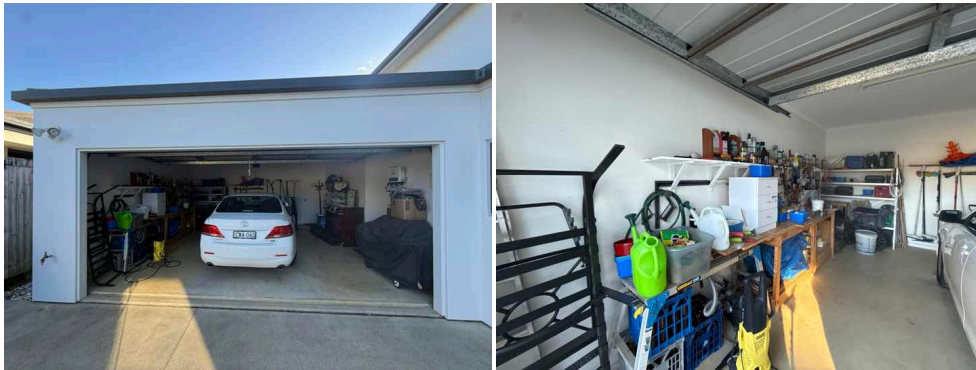
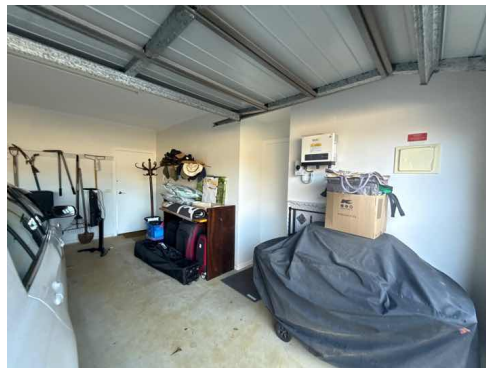
Stored items restricted a full and thorough inspection of this area. Defects may exist in the obstructed and inaccessible areas. It is strongly recommended that full access be granted to enable a thorough inspection as there may be timber pest activity, damage or defects. Note: Where vehicles and storage has restricted a full inspection it is advised that this area be cleared so a full and unobstructed inspection can be carried out.

From the visible and accessible areas, the garage appears to be in a serviceable condition for the age of the property with no notable structural defects sighted.

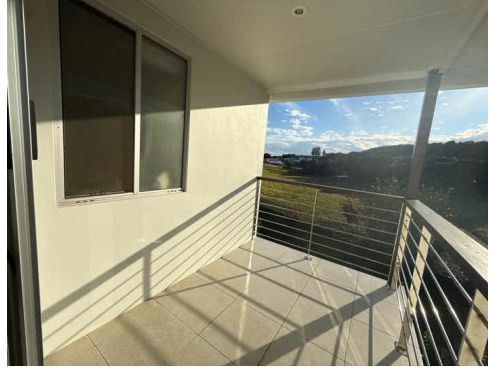
Though we are not structural engineers the balcony/s appear to be in a serviceable condition.

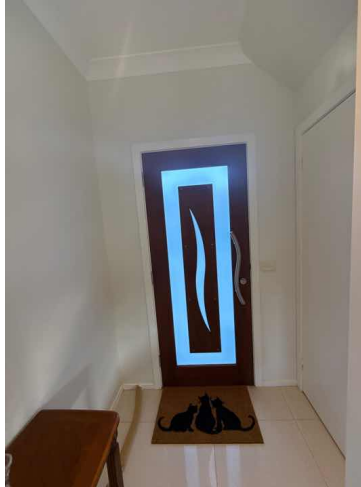
Front Entry Doors

The doors are in serviceable condition with no notable defects observed.

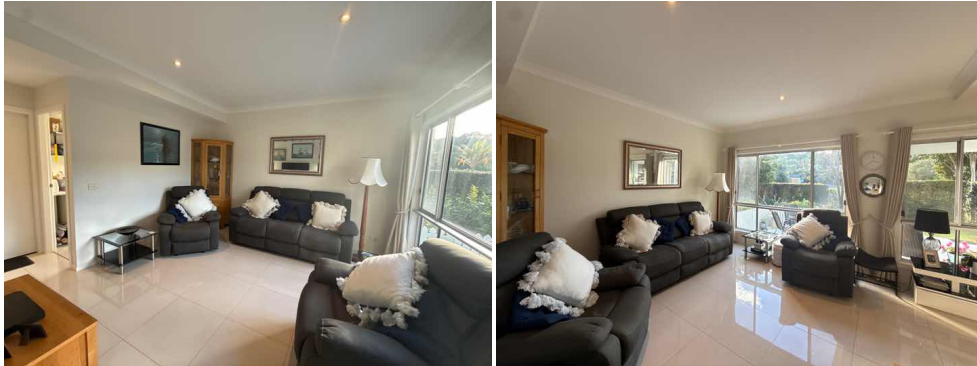
Living Room

From the visible and accessible areas, this room appears to be in a serviceable condition for the age of the property with no notable structural defects sighted.

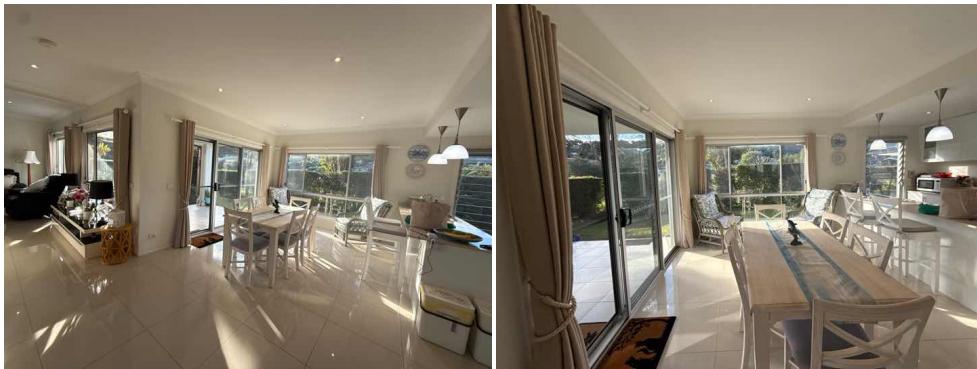
Typical cornice separation/detachment observed. I recommend you contact a qualified painter for repairs.

From the visible and accessible areas, this room appears to be in a serviceable condition for the age of the property with no notable structural defects sighted.

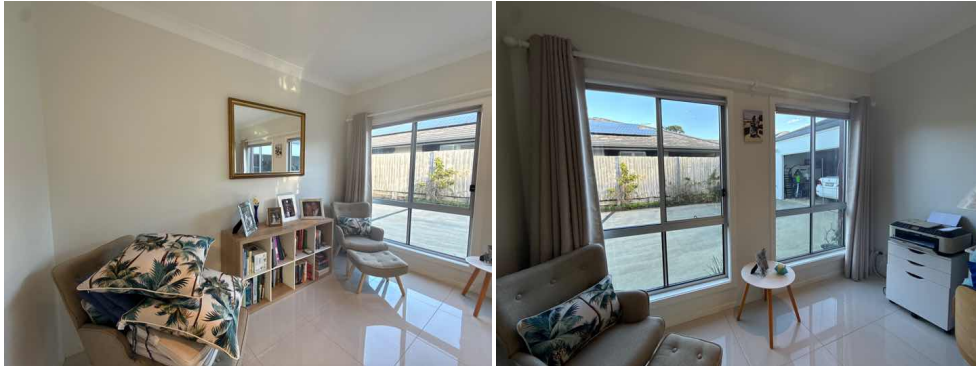
Typical cornice separation/detachment observed. I recommend you contact a qualified painter for repairs.

From the visible and accessible areas, this room appears to be in a serviceable condition for the age of the property with no notable structural defects sighted.

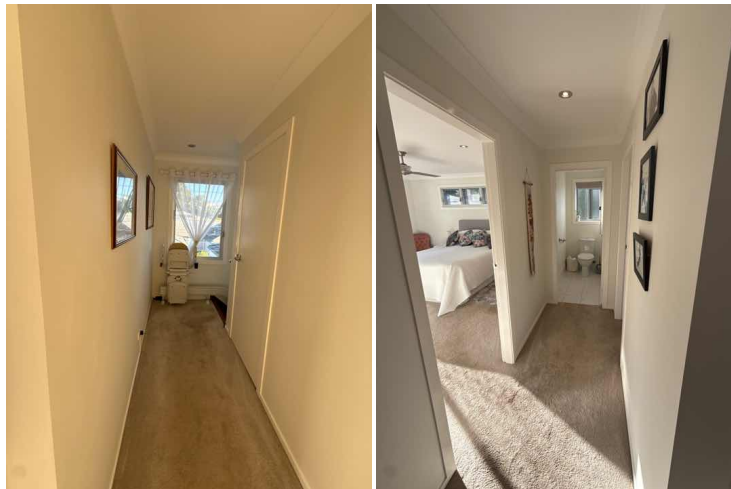
Typical cornice separation/detachment observed. I recommend you contact a qualified painter for repairs.

From the visible and accessible areas, the hallway/s/ appears to be in a serviceable condition for the age of the property with no notable structural defects sighted.

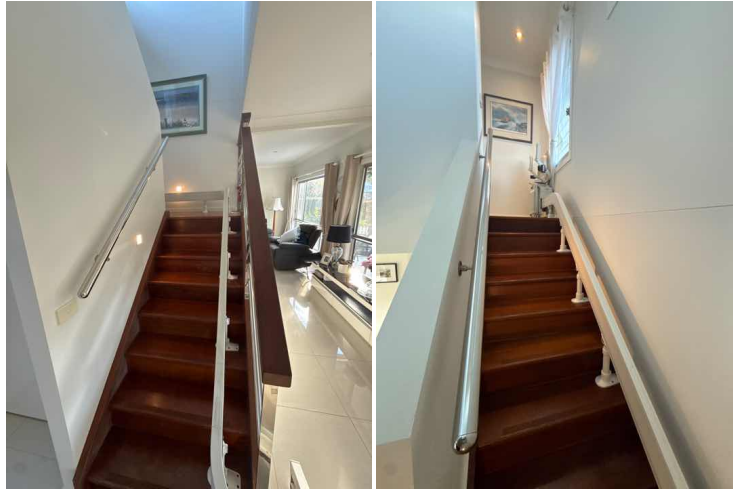
Stains observed - Steam cleaning may rectify stained areas but they appear entrenched.

The internal staircase and components appear to be in a serviceable condition for the age with no notable defects sighted.

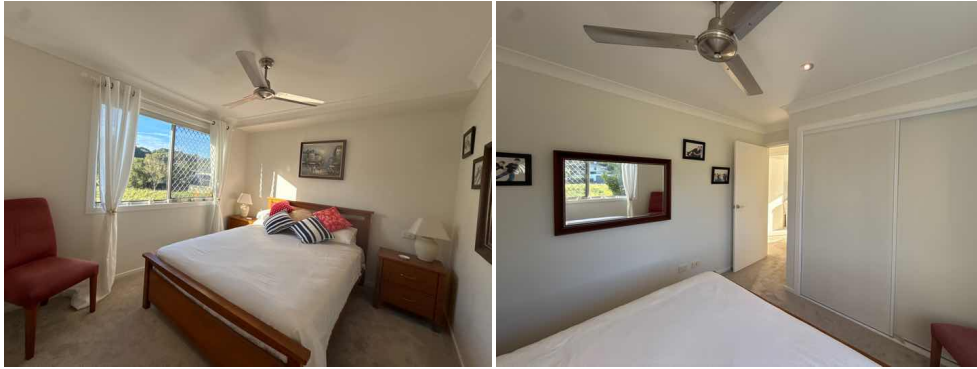
Bedroom 2

From the visible and accessible areas, this bedroom appears to be in a serviceable condition for the age of the property with no notable structural defects sighted.

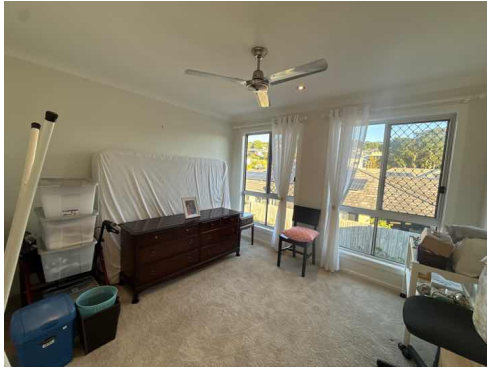
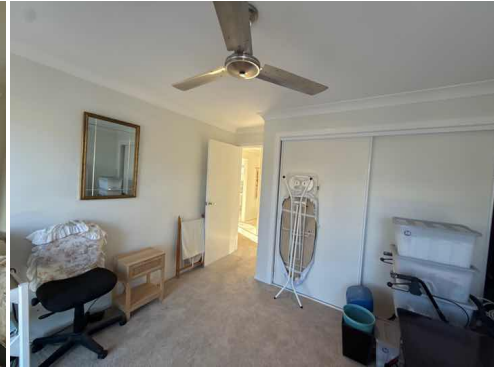
Bedroom 3

From the visible and accessible areas, this bedroom appears to be in a serviceable condition for the age of the property with no notable structural defects sighted.

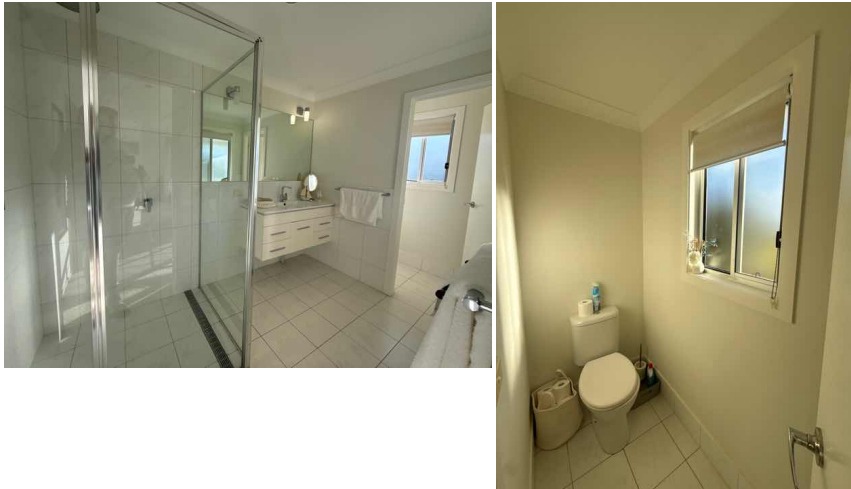
No exhaust fan is installed - Recommend having one installed.

Of the visible areas, the general condition of this bathroom is serviceable or in reasonable condition for age of dwelling.

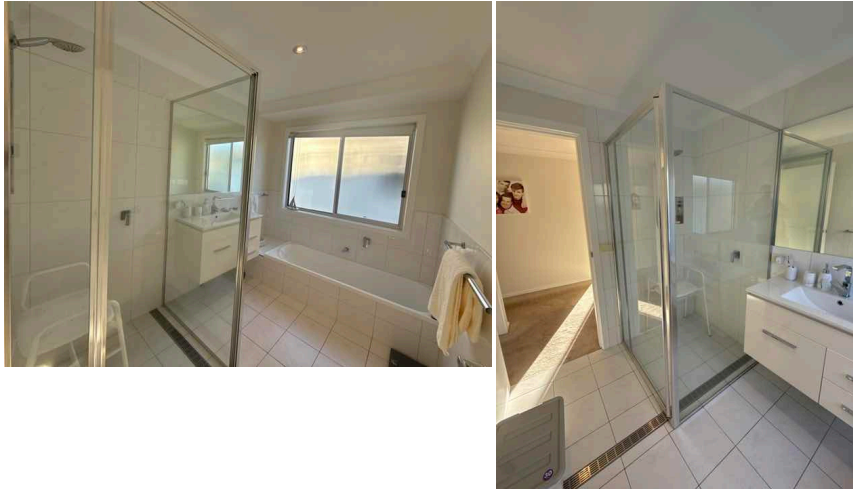
Binding/out of square door frame - This can relate to some differential settlement in the footings, frame movement, age, expansion, shrinkage and the like. A qualified carpenter should be engaged for advice and recommendations.

The vanity mirror is desilvering at edges. Replacement recommended.

The shower screen door requires adjustment, maintenance or repair to operate properly.

No exhaust fan is installed - Recommend having one installed.

Of the visible areas, the general condition of this bathroom is serviceable or in reasonable condition for age of dwelling.

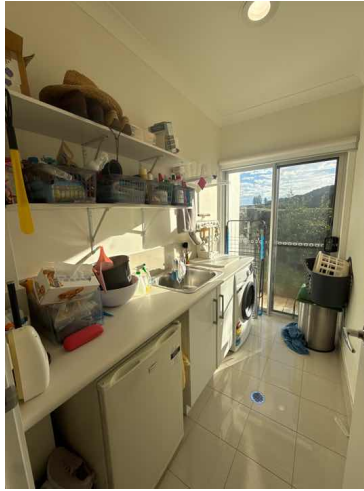
Of the visible areas, the general condition of the laundry is serviceable or in reasonable condition for age of dwelling.

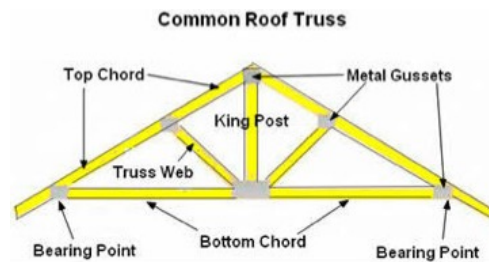
Roof Frame Type

The roof frame is a truss timber frame.

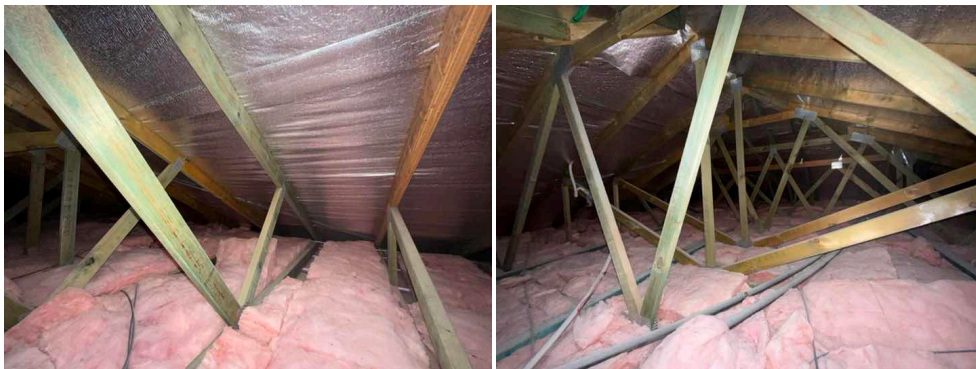
Visible sections of the roof void is in a serviceable condition for age of this dwelling.
