# Building and Pest Report

## 58B Stoneyhurst Dr, Lennox Head

### Pest And Building Inspection

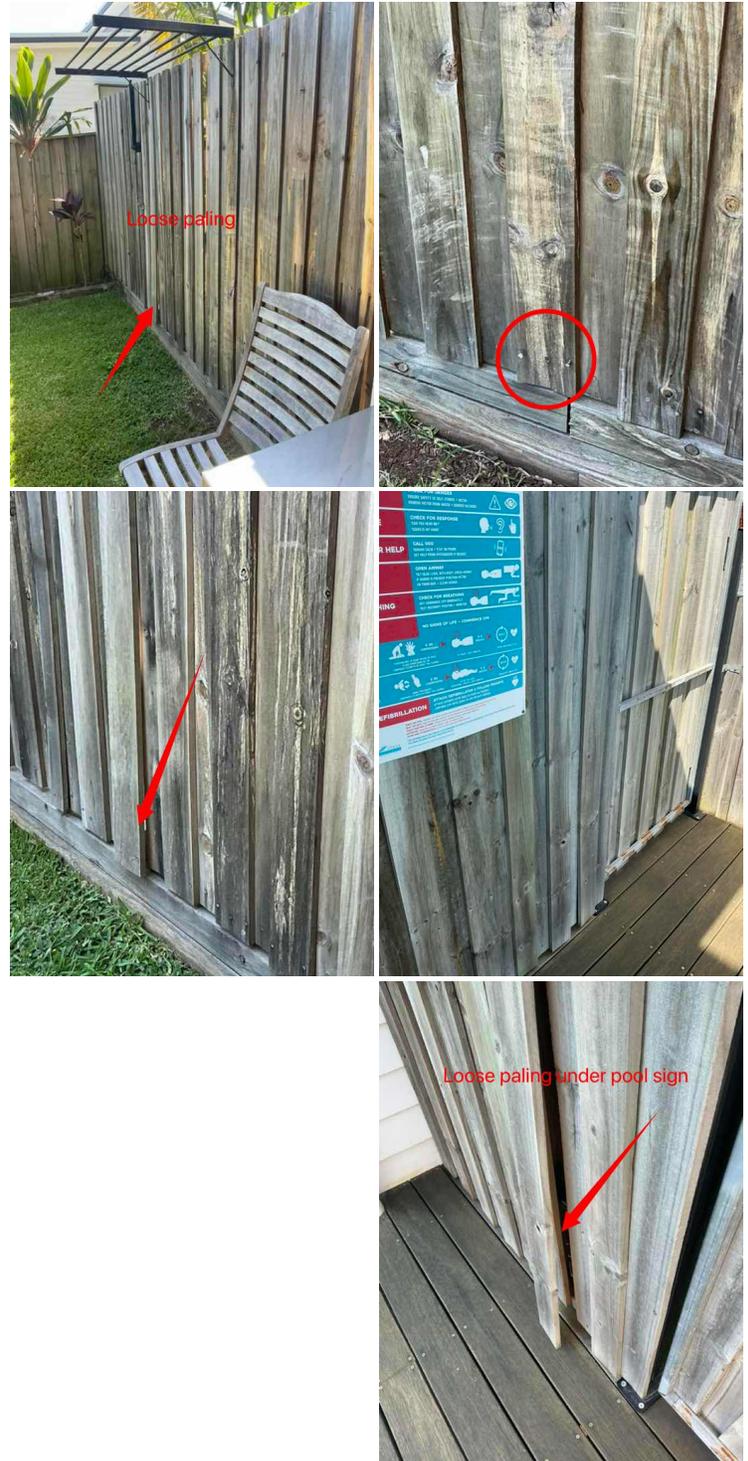
Of the visible areas, the general condition of the fences and gates is serviceable for the age of dwelling. On inspection, defects were present that will require further accessing and recommendations by licensed and qualified trades persons.

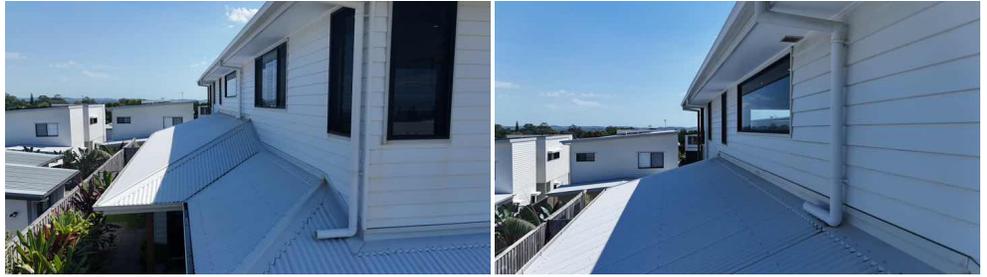
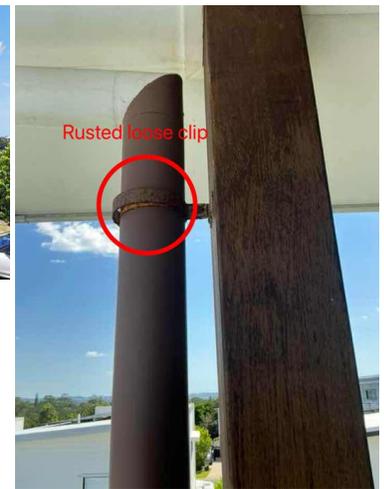
The downpipe/s wall clips is detached or missing. Although minor and easily rectifiable, we recommend a licensed roof plumber be engaged for repairs.

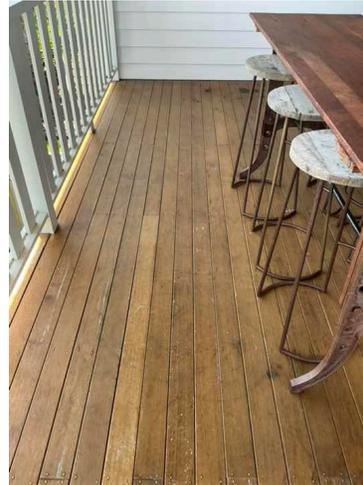
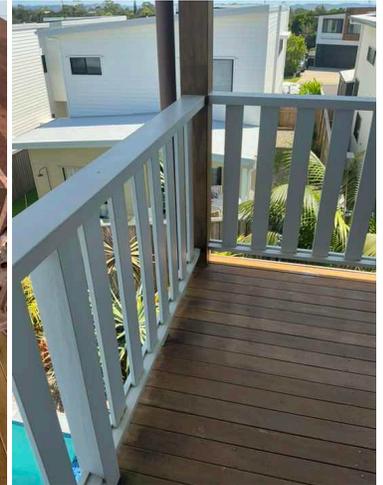
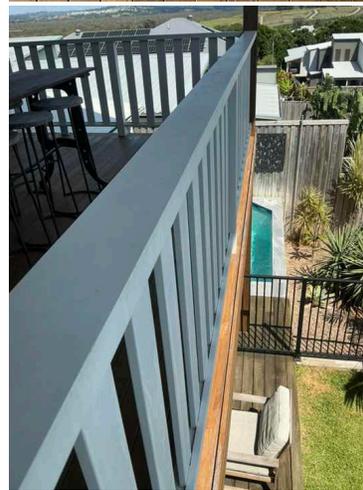
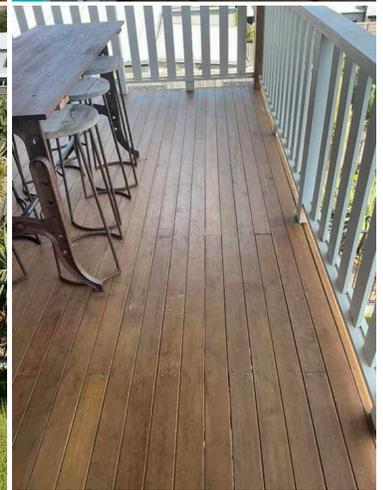
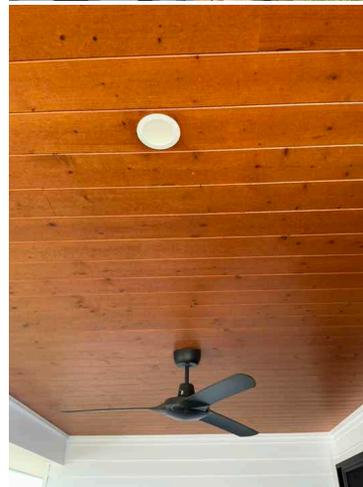
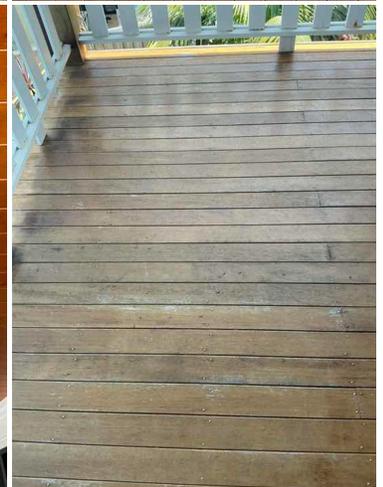
Upon visual inspection, the deck shows signs of weathering and discoloration. Recommend cleaning and resealing the surface to protect against moisture and UV damage. Ensure all fasteners are secure and replace any that are corroded. Consult a licensed tradesperson for further assessment and maintenance.

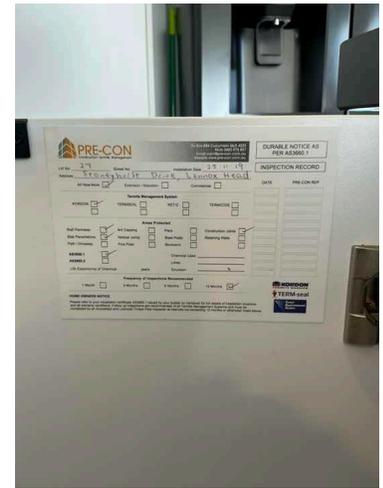
Yes kitchen cupboard
