Inspection Report

Naraic Building & Pest Inspections Pty Ltd

32 Lakeview Cct, East Ballina, NSW, 2478

Pest And Building Inspection

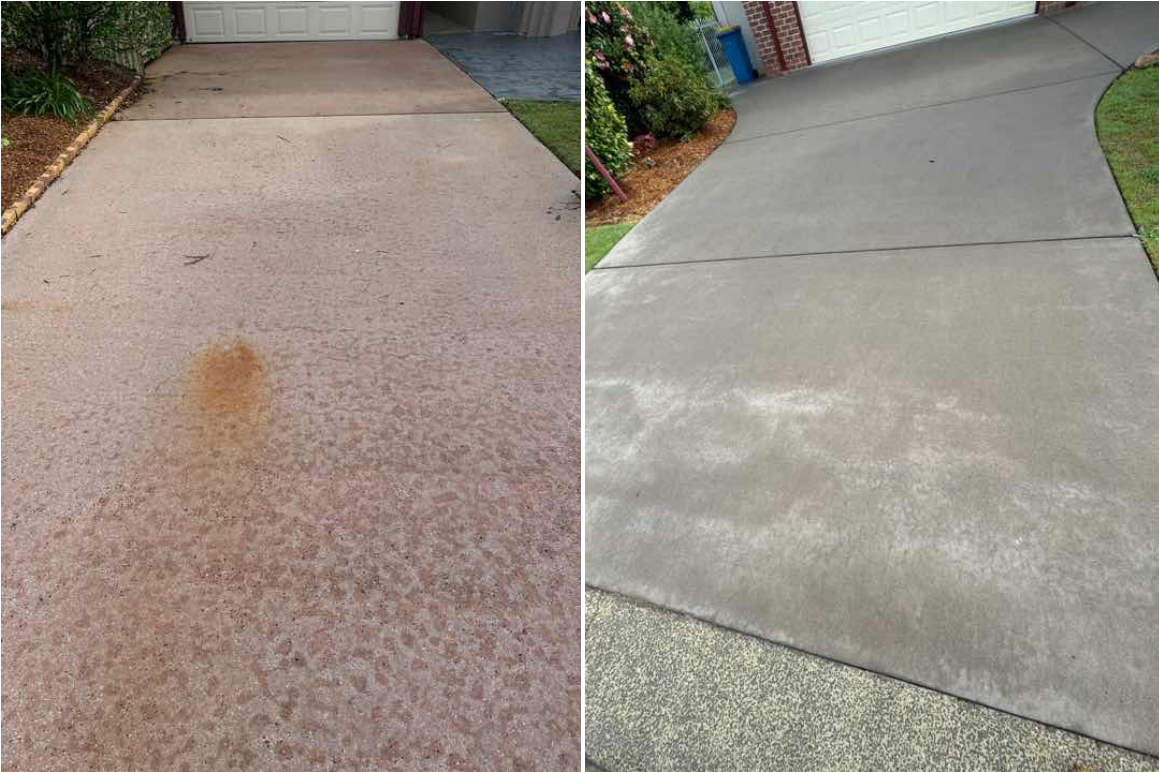
On visual inspection, the general condition of the driveway is serviceable.

Common cracks were observed on the driveway. Whilst these cracks appeared to be typical at the time of inspection, we strongly recommend you monitor these cracks and if worsening occurs contact a concreter for further advice.

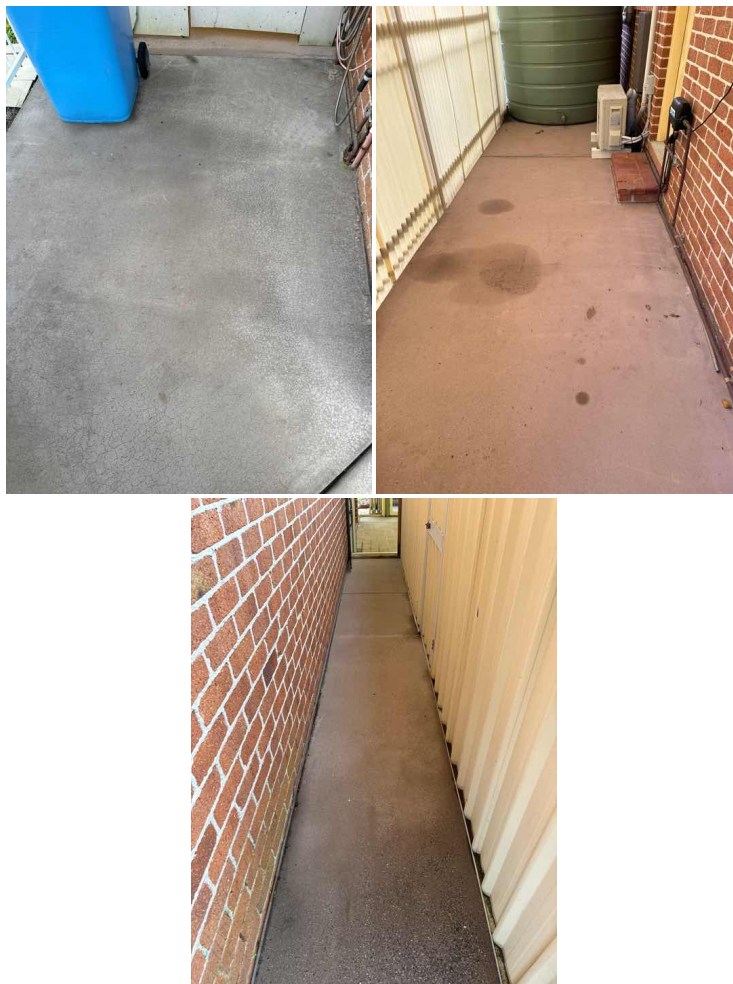
The paths around the home are in a serviceable condition for the age of this dwelling with no major defects visible.

Common cracks and settlement were observed on paths. Whilst these cracks appeared to be typical at the time of inspection, we strongly recommend you monitor these cracks and if worsening occurs contact a concreter for further advice.

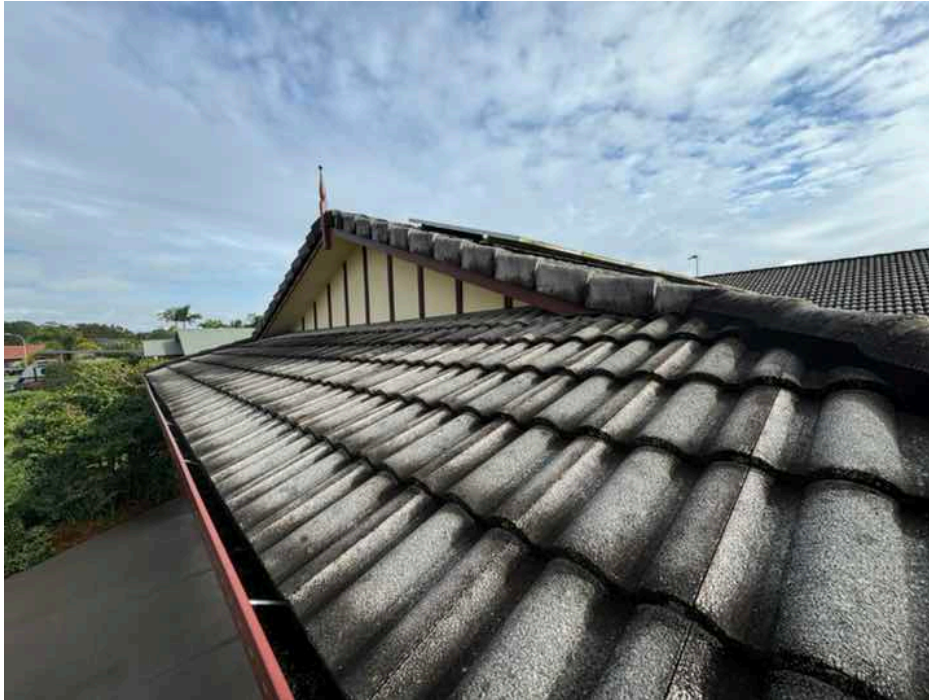
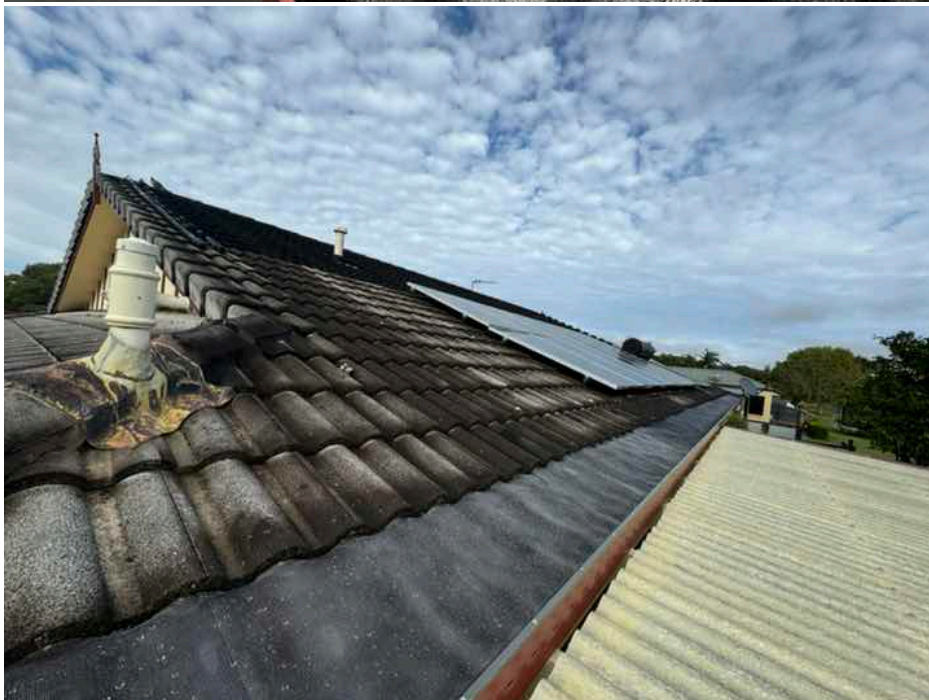
Of the visible areas, the general condition of the roof is in serviceable condition for the age.
Note: In the absence of rainfall there is no guarantee that the roof won't leak.

Visible section of The roof cladding appeared in a serviceable condition for the age of this dwelling. Annual maintenance inspection recommended.

Deterioration & ageing evident. I recommend you contact a roof restorer to clean, seal, and repoint the mortar.

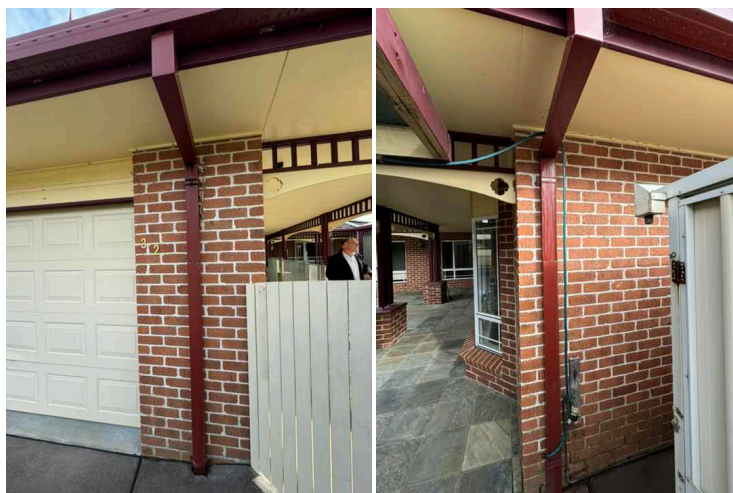
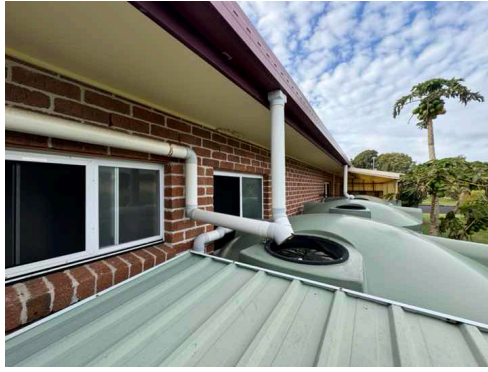
Leaking downpipe joints visible. This can be conducive to termite infestation and cause water damage to cladding over time. A qualified roof plumber should be engaged to repair.

Rust penetrations observed to downpipe. Over time this has potential to cause differential settlement to the footings, cause rising damp and is also conducive to termite infestation. A qualified plumber should be engaged for advice and recommendations.

Minor downpipe rust visible. A qualified plumber should be engaged for advice and recommendations.

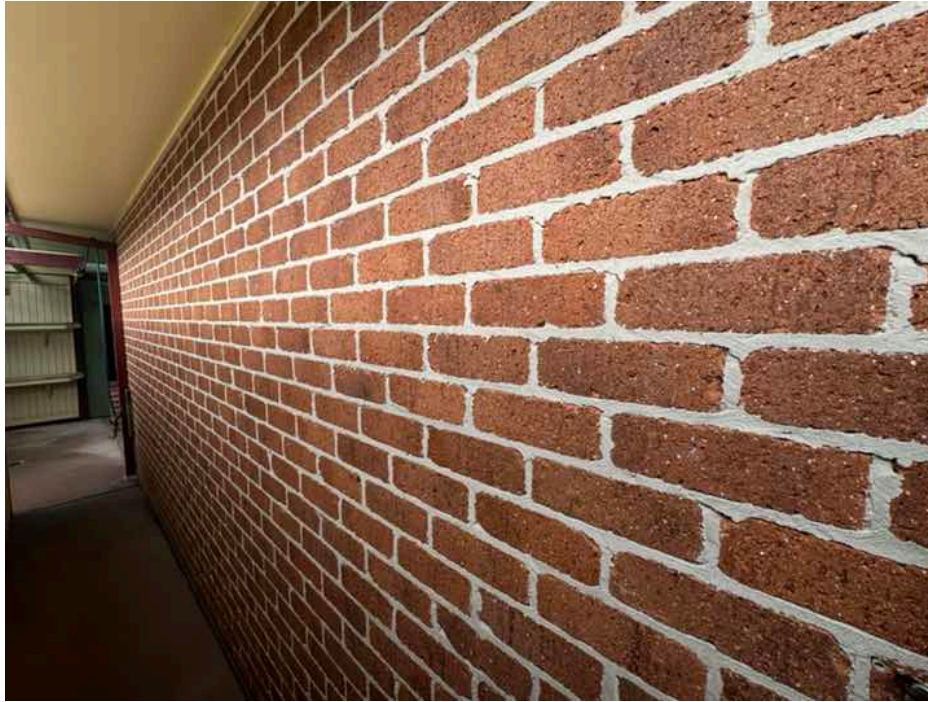
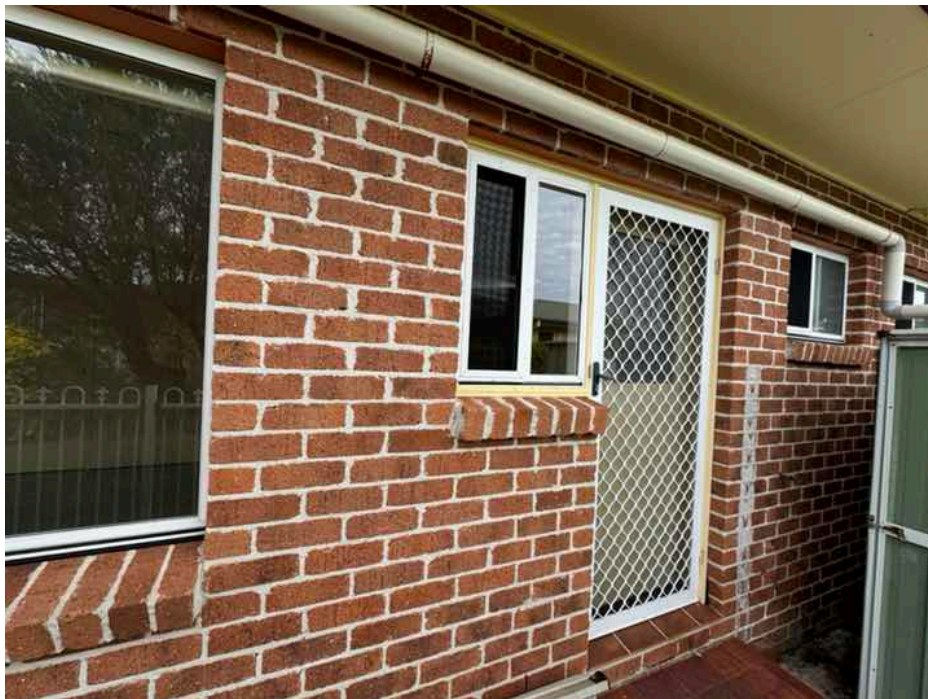
On visual inspection, the general condition of the exterior walls is serviceable for the age.

There appears to have been some settlement in the building which has caused some cracking to the walls. These cracks are categorized as 0 to 2. This can also cause some doors to bind or be out of square. In the inspectors opinion these cracks are due to settlement, usually due to ground movement and subsequent movement to building materials can be expected. Any cracks should be monitored and if cracks increase in size, further investigation should be carried out by a structural engineer.

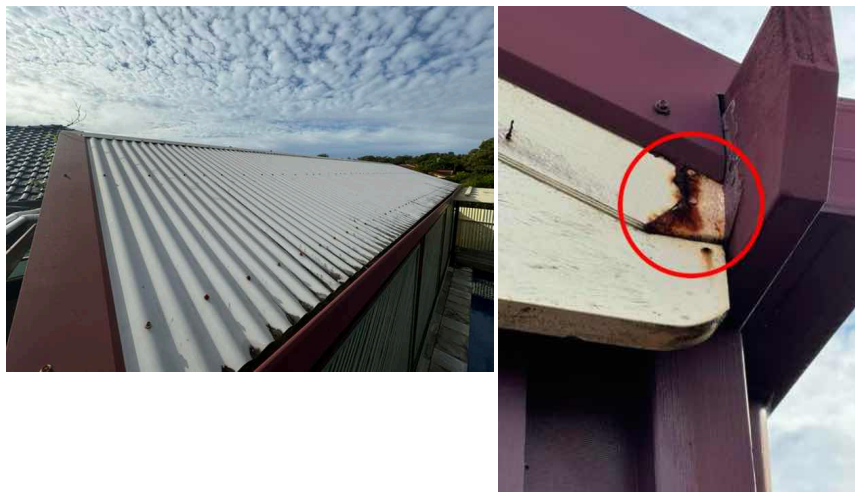
Corrosion noted to the screw fixings of the metal roof. Have these checked and replaced by qualified roofing contractor.

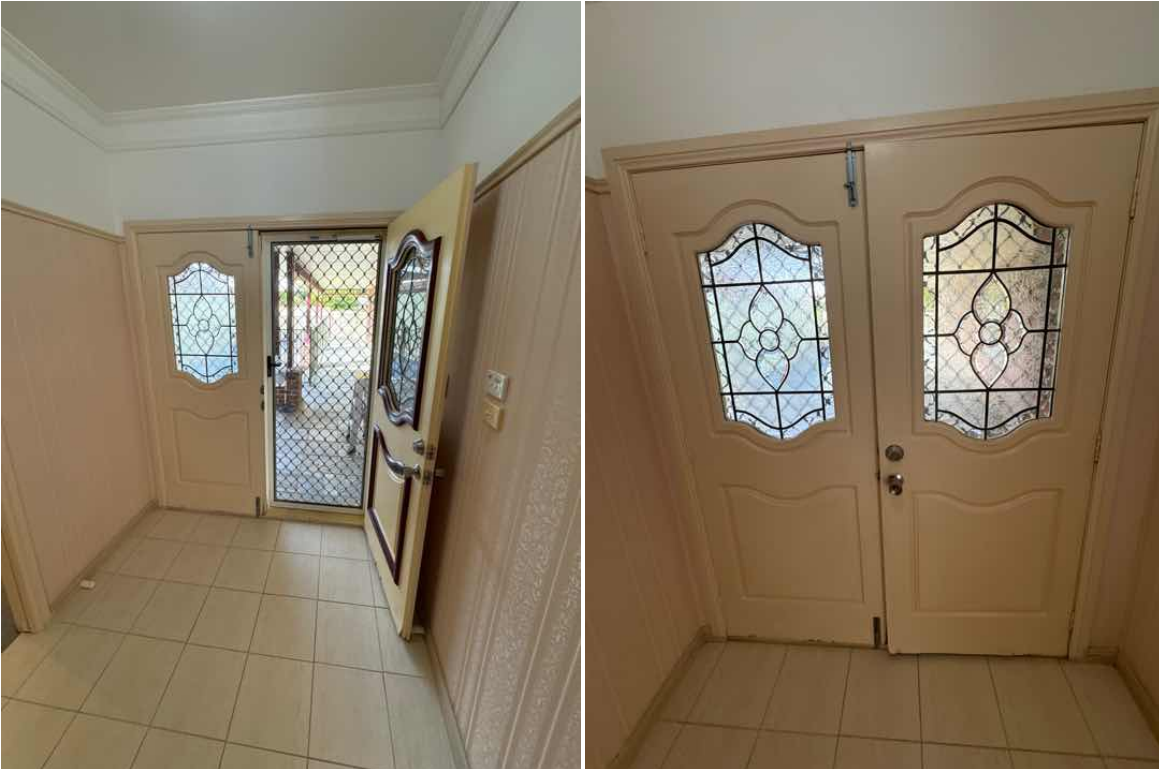
Damp damage to entry door/frame - It appear water has damaged / penetrated areas of the door/frame. I am not able to ascertain if this is still occurring and this can only be ascertained during heavy rainfall periods. If penetration occurs a qualified carpenter should be engaged for advice and recommendations re repair/sealing from weathering.

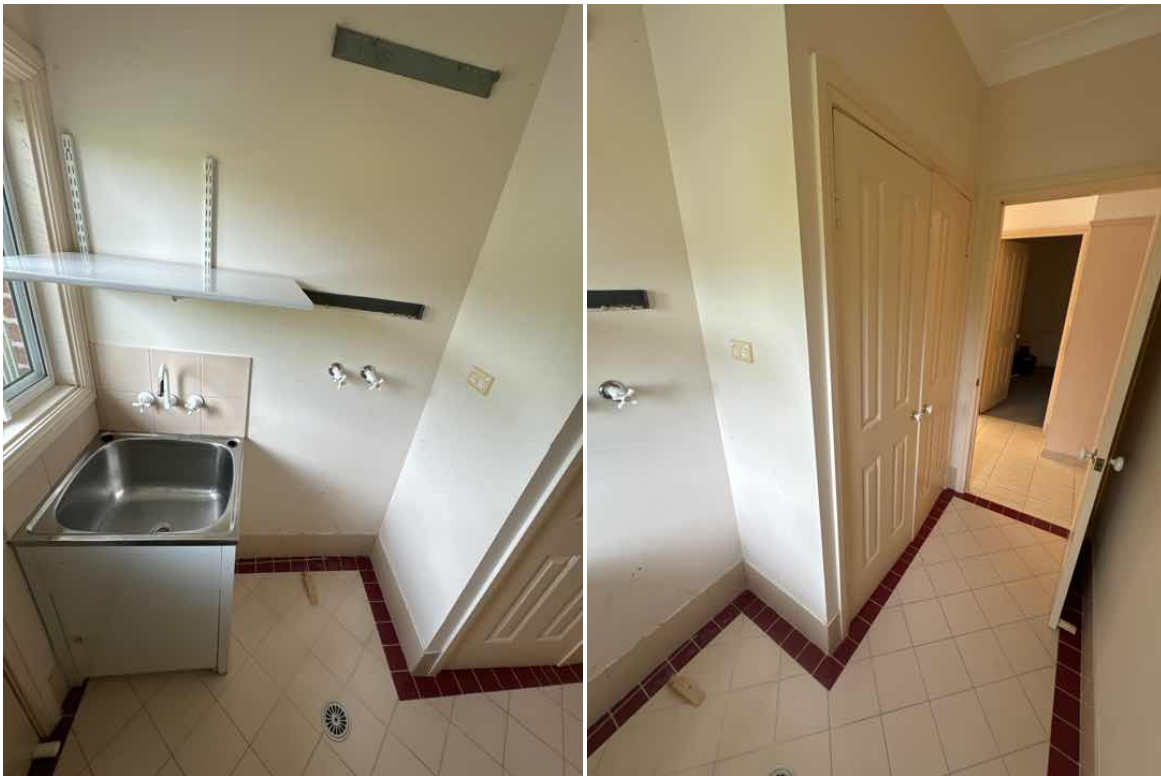
Cornice separation. I recommend you contact a licensed painter for repairs.

Impact damage noted. Patch and paint will generally suffice, however see a qualified plasterer for further advice
