PEST AND BUILDING PRE-PURCHASE REPORTS

BUILDING & PEST INSPECTIONS

45 Fox Valley Way
Lennox Head

BPI - INSPECTION REPORT

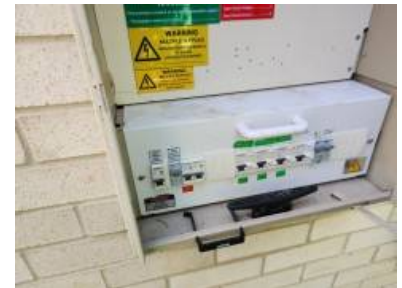
Whilst not an electrician, it appears that an electrical safety switch is present.

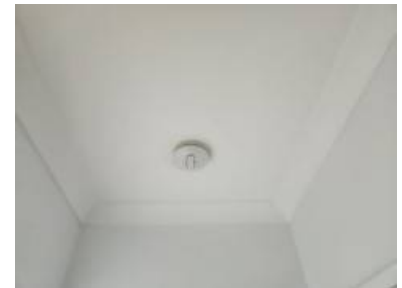
Present - Hall.

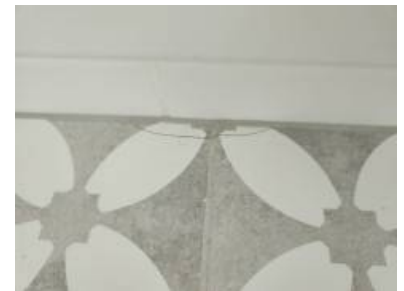
Cracks to some shower base floor tiles, Bathroom.

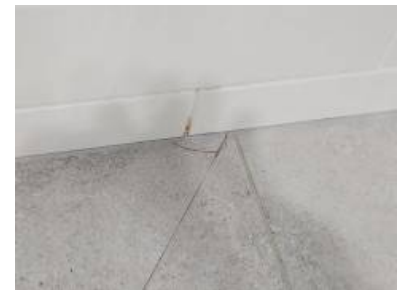
1 x cracked floor tile to shower in Ensuite.

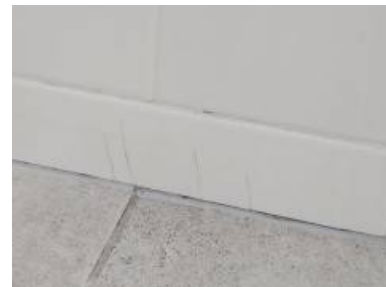
Some hairline cracks to some wall tiles at the base of the shower in Ensuite.

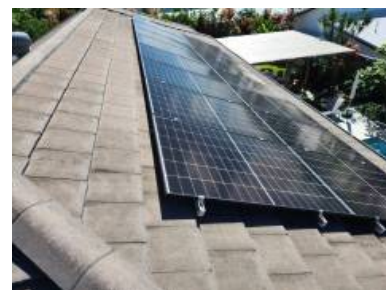
Solar Panels are present to the Roof Exterior and restricted the inspection of the roofing material beneath. Concealed damage may be present but not identified in the report.

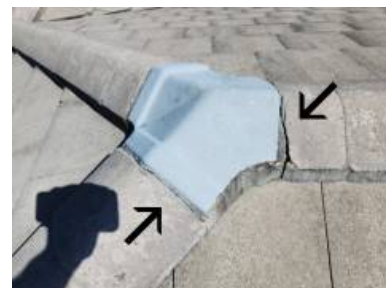
Some pointing to ridge & hip capping tiles shows signs of minor cracking / deterioration and will require renewing in the future. At least 12 monthly inspections should be carried out to monitor the condition of the roof tiles and pointing, however more regular inspections are strongly recommended.

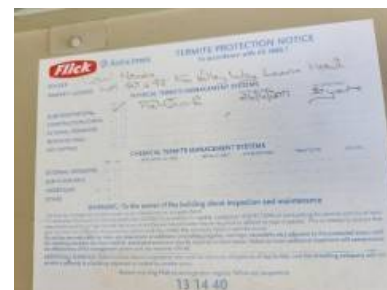
A termite barrier / treatment notice in the Meter Box / Kitchen Cupboard indicates that the slab penetrations are protected from termite activity by Flickguard physical barriers. We strongly recommend you obtain all barrier paperwork & warranty information. These barriers were installed in 2017.
