Building and Pest Report

698 Uralba Road, Lynwood

Report/Agreement #	140125085905125
Inspection Date:	14 Jan 2025
Inspection Time:	08:59 am

Pest And Building Inspection

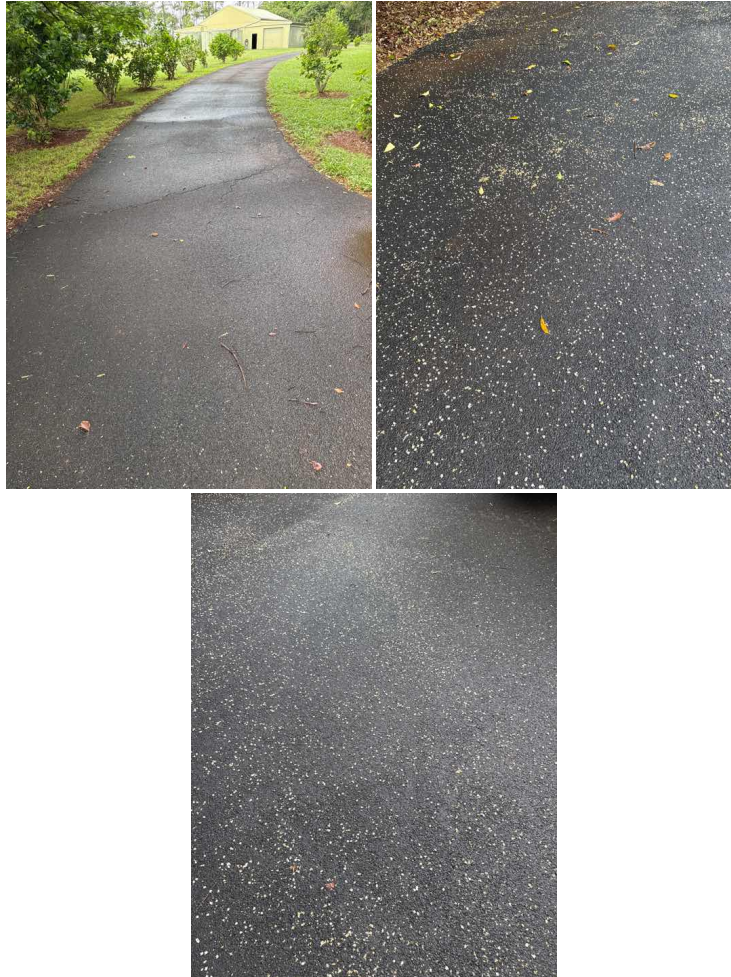
Driveway Condition

On visual inspection, the general condition of the driveway is serviceable.

Common cracks were observed on the driveway. Whilst these cracks appeared to be typical at the time of inspection, we strongly recommend you monitor these cracks and if worsening occurs contact a concreter for further advice.

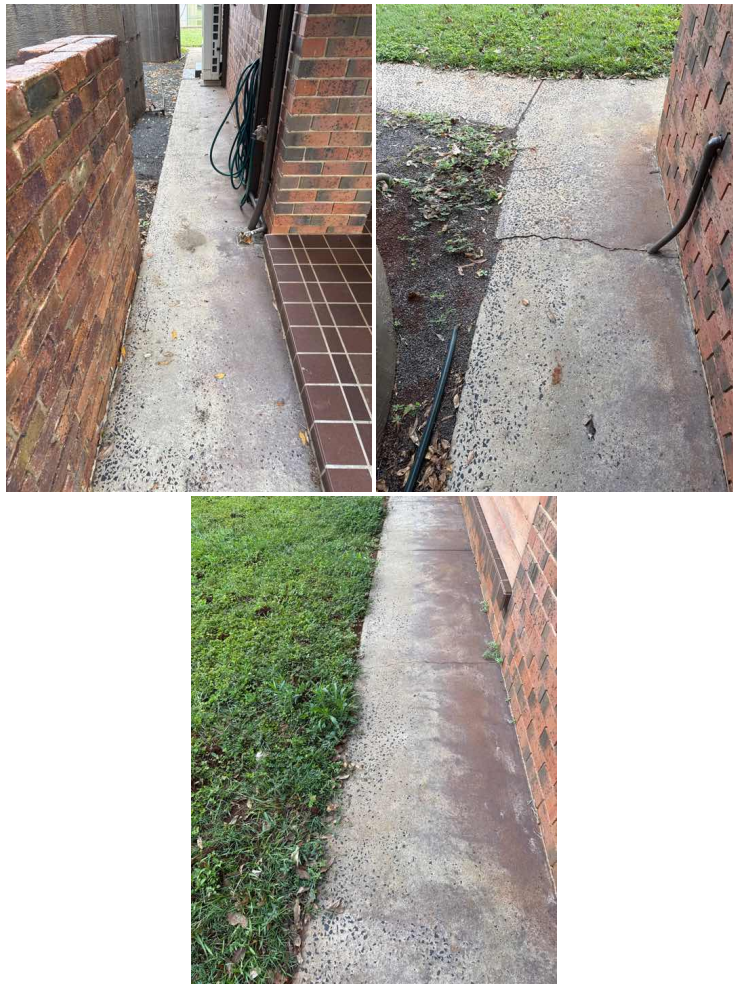
Pathways Condition

The paths around the home are in a serviceable condition for the age of this dwelling with no major defects visible.

Common cracks and settlement were observed on paths. Whilst these cracks appeared to be typical at the time of inspection, we strongly recommend you monitor these cracks and if worsening occurs contact a concreter for further advice.

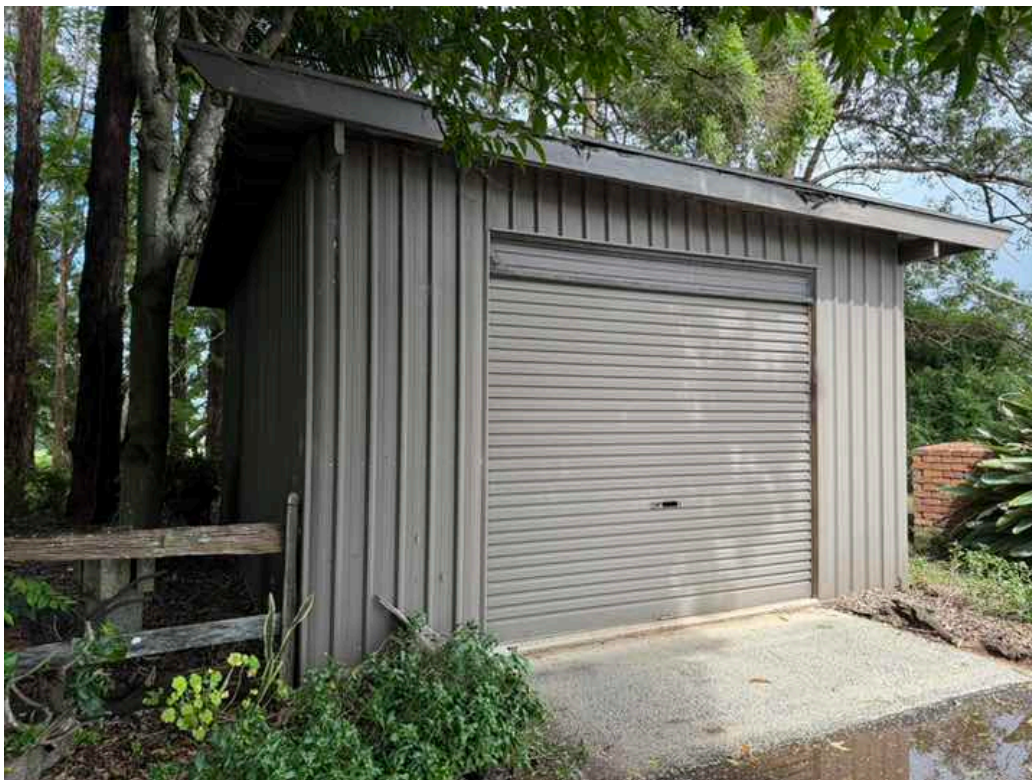
Shed Condition

Timber fungal decay in the framing. A qualified carpenter should be engaged for advice and recommendations.

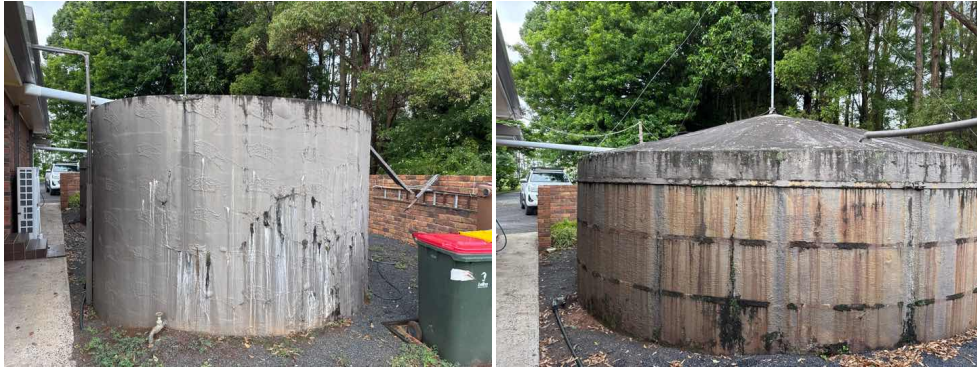
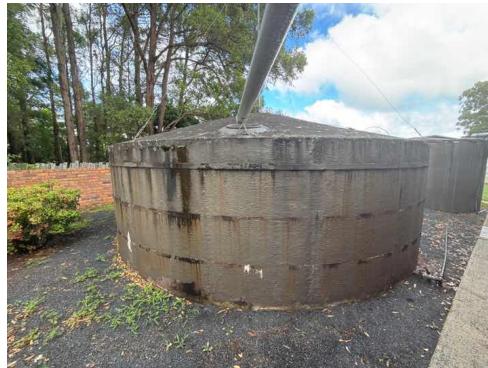
Water Tank Condition

Leaking section. Recommendations: Assessment conducted by a licensed plumber advised.

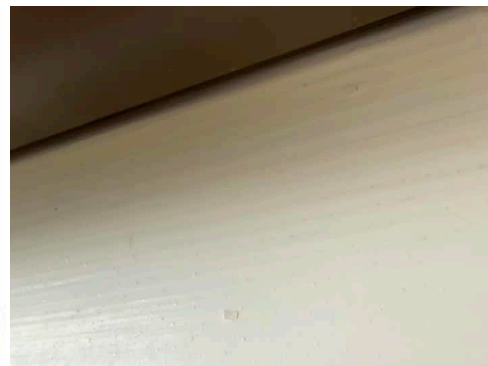
On visual inspection, the general condition of the fascia/barge boards is serviceable.

Timber fungal decay (rot) visible. Recommendations: A qualified carpenter should be engaged to replace all affected timbers.

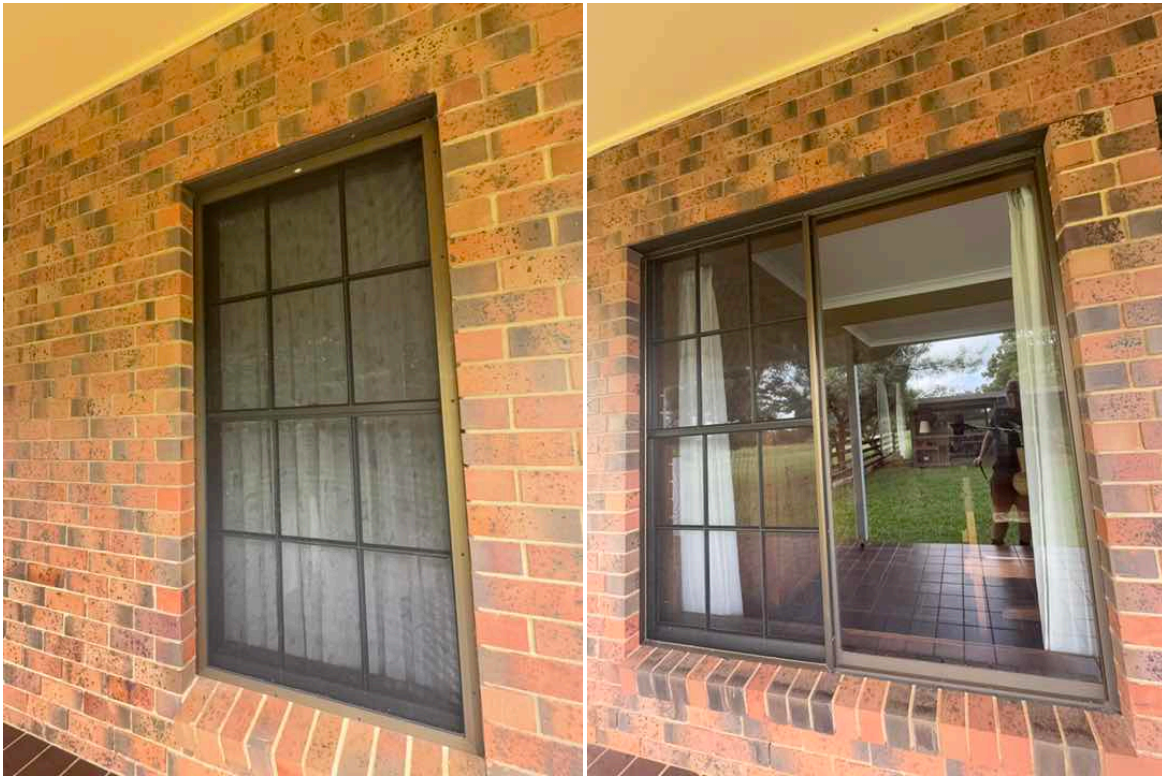
On visual inspection, the general condition of the windows is serviceable for the age.

Deterioration of sections of window rubber seals was observed. A qualified glazier should be engaged for advice and recommendations.

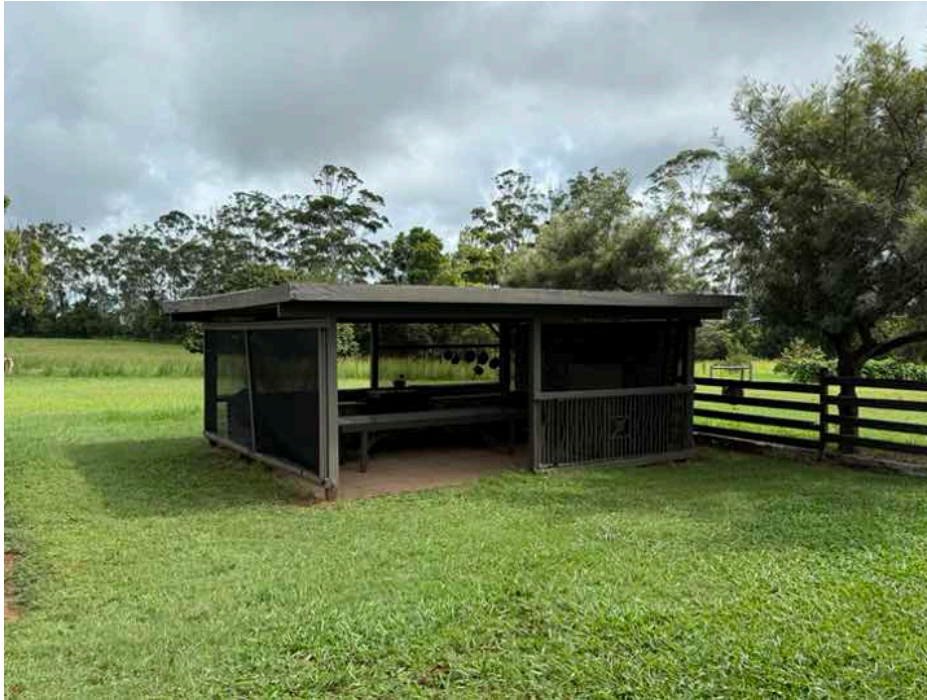
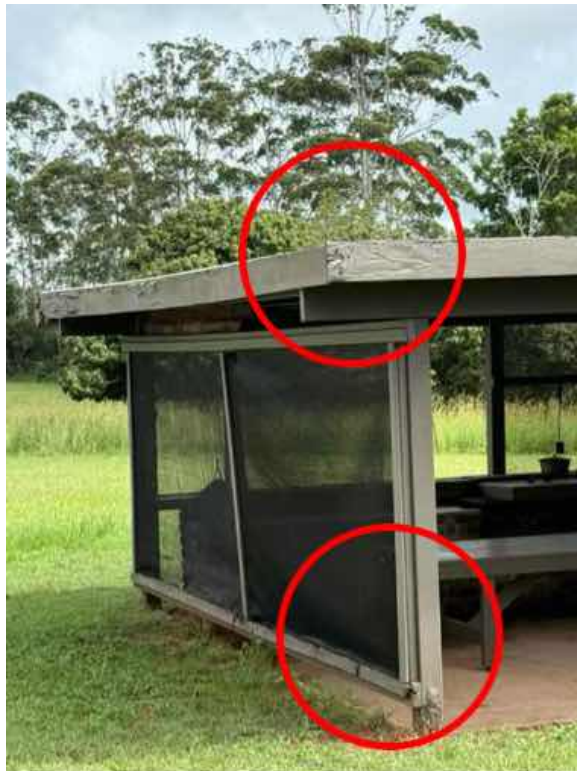
Pergola Framework

Timber fungal decay in the framework is visible. A qualified carpenter should be engaged for advice and recommendations.

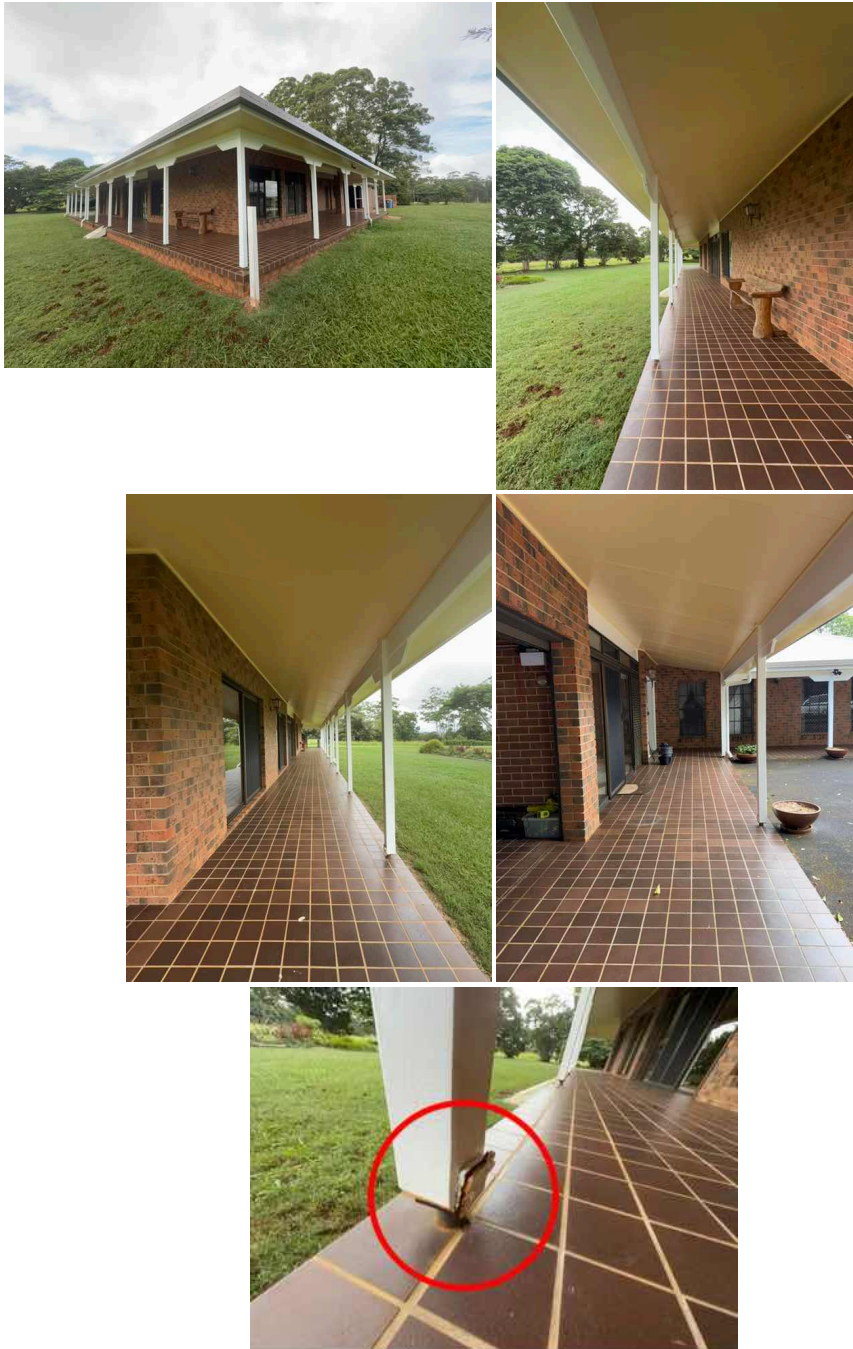
Veranda Posts

Upon visual inspection, the shoe post exhibits significant rust, compromising structural integrity. Immediate action is required to prevent further deterioration. Recommend engaging a licensed tradesperson to remove rust, apply a rust-inhibiting primer, and repaint the post. If corrosion is extensive, consider replacing the shoe post entirely to ensure safety and stability. Regular maintenance checks are advised to prevent future issues.

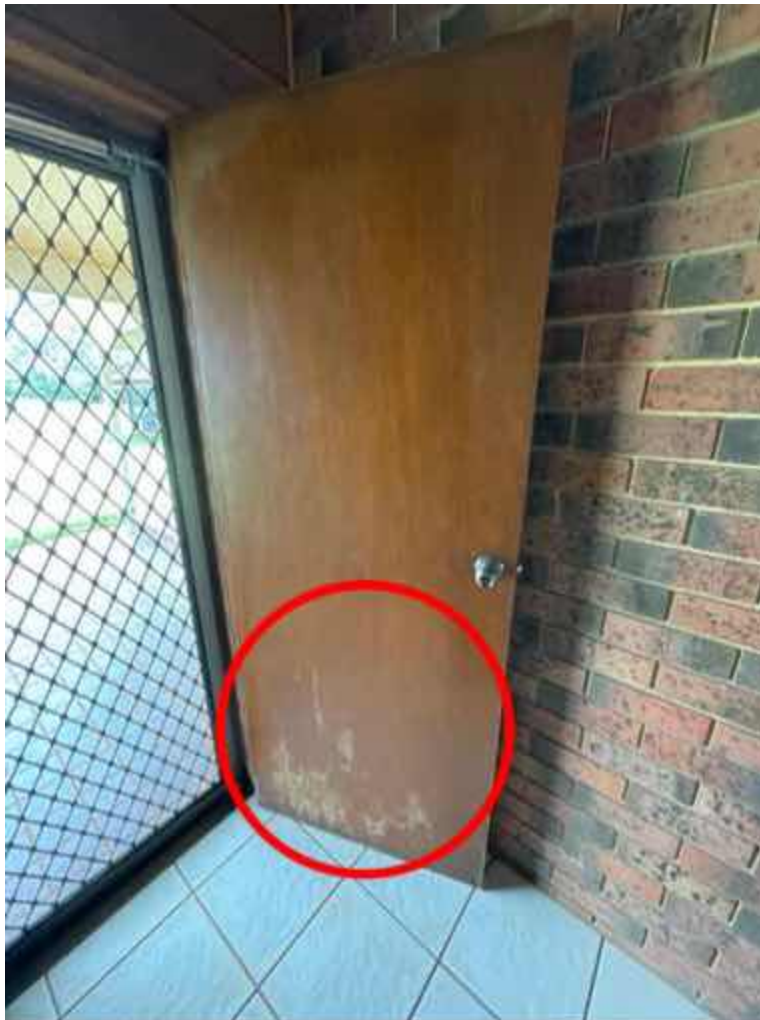
Rear door / frame deterioration - General age/damage has occurred to door frame, face or components.
Recommendations: A qualified carpenter should be engaged for advice and recommendations.

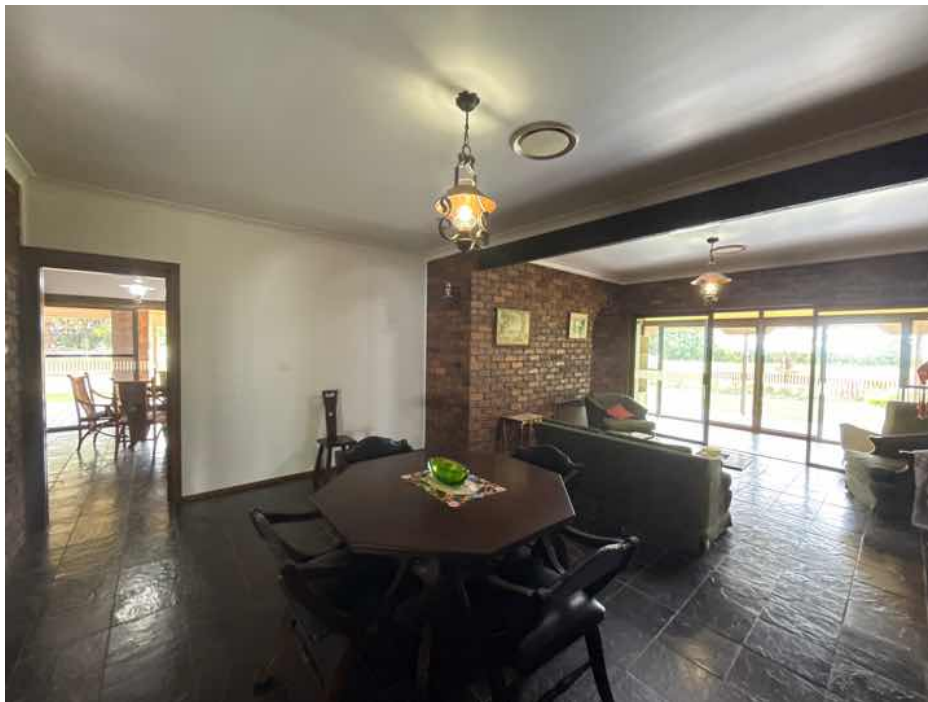
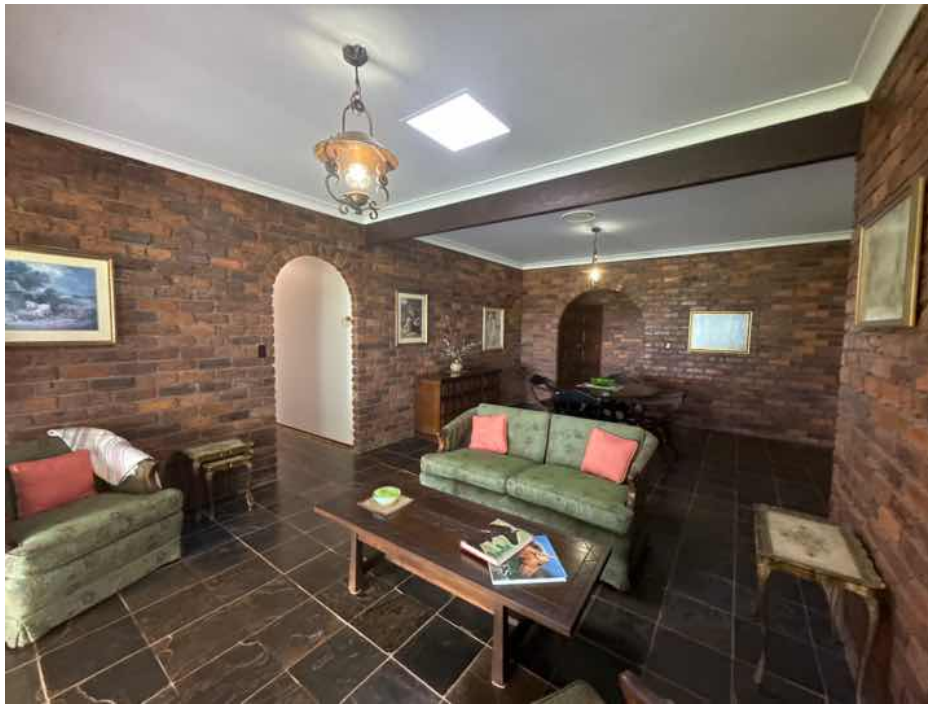
Ceiling

Settlement Cracks Noted. These are typical and generally patch and paint will suffice, however monitoring these cracks is advised for 12 months and if they become worse, further investigation by a suitably qualified professional is advised.

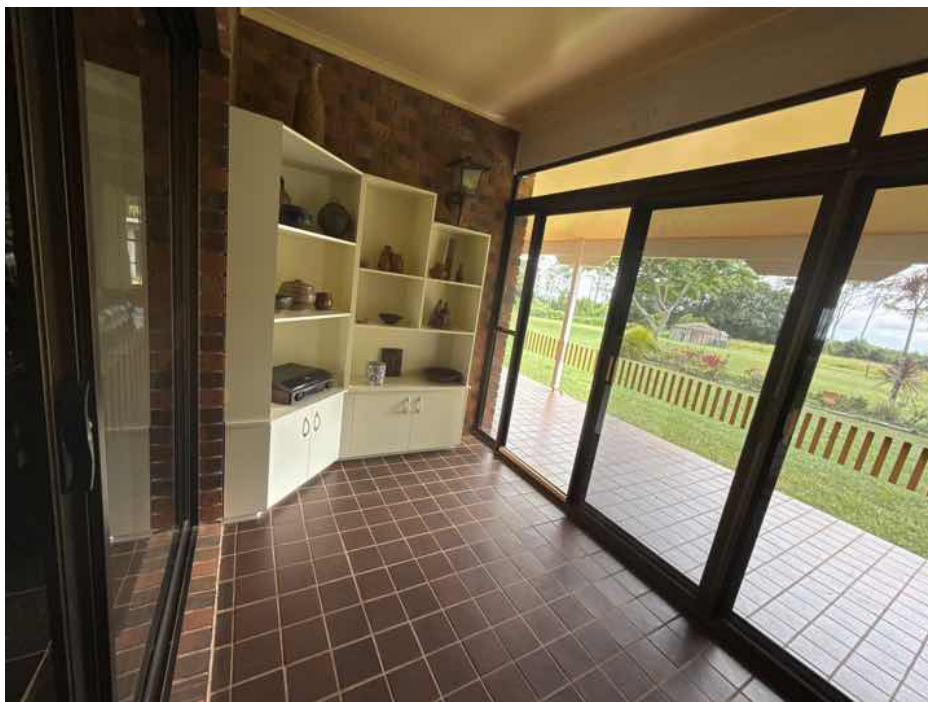
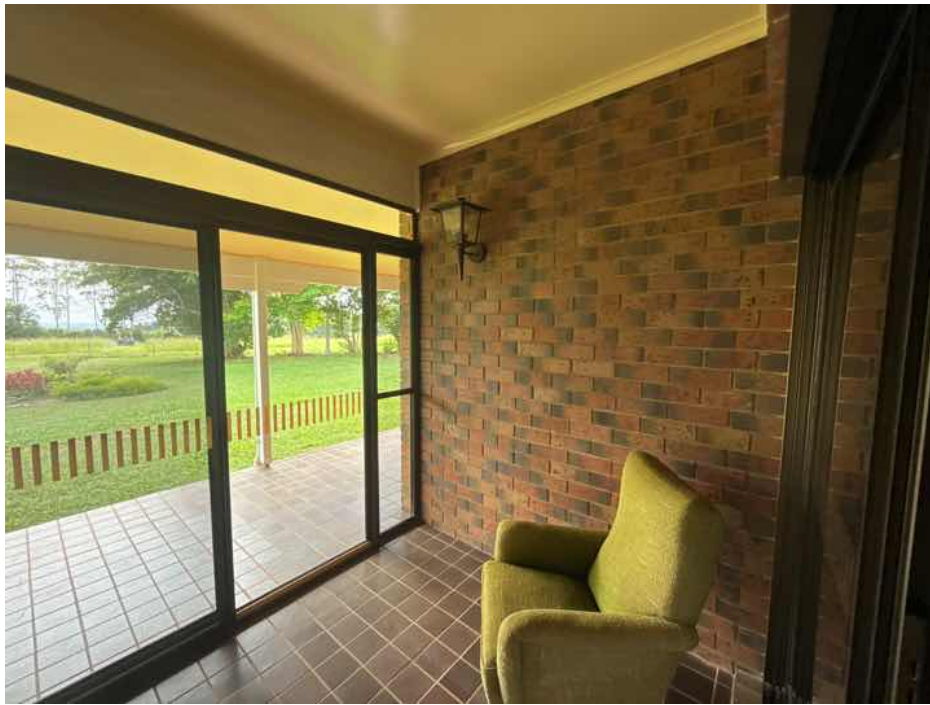
Ceiling

Settlement Cracks Noted. These are typical and generally patch and paint will suffice, however monitoring these cracks is advised for 12 months and if they become worse, further investigation by a suitably qualified professional is advised.

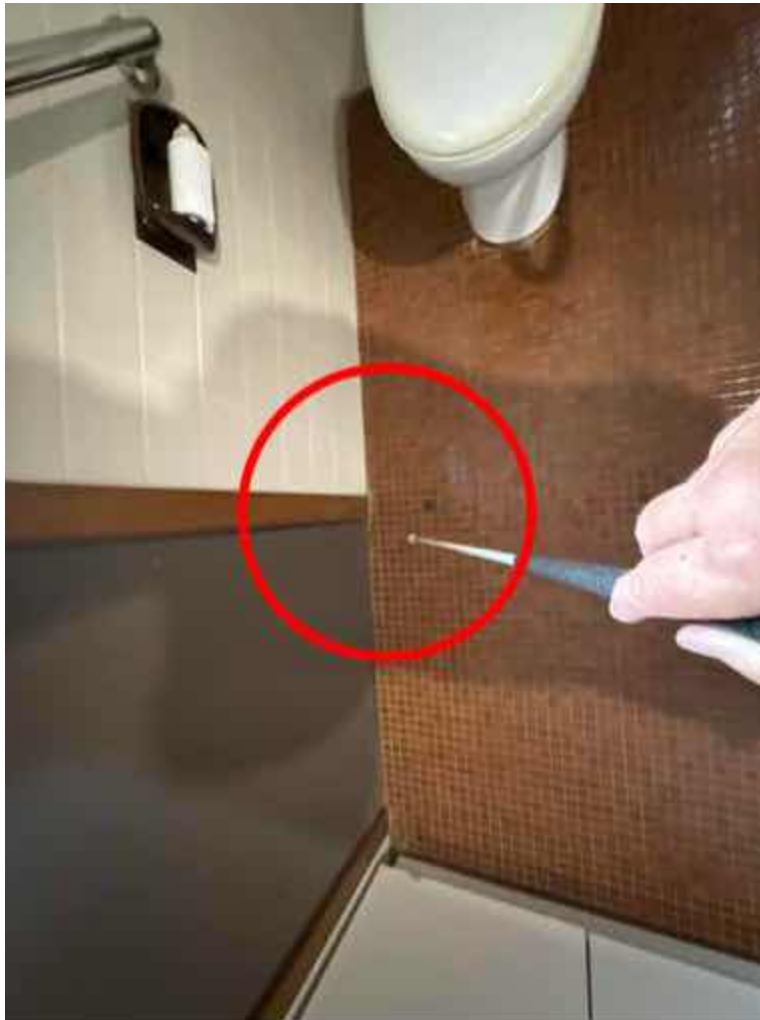
Flooring

Drummy tiles noted. This needs to be repaired at the earliest as this has the potential to lead to many related issues such as damp, water ingress to other areas and cracked tiles. Contact a qualified tiler for repairs and recommendation
