# Building and Pest Report

## 15 Outrigger Road Lennox Head

Report/Agreement #	170725115953573
Inspection Date:	17 Jul 2025
Inspection Time:	11:59 am

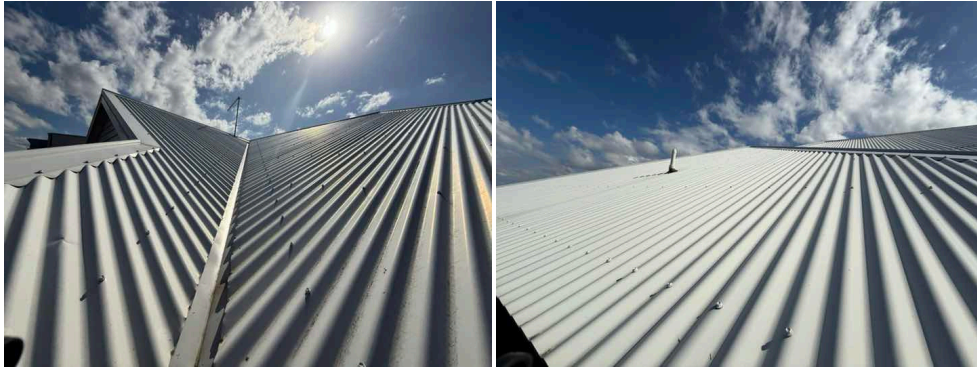
Of the visible areas, the general condition of the roof is in serviceable condition for the age.

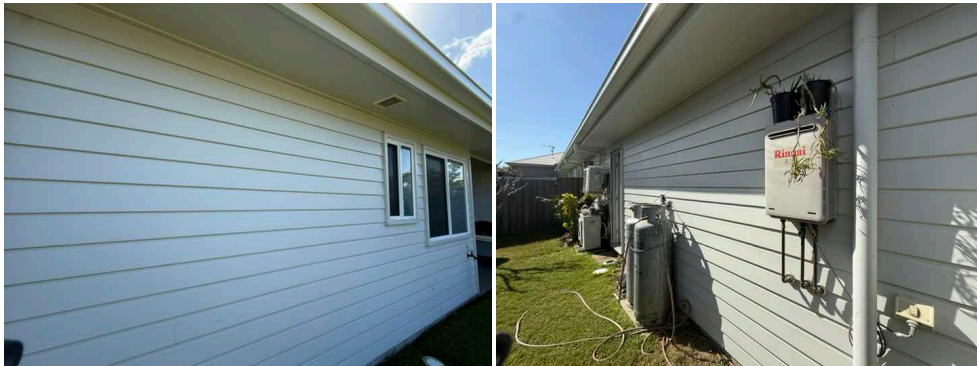
On visual inspection, the general condition of the exterior walls is serviceable for the age.

Minor cladding damage observed. This should be repaired so as to avoid moisture ingress and pests entry.

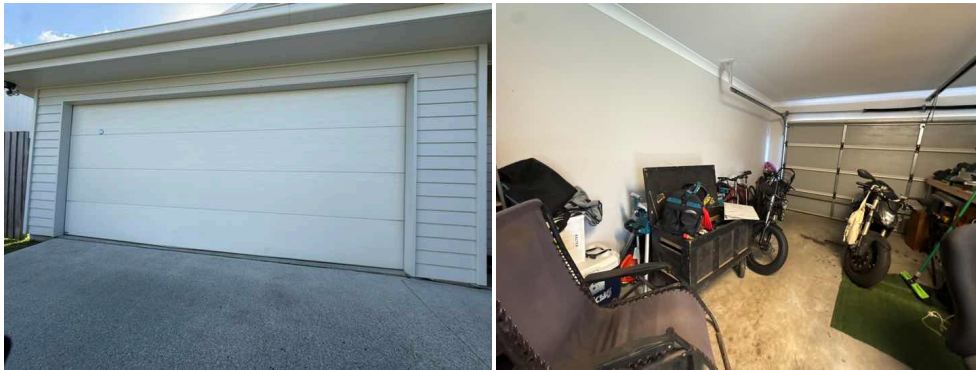
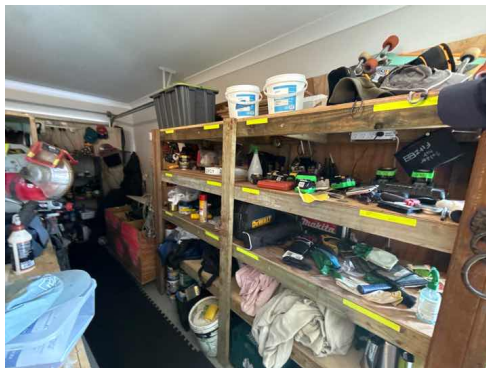
From the visible and accessible areas, the garage appears to be in a serviceable condition for the age of the property with no notable structural defects sighted.

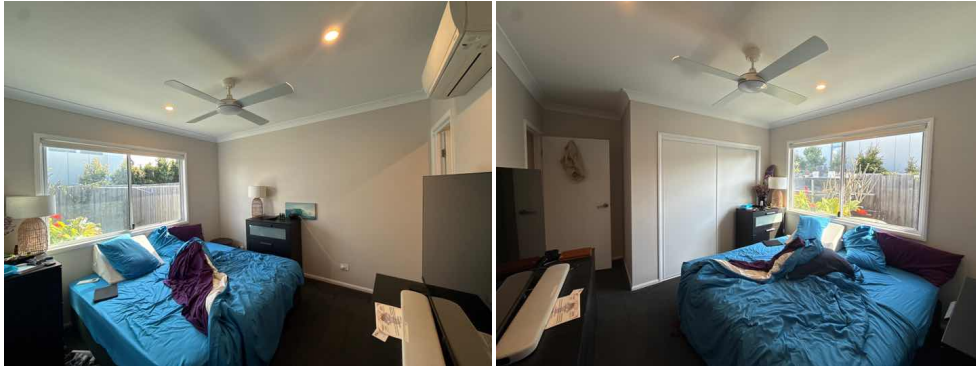
From the visible and accessible areas, this bedroom appears to be in a serviceable condition for the age of the property with no notable structural defects sighted.

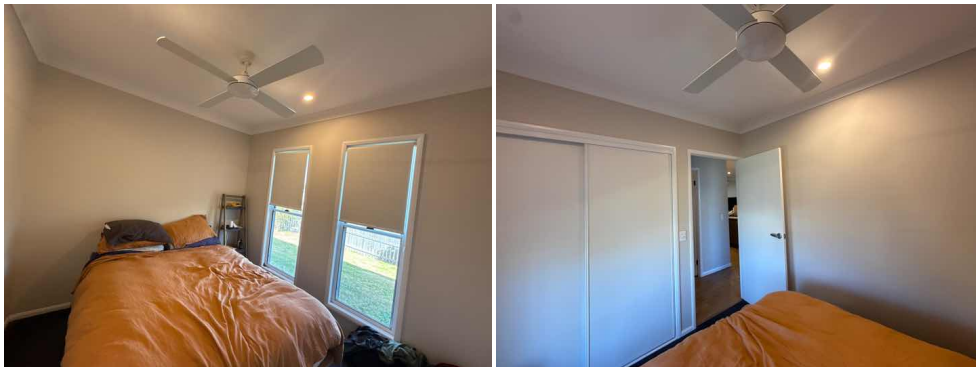
From the visible and accessible areas, this bedroom appears to be in a serviceable condition for the age of the property with no notable structural defects sighted.

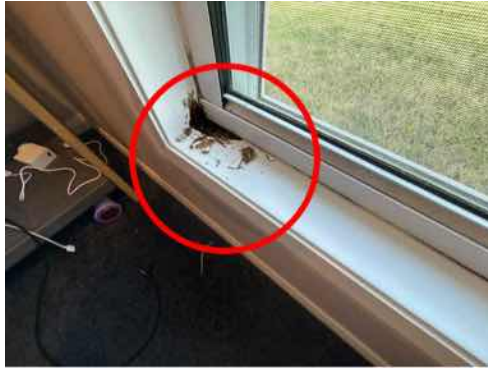
Moisture damage and high moisture readings recorded. Possible water ingress or condensation. Contact a glazier/carpenter for repairs.

Timber fungal decay on window frames. A qualified carpenter should be engaged for advice and recommendations.

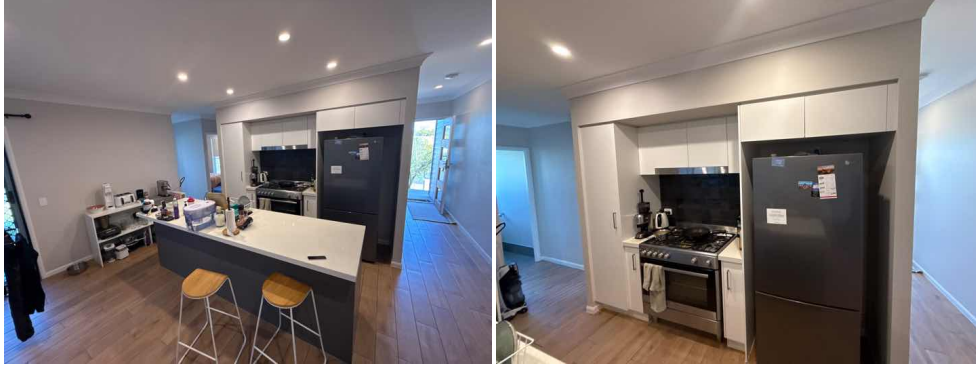
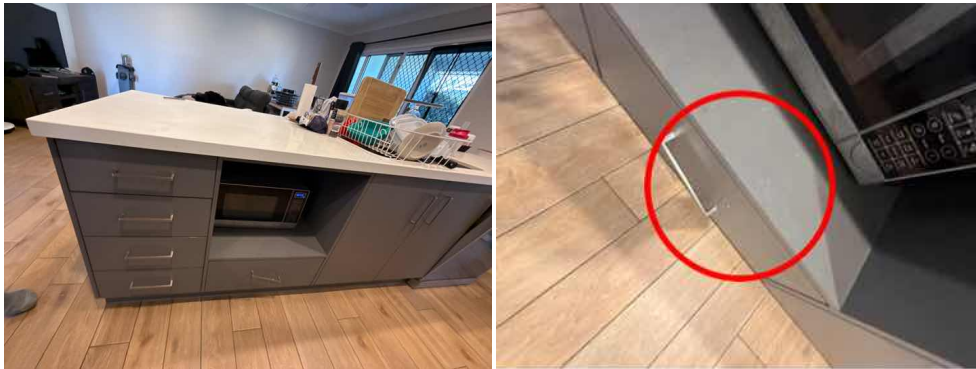
Of the visible areas, the general condition of the kitchen and pantry is serviceable or in reasonable condition for age of dwelling.
