Building and Pest Report

3/20 Byron Street
Lennox Head

Inspection Report

3/20 Byron Street , Lennox Head , NSW , 2478

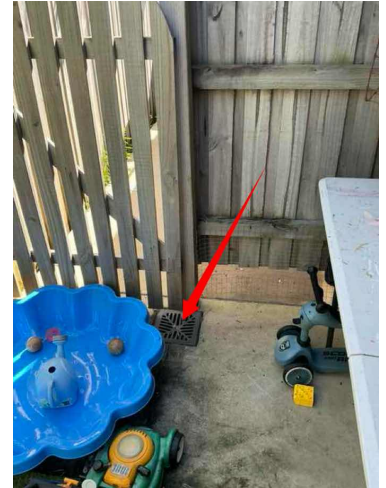
Drainage Findings

There was no visible evidence of excess ponding or fall towards the property walls at the time of the inspection. Regardless, it is difficult to ascertain in dry conditions and it is therefore recommended that you assess same after a rainfall period to be able to sufficiently ascertain if any problems exist in this regard. If water is ponding around perimeter walls and paths or appears to be flowing into the footings/ foundations you must have assessed by a qualified plumber or landscaper.

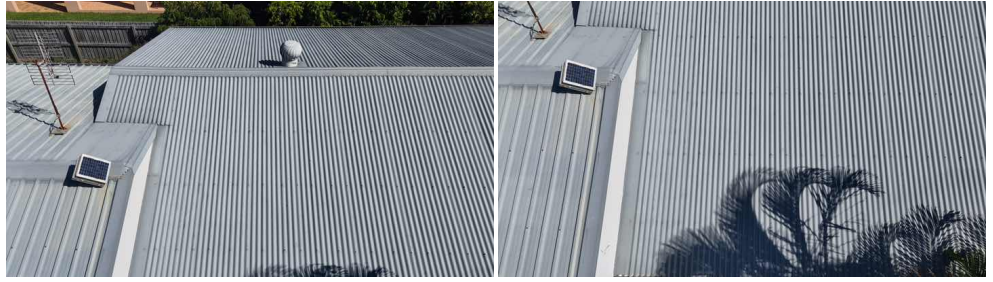
Overall Condition

Of the visible areas, the general condition of the roof is in serviceable condition for the age.

Note: In the absence of rainfall there is no guarantee that the roof won't leak.

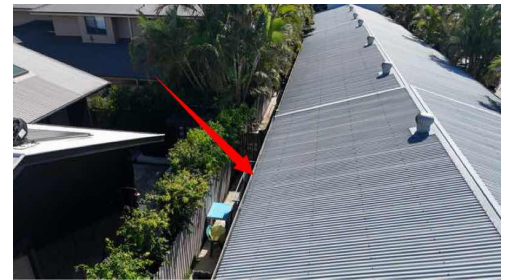
Gutter Findings

All visible and accessible of the physical nature of the guttering system appears to be in a serviceable condition with no apparent defects at the time of inspection. In the absence of prolonged rain fall efficiency of the guttering can not be assessed and you may find that further investigation or repairs maybe required. Note: Periodic maintenance checks should be carried out for rust penetrations and leaks.

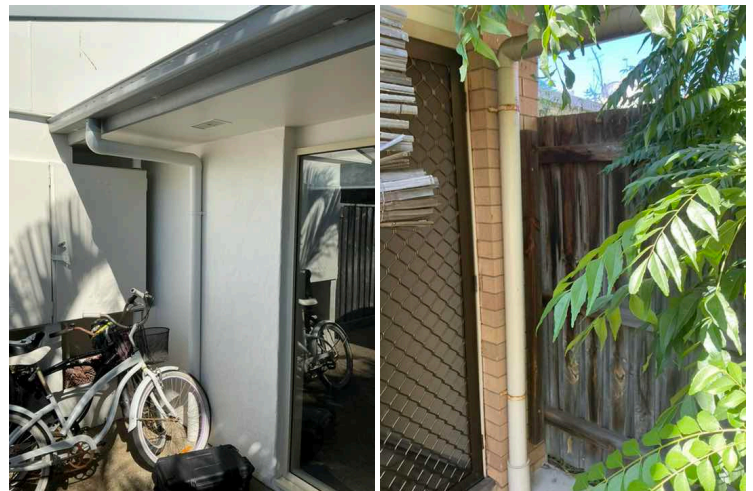
Downpipe Findings

On visual inspection no apparent defects were noted to the down pipes and are considered serviceable, however no comment can be made with regard to blockages or connections to stormwater or functionality in the absence of rain. Note: Periodic maintenance checks should be carried out for rust penetrations and leaks.

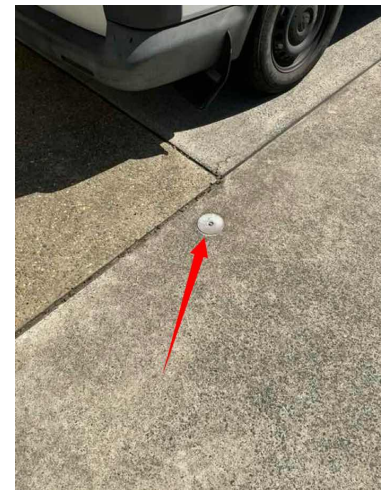
Any Evidence of previous Treatments Found

Yes, a termite bait station was located at the dwelling.

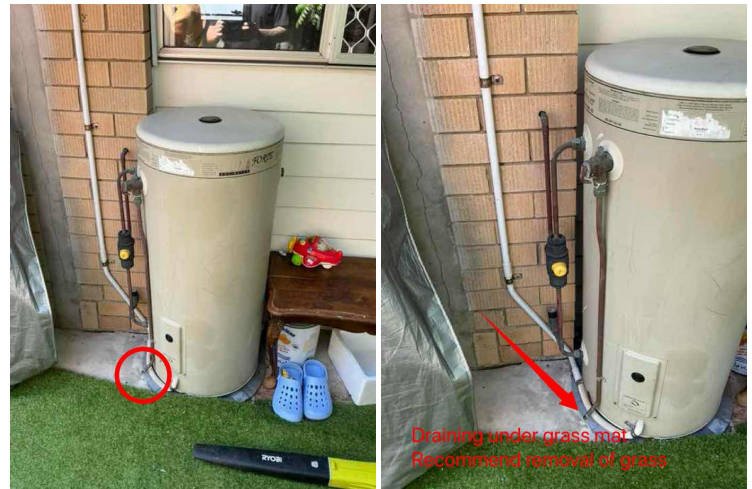
Was the overflow sufficiently drained

No. Divert hot water overflow away from the building perimeter.
