# Building and Pest Report

## 9 Outrigger Road, Lennox Head

# Inspection Report

**9 Outrigger Rd, Lennox Head, NSW, 2478**

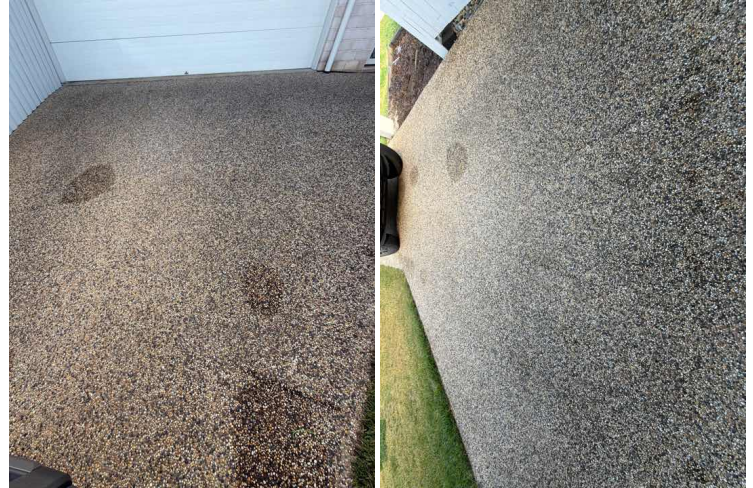
On visual inspection, the general condition of the driveway is serviceable.

Common cracks were observed on the driveway. Whilst these cracks appeared to be typical at the time of inspection, we strongly recommend you monitor these cracks and if worsening occurs contact a concreter for further advice.

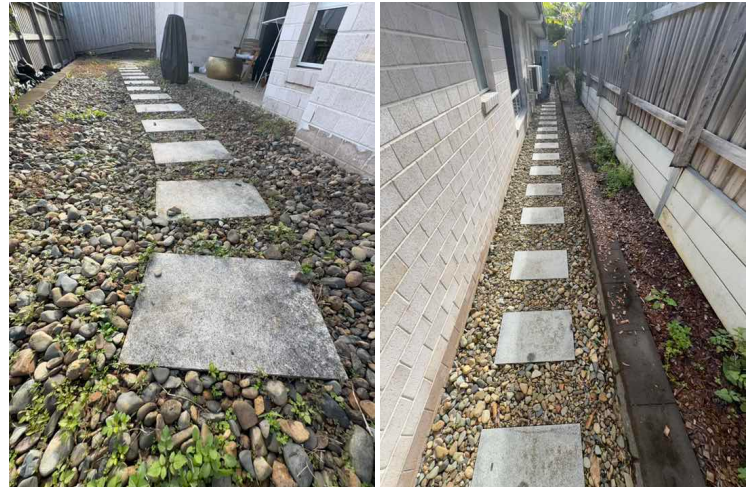
The paths around the home are in a serviceable condition for the age of this dwelling with no major defects visible.

Common cracks and settlement were observed on paths. Whilst these cracks appeared to be typical at the time of inspection, we strongly recommend you monitor these cracks and if worsening occurs contact a concreter for further advice.

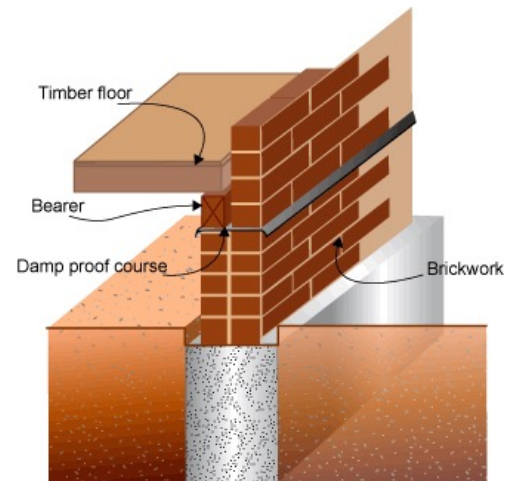
Salt residue on lower external wall visible - Salt residue can be associated with rising damp problems. Further investigation by a specialist in this field is recommended.

A damp proof course (DPC) was noted.

| Section | Location | Name | Comment |
|---|---|---|---|
| EXTERIOR | Rising Damp | Rising Damp Findings | Salt residue on lower external wall visible - Salt residue can be associated with rising damp problems. Further investigation by a specialist in this field is recommended. |

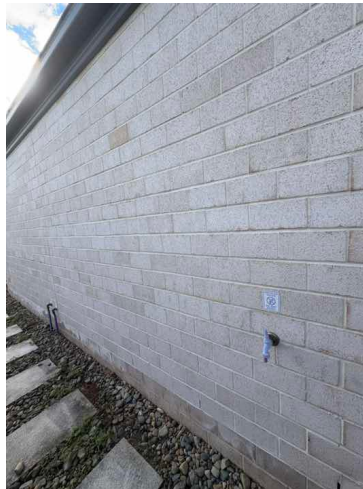
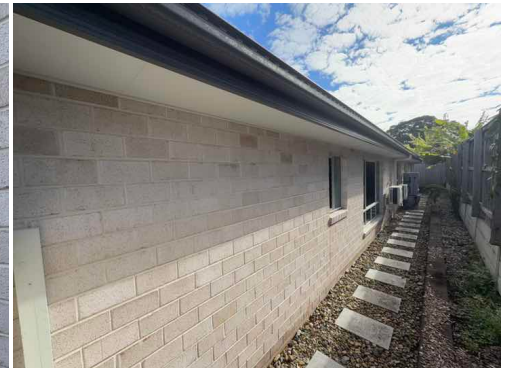
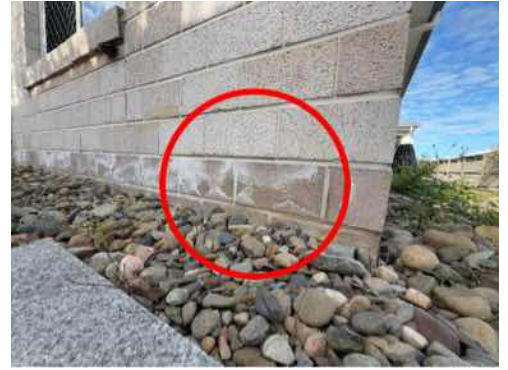
On visual inspection, the general condition of the exterior walls is serviceable for the age. Rising damp detected. A qualified damp proof specialist should be engaged for advice and recommendations. Accurate diagnosis of the cause and extent of the damp problem is very important. It is strongly advised that you have this issue assessed prior to purchasing the dwelling as can be quite costly if a damp proof course has to be reinstated.

| Section | Location | Name | Comment |
|---|---|---|---|
| EXTERIOR | Walls | Condition | Rising damp detected. A qualified damp proof specialist should be engaged for advice and recommendations. Accurate diagnosis of the cause and extent of the damp problem is very important. it is strongly advised that you have this issue assessed prior to purchasing the dwelling as can be quite costly if a damp proof course has to be reinstated. |

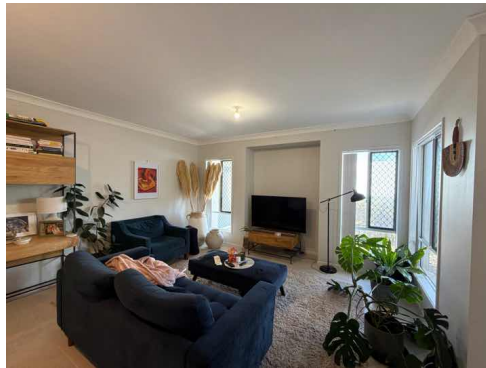
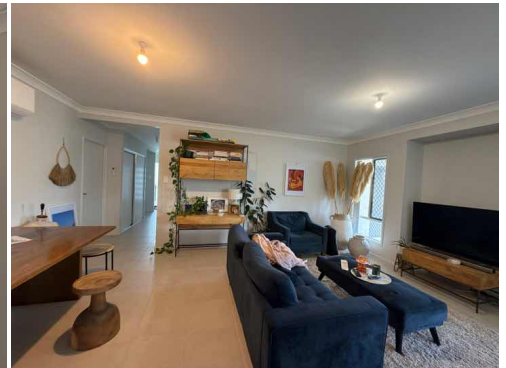
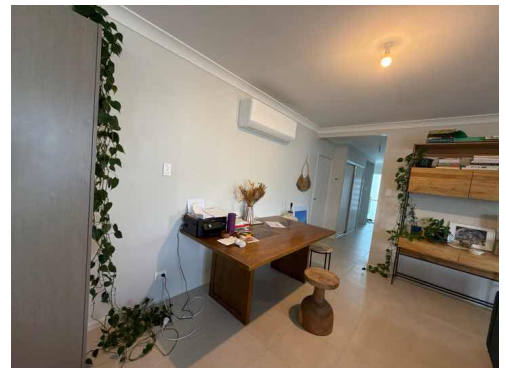
Tile grout deteriorating. Contact a qualified tiler for repairs

| Section | Location | Name | Comment |
|---|---|---|---|
| INTERIORS | Combined Living & Dining | Flooring | Tile grout deteriorating. Contact a qualified tiler for repairs |

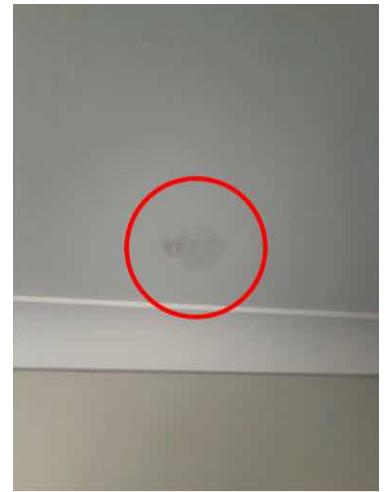
Though reporting on mould does not form part of this inspection it's worth noting that mould growth is noted. Due to health risks we strongly recommend that a expert in the field of mould treatment be engaged for further advise and recommendations.

| Section | Location | Name | Comment |
|---|---|---|---|
| BATHROOM(S) | Bathroom 1 | Ceiling | Though reporting on mould does not form part of this inspection it's worth noting that mould growth is noted. Due to health risks we strongly recommend that a expert in the field of mould treatment be engaged for further advise and recommendations. |

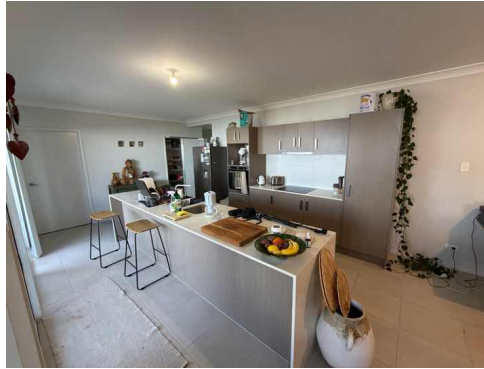
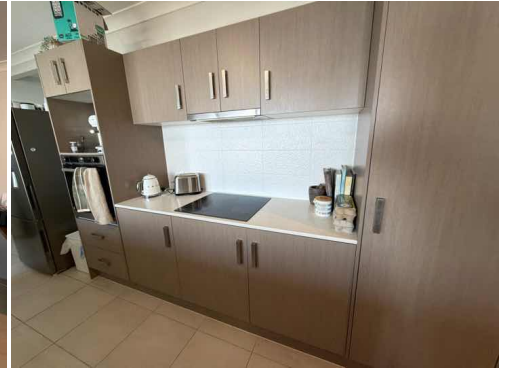
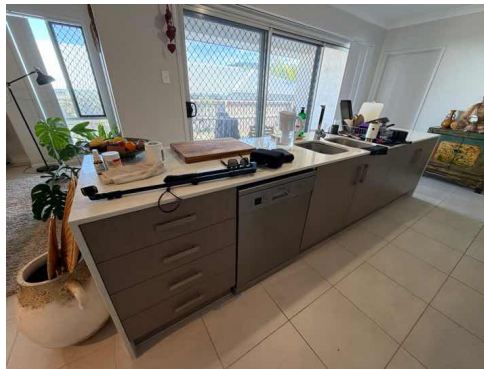
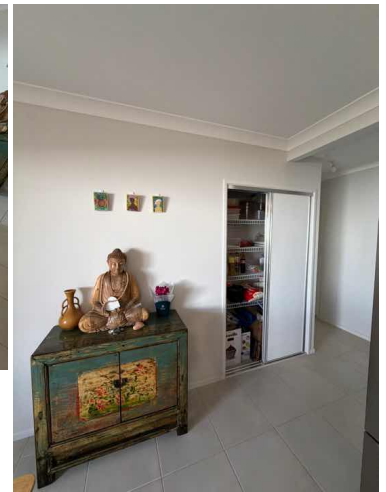
These components appear to be in a serviceable condition

Adjustment to cabinet doors required, in some instance hinges may need to be replaced.

| Section | Location | Name | Comment |
|---|---|---|---|
| KITCHEN & LAUNDRY | Kitchen and Pantry | Cupboards And Bench Tops | Adjustment to cabinet doors required, in some instance hinges may need to be replaced. |
