# Building and Pest Report

## 3 Claremont Place Lennox Head

# Inspection Report

**3 Claremont Place , Lennox Head , NSW, 2478**

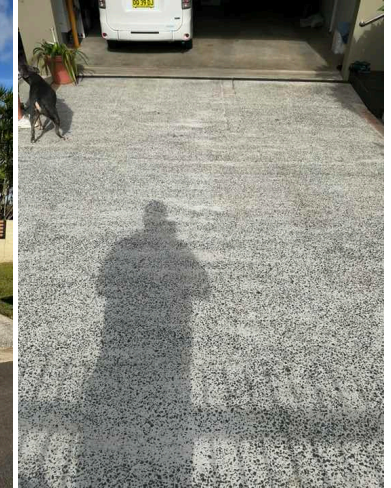
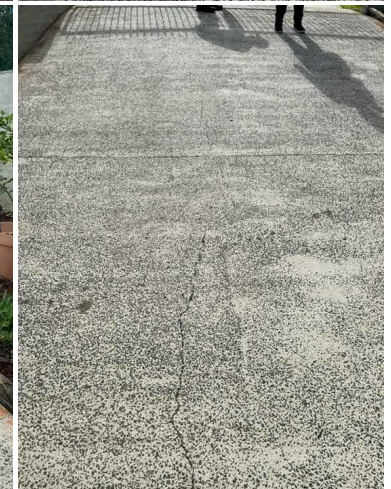
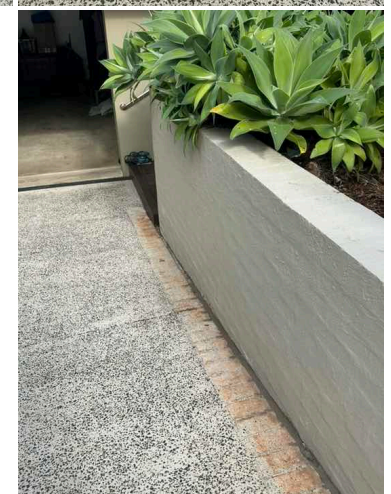
Common cracks were observed on the driveway. Whilst these cracks appeared to be typical at the time of inspection, we strongly recommend you monitor these cracks and if worsening occurs contact a concreter for further advice.

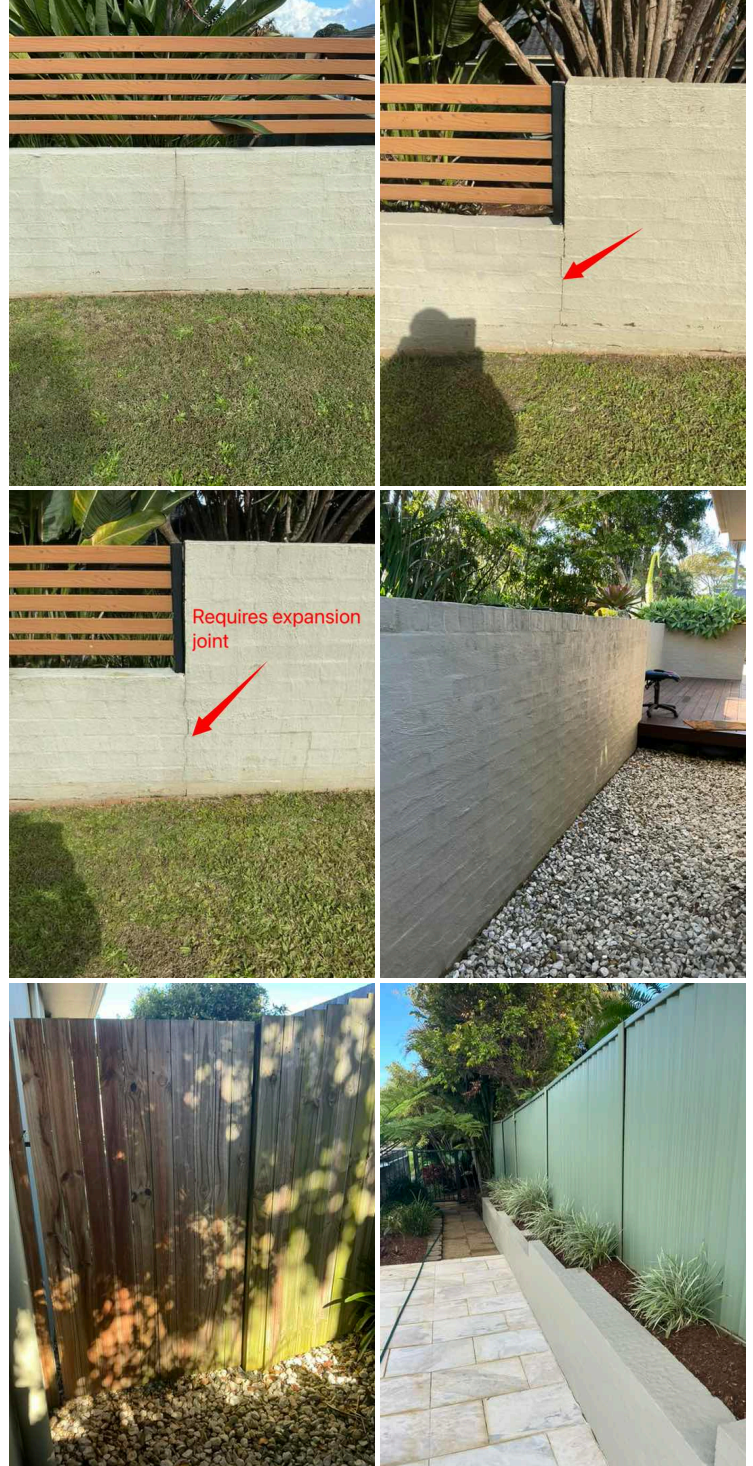
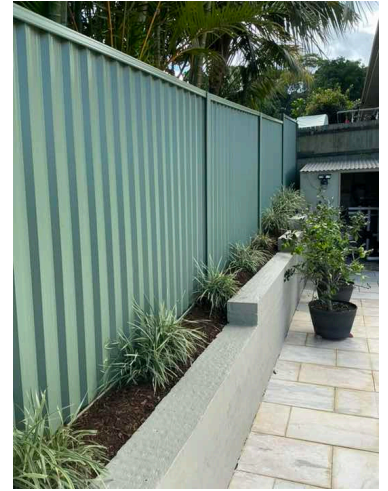
On inspection, defects were present that will require further accessing and recommendations by licensed and qualified trades persons. Upon visual inspection, a vertical crack is evident in the wall. Recommend engaging a licensed mason to assess and repair the crack to prevent further structural issues. Ensure proper sealing and reinforcement to maintain integrity and aesthetics.

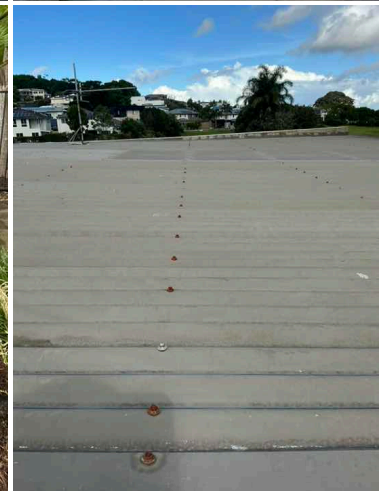
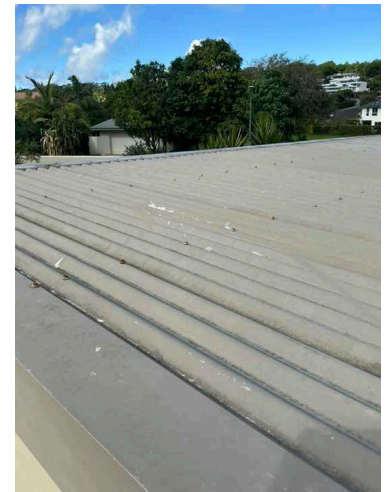
#2. Minor rust on carport roof sheeting. A qualified roof plumber should be engaged for advice and recommendations.

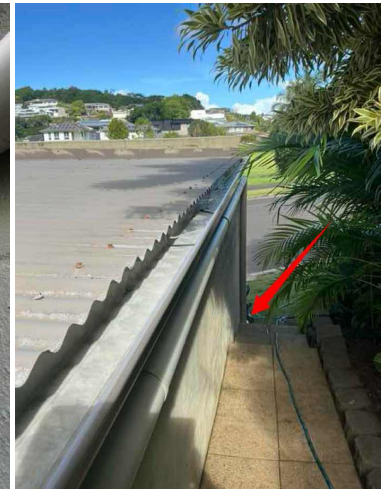
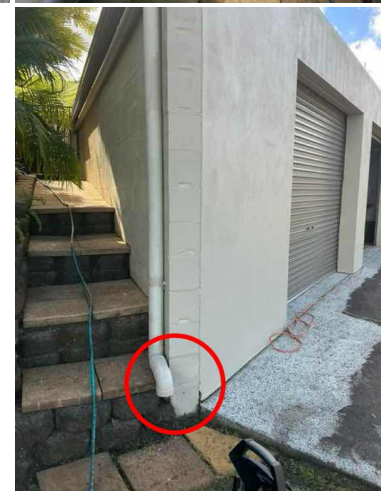
#3. Down pipe is not connected to storm water.  
Contact a roof plumber for repairs

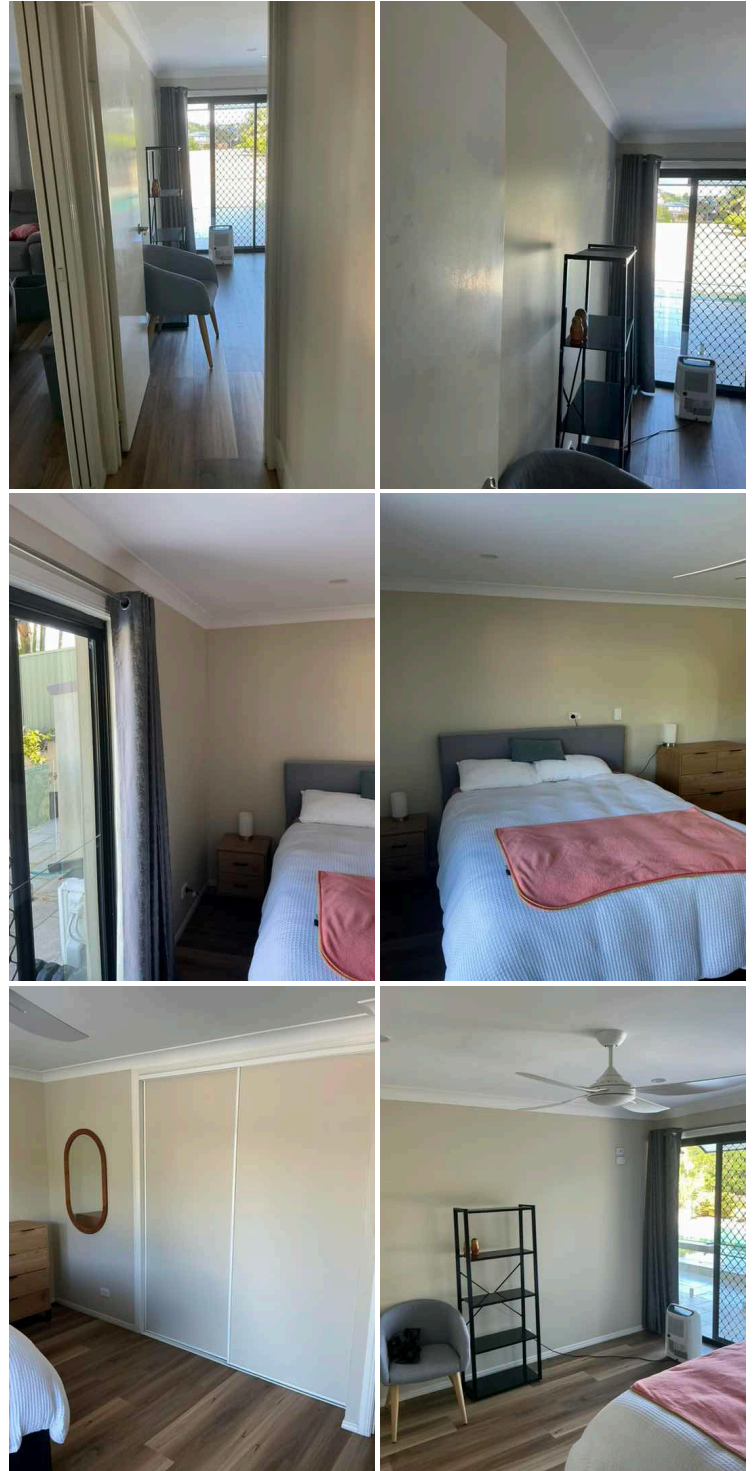
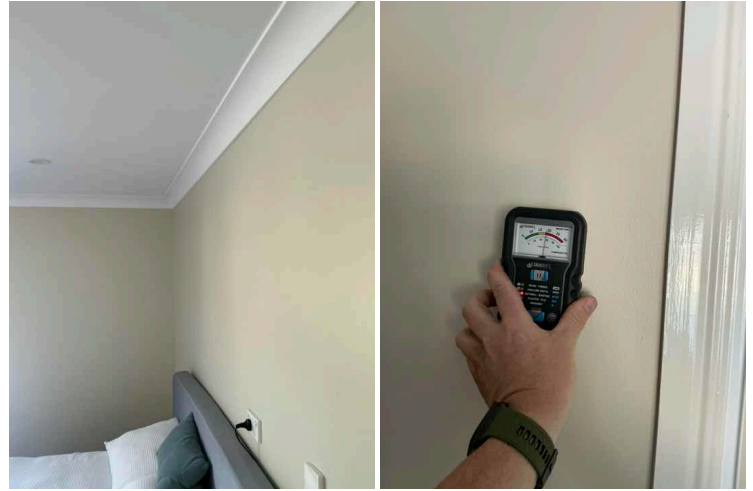
Upon visual inspection, the moisture meter indicates elevated moisture levels in the wall. It is recommended to engage a licensed plumber to investigate potential leaks or water ingress. Additionally, a licensed builder should assess any structural implications and ensure proper remediation to prevent further moisture-related issues.

#4. Walls are below ground level. High moisture levels obtained. Contact a licensed drainage plumber for further advice and recommendations.

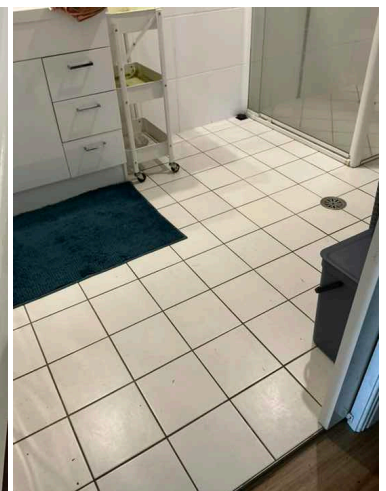
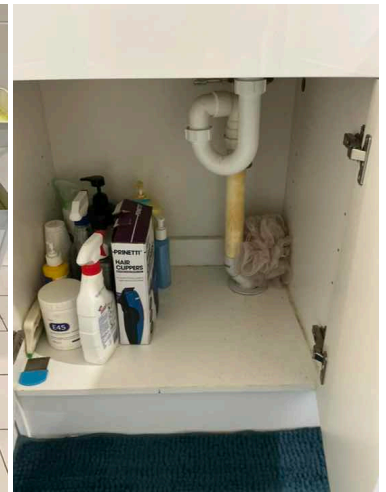
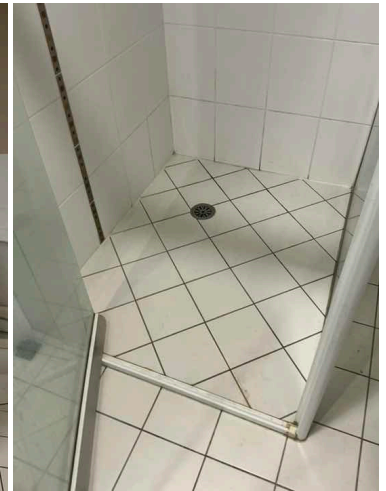
On inspection, defects were present that will require further assessing and recommendations by licensed and qualified trades persons, please read below for details.see photos attached.

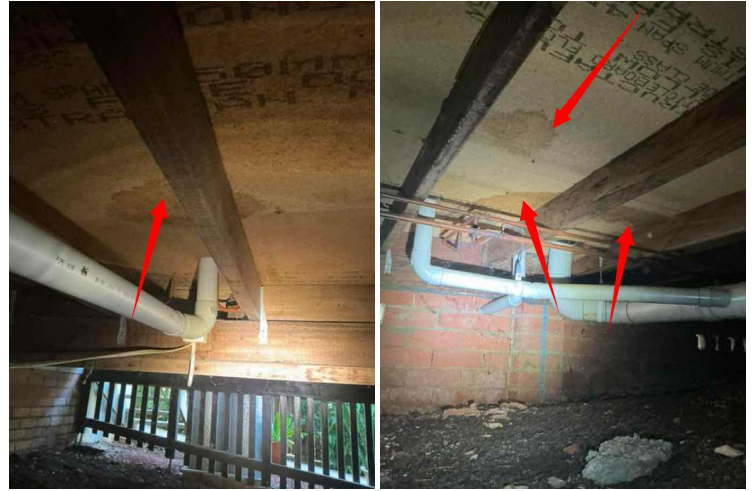
#5. Damaged was observed to the underside of the floorboards of which reason is unknown. The floor Above appears to be stable at this time with little to no bounce. If this changes replacement of the affected boards is recommended.

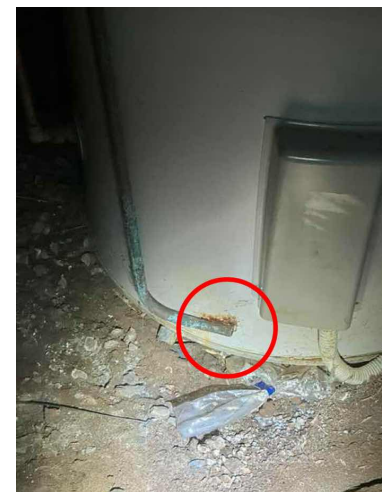
No. Divert hot water overflow away from the building perimeter.
