Building and Pest Report

39 Gibbon Street, Lennox Head

Inspection Report

39 Gibbon Street, Lennox Head , NSW, 2478

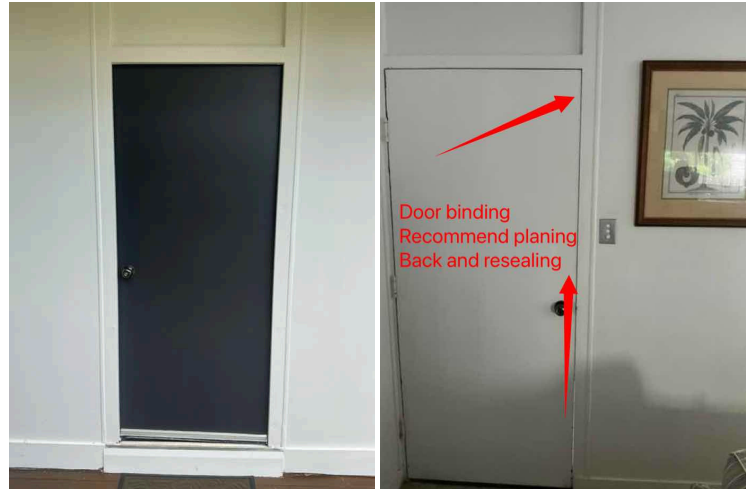
Front Entry Doors

#1. Binding entry door - Doors that bind on the frame can relate to some differential settlement, frame movement, age, expansion, shrinkage or poor hanging. A qualified carpenter should be engaged for repairs.

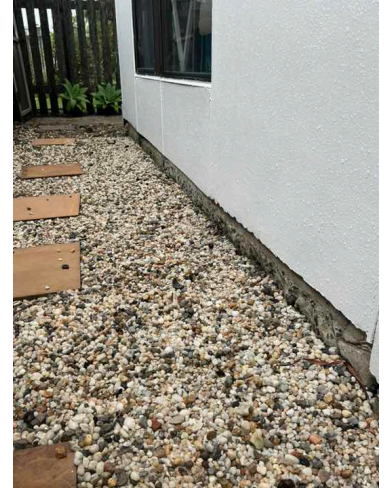
Is the Slab Edge adequately Exposed

Yes in some areas.

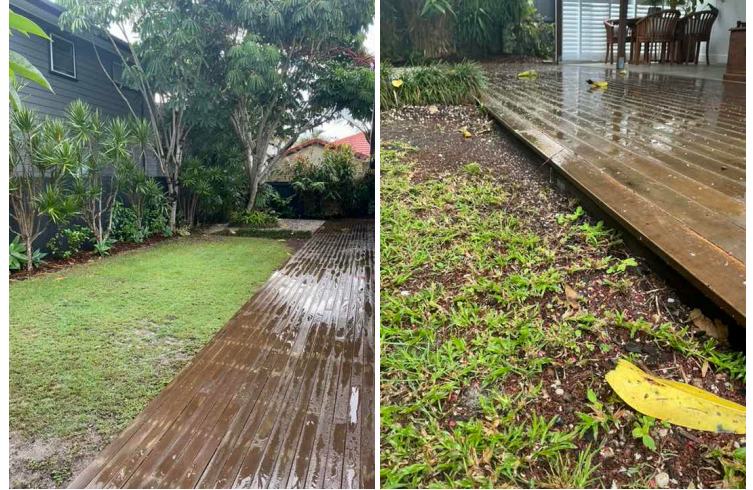
No access under decking. A full inspection must be carried out of the decking framing for any potential termite damage and/or infestation.

Timber in contact with ground. This provides conducive and concealed conditions and concealed entry for termite infestation.
