Building and Pest Report

127a Montwood Dr, Lennox Head

Pest And Building Inspection

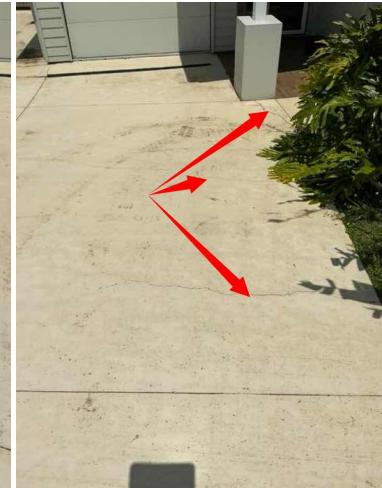
Driveway Condition

Common cracks were observed on the driveway. Whilst these cracks appeared to be typical at the time of inspection, we strongly recommend you monitor these cracks and if worsening occurs contact a concreter for further advice.

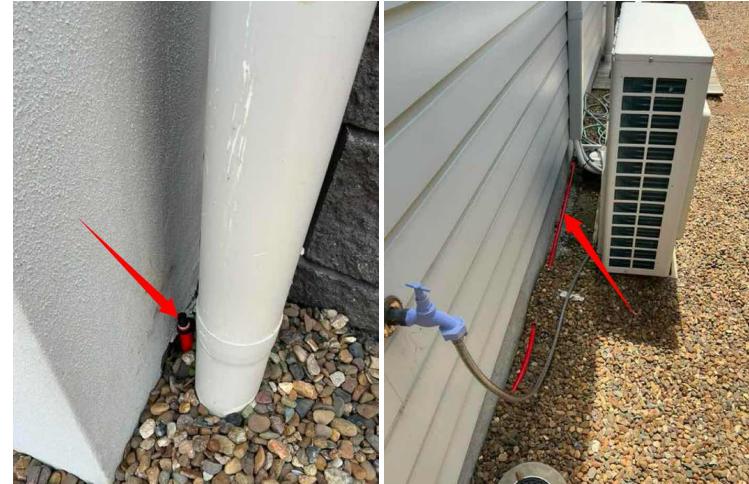
Yes, a reticulated pipe system was located at the dwelling.

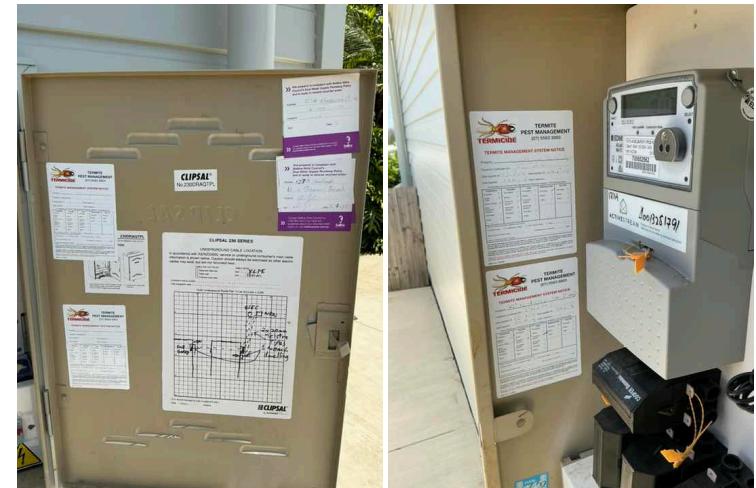
Yes, a durable notice was found in the meter-box during the inspection.

However numerous notices found none filled out with any information

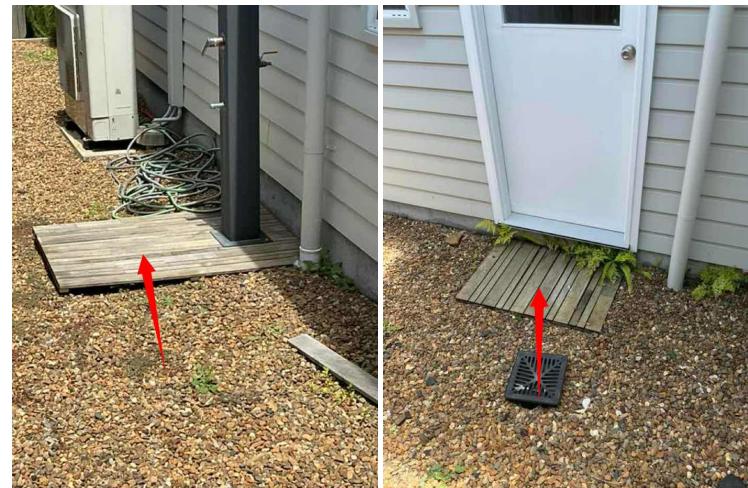
Timber in contact with ground. This provides conducive and concealed conditions and concealed entry for termite infestation.
