# Building and Pest Report

## 74A Stoneyhurst Drive Lennox Head

| Inspection Date: | 19 May 2025 |

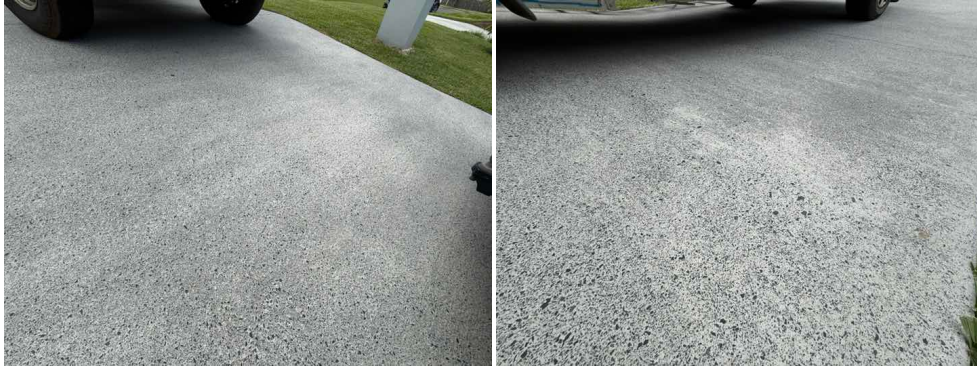
On visual inspection, the general condition of the driveway is serviceable.

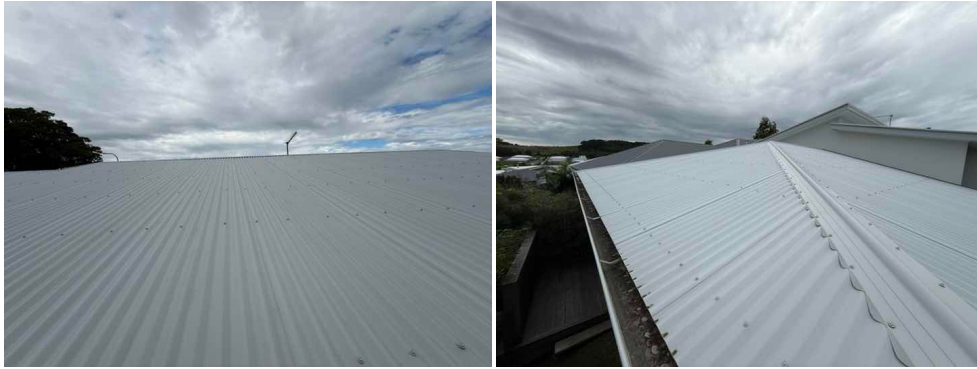
Of the visible areas, the general condition of the roof is in serviceable condition for the age.

Note: In the absence of rainfall there is no guarantee that the roof won't leak.

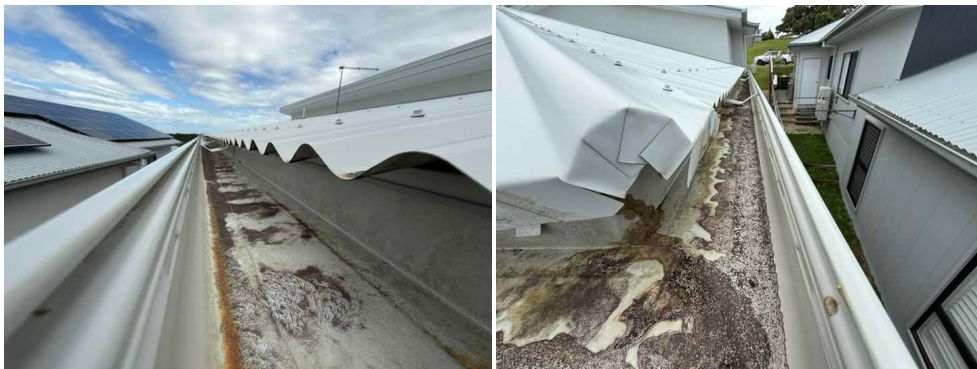
All visible and accessible of the physical nature of the guttering system appears to be in a serviceable condition with no apparent defects at the time of inspection. In the absence of prolonged rain fall efficiency of the guttering can not be assessed and you may find that further investigation or repairs maybe required. Note: Periodic maintenance checks should be carried out for rust penetrations and leaks.

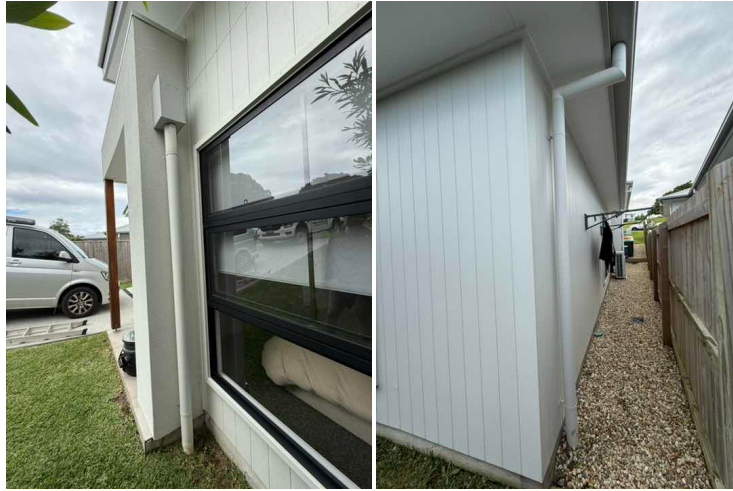
On visual inspection no apparent defects were noted to the down pipes and are considered serviceable, however no comment can be made with regard to blockages or connections to stormwater or functionality in the absence of rain. Note: Periodic maintenance checks should be carried out for rust penetrations and leaks.

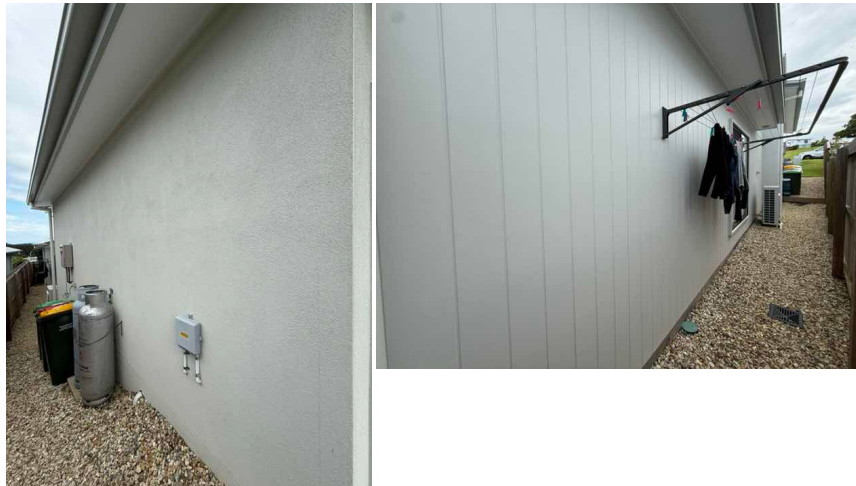
On visual inspection, the general condition of the exterior walls is serviceable for the age.

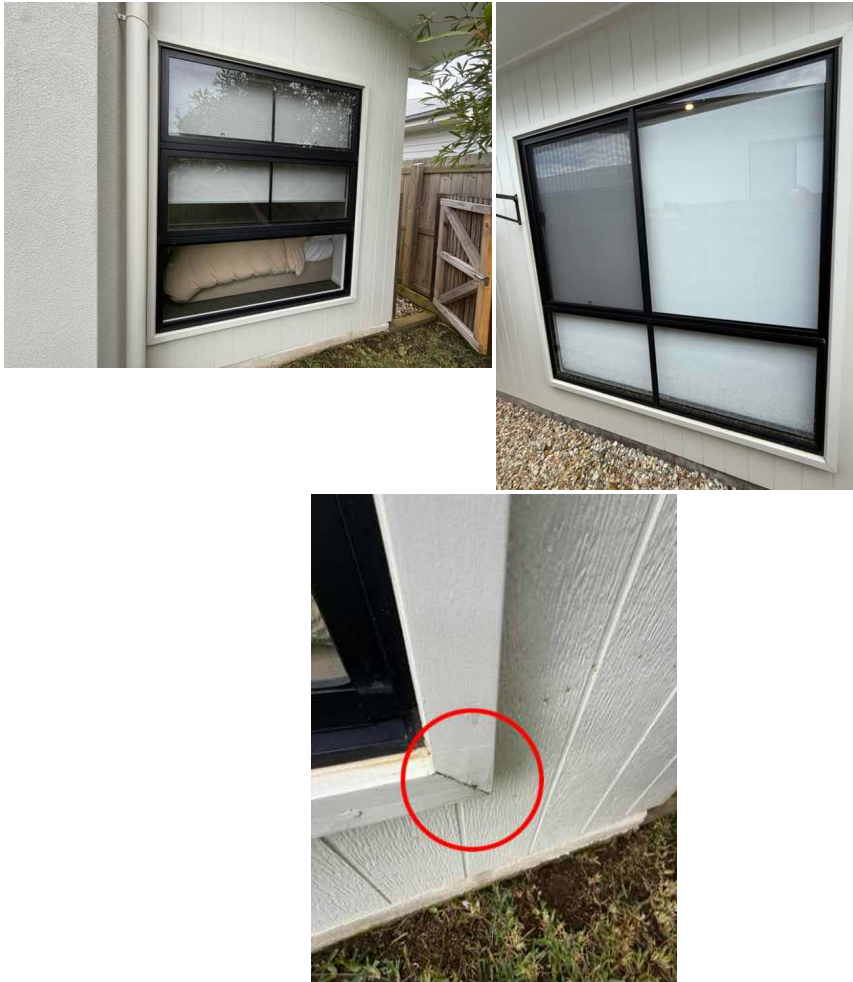
Minor Timber fungal decay is evident in sections of the window framework - Some areas should be replaced. A qualified carpenter should be engaged for advice and recommendations.

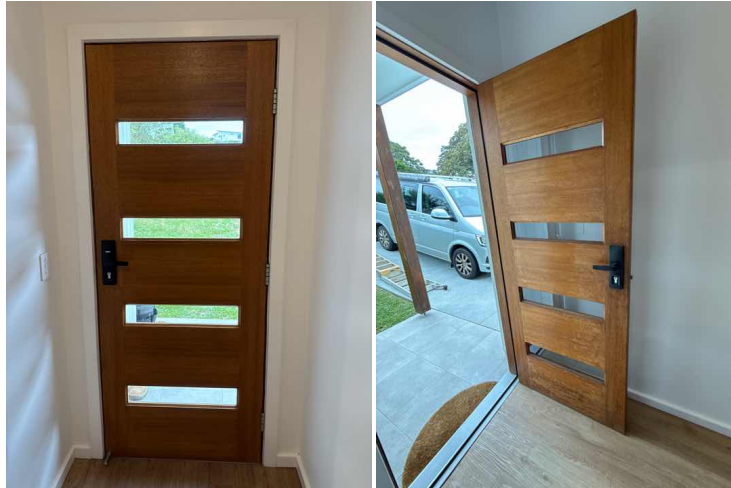
Binding entry door - Doors that bind on the frame can relate to some differential settlement, frame movement, age, expansion, shrinkage or poor hanging. A qualified carpenter should be engaged for repairs.

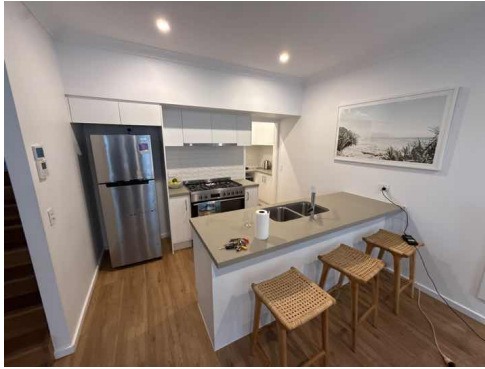
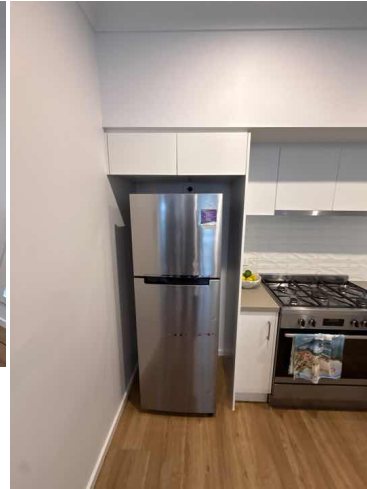
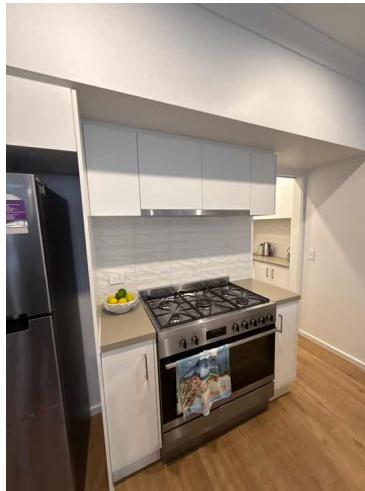
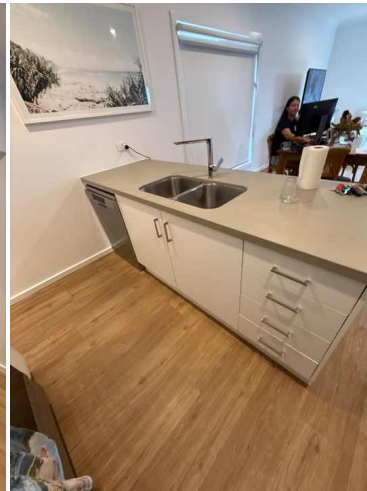
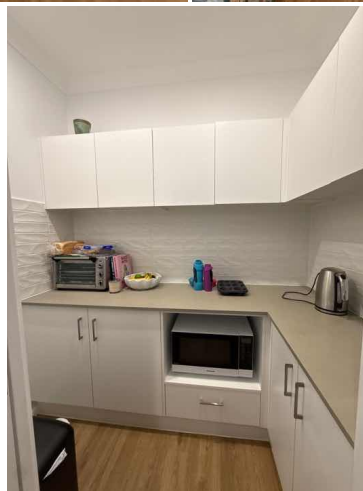
Adjustment to cabinet doors required, in some instance hinges may need to be replaced.

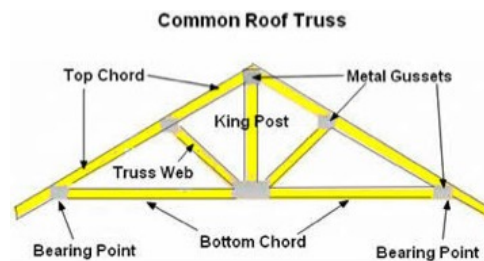
The roof frame is a truss timber frame.

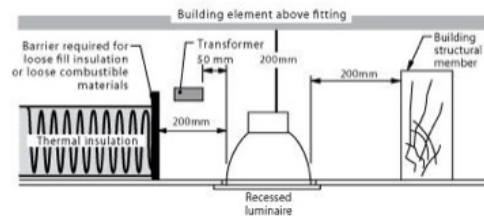
Insufficient spacing between insulation and down lights. This poses a fire risk. Contact a qualified electrician for further advice and recommendations prior to a decision to purchase.
