PEST AND BUILDING PRE-PURCHASE REPORTS

46 Sunray Crescent
Lennox Head

BPI - INSPECTION REPORT

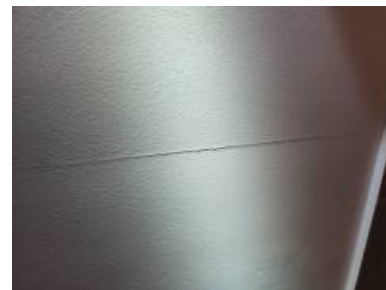
Cracking / Defective Lining
Minor crack to wall sheet join to bathroom. *These types of cracks are common and are generally due to minor settlement &/or material shrinkage.*

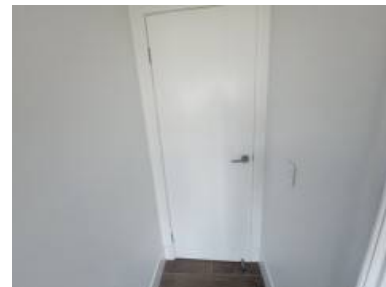
Laundry door is binding and requires repair / easing / adjustment.

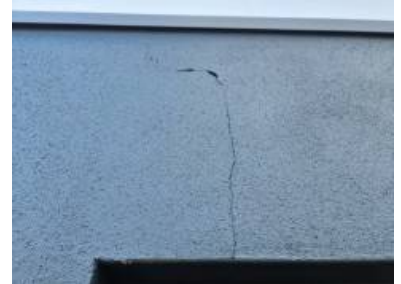
Small crack above toilet window down stairs.

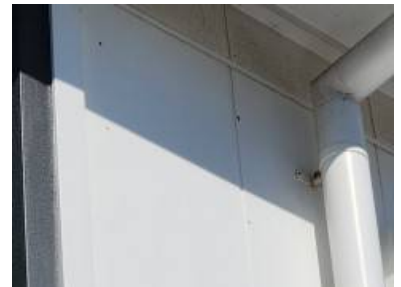
Some nails to cladding above garage are showing signs of rust and require repair with kill rust and repainting.

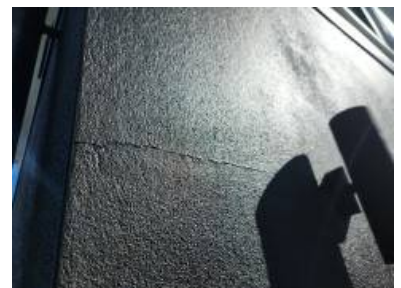
Hairline cracks present to some render.

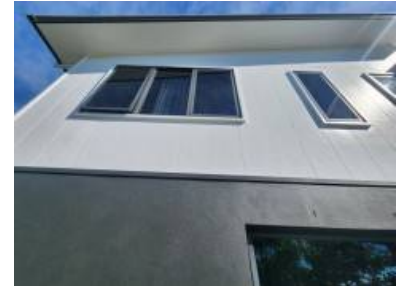
Condition:
The external paintwork / finish to the external surfaces and timberwork is generally satisfactory. There are some sections / areas that require touching up / repainting.

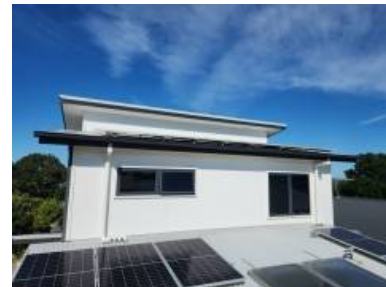
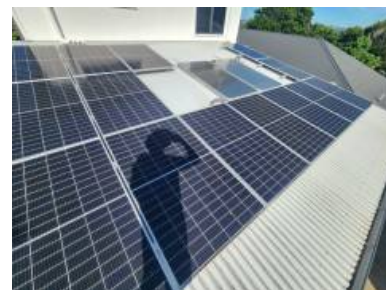
No Safe Access could be gained to the Top Level roof exterior from a 3.6m ladder. No inspection of the Top Level roof exterior could be carried out. See Terms & Conditions: Reasonable Access.

Solar Panels are present to the Roof Exterior and restricted the inspection of the roofing material beneath. Concealed damage may be present but not identified in the report. A Solar Hot Water System is present to the Roof Exterior and restricted the inspection of the roofing material beneath. Concealed damage may be present but not identified in the report.

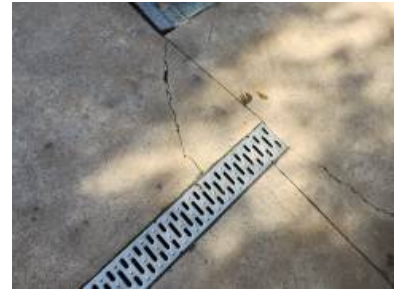
Some surface cracks to concrete slabs.
