# Building and Pest Report

## 6 Isabella Drive Skennars Head

| Inspection Date: | 23 Mar 2026 |

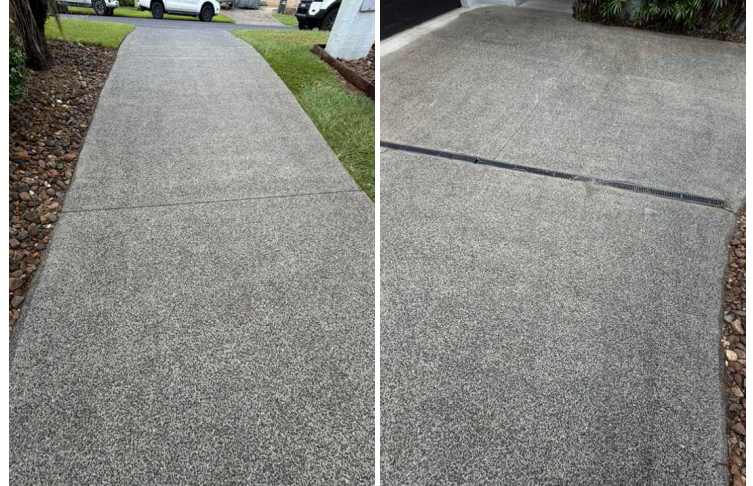
Common cracks were observed on the driveway. Whilst these cracks appeared to be typical at the time of inspection, we strongly recommend you monitor these cracks and if worsening occurs contact a concreter for further advice.

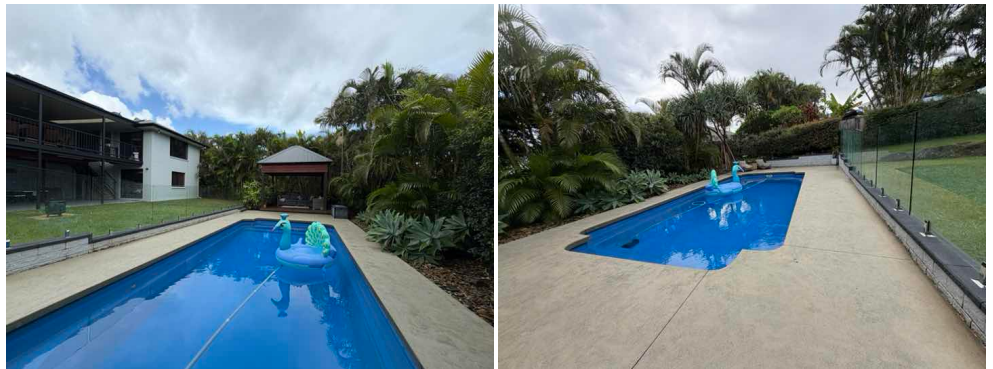
Pool fence and signage were sighted.  
The appropriate warning signs do not appear to be present. You should check with your local council regarding the required signs.

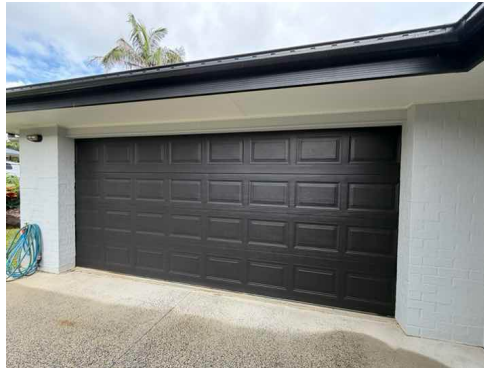
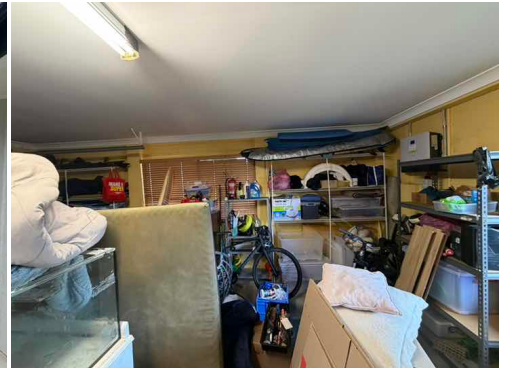
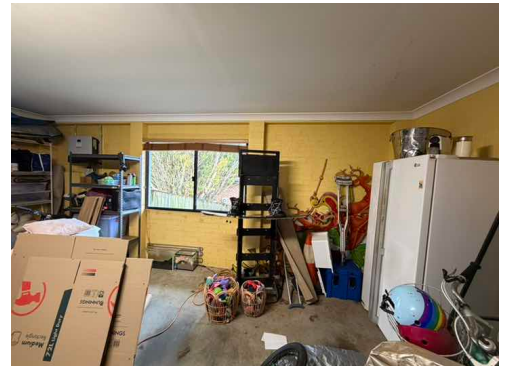
There appears to have been some settlement which has caused some cracking to the walls. These cracks are categorized as 0 to 2. This can also cause some doors to bind or be out of square. In the inspectors opinion these cracks are due to settlement, usually due to ground movement and subsequent movement to building materials can be expected. Any cracks should be monitored and if cracks increase in size, further investigation should be carried out by a structural engineer.

Settlement Cracks Noted . These are typical and generally patch and paint will suffice, however Monitoring these cracks advised for 12 months and if become wider or longer, you will need to contact a structural engineers to assess.

Storage restricted - Storage items restricted an entire internal inspection of the garage. Defects may exist once storage has been removed.

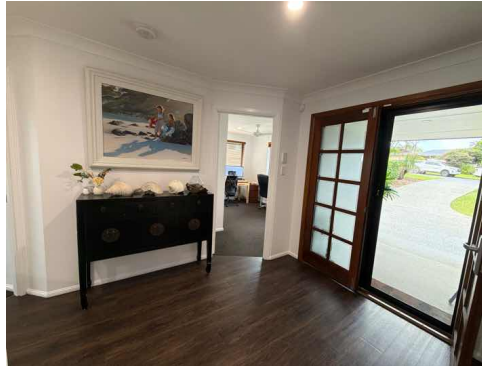
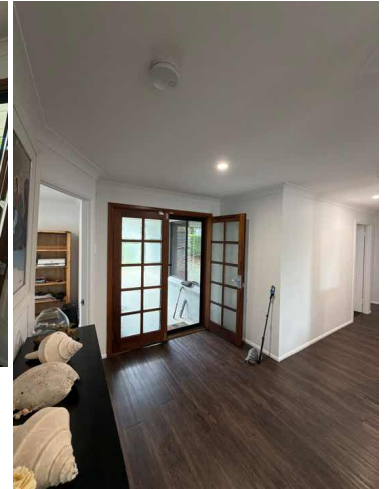
Impact damage to wall from door handle. Repairs and installation of a door stop recommended

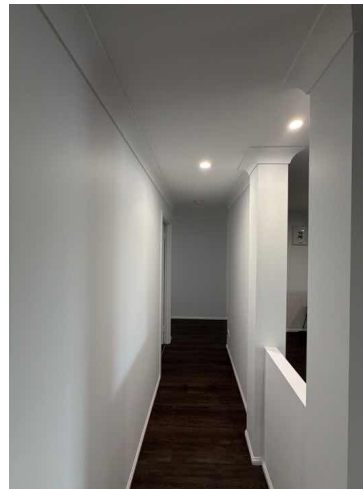
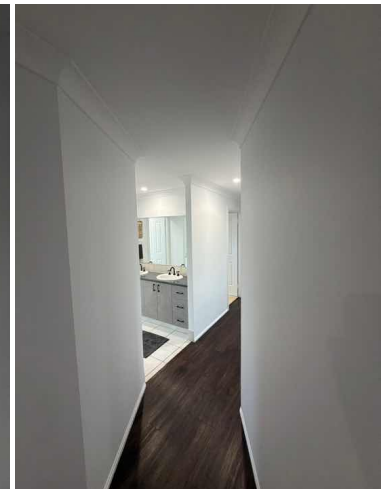
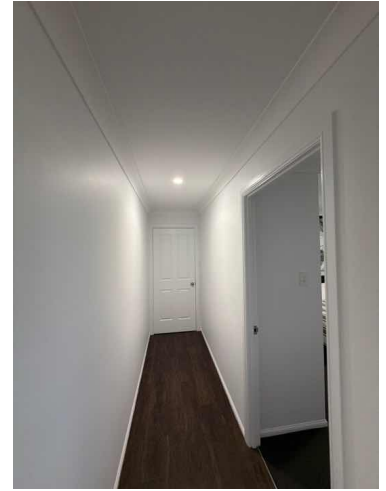
Settlement Cracks Noted. These are typical and generally patch and paint will suffice, however monitoring these cracks is advised for 12 months and if they become worse, further investigation by a suitably qualified professional is advised.

Typical cornice separation/detachment observed. I recommend you contact a qualified painter for repairs.

Nail popping observed to the ceiling lining. This is should be repaired as soon as possible by a qualified plasterer to avoid any unsafe conditions.

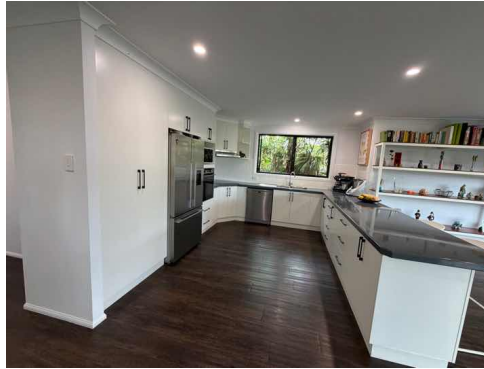
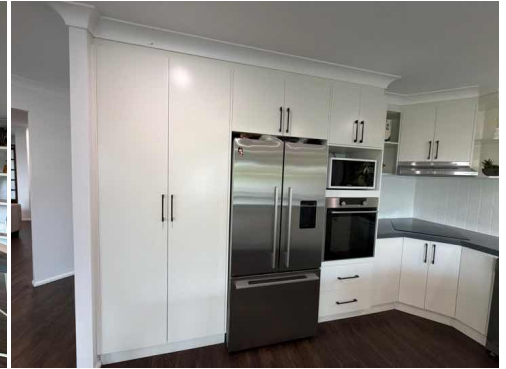
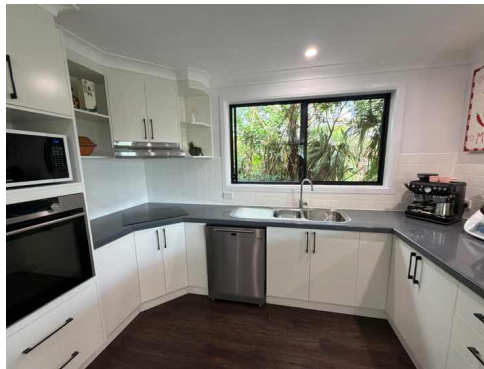
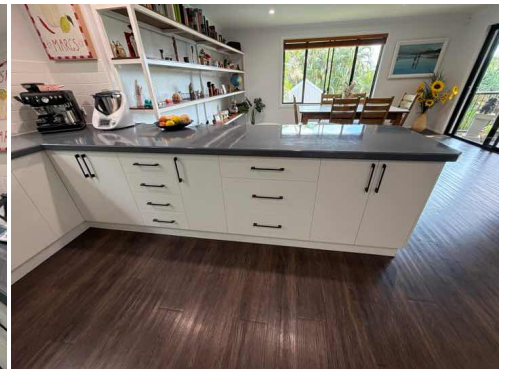
Adjustment to cabinet doors required, in some instance hinges may need to be replaced.
