Building and Pest Report

20A Killarney Cres Lennox Head

Pest And Building Inspection

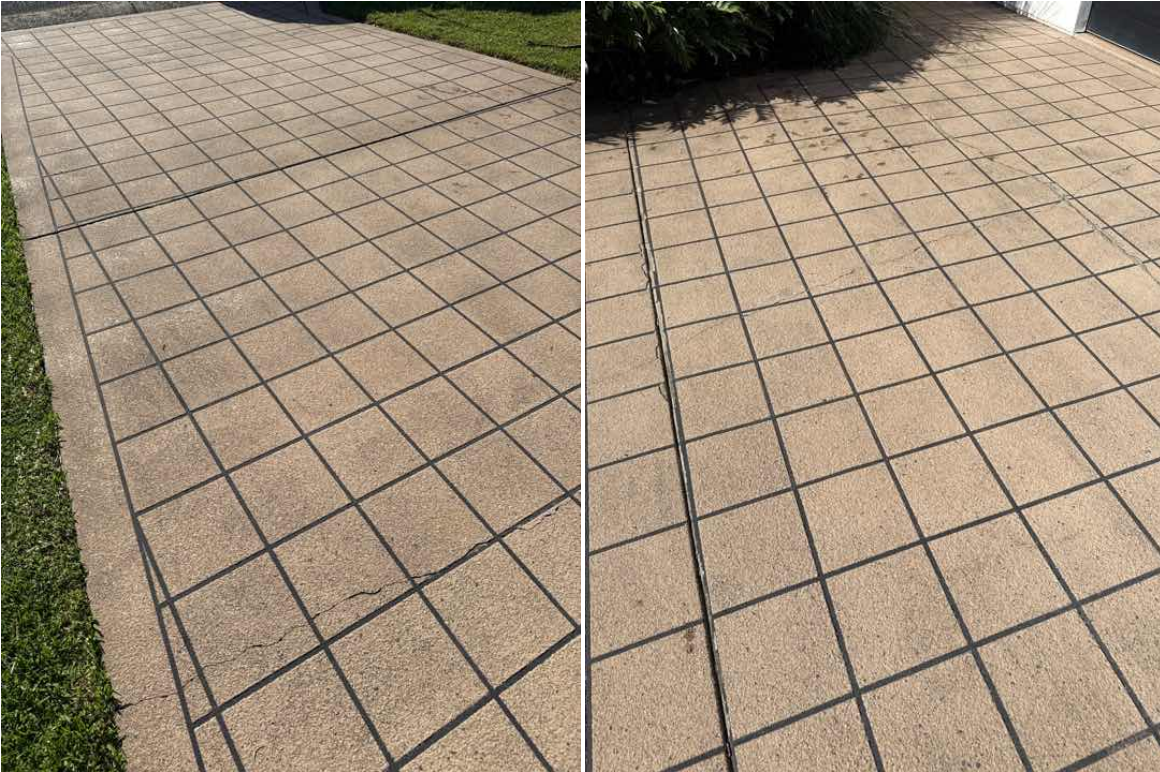
Common cracks were observed on the driveway. Whilst these cracks appeared to be typical at the time of inspection, we strongly recommend you monitor these cracks and if worsening occurs contact a concreter for further advice.

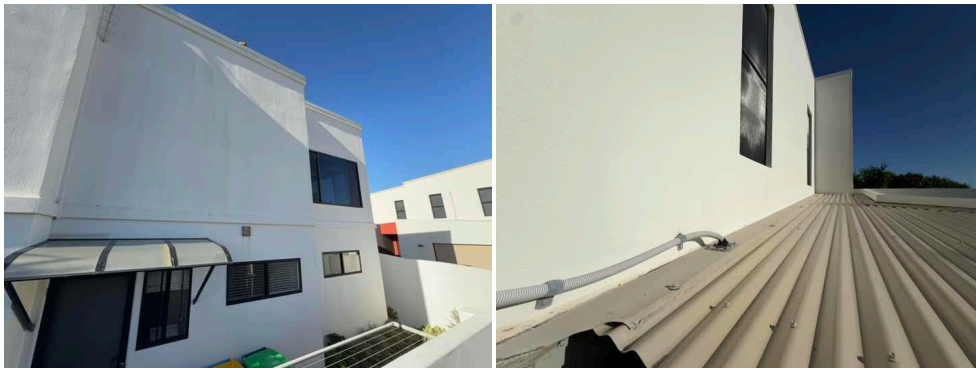
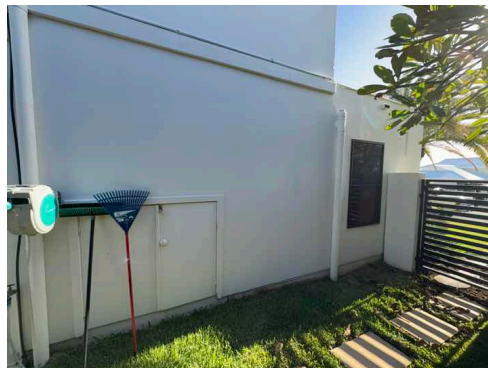
There appears to have been some settlement in the building which has caused some cracking to the walls. These cracks are categorized as 0 to 2. This can also cause some doors to bind or be out of square. In the inspectors opinion these cracks are due to settlement, usually due to ground movement and subsequent movement to building materials can be expected. Any cracks should be monitored and if cracks increase in size, further investigation should be carried out by a structural engineer.

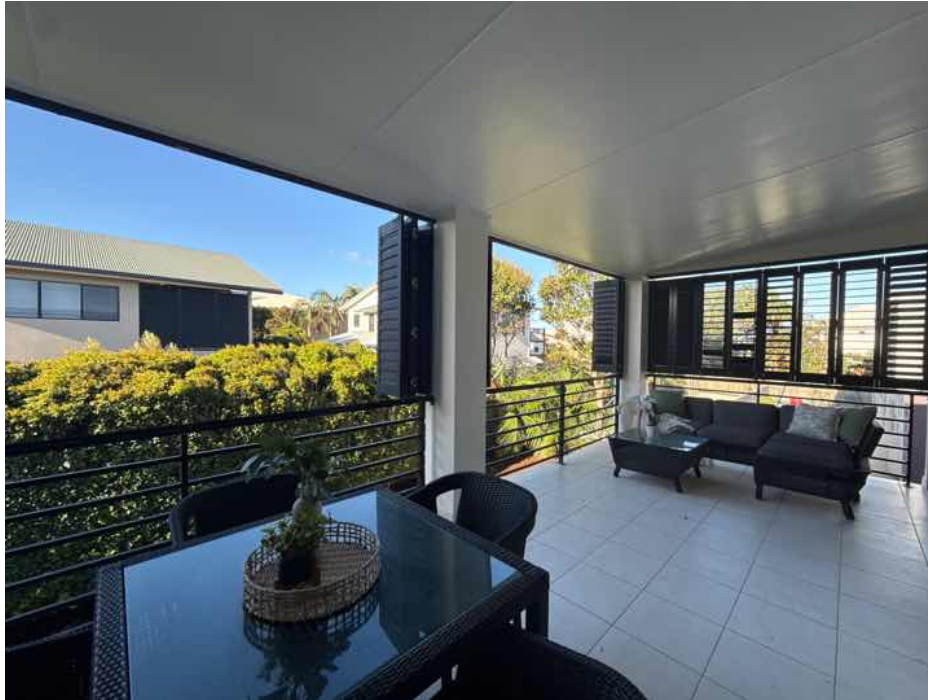
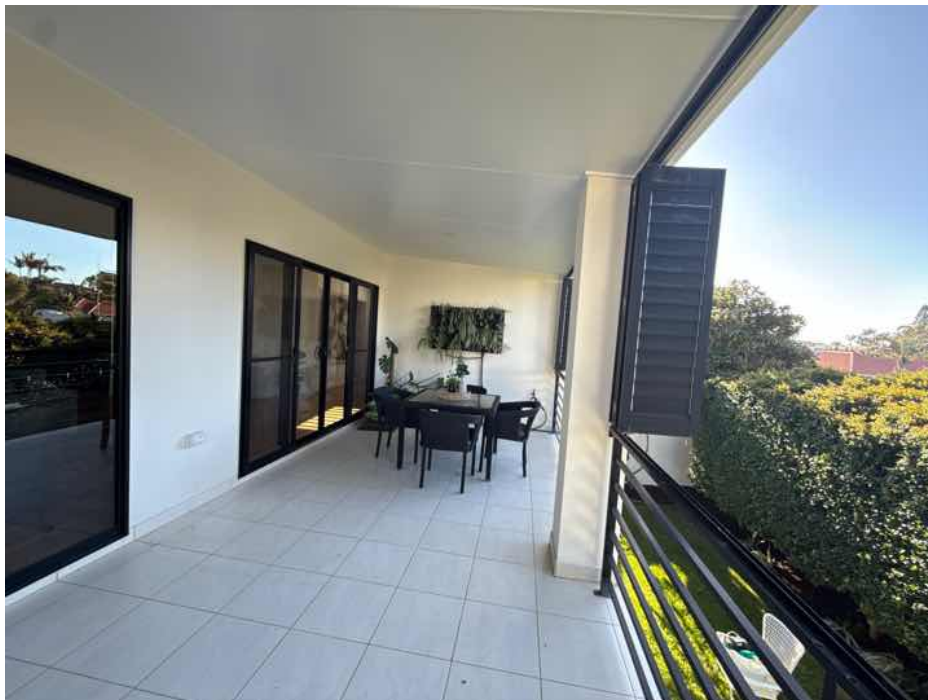
Upon visual inspection, wood rot was identified in the soffit timber trims. The affected areas show signs of decay, compromising structural integrity. It is recommended to remove and replace the damaged timber with treated wood to prevent future rot. Ensure proper sealing and painting to protect against moisture. Regular maintenance checks are advised to maintain the condition of the soffit trims.

Tile cracking observed. A qualified tiler should be engaged for advice and recommendations. This may cause leaking and water penetration.

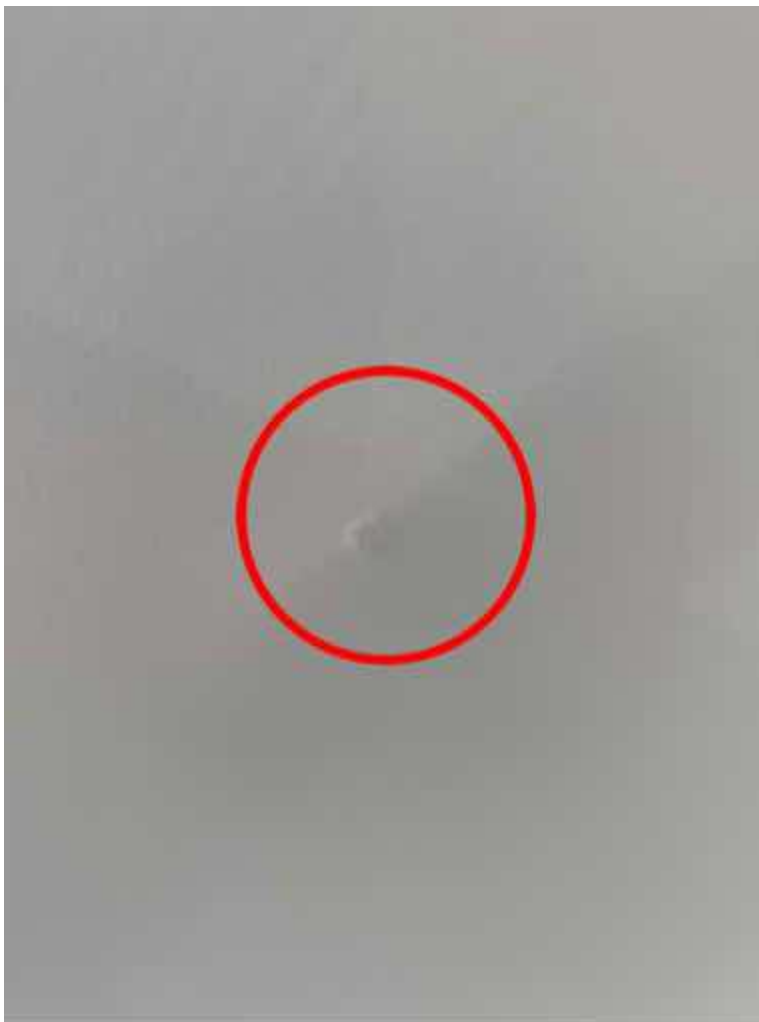
Nail popping observed to the ceiling lining. This should be repaired as soon as possible by a qualified plasterer to avoid any unsafe conditions.

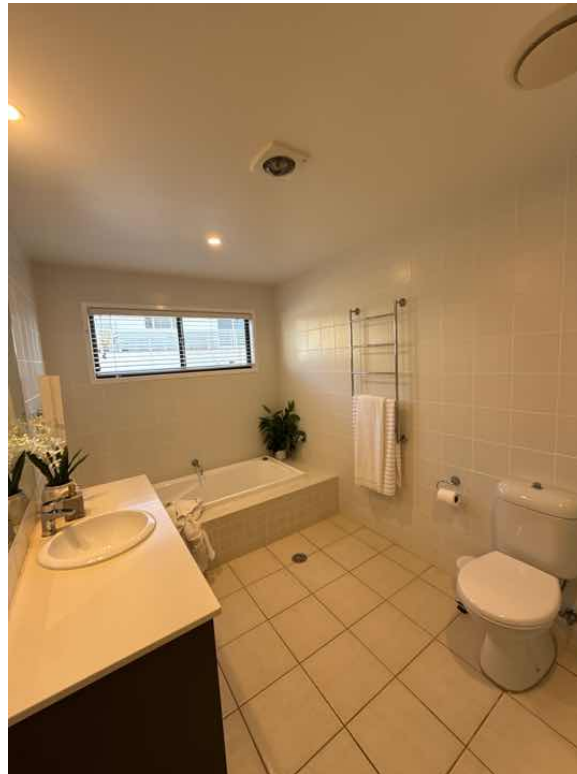
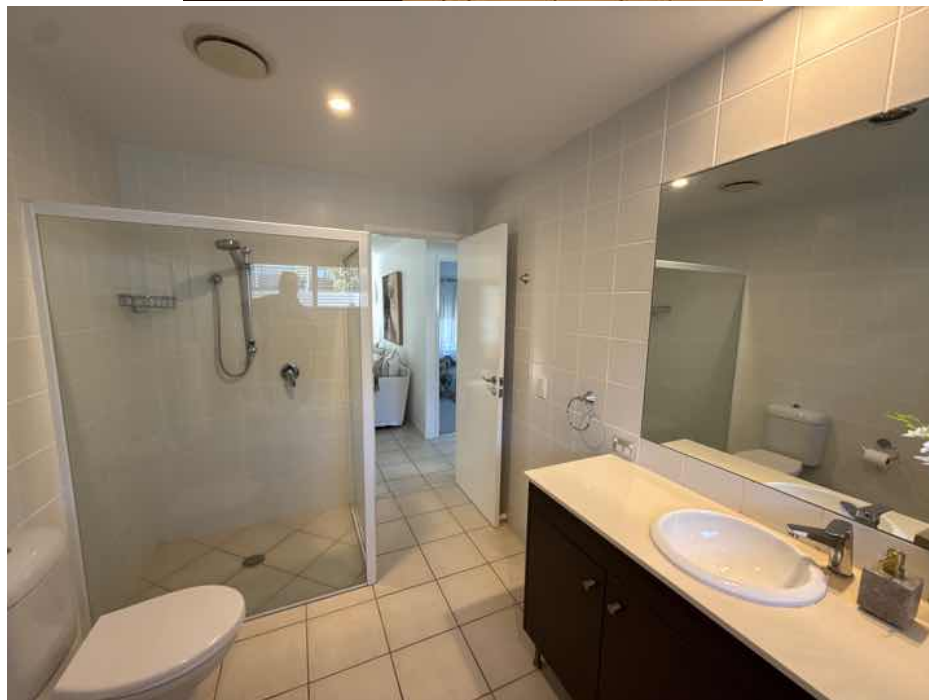
The cistern is leaking and should be repaired. Contact a qualified plumber for repairs.

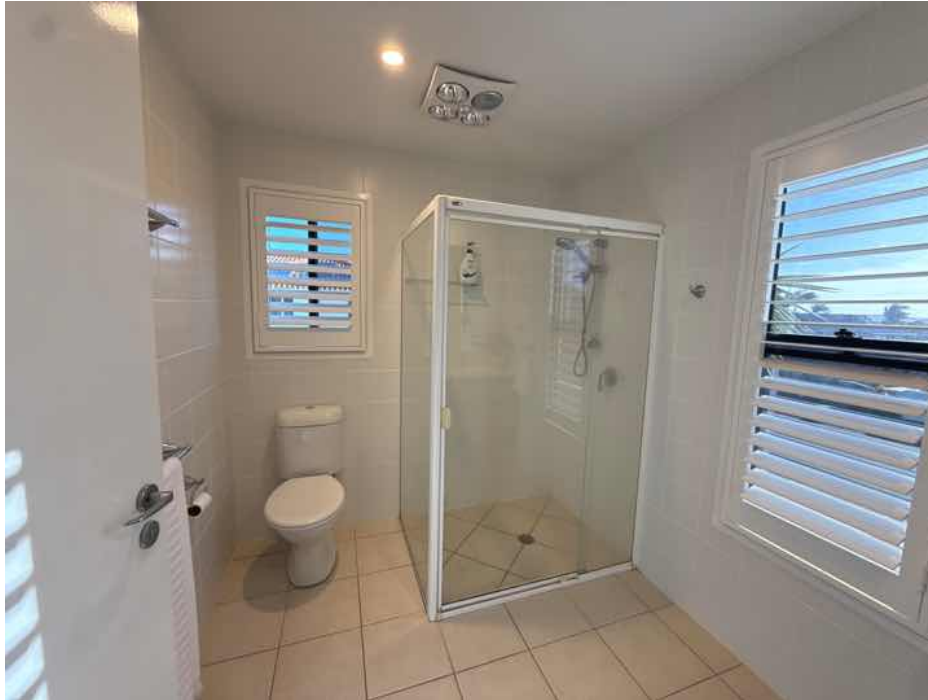
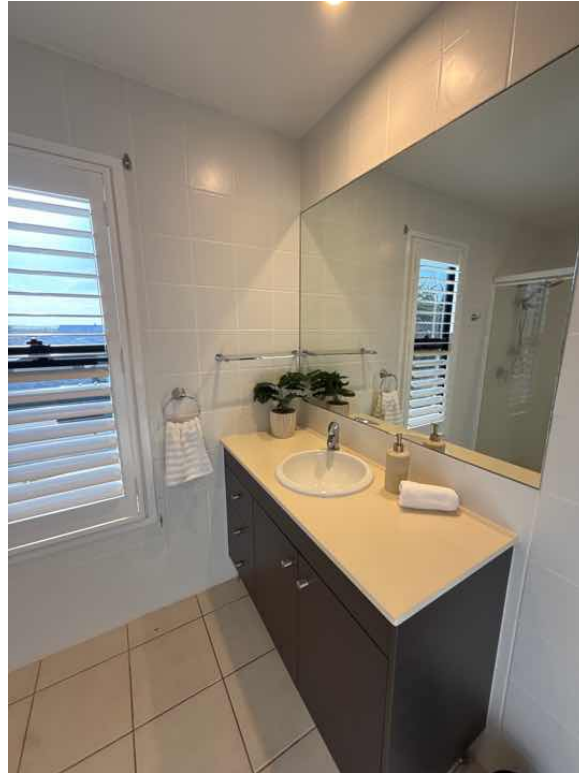
Silicone sealant has been applied to the interface of the floor and walls in the bathroom in an apparent attempt to prevent water penetration to surrounding areas. This method of repair can only be considered to be temporary. Further waterproofing may be necessary.

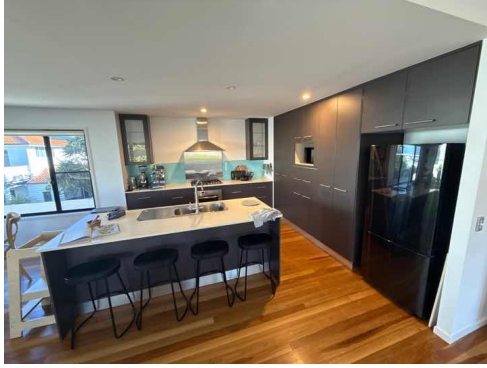
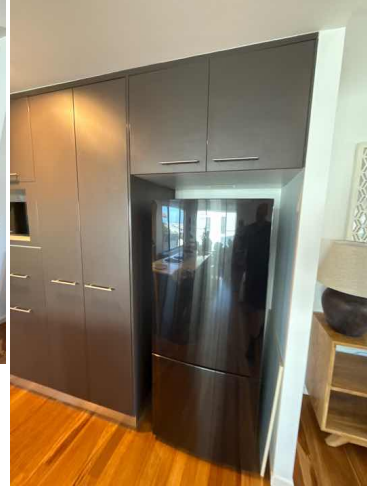
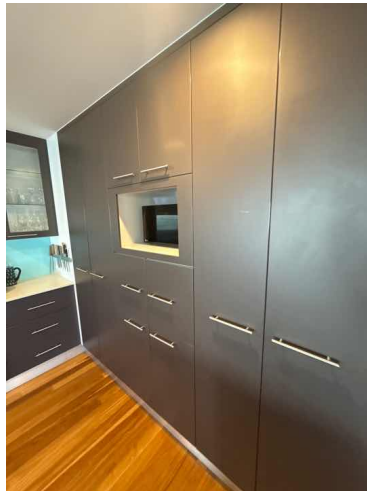
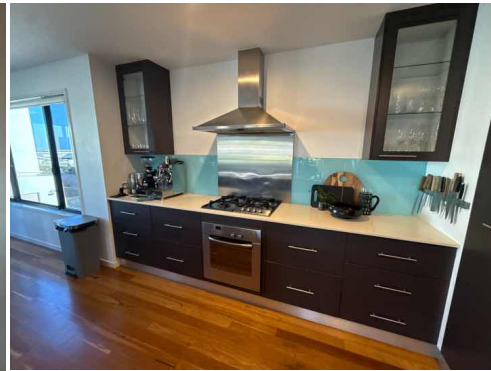
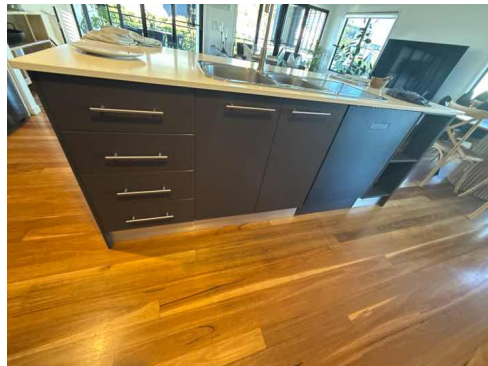
Adjustment to cabinet doors required, in some instance hinges may need to be replaced.

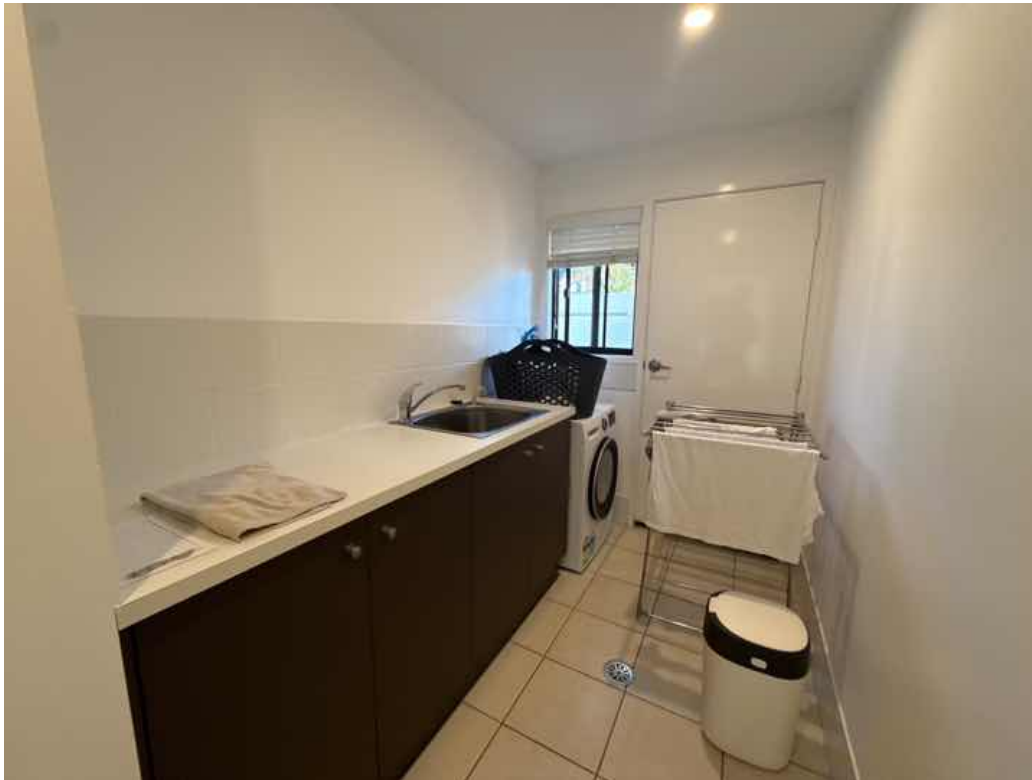
Incomplete Patch/Paint repairs noted. Call a qualified painter for repairs.

Drummy tiles noted. This needs to be repaired at the earliest as this has the potential to lead to many related issues such as damp, water ingress to other areas and cracked tiles. Contact a qualified tiler for repairs and recommendation.
