# PEST AND BUILDING PRE-PURCHASE REPORTS

# BPI BUILDING & PEST INSPECTIONS

29 Ibis Place  
Lennox Head

### **REPORT TABLE OF CONTENTS**

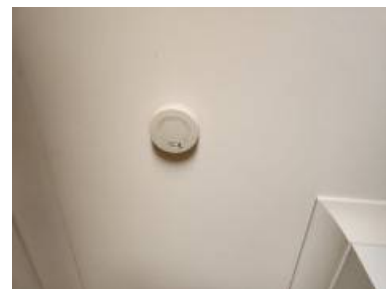
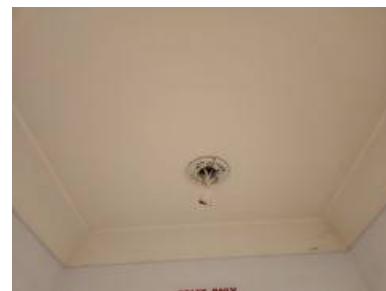
Present - Bed 1.

Missing to hallway at one end.

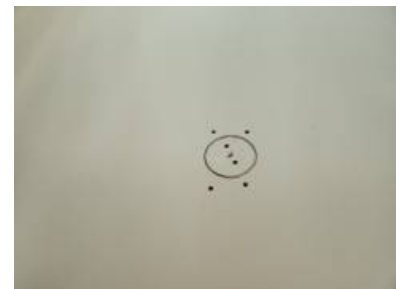
Some minor damage to ceiling sheeting requires touching up / repair / repainting.

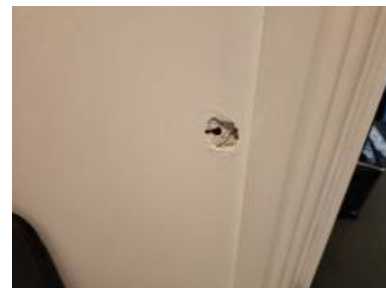
Hole behind door handle requires patching / painting.

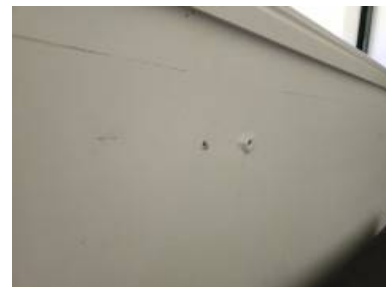
Some minor damage to wall sheeting requires touching up / repair / repainting.

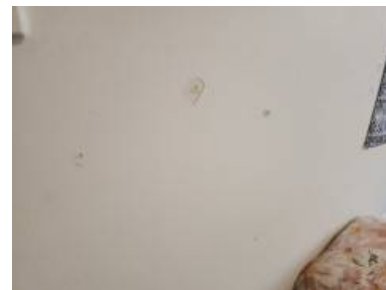
Some paintwork / walls require touching up / repainting.

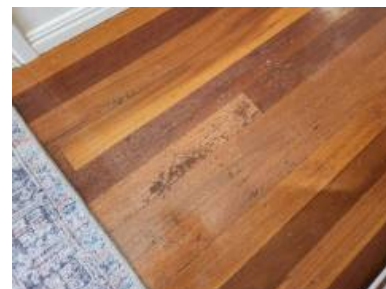
Polished timber floors show signs of wear.

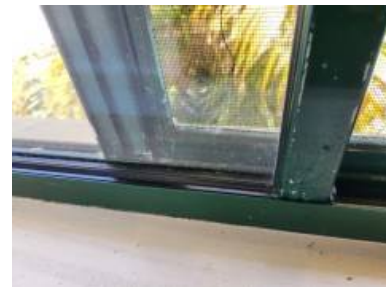
Various windows show evidence of minor corrosion and require maintenance / repair.

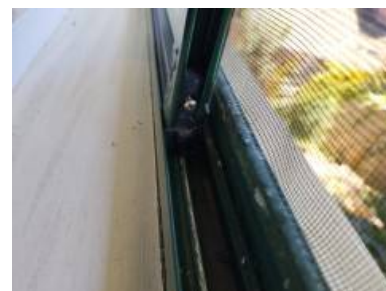
Various window slider rollers show signs of wear or are worn and require lubrication / replacement.

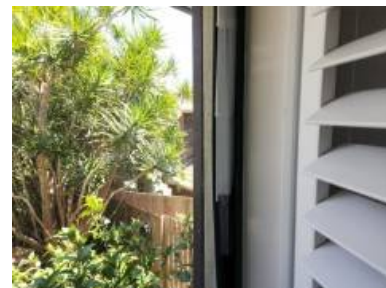
Present, Some screens require repair.

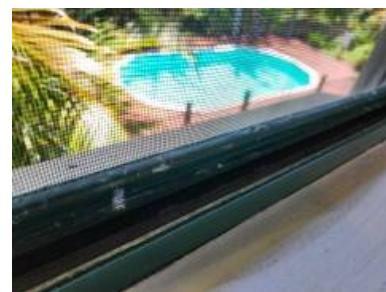
Corrosion to some fly screen frames.

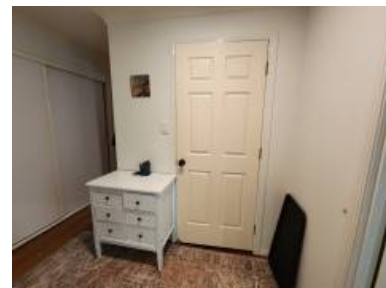
Front door is binding and requires repair / easing / adjustment.

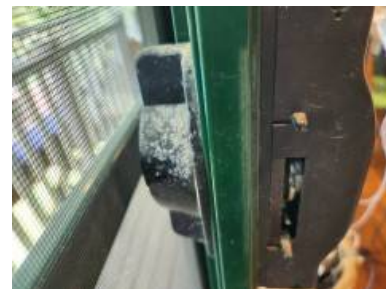
Signs of corrosion to some external door handles.

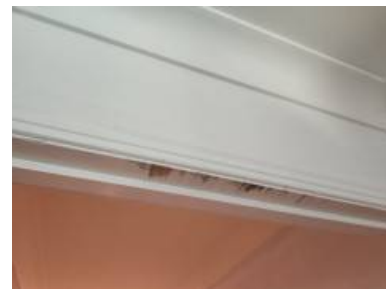
Paintwork to some door frames requires touching up / repainting.

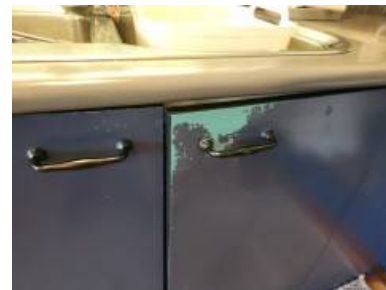
The Kitchen cabinetry / bench tops / laminate show evidence of general wear & scratches.

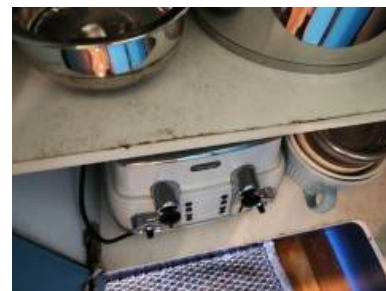
The Kitchen cabinetry / bench tops / laminate show evidence of general wear & scratches.

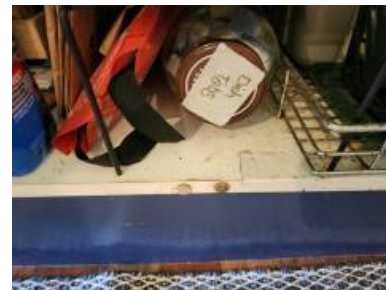
Evidence of past water penetration to sink cupboard.

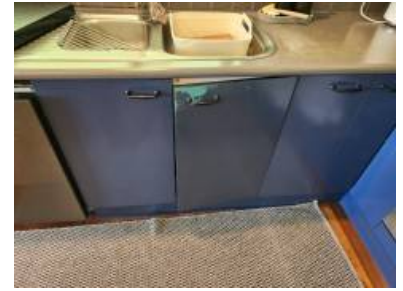
Some doors require adjustment.

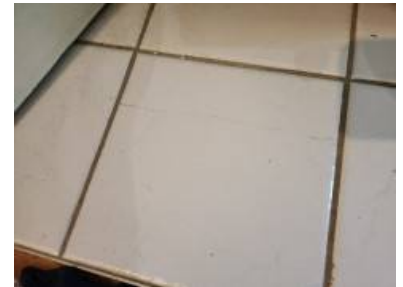
Hairline cracks to some floor tiles to Laundry.

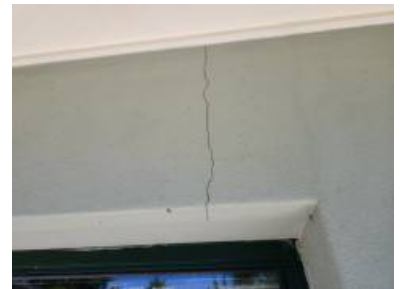
Minor crack to some render above garage window.

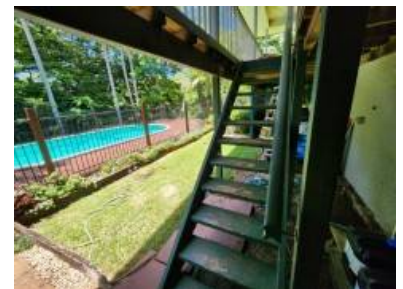
**Condition:**  
The handrail & balustrades do not comply with current BCA standards however, they may comply with the date of construction. Although this report does not generally comment on items of compliance, this issue may become a safety issue / fall hazard and therefore was included in this report. We recommend you further investigate this matter and upgrade if / where necessary.

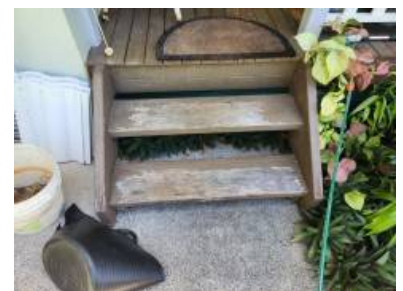
Some stair stringers, treads, posts & rails show signs of weather damage / decay and require repair / resealing.

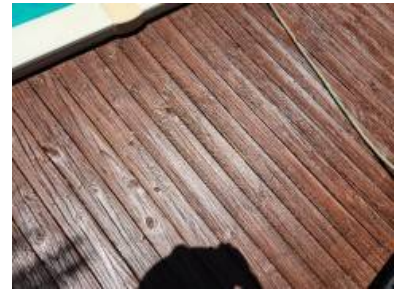
Some verandah decking & framing timbers around pool show signs of weather damage / decay and require repair in the future as its it gets worse.

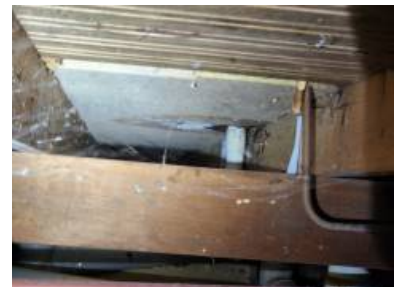
Some flooring shows signs of past water damage around bath waste. Waste pipe may be loose and need tightening.

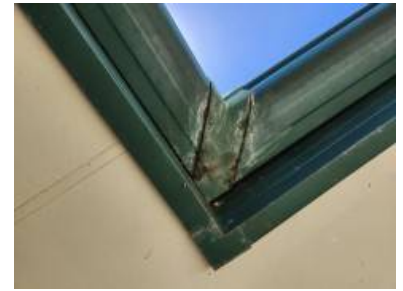
Some gutter and downpipe joins are leaking and require re-sealing.

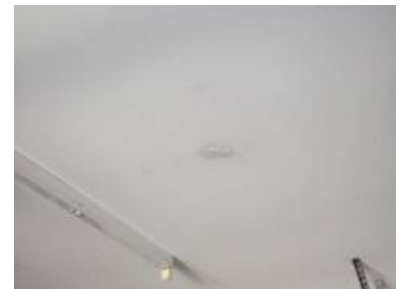
Some minor damage to ceiling needs touching up and repainting.

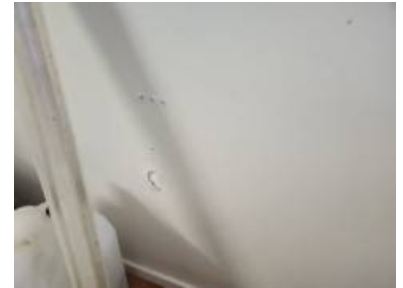
Minor damage to some walls.

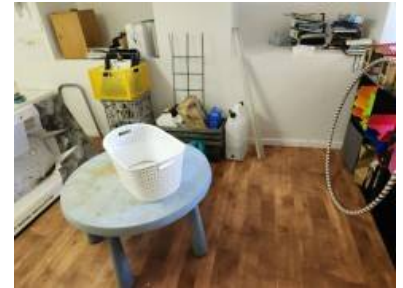
Rooms below ground level will be subject to dampness.

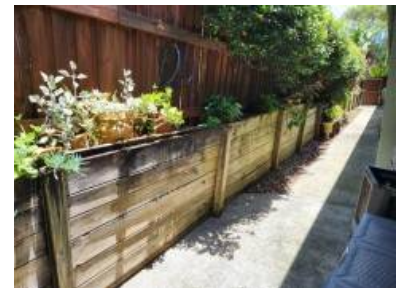
The timber retaining wall shows signs of some movement & weather damage / decay and require some maintenance / rectification. The retaining walls will require further rectification work / replacement at some stage in the future as timbers decay further. I strongly recommend that an appropriately qualified tradesman be engaged for further investigation and to quote the cost of rectification (if required) prior to making a purchase decision.

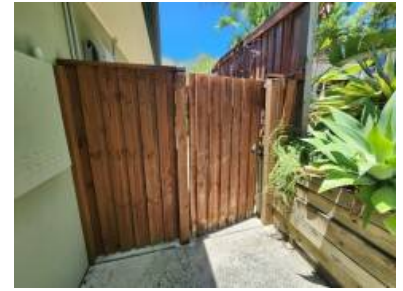
Gate at W side requires repair / adjustment / refixing. South.

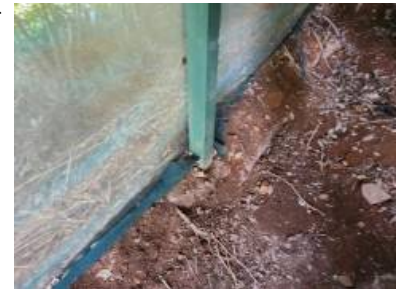
- Some external timbers to the Building are in contact with the ground / soil. Timber to ground contact may allow concealed termite entry / attack. The situation should be modified so that timber to soil contact does not occur (by creating a 75mm visual barrier) or have them treated with termiticide
