# Building and Pest Report

## 54 Beacon Road, Teven

# Inspection Report

**54 Beacon Rd, Teven, NSW, 2478**

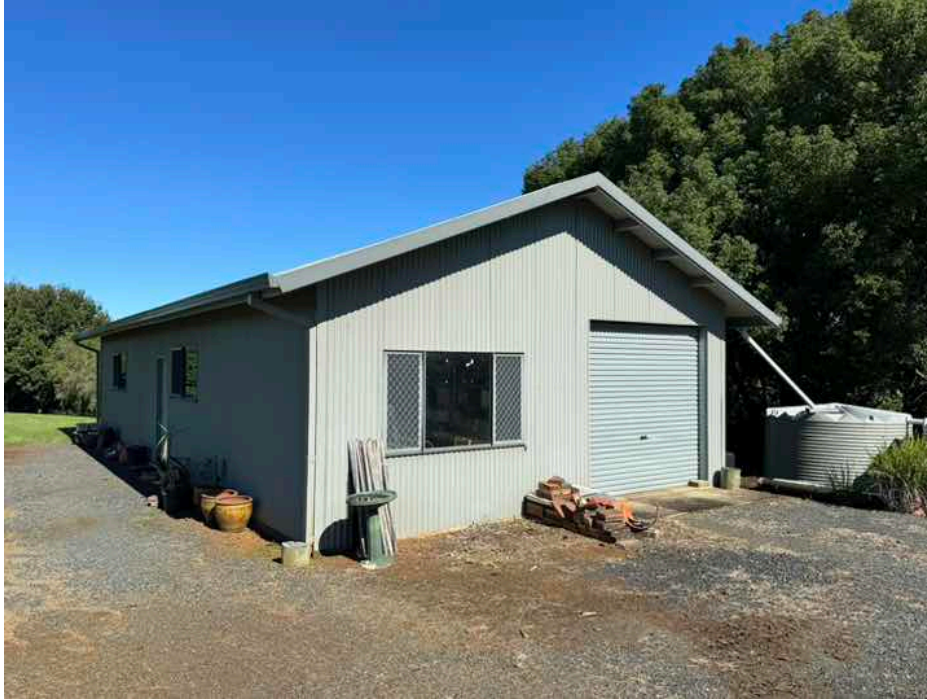
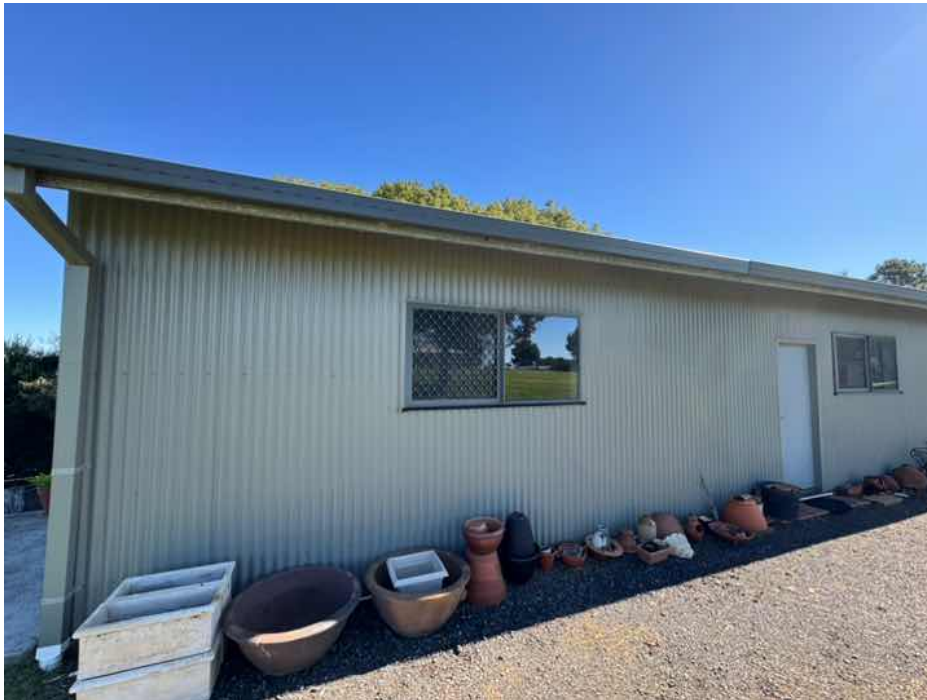
The shed is in fair usable condition.

Surface rust on the ends of some parts of the shed.

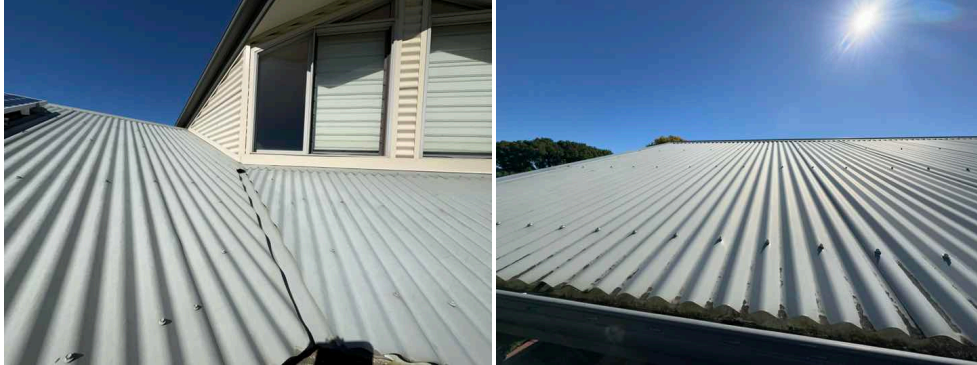
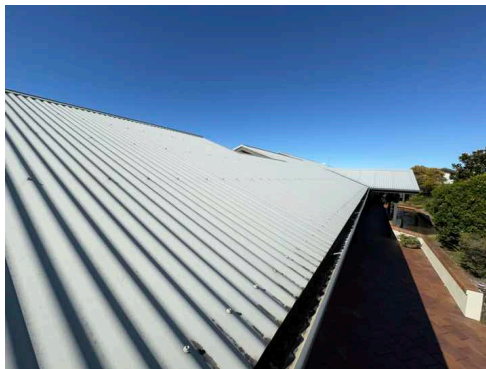
Of the visible areas, the general condition of the roof is in serviceable condition for the age.

Visible section of The roof cladding appeared in a serviceable condition for the age of this dwelling. Annual maintenance inspection recommended.

Corrosion noted to the screw fixings of the metal roof. Have these checked and replaced by qualified roofing contractor.

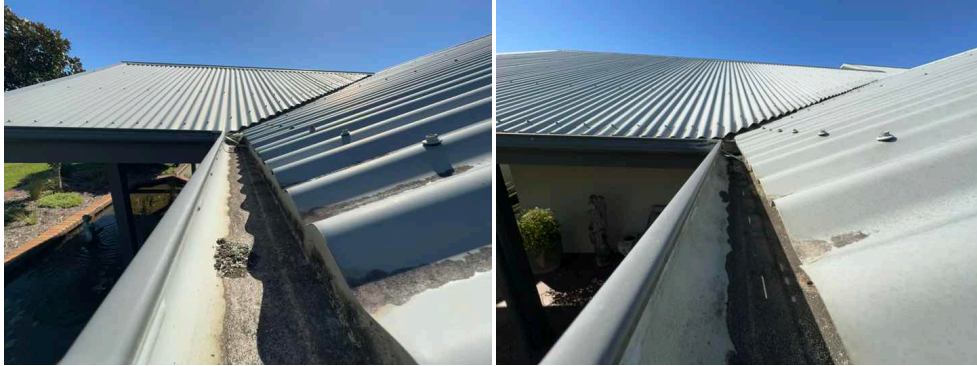
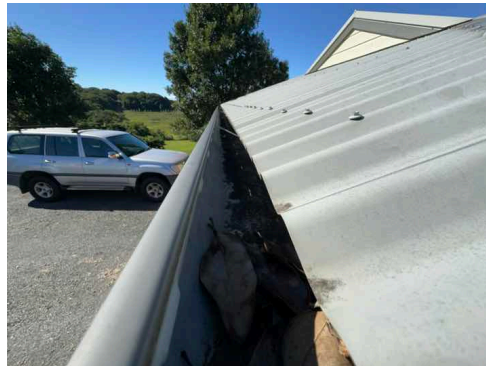
Debris in guttering areas- this requires cleaning out to prevent blocking of downpipes and leaking into eaves and fascia. Have gutters cleaned and assessed by a plumber for adequate fall. Regularly clean to prevent ponding. Ponding water will contribute to rust.

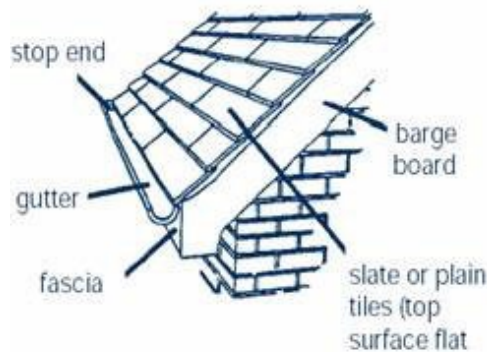
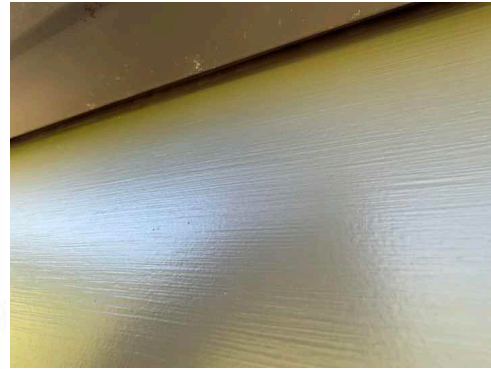
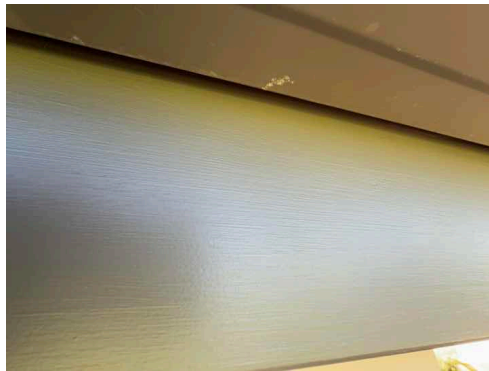
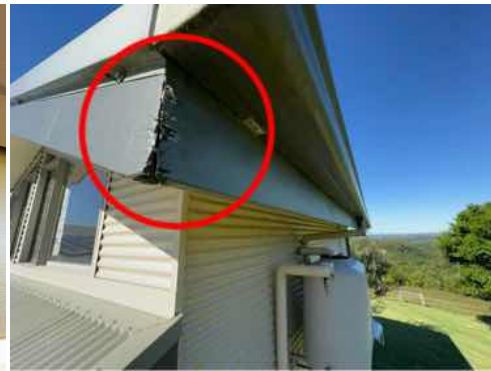
Timber fungal decay (rot) visible. Recommendations: A qualified carpenter should be engaged to replace all affected timbers.

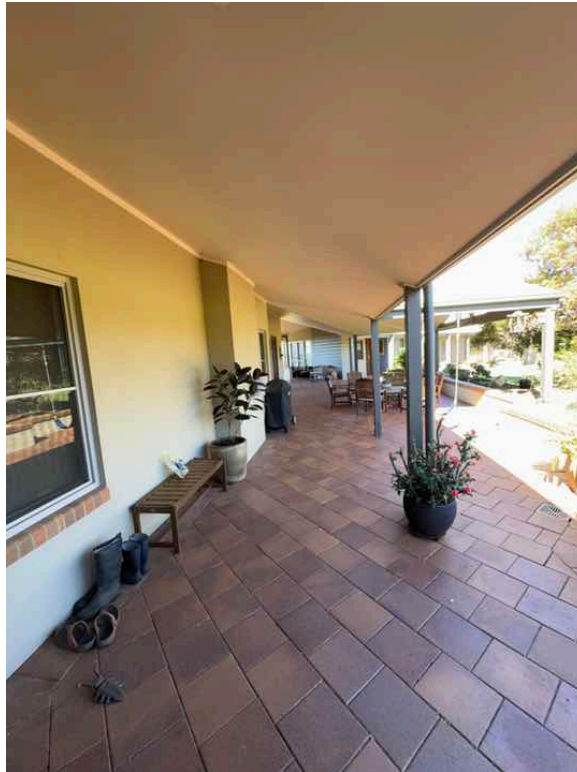
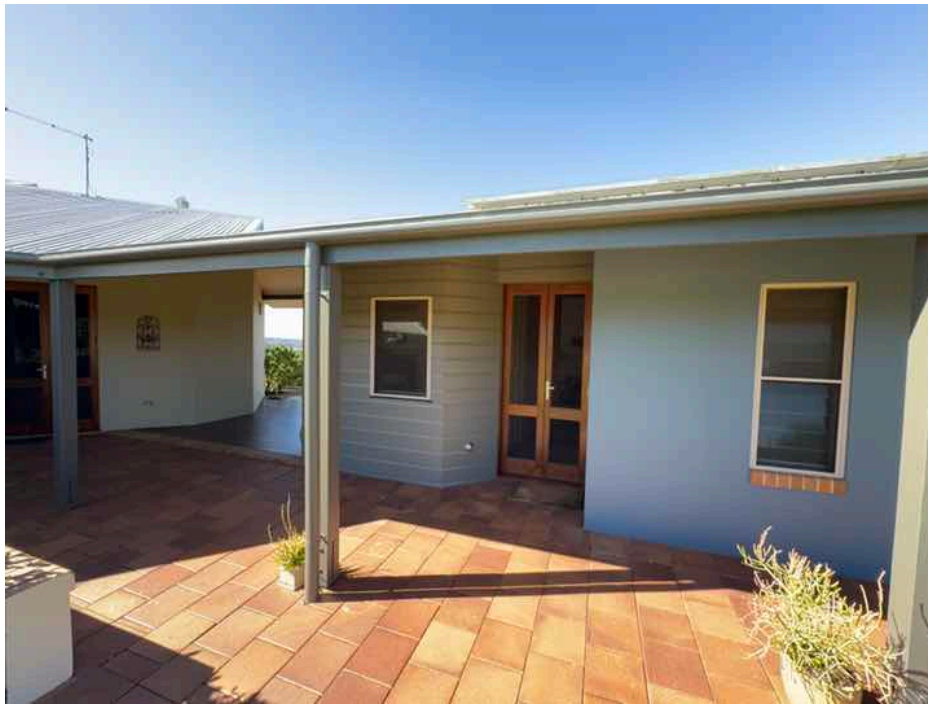
Minor cornice cracks. I recommend you contact a qualified painter for repairs.

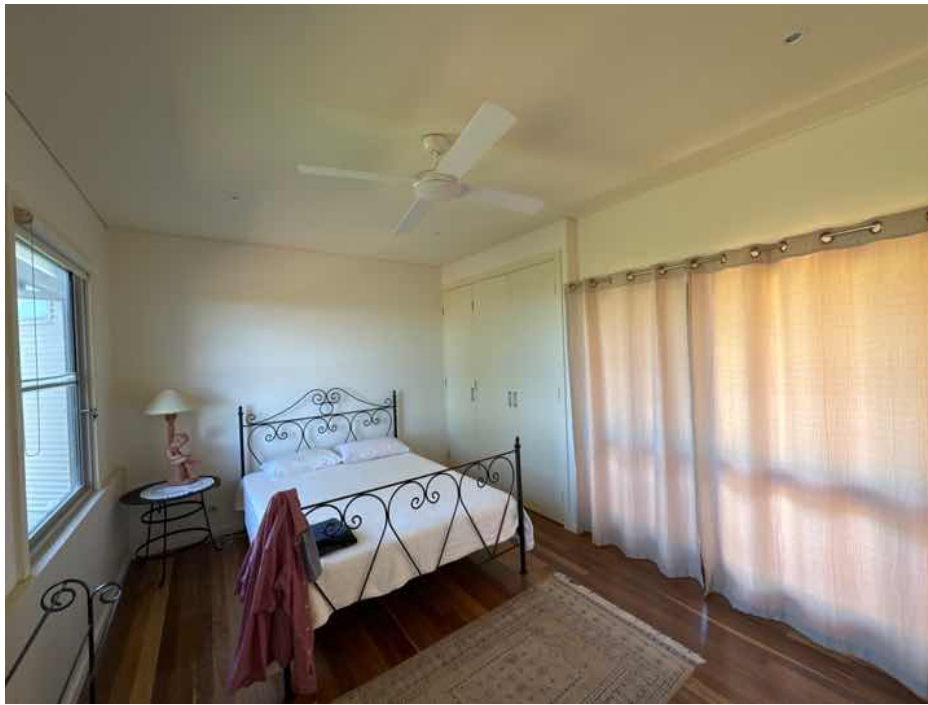
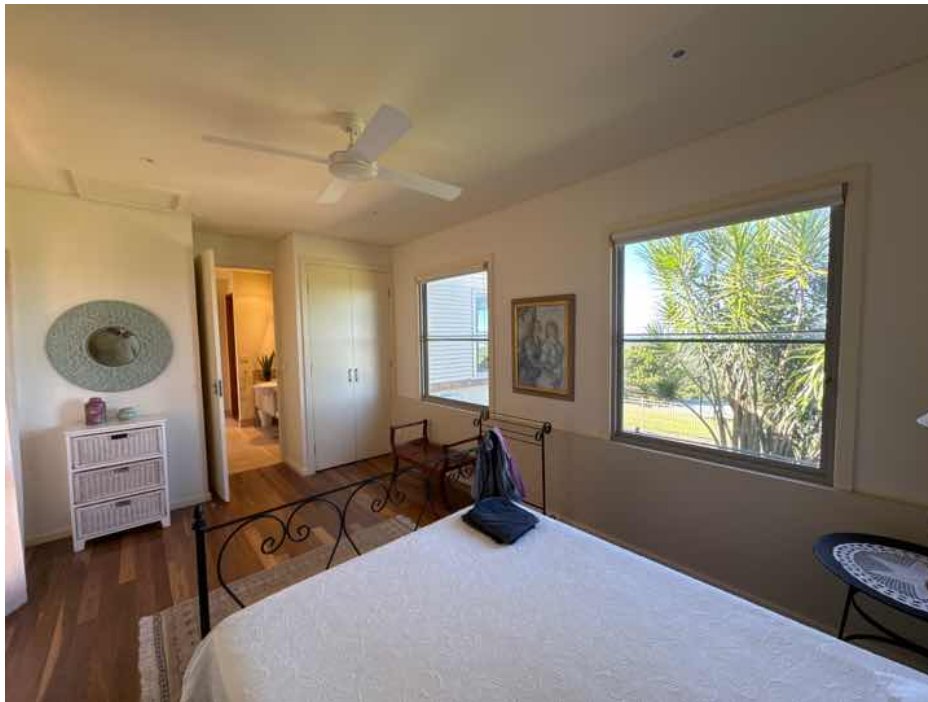
Settlement Cracks Noted. These are typical and generally patch and paint will suffice, however monitoring these cracks is advised for 12 months and if they become worse, further investigation by a suitably qualified professional is advised.

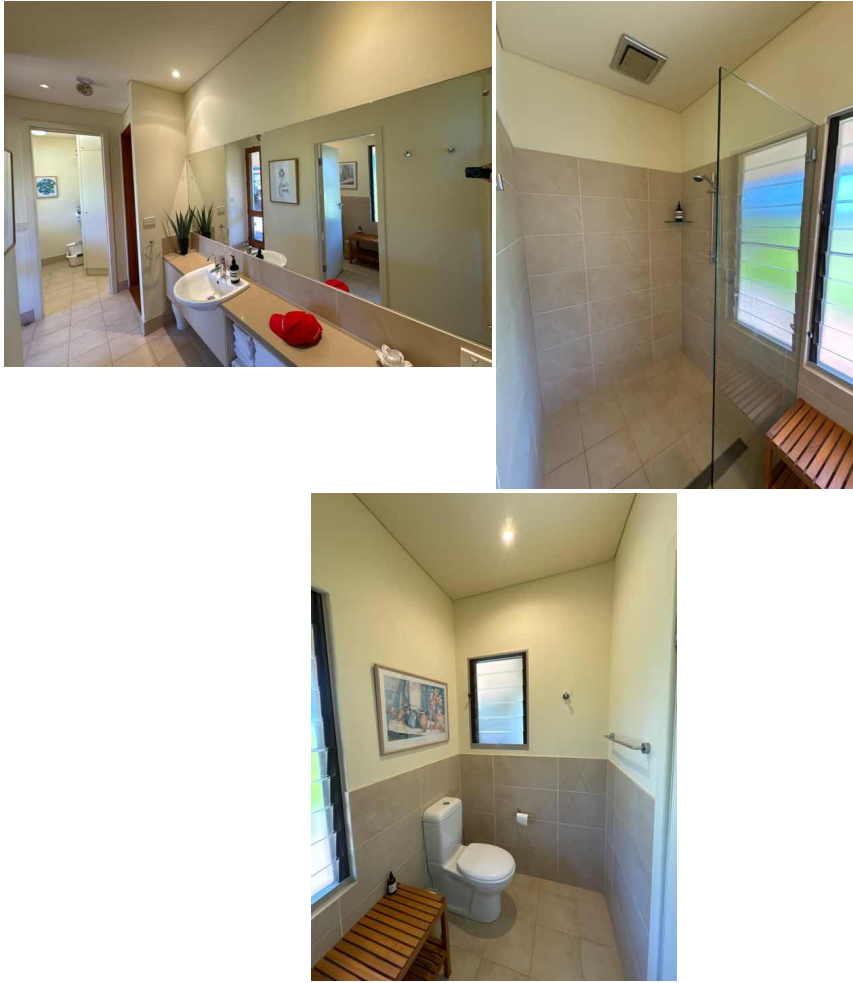
Settlement Cracks Noted . These are typical and generally patch and paint will suffice, however Monitoring these cracks advised for 12 months and if become wider or longer, you will need to contact a structural engineers to assess.

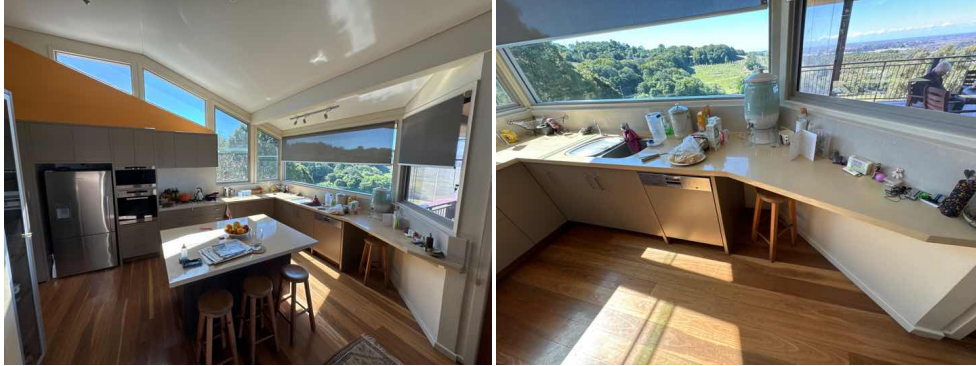
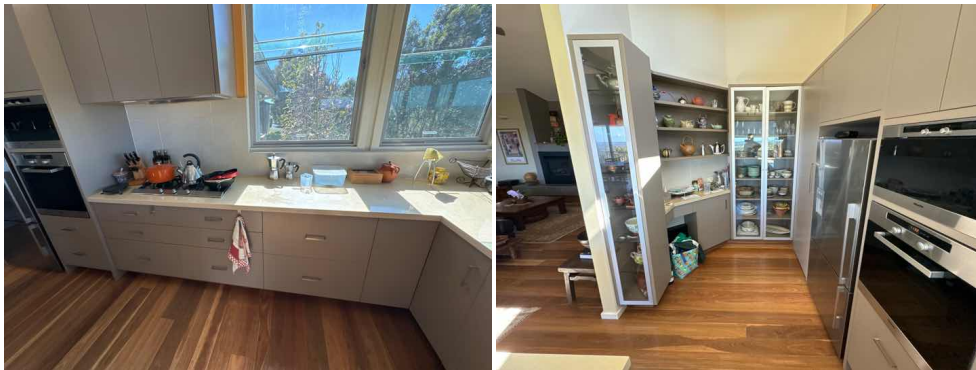
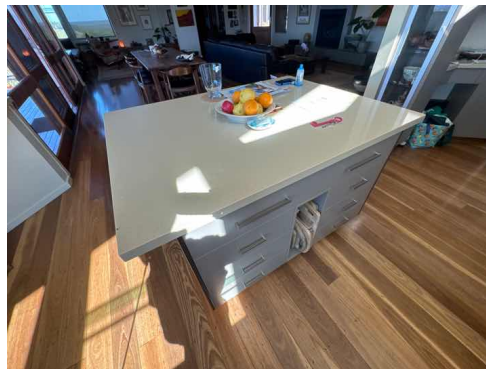
Minor cornice cracks - Minor cornice cracks visible. Recommendations: I recommend you contact a licensed plasterer for further advice and recommendations.

Adjustment to cabinet doors required, in some instance hinges may need to be replaced.

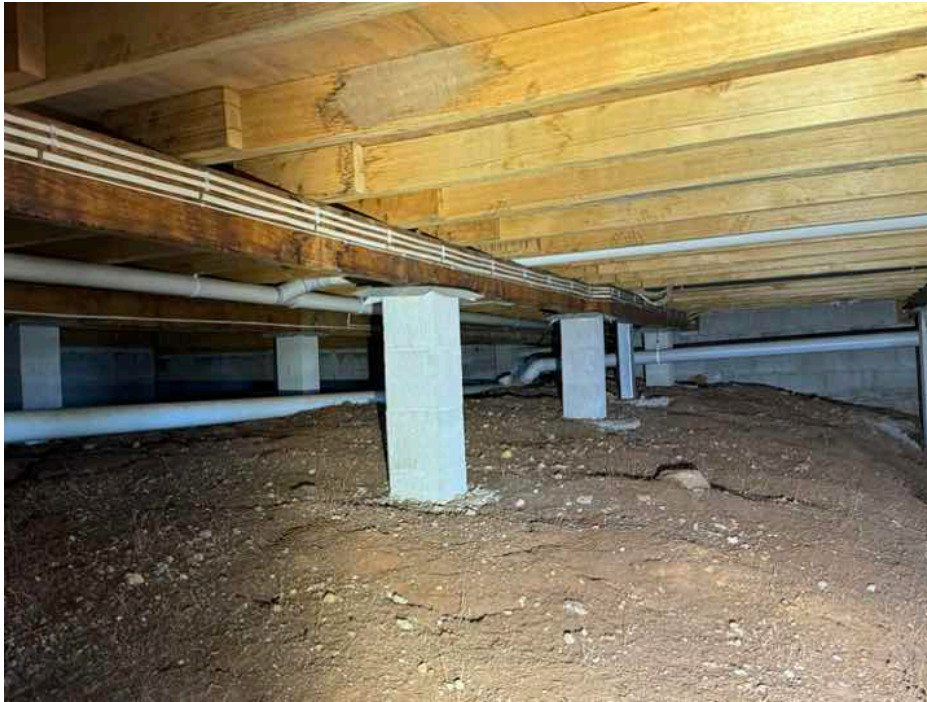
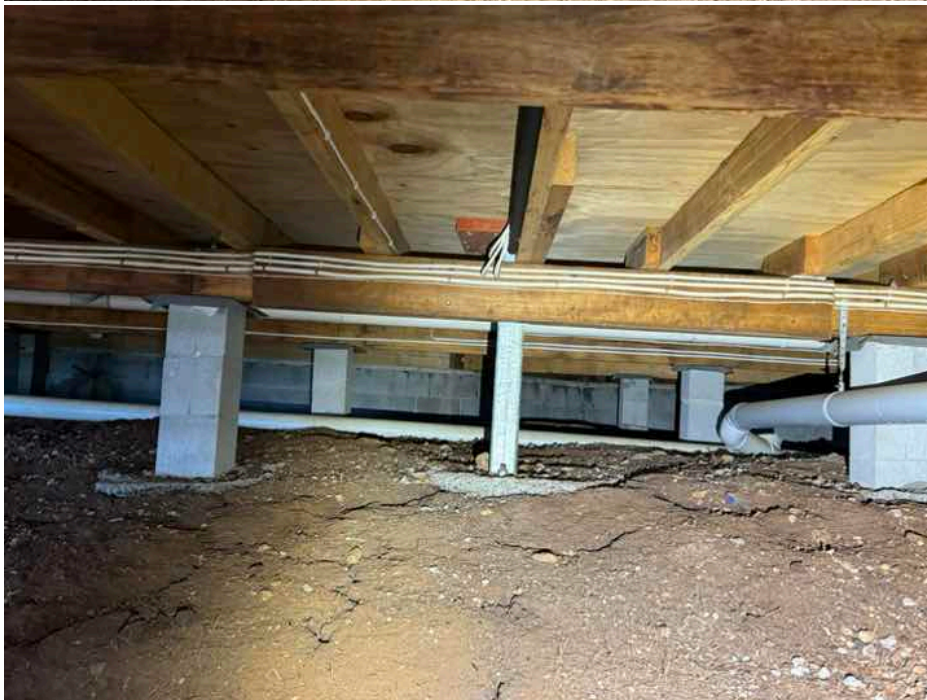
Timber fungal decay evident in end of bearers. A qualified carpenter should be engaged for advice and recommendations.
