# PEST AND BUILDING PRE-PURCHASE REPORTS

# BPI BUILDING & PEST INSPECTIONS

137 Stewart Street  
Clunes

# BPI - INSPECTION REPORT

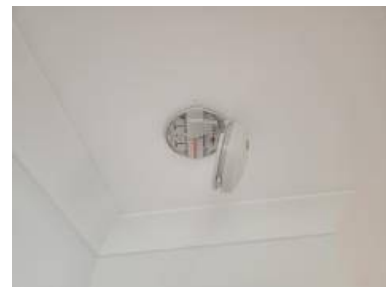
Present - Hall, (new backup battery required)

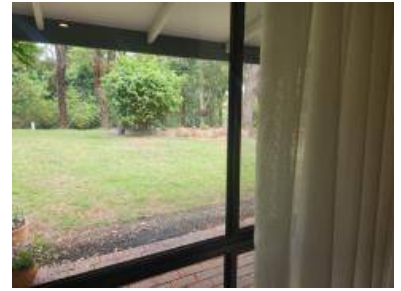
New slider cliplocks required to some windows.

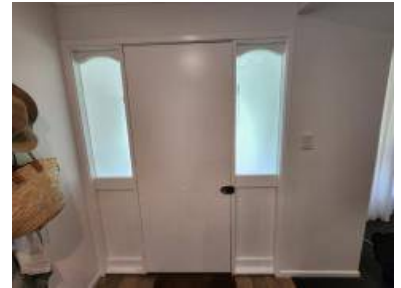
Front and master bedroom doors are binding and require repair / easing / adjustment.

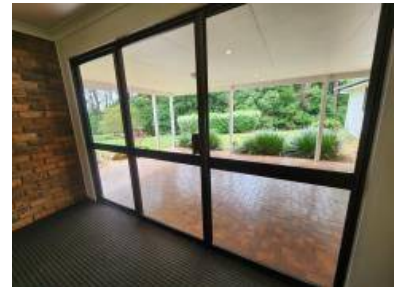
Some external slider rollers show signs of wear or are worn and require lubrication / replacement.

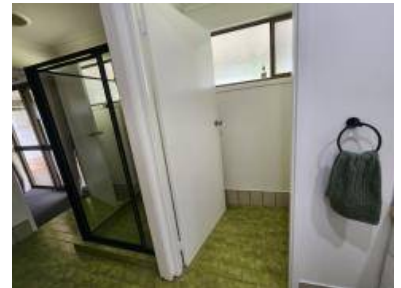
No lift off hinges present to the toilet door. This may comply with the date of construction however, this is a safety issue and therefore was included in this report. We recommend the installation of lift off hinges.

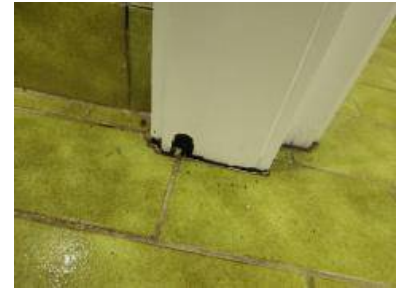
Base of the bathroom door frame shows signs of past water penetration / damage and requires repair / repainting.

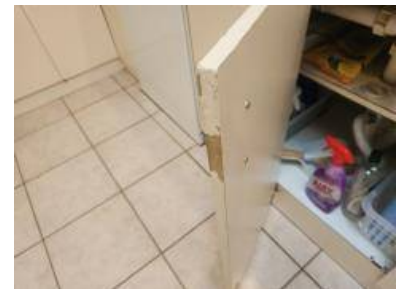
Some edge stripping laminate is damaged / peeling.

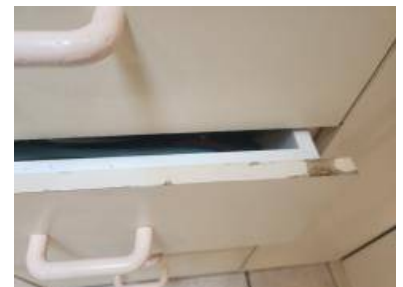
The Kitchen cabinetry / bench tops / laminate show evidence of general wear & scratches.

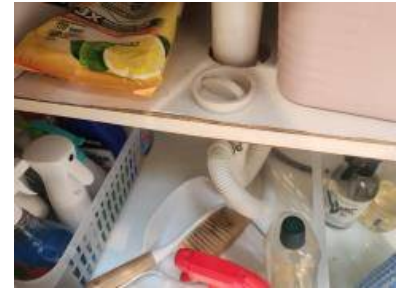
Evidence of water penetration to sink cupboard & shelving below sink.

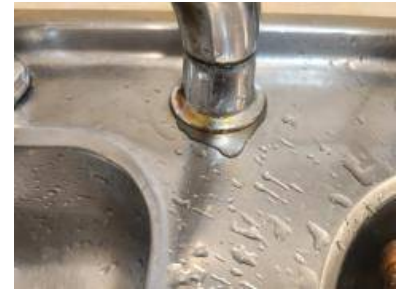
Leak to tap. It is recommended that a licensed plumber be engaged to inspection / rectification.

Signs of leak to Kitchen tap.

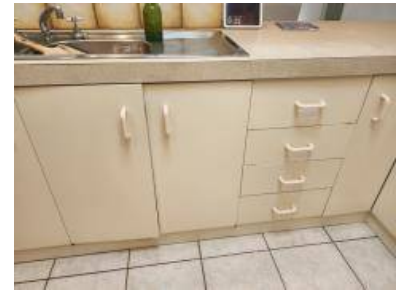
Some doors and drawers require adjustment.

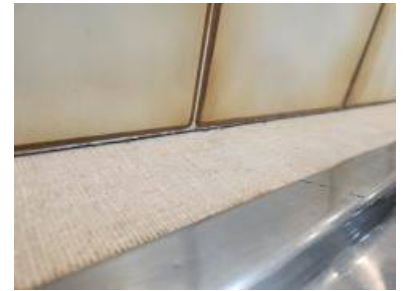
Junctions of bench tops and splashback tiles require resealing with silicone.

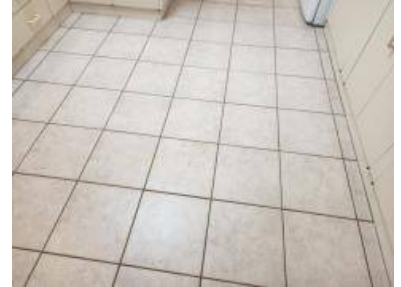
Some drummy floor tiles. Floor tiles become drummy due to the loss of adhesion to the underside of the tiles and may become loose or cracked. I recommend that a qualified tiler be engaged for further inspection / advice.

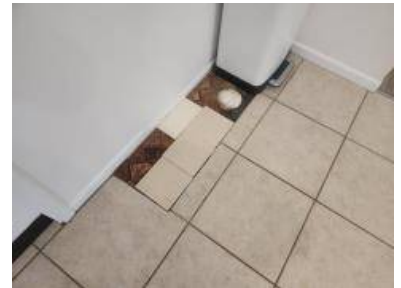
Some tiles are missing and require installation.

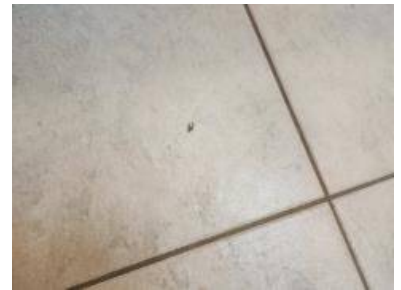
Percussion chips to some floor tiles.

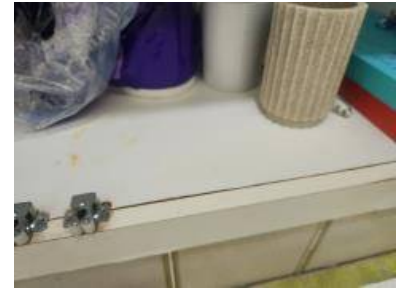
Signs of past water damage to Bathroom vanity cabinet.

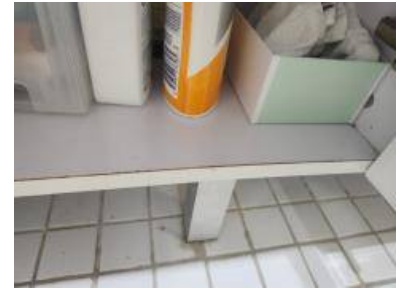
Signs of past water damage to the Ensuite vanity cabinet.

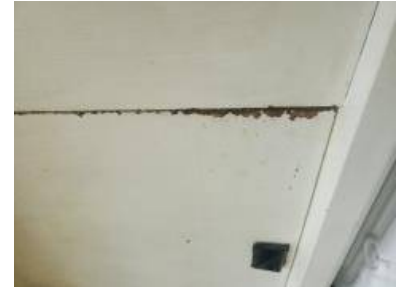
Laundry tub cabinet shows signs of rust and requires repair / painting with Killrust or better.

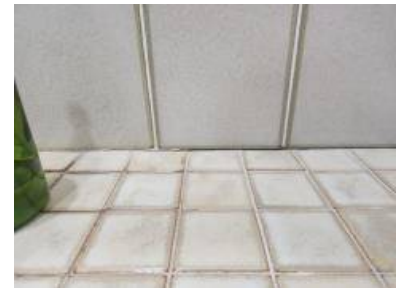
Junctions of Bathroom vanity and wall tiles require resealing with silicone.

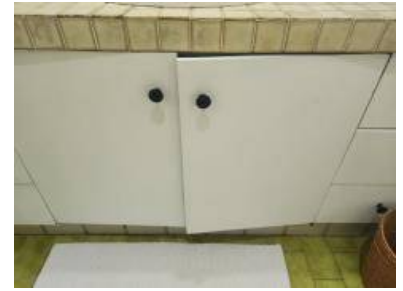
Vanity doors adjustment / refixing.

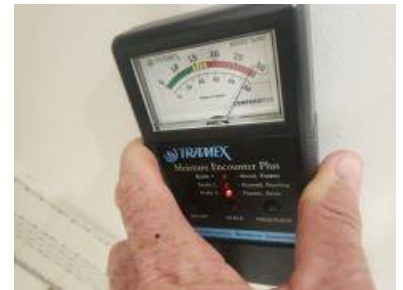
There are signs of high moisture levels in the walls adjacent to the Bathroom shower. I recommend that a plumber be engaged to inspect the taps / washers, conduct a compression check on the pipes. If not leaking pipes then I recommend engaging a shower sealer to reseal and water proof the shower floor and walls.

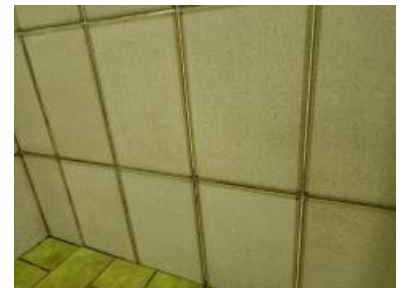
Some Shower wall tiles require regrouting & resealing.

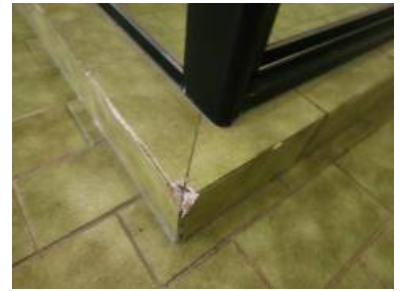
Chips to hob tiles.

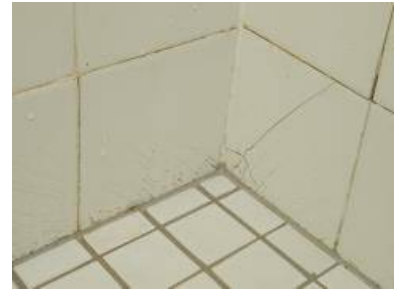
Some hairline cracks to some wall tiles of the shower.

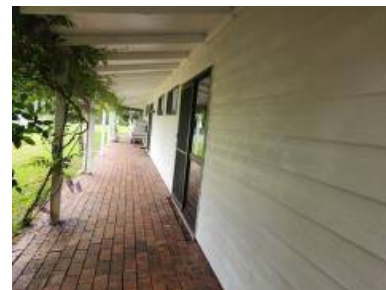
The external paintwork / finish to the external surfaces and timberwork is generally satisfactory. There are some sections / areas that require touching up / repainting.

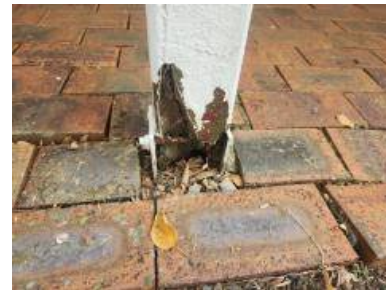
Various timber post bases.

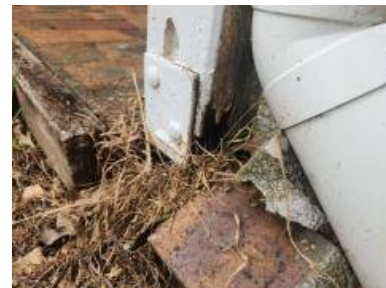
Most verandah / patio post bases show evidence of decay and require repair / sealing.

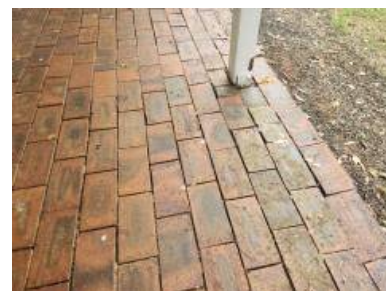
Some pavers are uneven / undulate and require leveling / relaying.

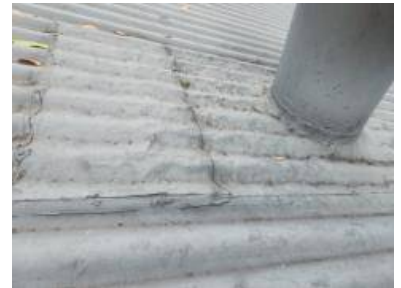
**Condition:**  
Flue flashing shows signs of hail damage.

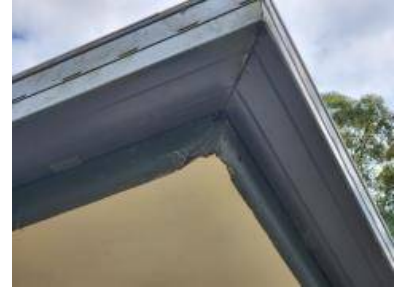
Some fascia timbers show signs of weather damage and require repair.

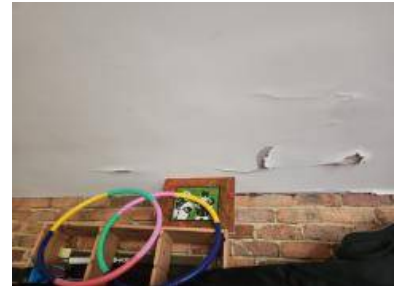
Some ceilings require repair and repainting.

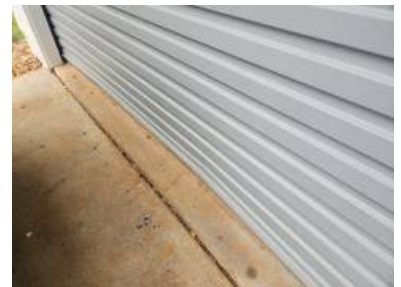
The roller door has minor damage and requires repair. I recommend that a qualified Garage door technician be engaged for further investigation / maintenance.

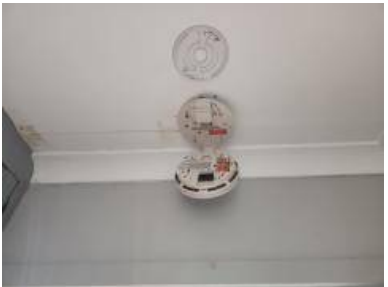
Present - Hall, New battery required.

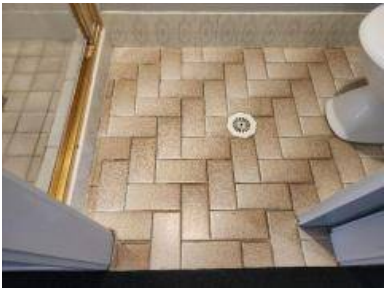
Some floor tiles are drummy.

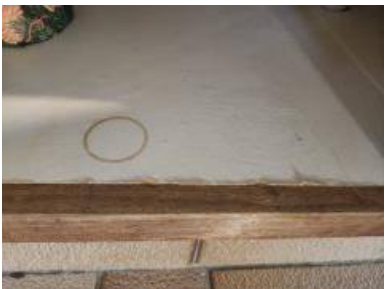
Signs of past water penetration to the vanity cabinet.

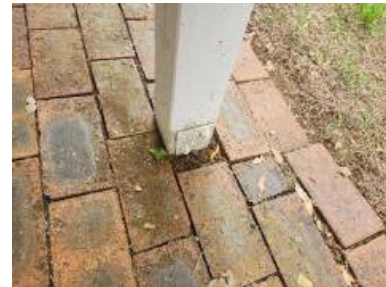
- Some Verandah / Patio timber support post bases are in contact with the ground / concrete / soil. This may allow concealed termite entry. The situation should be modified so that timber to soil contact does not occur (by creating a 75mm visual barrier) or have them treated with termiticide.

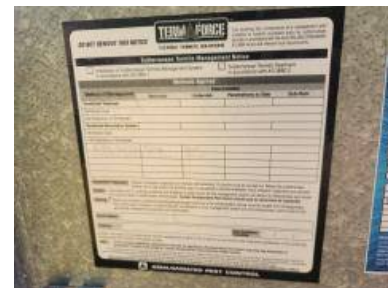
A termite barrier / treatment notice in the Meter Box / Kitchen Cupboard indicates that Termidor termiticide was applied to the perimeter in 2011. The treatment notice indicates a life expectancy of 8 years. The property needs a new treatment.
