# PEST AND BUILDING PRE-PURCHASE REPORTS

# Inspection Report

**16 Survey St, Lennox Head, NSW, 2478**

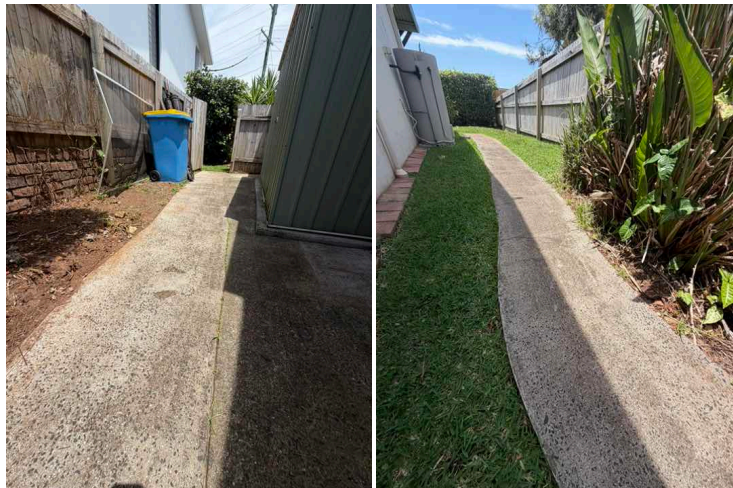
Common cracks and settlement were observed on paths. Whilst these cracks appeared to be typical at the time of inspection, we strongly recommend you monitor these cracks and if worsening occurs contact a concreter for further advice.

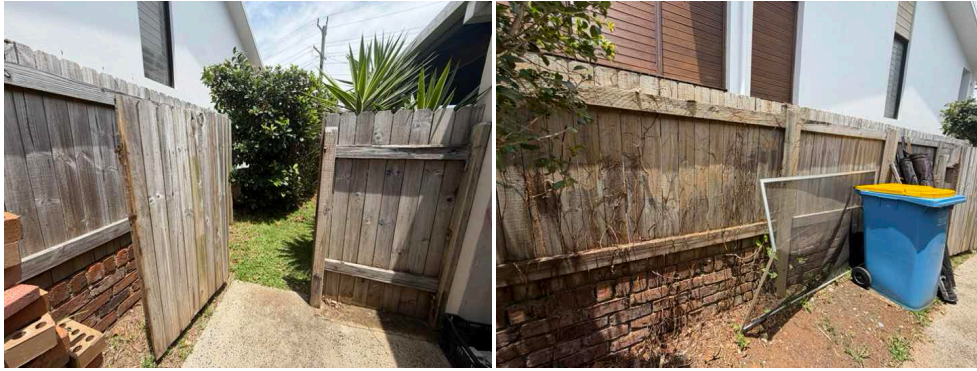
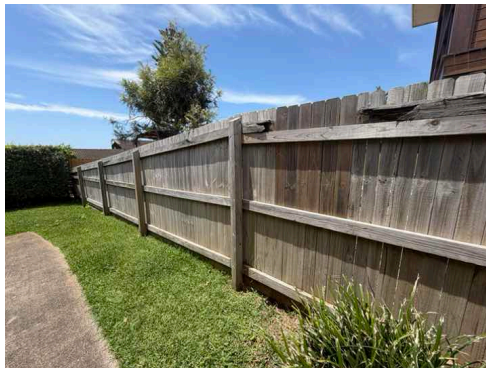
General age/damage/binding of gate/s components - Recommendations: A qualified fencing contractor should be engaged for advice and recommendations.

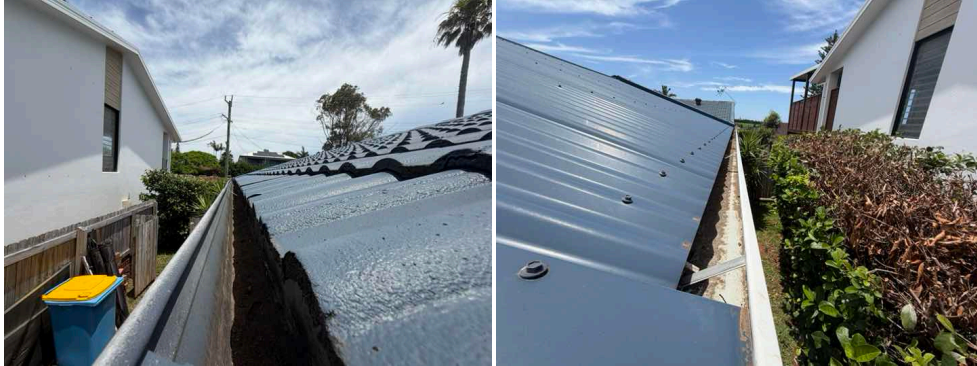
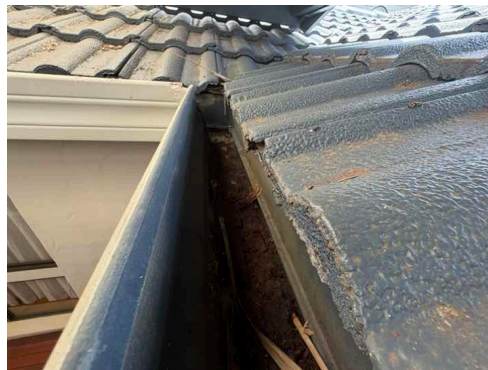
There is evidence of leaking gutters. Contact a roof plumber for advice and repairs.

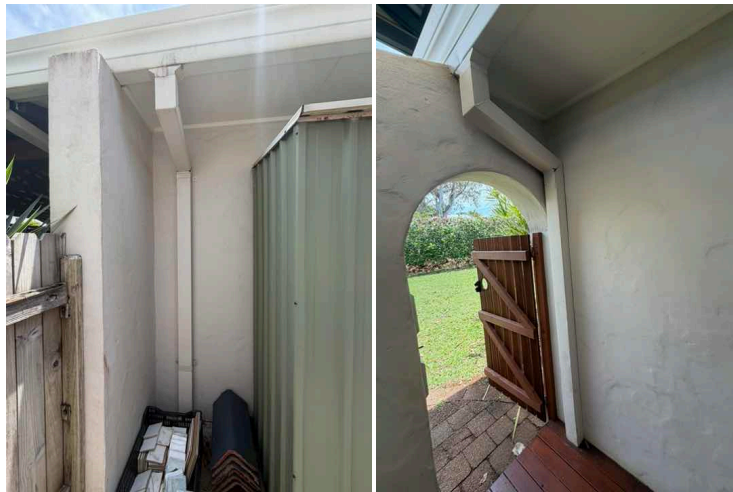
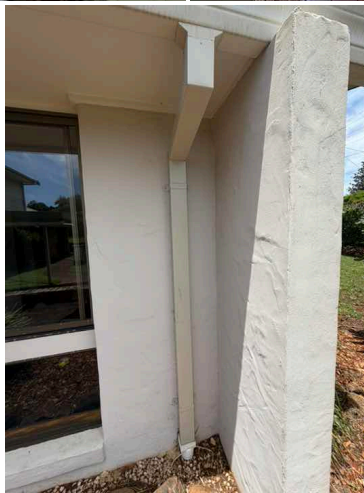
Leaking downpipe joints visible. This can be conducive to termite infestation and cause water damage to cladding over time. A qualified roof plumber should be engaged to repair.

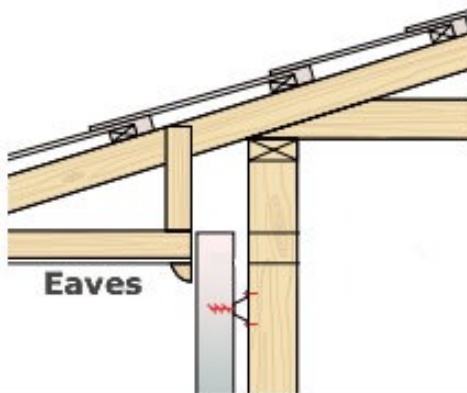
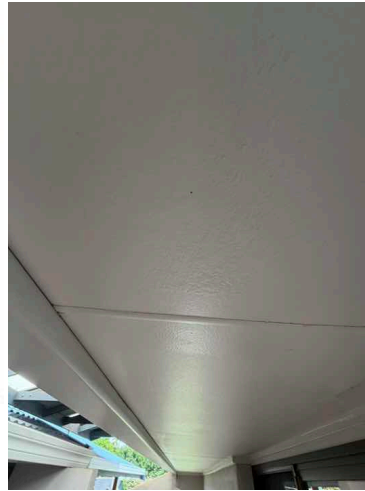
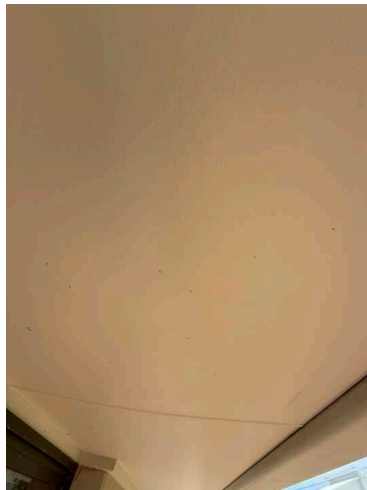
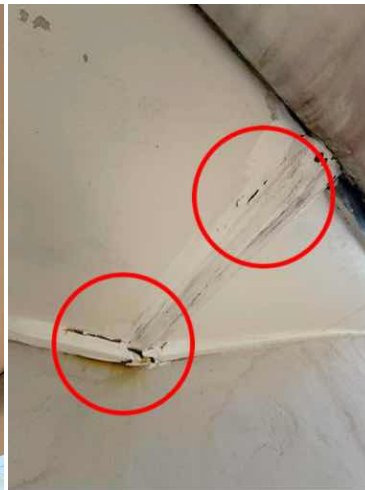
Minor eave deterioration & ageing evident. Recommendations: Maintenance works, general upkeep should be carried out.

Eave lining timber fungal decay visible. Recommendations: A qualified carpenter should be engaged for repairs and recommendations.

Eave lining stains observed. Normally this occurs due to overflow in blocked gutters. Recommendations. Gutters should be kept clear of debris and eave linings can then be painted or repaired as required.

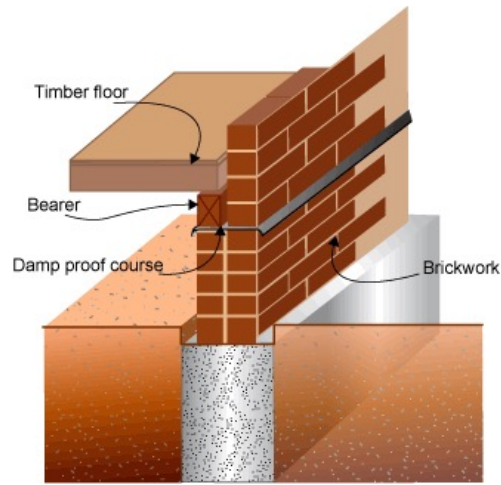
A damp proof course is not visible or could not be visually identified. This may cause rising damp issues. Contact a specialist in this field to further investigate and make recommendation.

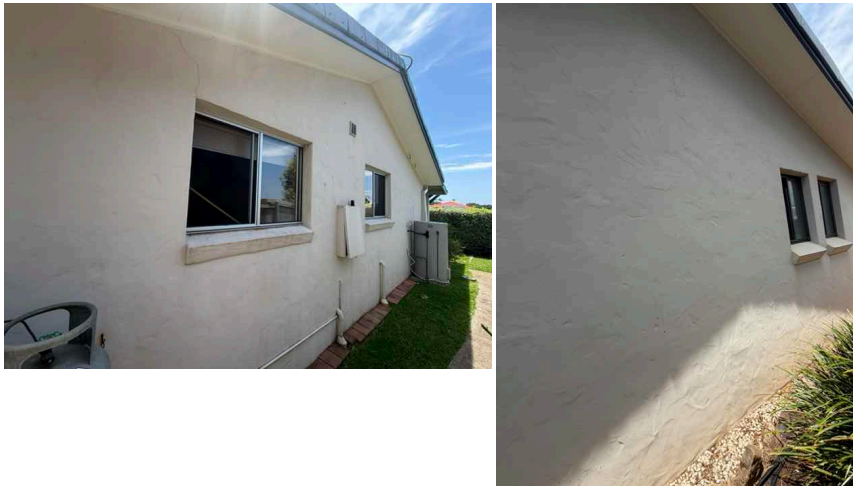
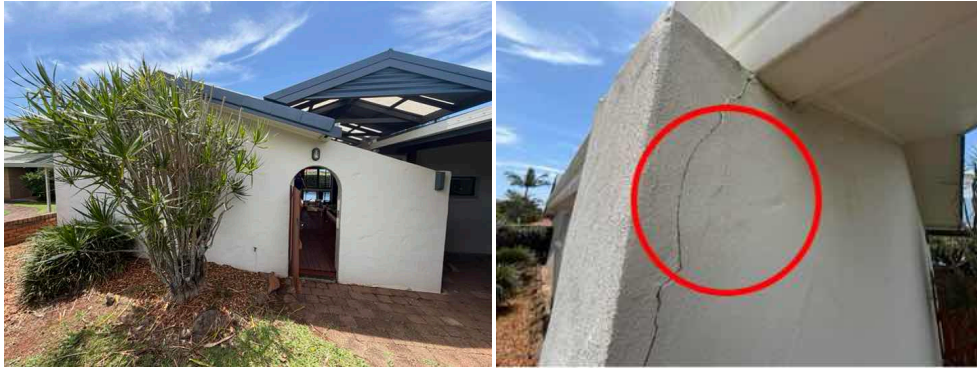
There appears to have been some settlement in the building which has caused some cracking to the walls. These cracks are categorized as 0 to 2. This can also cause some doors to bind or be out of square. In the inspectors opinion these cracks are due to settlement, usually due to ground movement and subsequent movement to building materials can be expected. Any cracks should be monitored and if cracks increase in size, further investigation should be carried out by a structural engineer.

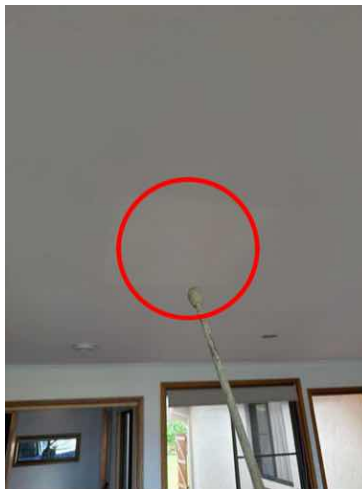
Incomplete patch/paint repairs noted. I recommend you contact a qualified painter for repairs.

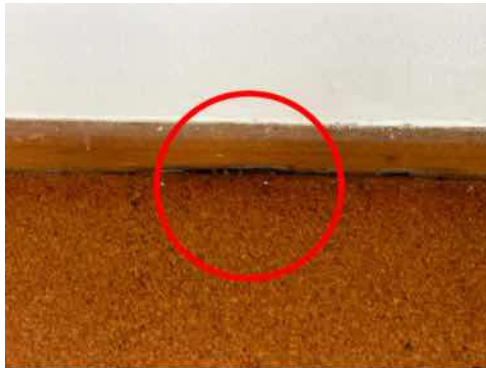
Skirting board damage/deterioration. A qualified carpenter should be engaged to replace.

Skirting board damage. Possibly bath/shower recess leak related. Have bathroom/shower assessed by a qualified plumber for leaks and maintenance/replace skirting boards as required.

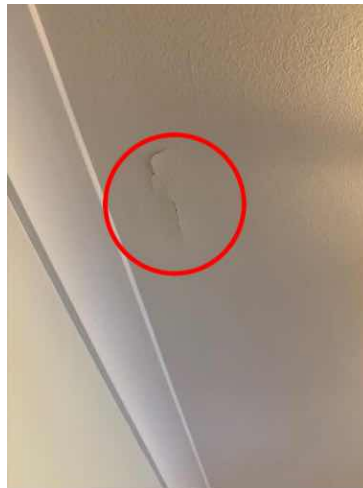
Settlement Cracks Noted. These are typical and generally patch and paint will suffice, however monitoring these cracks is advised for 12 months and if they become worse, further investigation by a suitably qualified professional is advised.

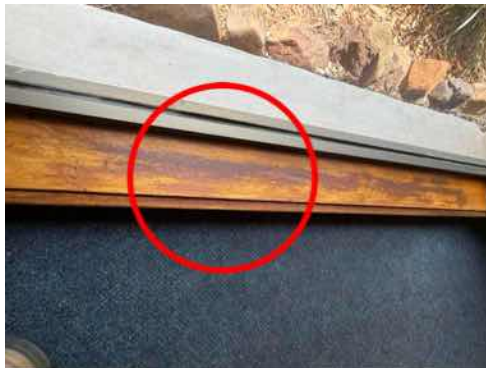
Uneven / out of square door causing binding. A qualified carpenter should be engaged to refit.

Upon visual inspection, the window sill shows signs of moisture staining, indicating potential water intrusion. This may lead to wood rot or mold growth if not addressed. It is recommended to have a licensed contractor assess the source of moisture, repair any leaks, and replace or treat the affected sill to prevent further damage and ensure structural integrity.

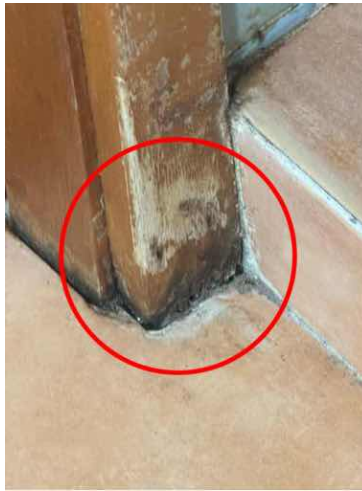
Water damaged door. Possible due to leak in bathroom. Replacement recommended.

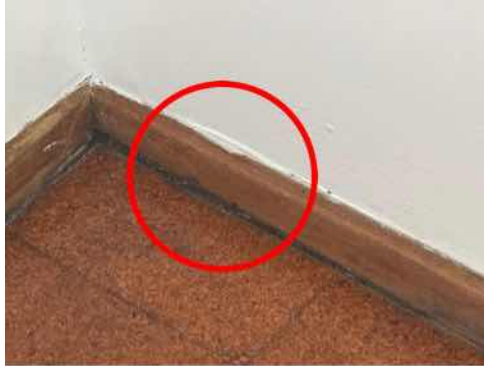
Skirting board damage/deterioration - Recommendations: A qualified carpenter should be engaged to replace.
