Inspection Report

36 Killarney Cr, Skennars Head, NSW, 2478

Pest And Building Inspection

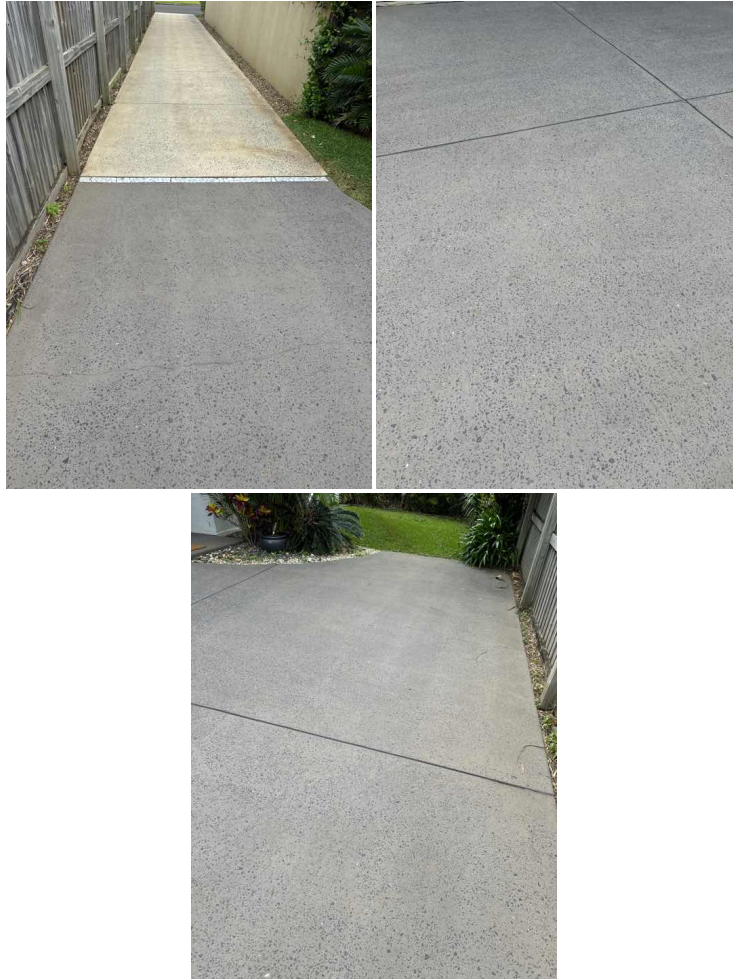
Driveway Condition

On visual inspection, the general condition of the driveway is serviceable.

Common cracks were observed on the driveway. Whilst these cracks appeared to be typical at the time of inspection, we strongly recommend you monitor these cracks and if worsening occurs contact a concreter for further advice.

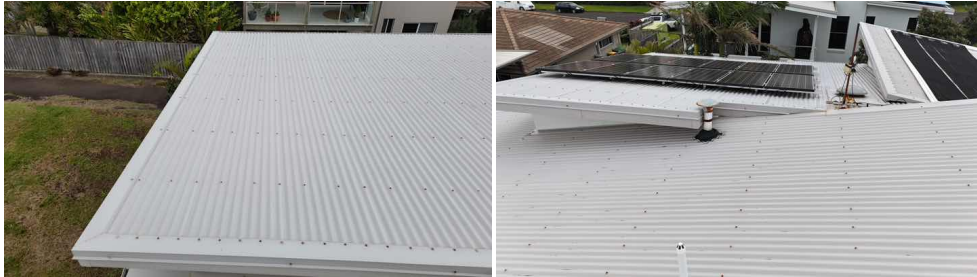
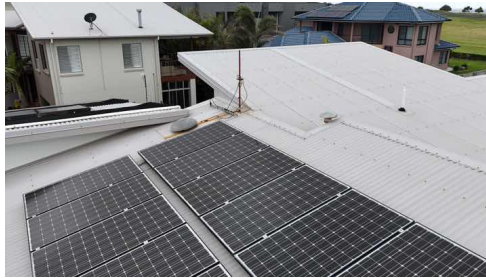
Roof Clad Condition

Visible section of The roof cladding appeared in a serviceable condition for the age of this dwelling. Annual maintenance inspection recommended.

Corrosion noted to the screw fixings of the metal roof. Have these checked and replaced by qualified roofing contractor.

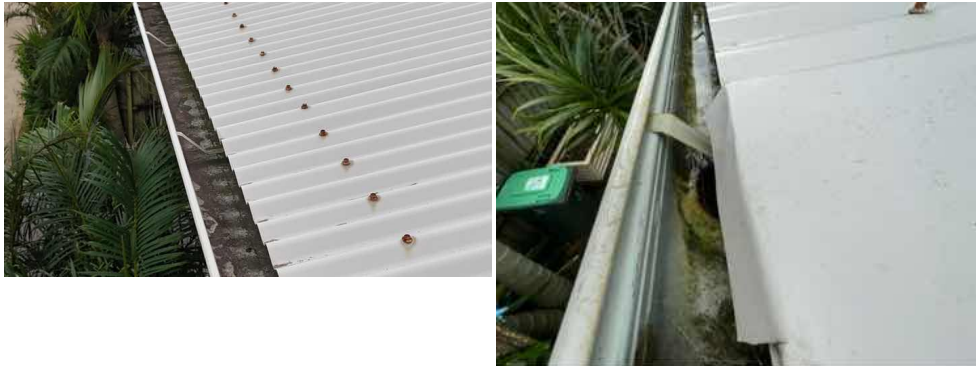
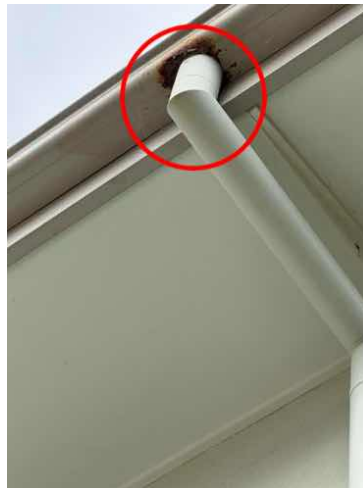
Gutter ponding - This can relate to poor fall, inadequate down pipes, gutter or debris build up. If debris presence has been noted above clean same out and re-assess for any ponding. If clean guttering is ponding it can be a blocked down pipe or the guttering fall is inadequate. A qualified roof plumber should be engaged for advice and recommendations.

Gutter surface rust in sections- the rust is yet to penetrate and repairs/sealing may be an option. A qualified roof plumber should be engaged for advice and recommendations.

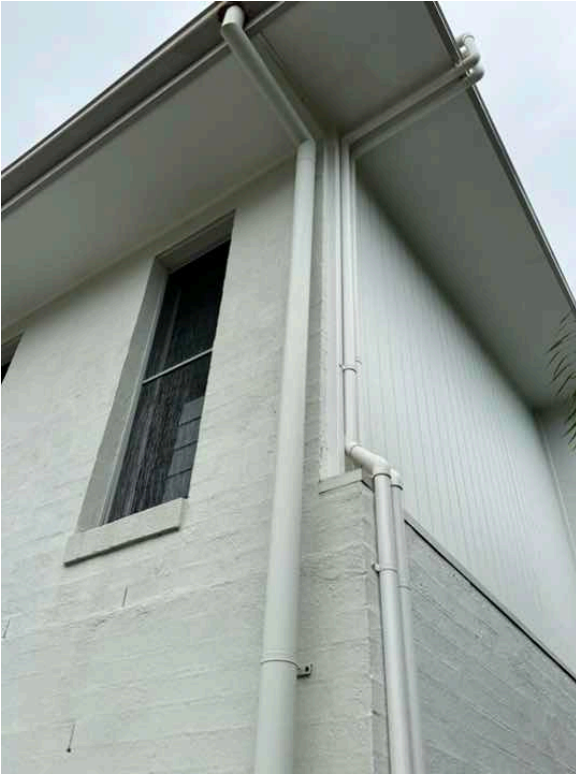
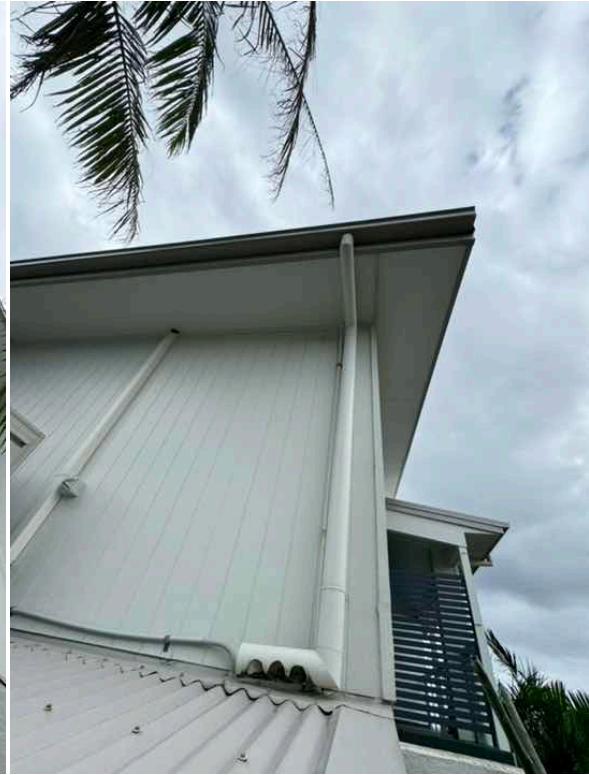
Downpipe Findings

The downpipe/s wall clips is detached or missing. Although minor and easily rectifiable, we recommend a licensed roof plumber be engaged for repairs.

Minor downpipe rust visible. A qualified plumber should be engaged for advice and recommendations.

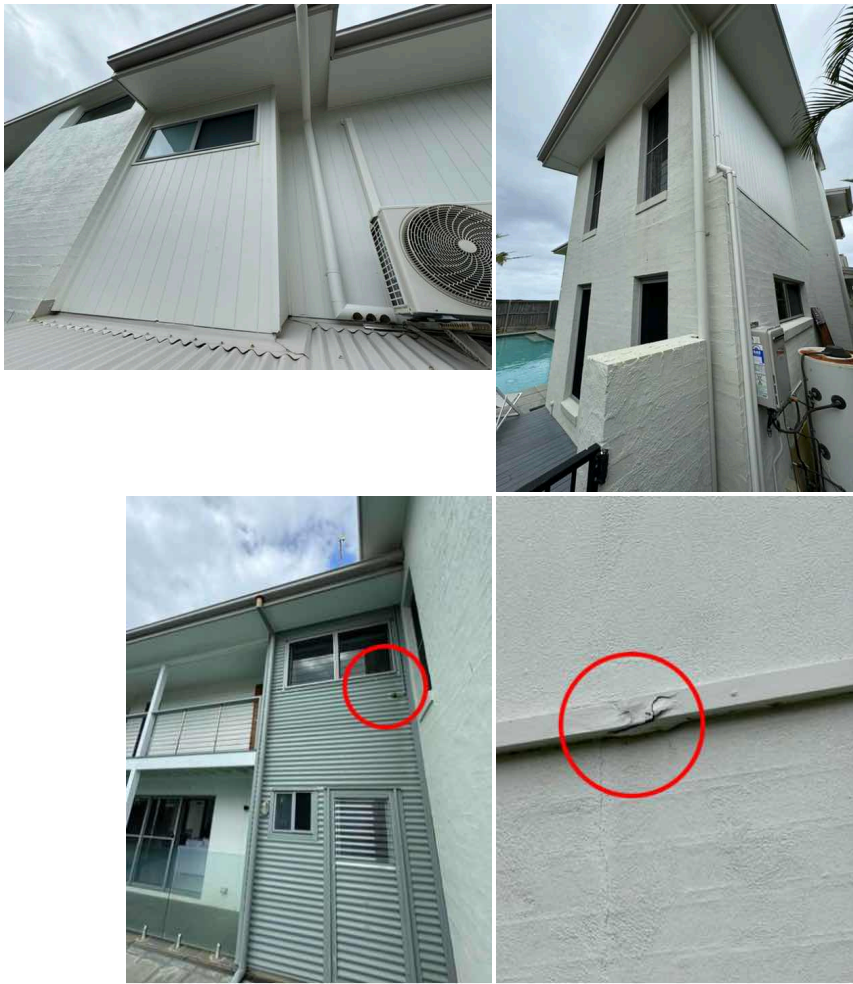
Condition

On visual inspection, the general condition of the exterior walls is serviceable for the age.

Minor decay was noted to the external wall lining. We recommend replacement of all affected timbers.

Surface rust to metal cladding.

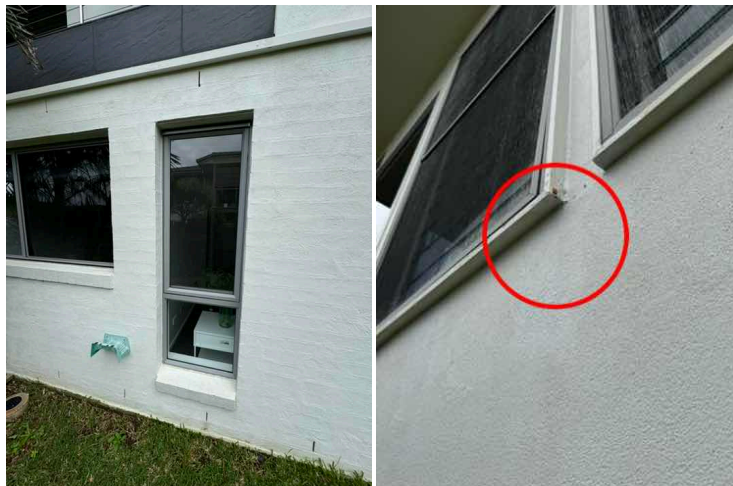
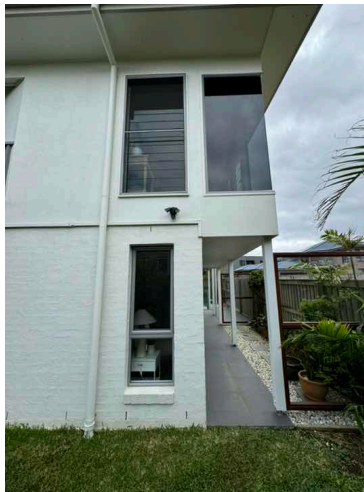
Overall Condition

Minor Timber fungal decay is evident in sections of the window framework - Some areas should be replaced. A qualified carpenter should be engaged for advice and recommendations.

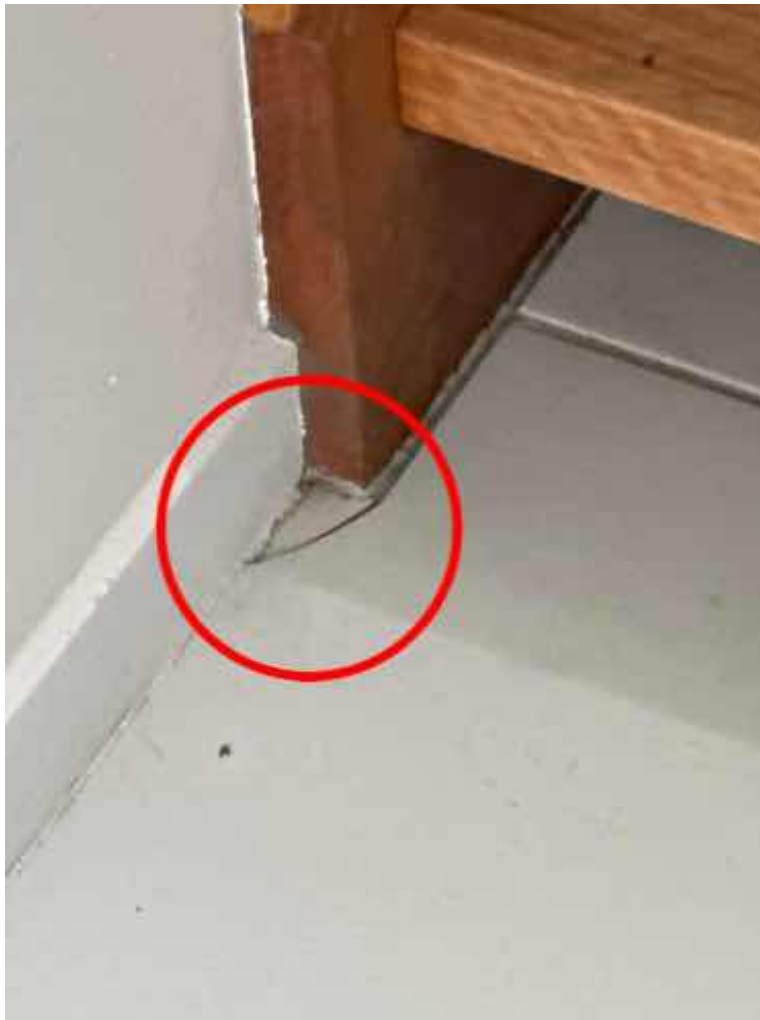
Flooring

Cracked floor tiles noted. A qualified tiler should be engaged for repairs.

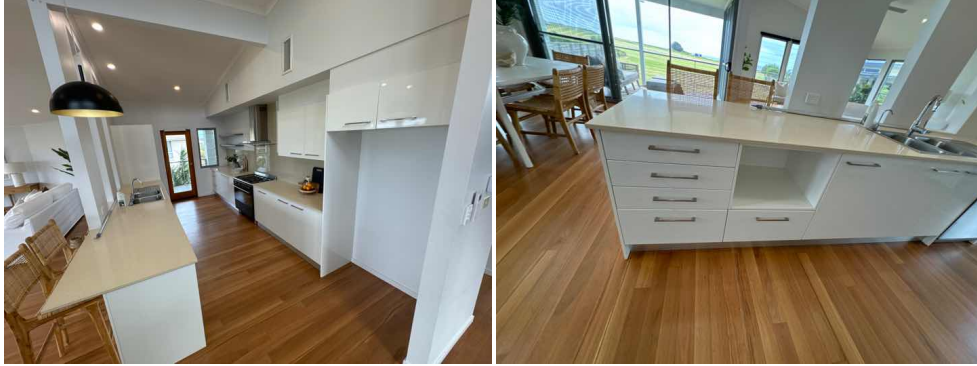
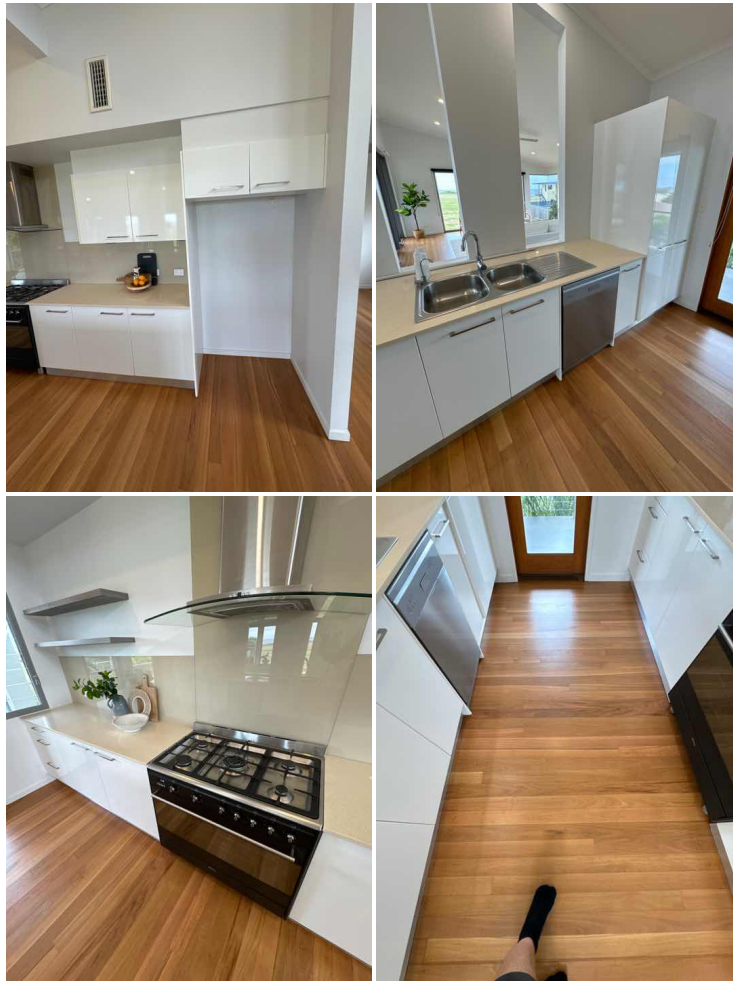
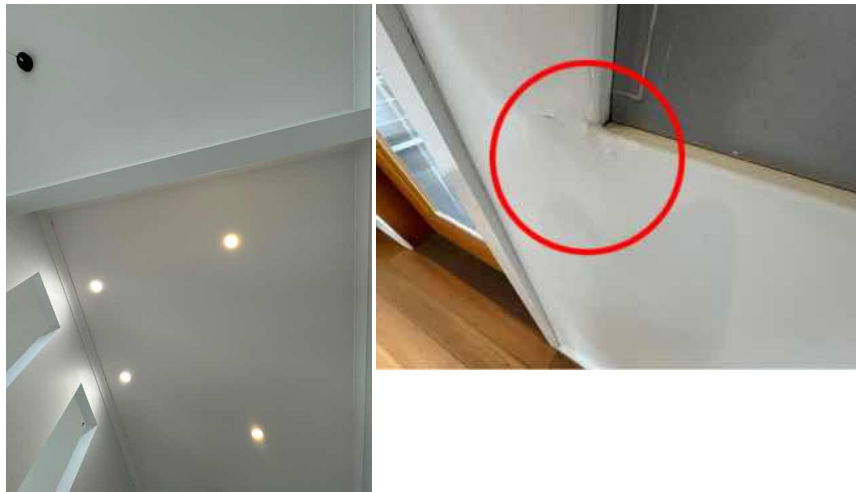
Walls

High moisture readings detected. There was no evidence of paint flake , Recommendations: Accurate diagnosis of the cause and extent of the damp problem is very important and should be assessed prior to purchasing the dwelling as can be quite costly if a damp proof course has to be reinstated.
