Building and Pest Report

8 Pintail Lane Lennox Head

Pest And Building Inspection

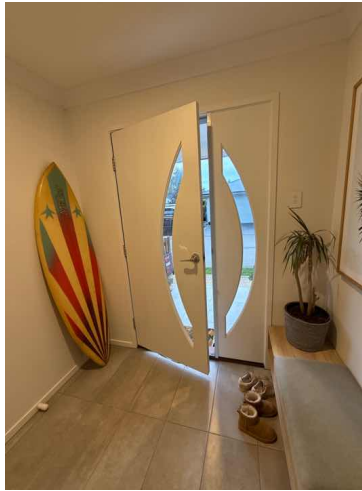
Loose handle

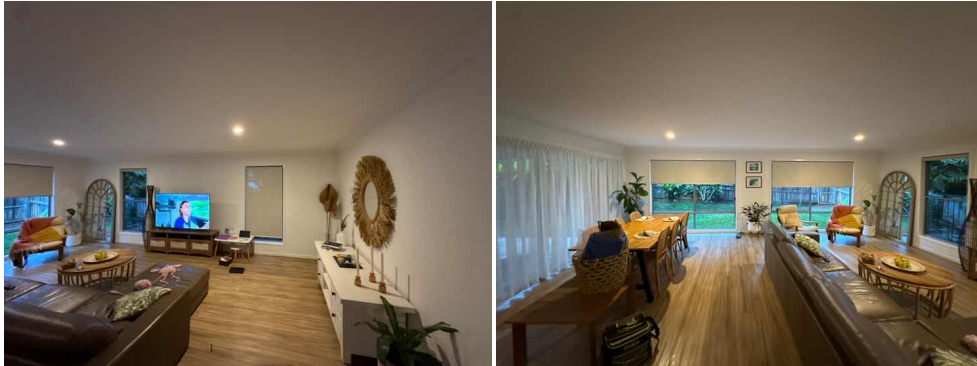
Settlement Cracks Noted. These are typical and generally patch and paint will suffice, however we recommend you monitor these cracks and if they become wider or longer, you will need to contact a structural engineers to assess.

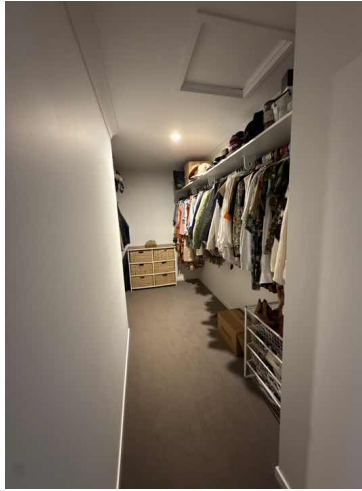
Door lock hardware is loose possibly damaged. Maintenance as required.

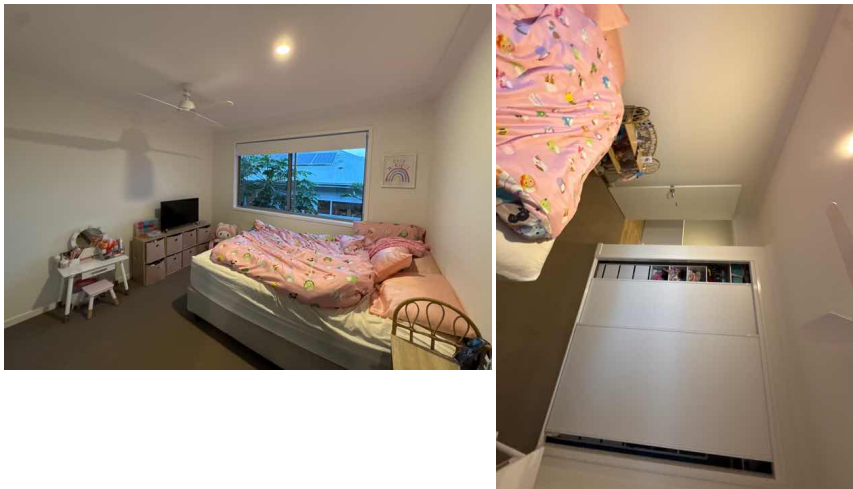
Door stop should be fitted - Wall damage from door handle impacting wall lining has occurred. I recommend you contact a qualified painter for repairs.

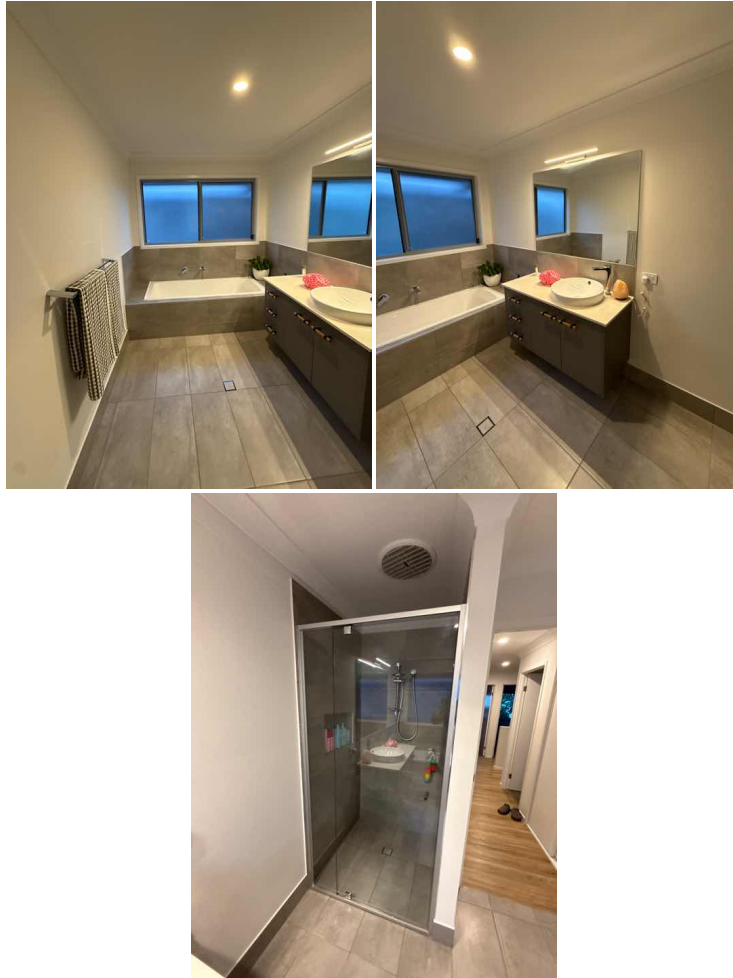
Drummy tiles noted. This needs to be repaired at the earliest as this has the potential to lead to many related issues such as damp, water ingress to other areas and cracked tiles. Contact a qualified tiler for repairs and recommendation

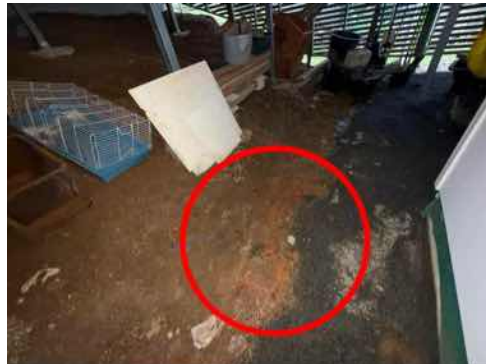
Dampness in sub floor soil. Damp sub floor soil should be avoided as it can cause fungal decay, mould and possibly footings problems. Recommendations: A qualified drainage plumber should be engaged for advice and recommendations.
