Building and Pest Report

2 Sunhaven Ave Skennars Head

Report/Agreement #	120226095828115
Inspection Date:	12 Feb 2026
Inspection Time:	09:00 am

Pest And Building Inspection

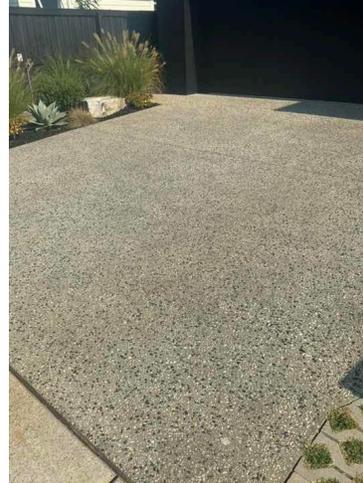
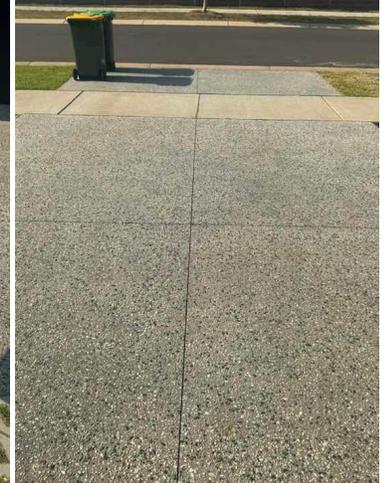
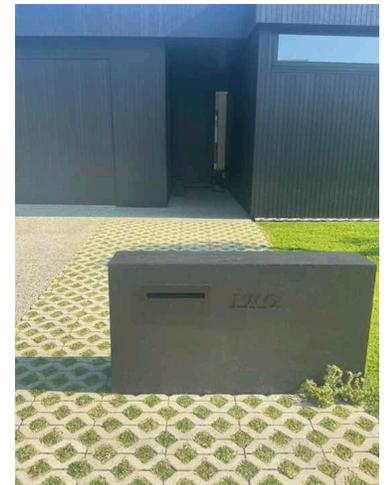
On visual inspection, the general condition of the driveway is serviceable.

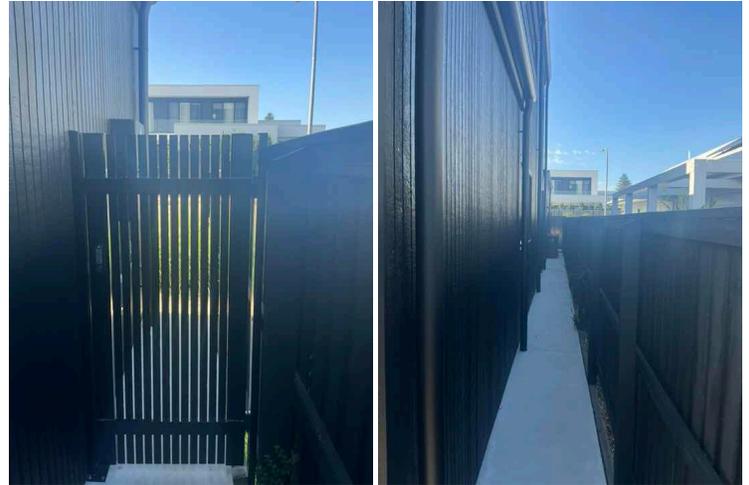
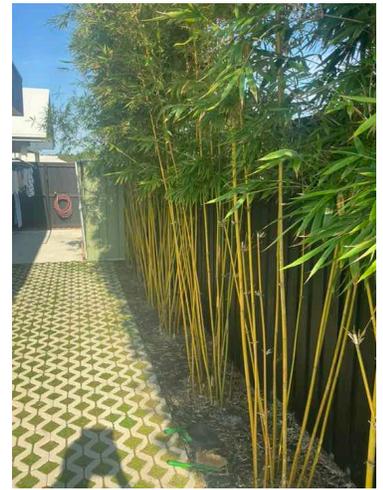
Of the visible areas, the general condition of the fences and gates is serviceable for the age of dwelling.

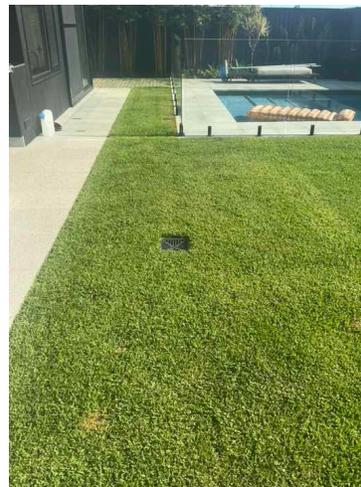
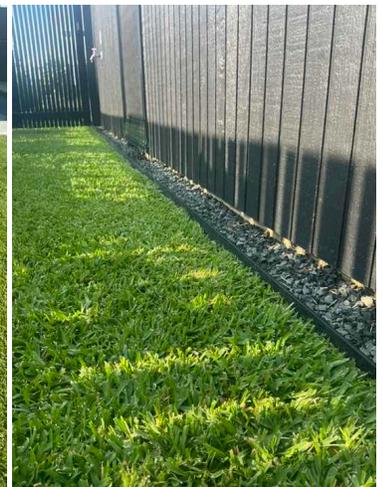
There was no visible evidence of excess ponding or fall towards the property walls at the time of the inspection. Regardless, it is difficult to ascertain in dry conditions and it is therefore recommended that you assess same after a rainfall period to be able to sufficiently ascertain if any problems exist in this regard. If water is ponding around perimeter walls and paths or appears to be flowing into the footings/foundations you must have assessed by a qualified plumber or landscaper.

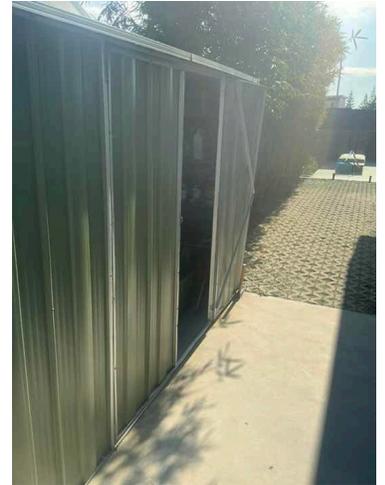
The shed is in fair usable condition.

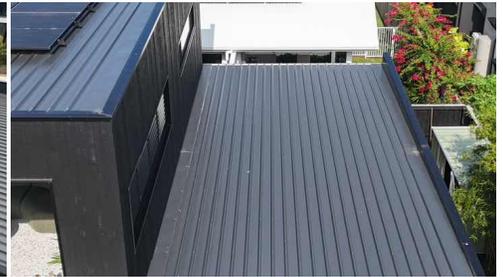
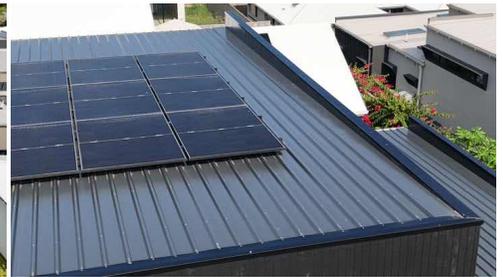
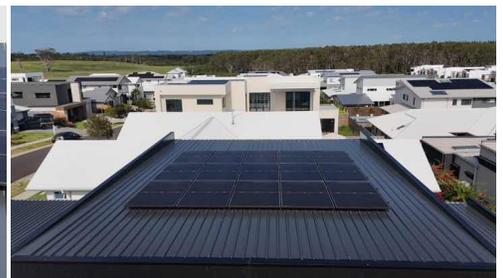
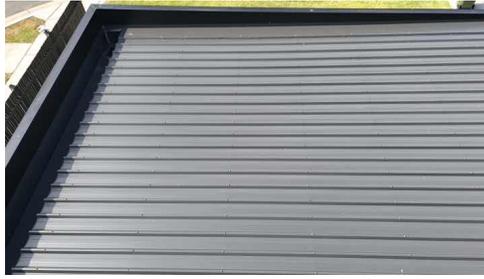
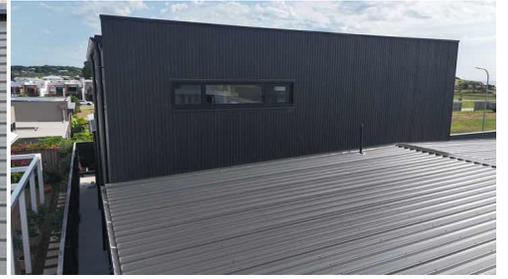
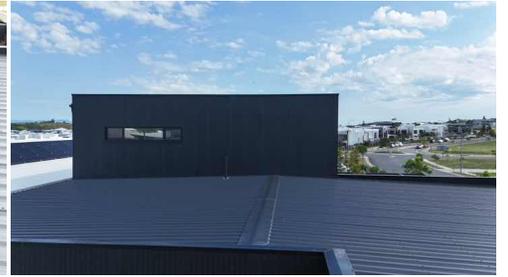
Of the visible areas, the general condition of the roof is in serviceable condition for the age.

Note: In the absence of rainfall there is no guarantee that the roof won't leak.

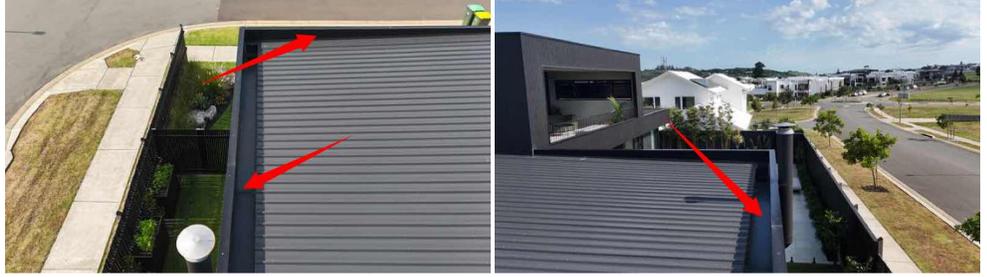
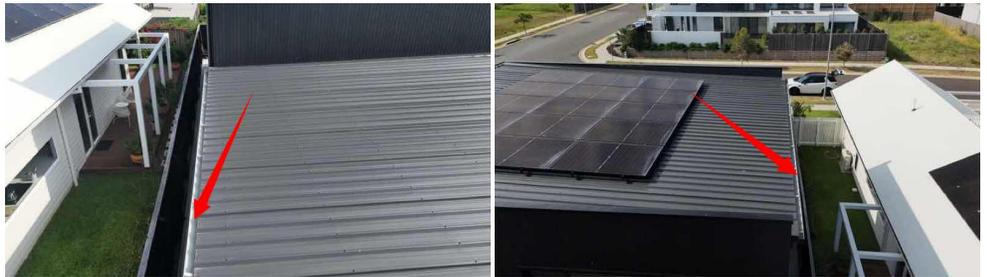
All visible and accessible of the physical nature of the guttering system appears to be in a serviceable condition with no apparent defects at the time of inspection. In the absence of prolonged rain fall efficiency of the guttering can not be assessed and you may find that further investigation or repairs maybe required. Note: Periodic maintenance checks should be carried out for rust penetrations and leaks.

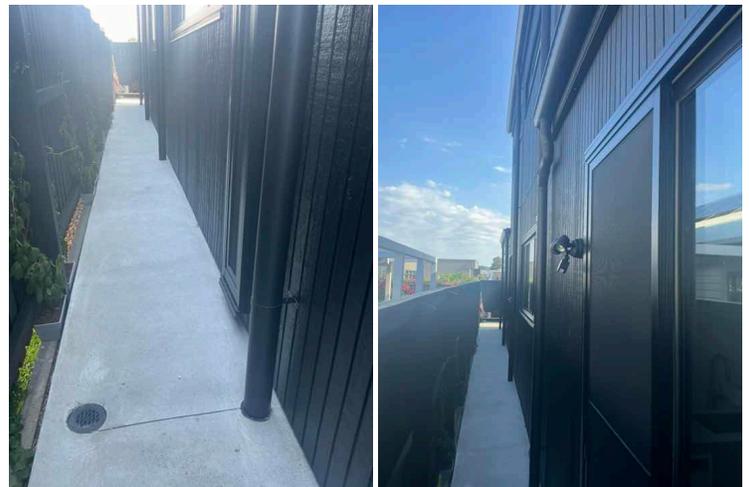
On visual inspection no apparent defects were noted to the down pipes and are considered serviceable, however no comment can be made with regard to blockages or connections to stormwater or functionality in the absence of rain. Note: Periodic maintenance checks should be carried out for rust penetrations and leaks.

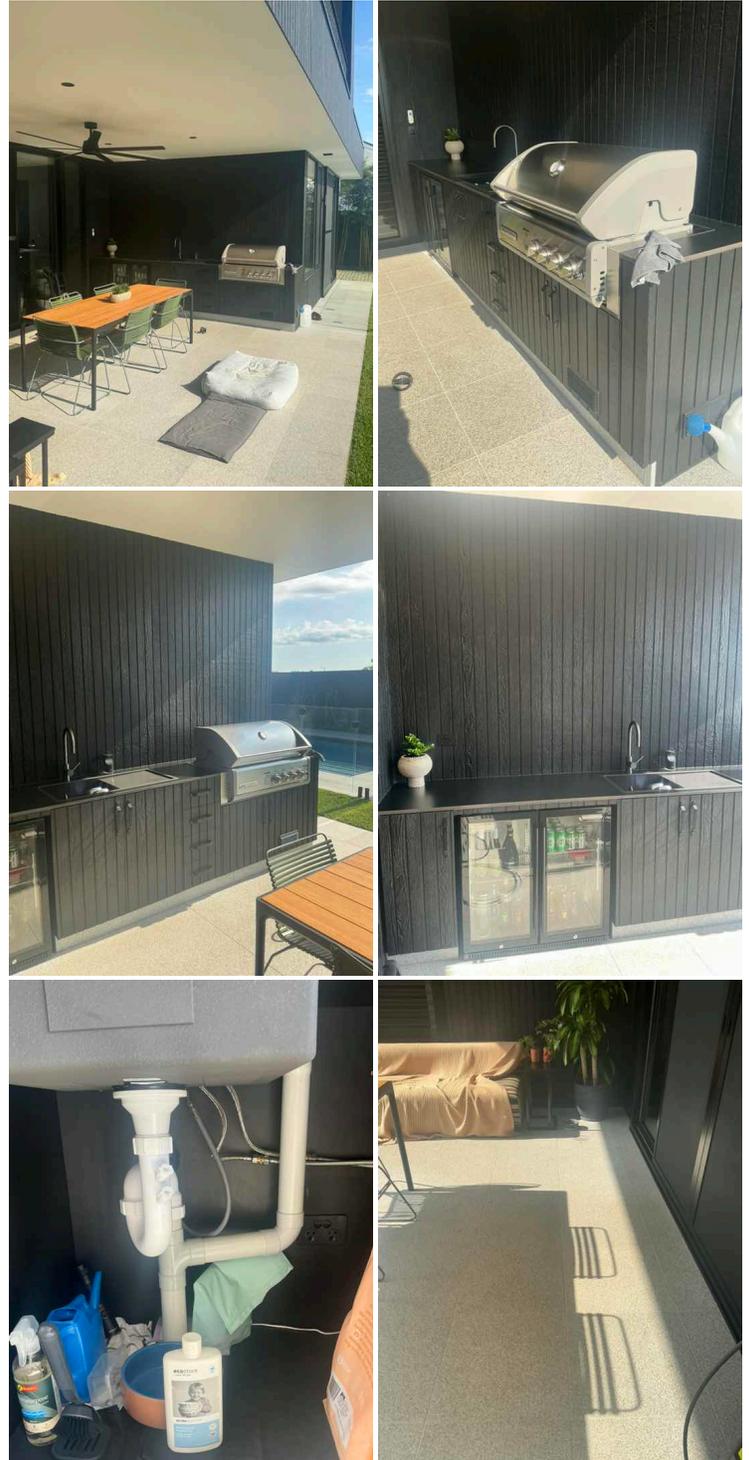
Visible sections of the Alfresco area are serviceable or in reasonable or condition for the age of this dwelling.

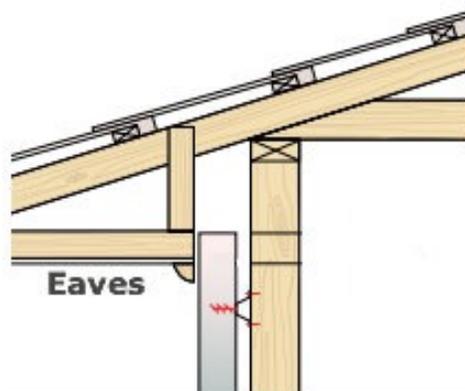
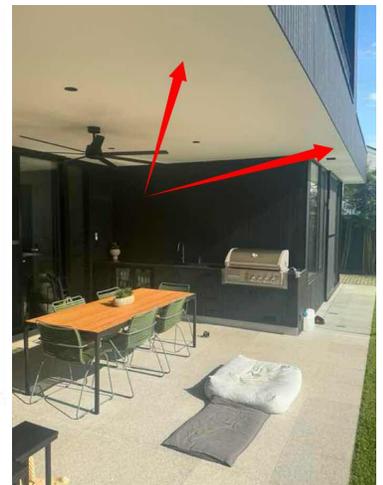
The soffit lining (eaves) are in a serviceable condition with no notable defects.

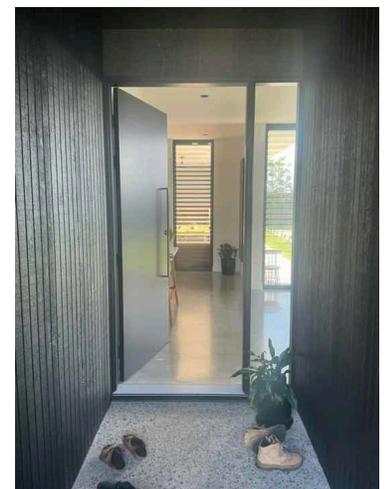
The entry porch serviceable or in reasonable or condition for the age of this dwelling.

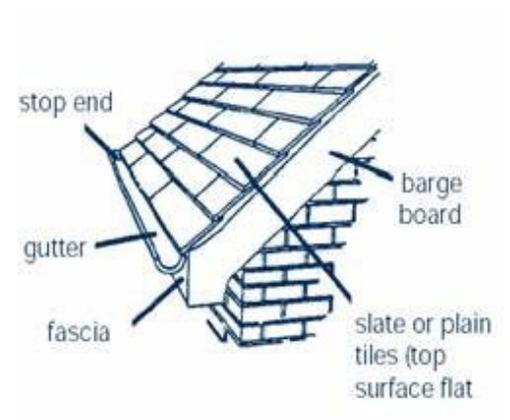
On visual inspection, the general condition of the fascia/barge boards is serviceable.

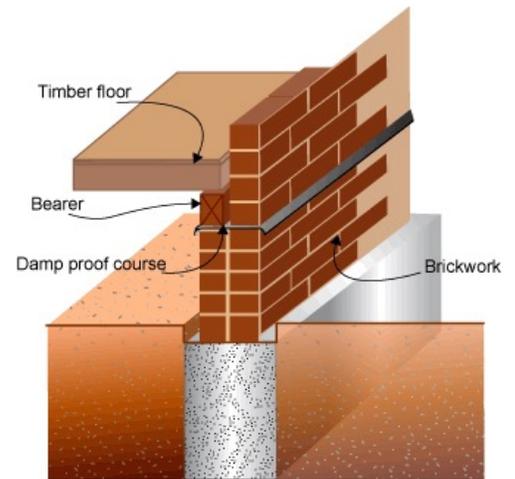
A damp proof course (DPC) was noted.

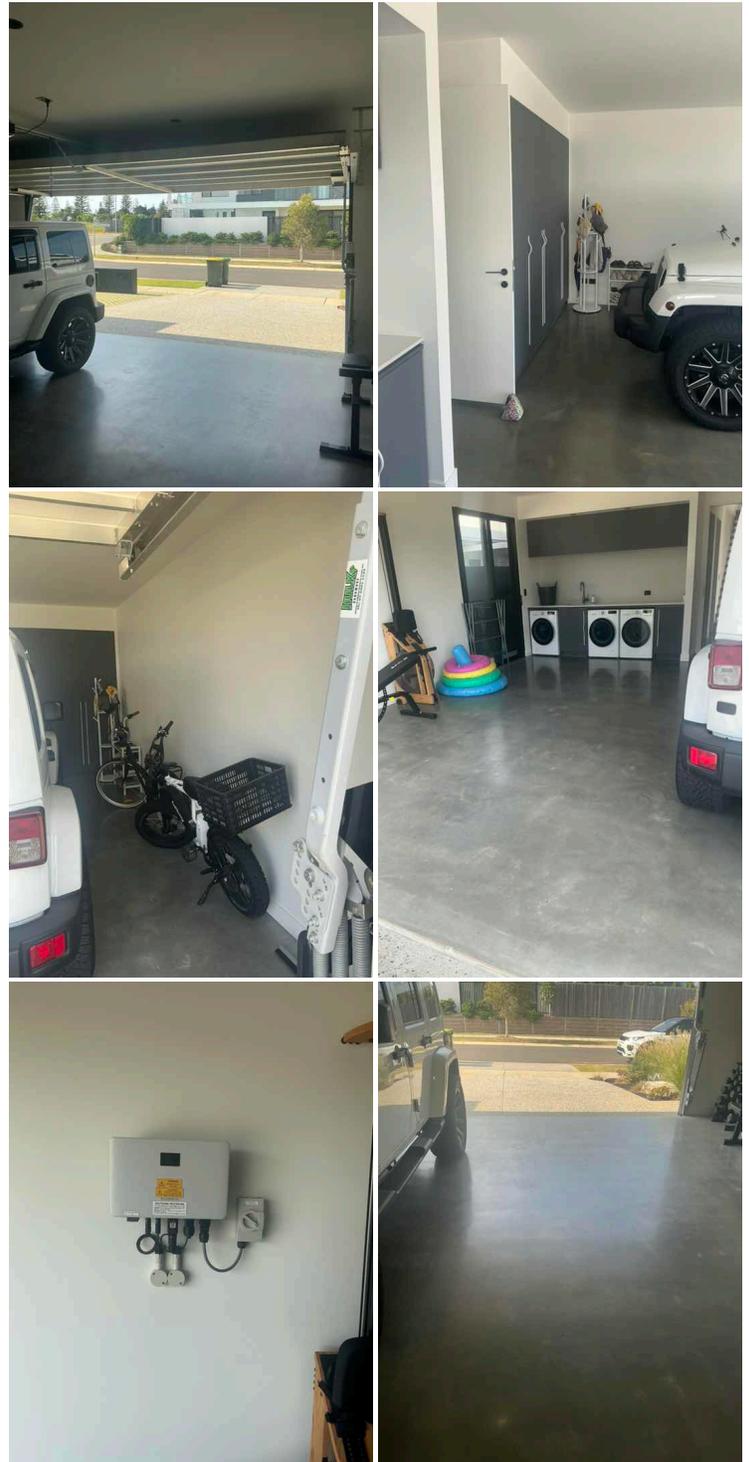
From the visible and accessible areas, the garage appears to be in a serviceable condition for the age of the property with no notable structural defects sighted.

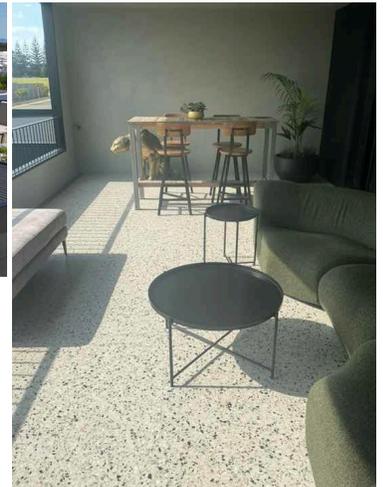
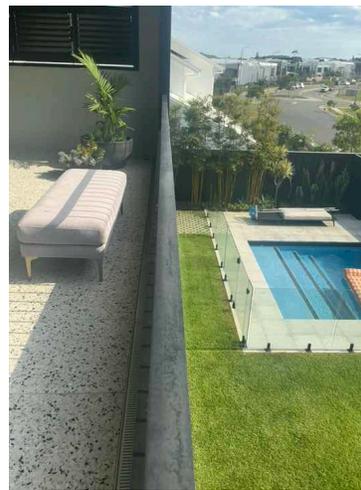
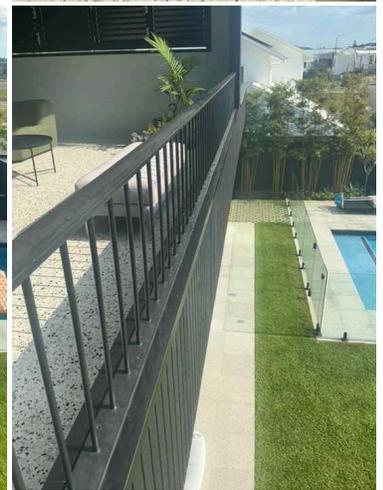
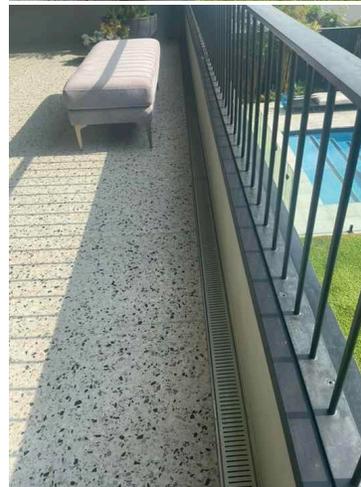
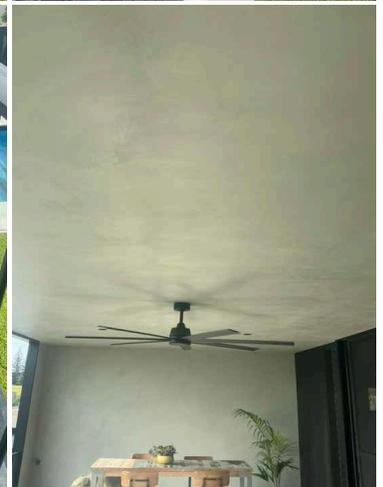
Though we are not structural engineers the balcony/s appear to be in a serviceable condition.

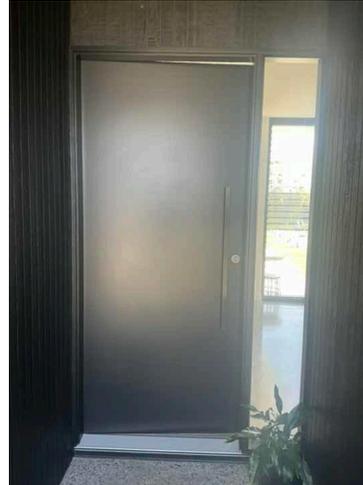
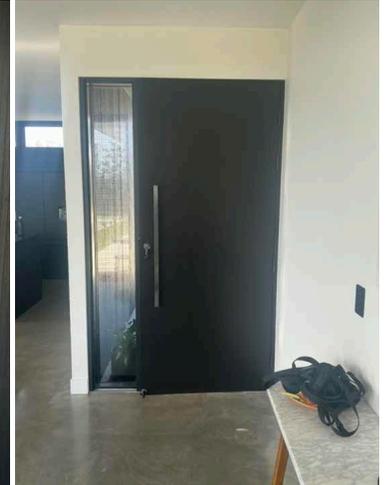
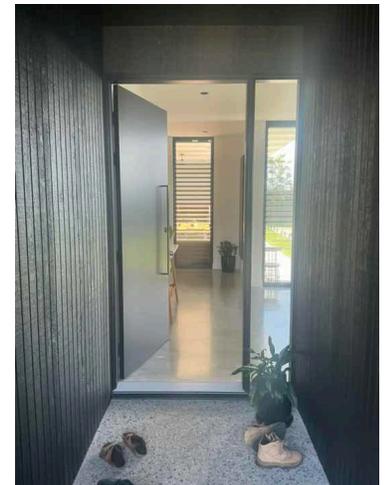
The doors are in serviceable condition with no notable defects observed.

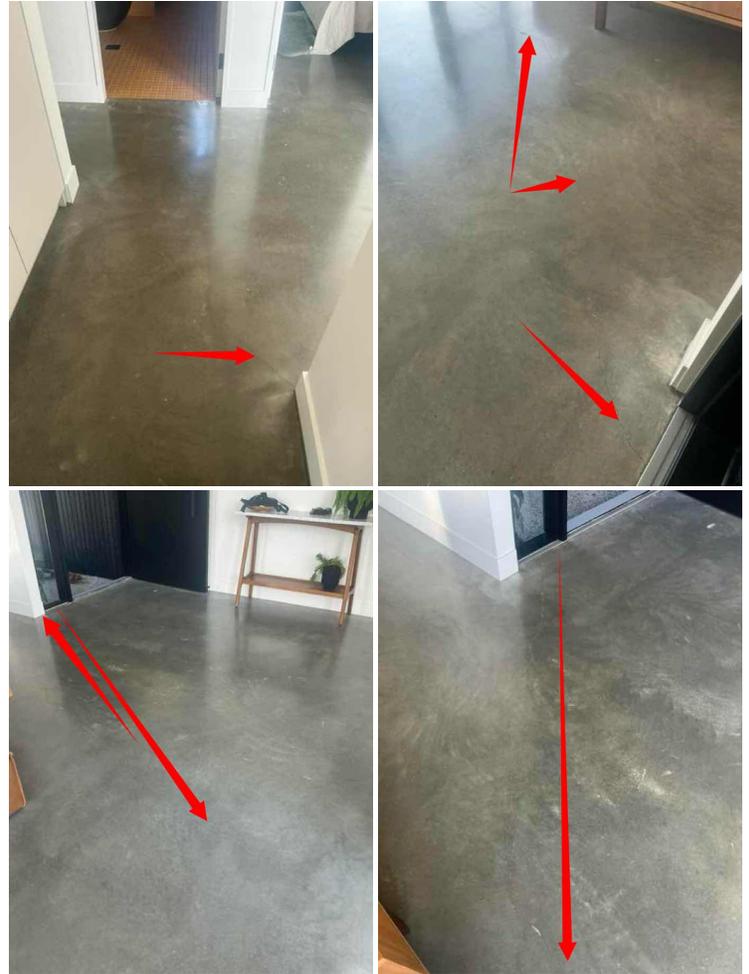
Upon visual inspection, the concrete floor shows visible cracks. It is recommended to have a licensed contractor assess and repair these cracks to prevent further deterioration. Consider sealing the surface to enhance durability and appearance.

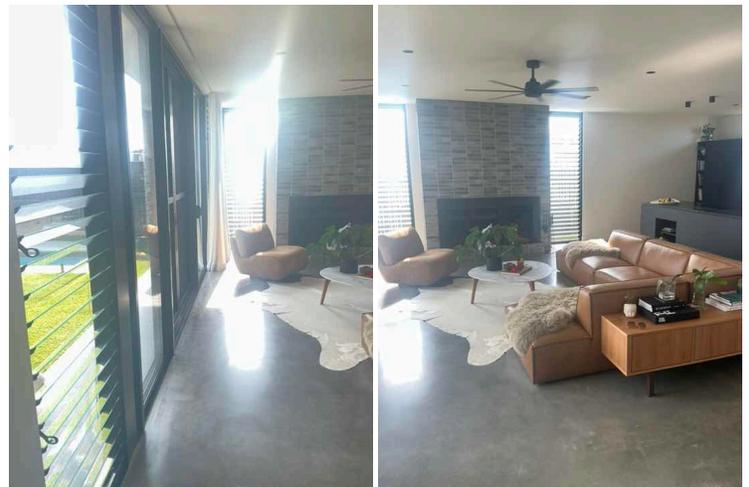
From the visible and accessible areas, this room appears to be in a serviceable condition for the age of the property with no notable structural defects sighted.

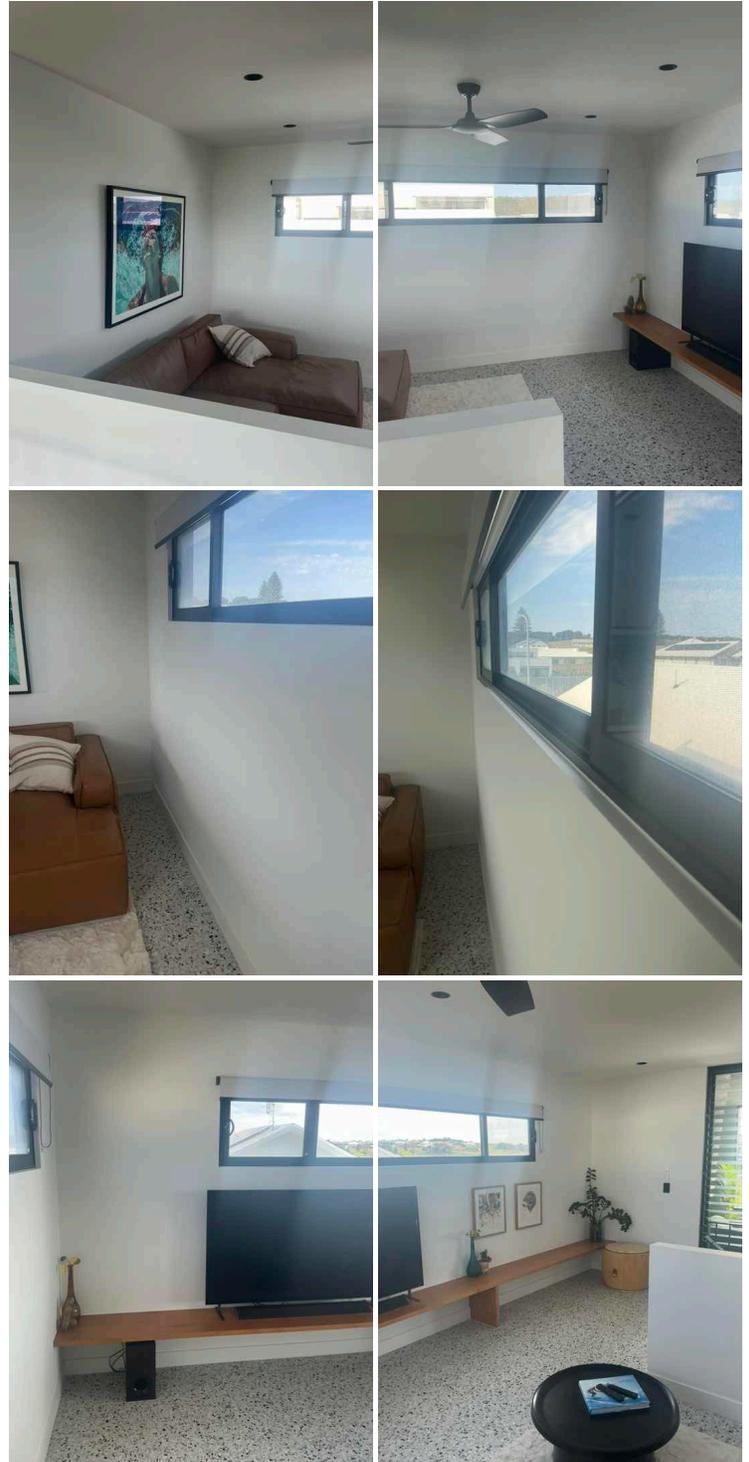
From the visible and accessible areas, this room appears to be in a serviceable condition for the age of the property with no notable structural defects sighted.

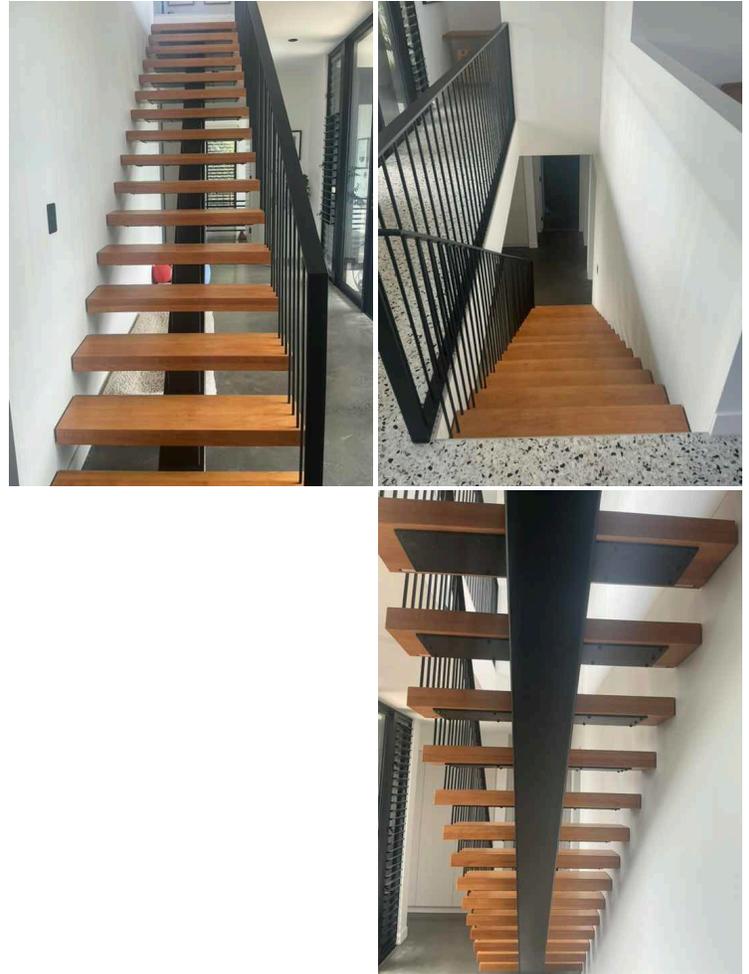
The internal staircase and components appear to be in a serviceable condition for the age with no notable defects sighted.

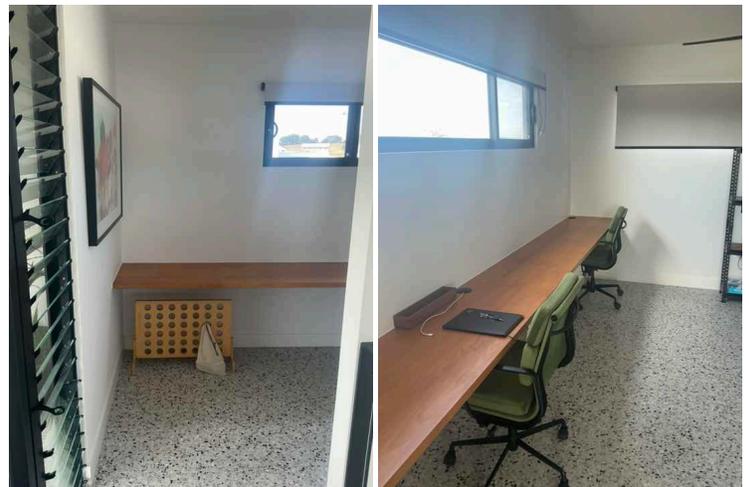
From the visible and accessible areas, this room appears to be in a serviceable condition for the age of the property with no notable structural defects sighted.

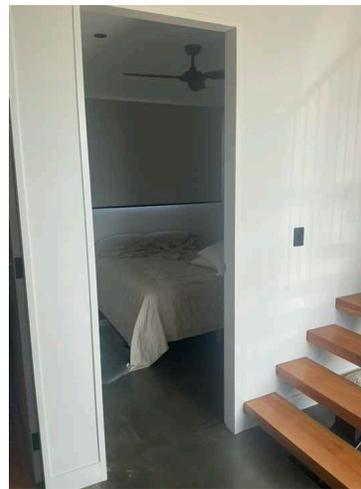
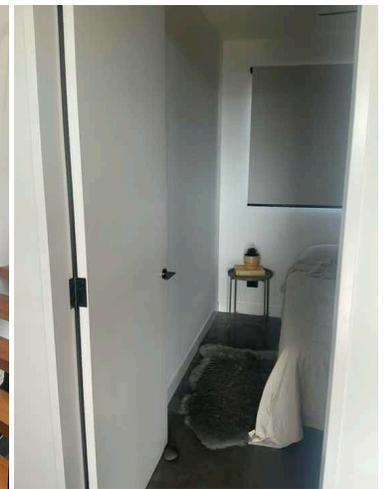
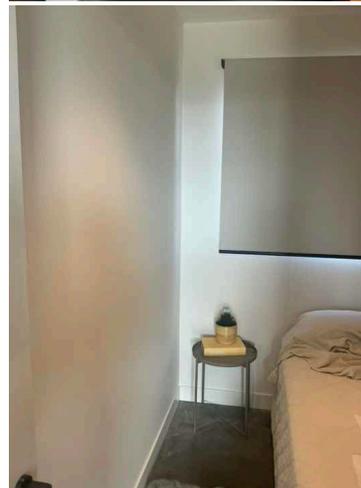
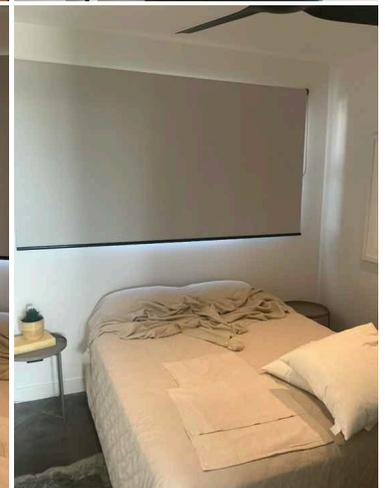
From the visible and accessible areas, this bedroom appears to be in a serviceable condition for the age of the property with no notable structural defects sighted.

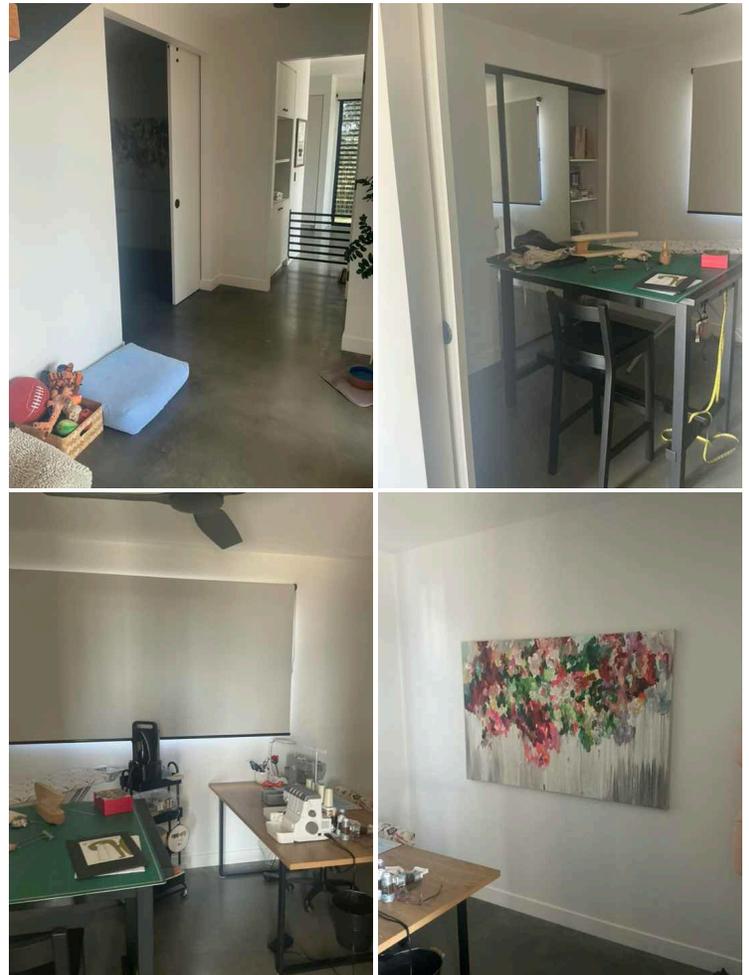
From the visible and accessible areas, this bedroom appears to be in a serviceable condition for the age of the property with no notable structural defects sighted.

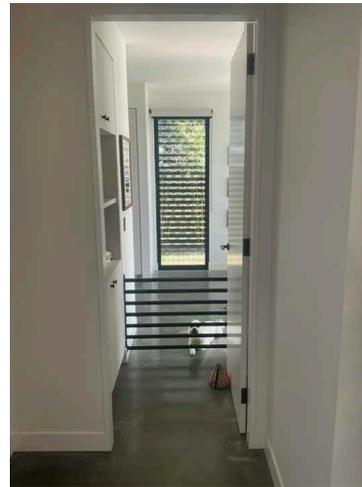
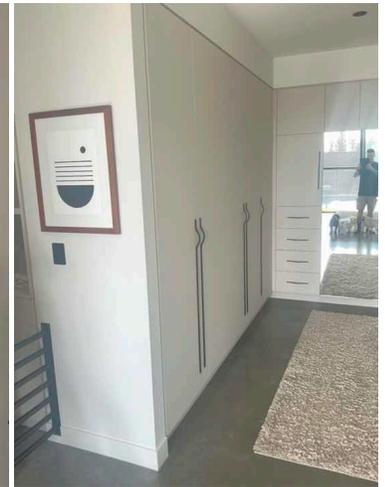
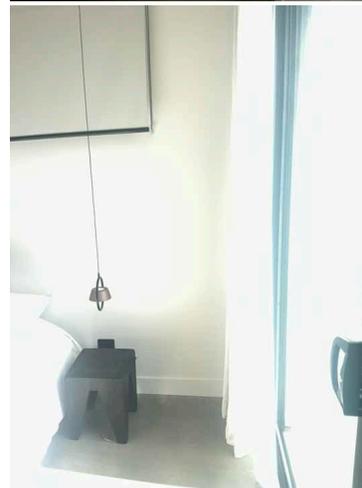
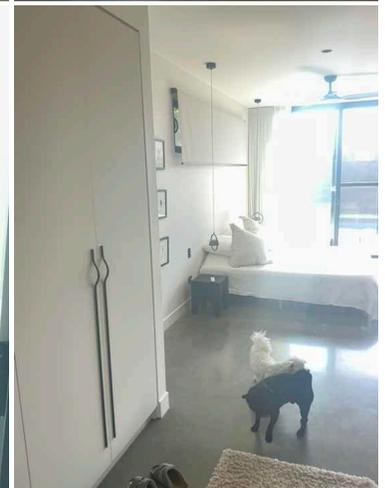
From the visible and accessible areas, this bedroom appears to be in a serviceable condition for the age of the property with no notable structural defects sighted.

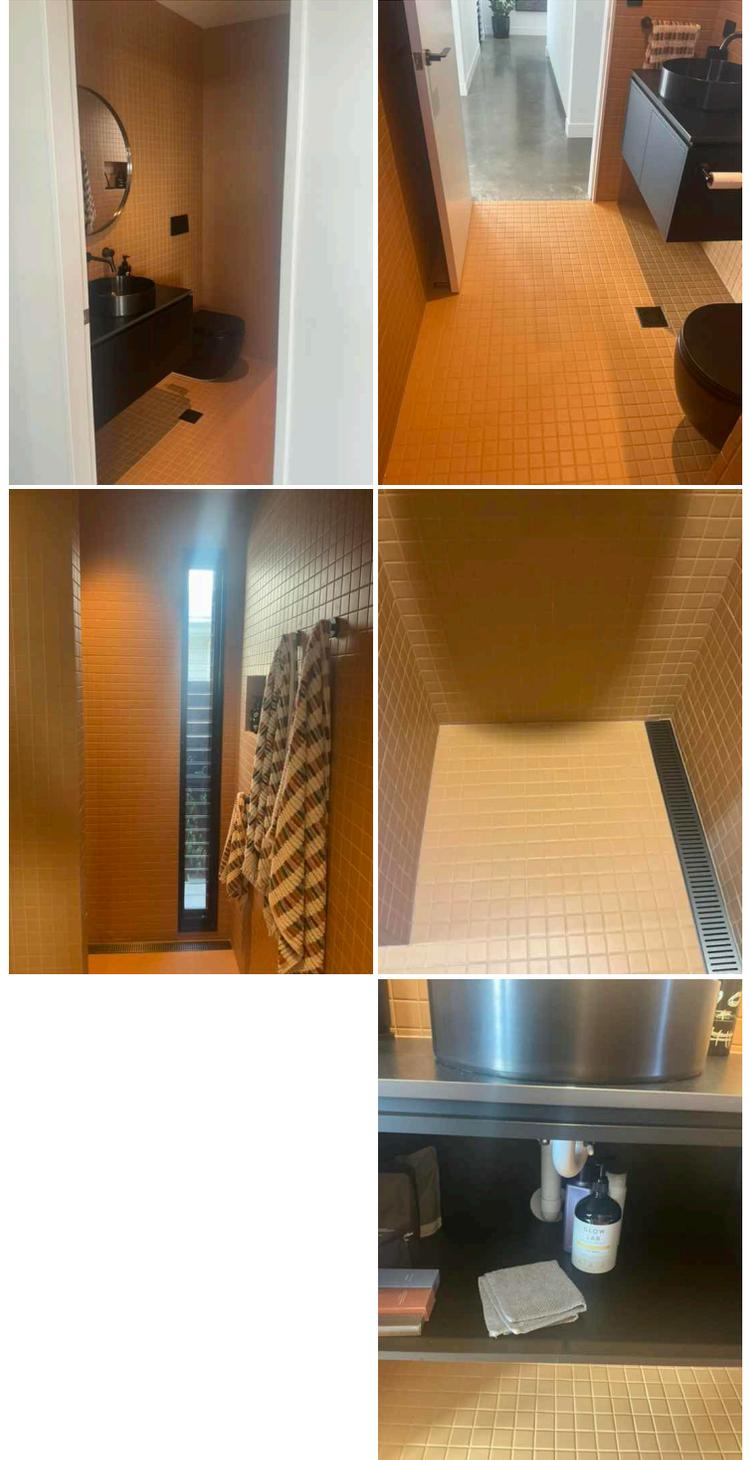
Of the visible areas, the general condition of this bathroom is serviceable or in reasonable condition for age of dwelling.

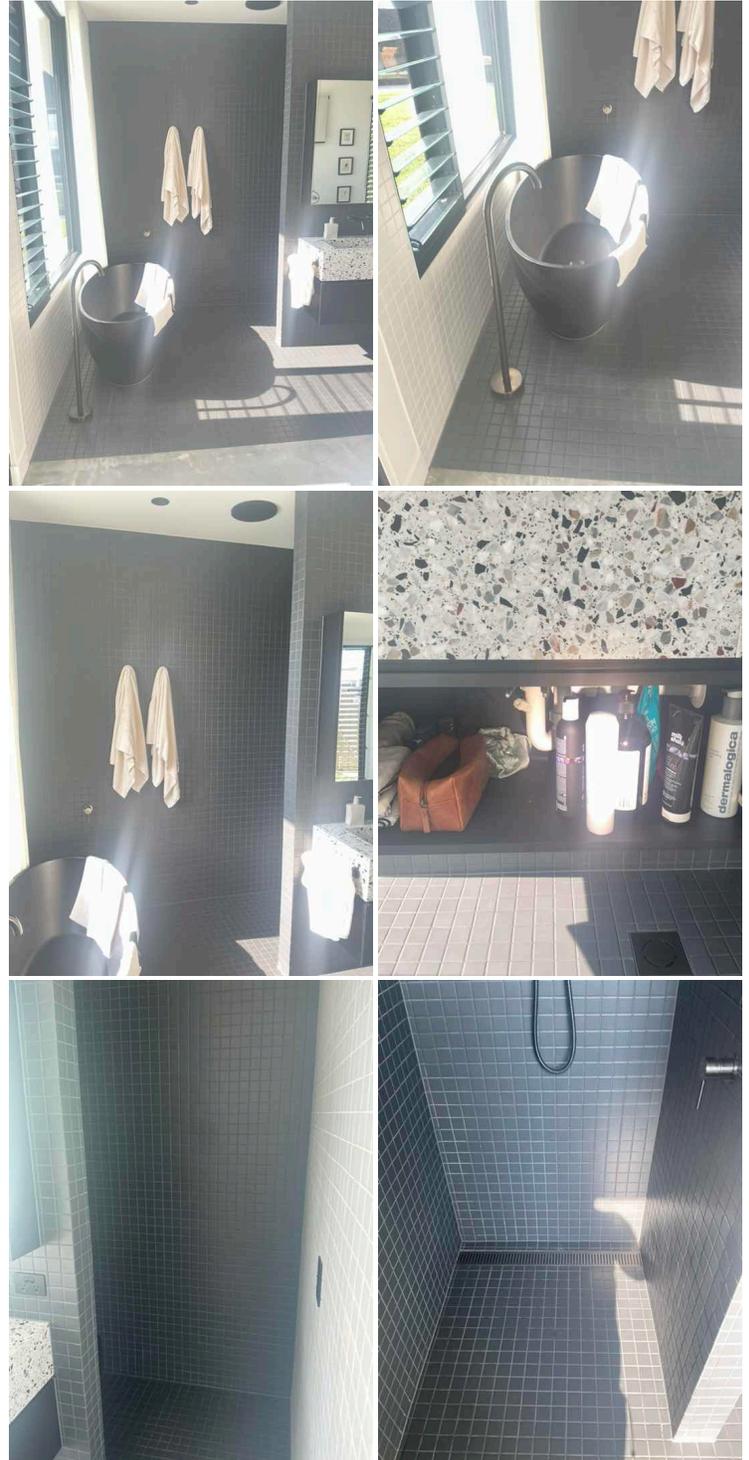
Of the visible areas, the general condition of this bathroom is serviceable or in reasonable condition for age of dwelling.

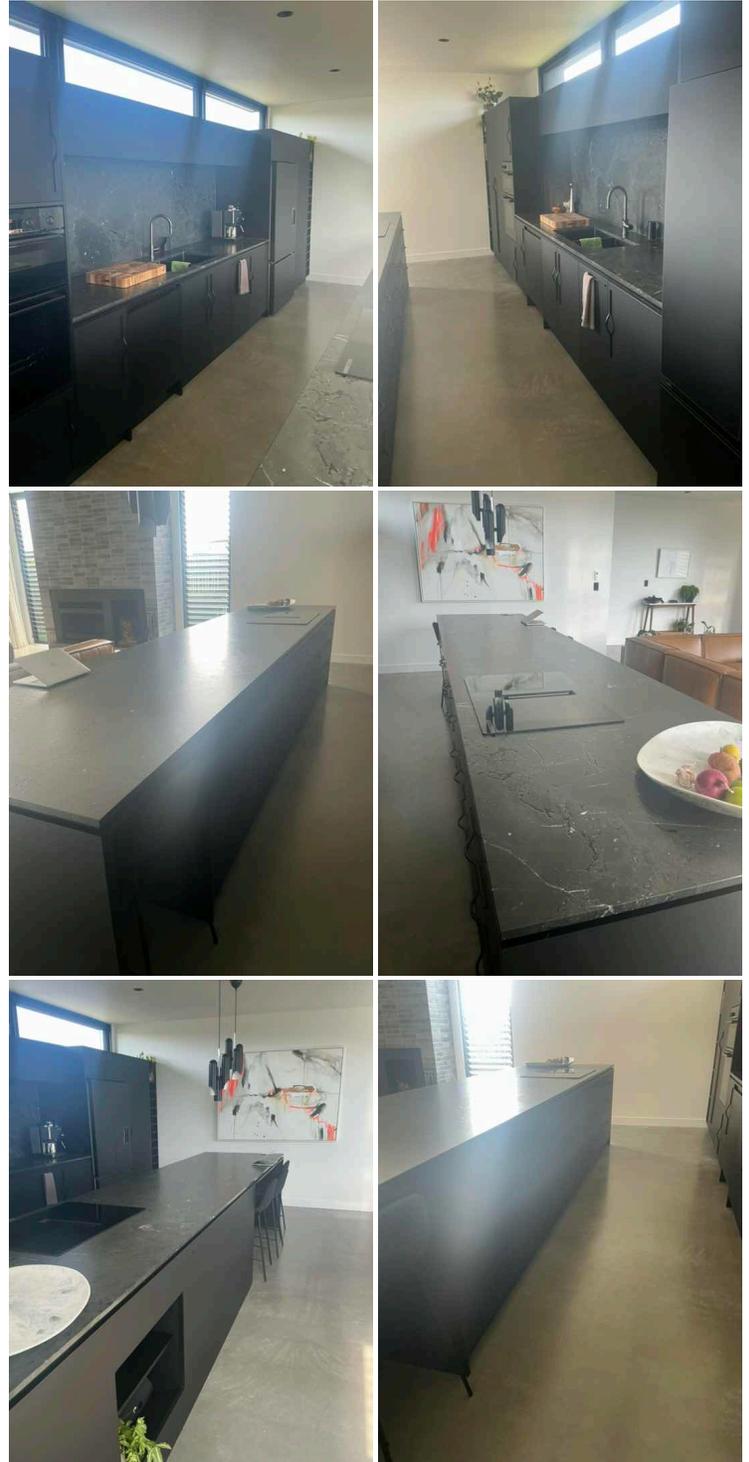
Of the visible areas, the general condition of the kitchen and pantry is serviceable or in reasonable condition for age of dwelling.

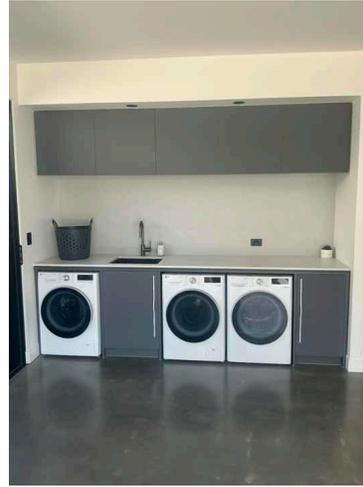
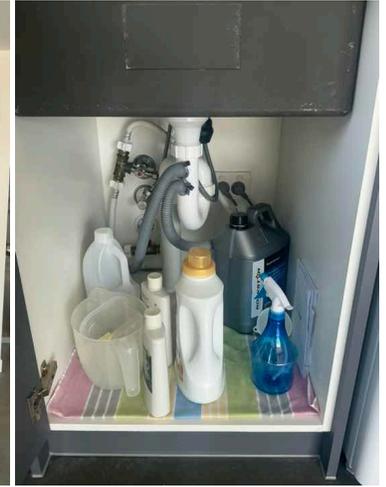
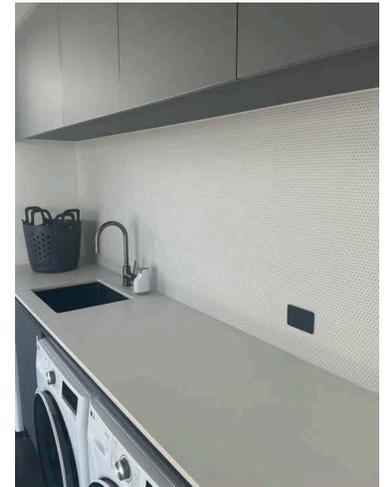
Of the visible areas, the general condition of the laundry is serviceable or in reasonable condition for age of dwelling.

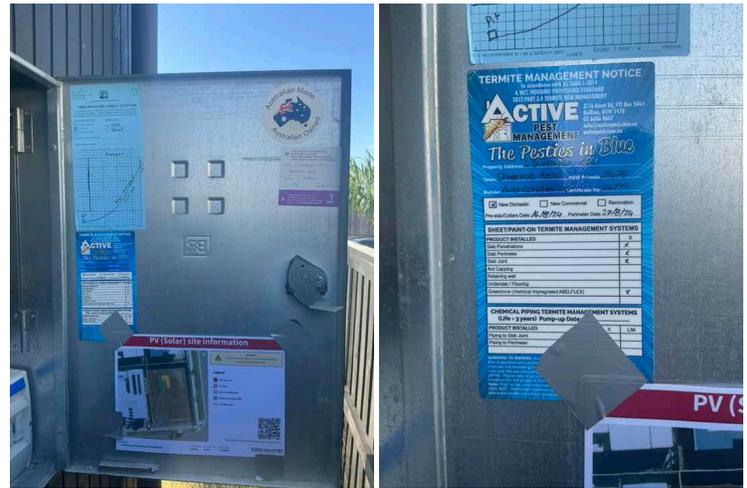
Yes, a durable notice was found in the meter-box during the inspection.
