# Building and Pest Report

## 48 Surf Avenue Lennox Head

| Inspection Date: | 06 Nov 2025 |

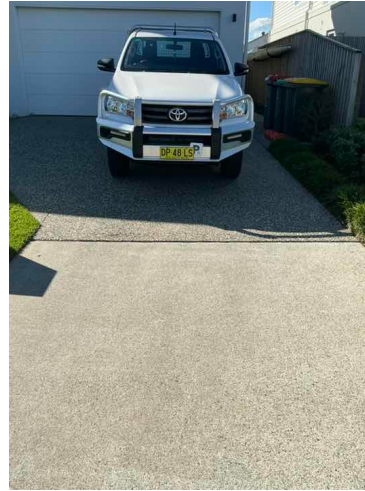
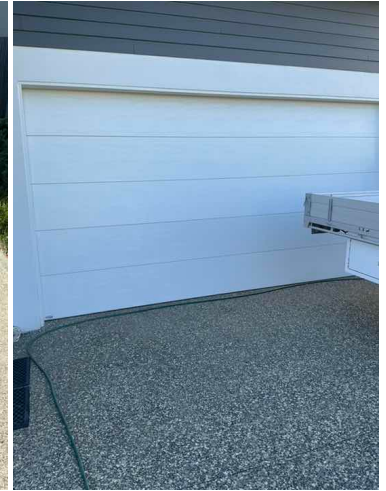
On visual inspection, the general condition of the driveway is serviceable.

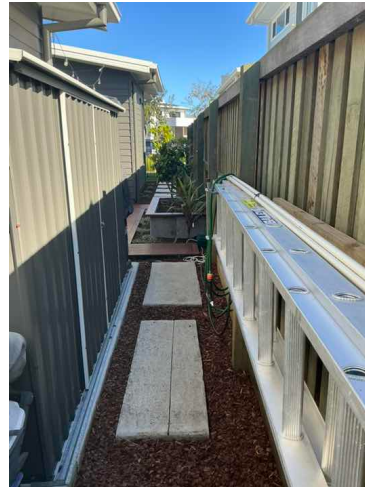
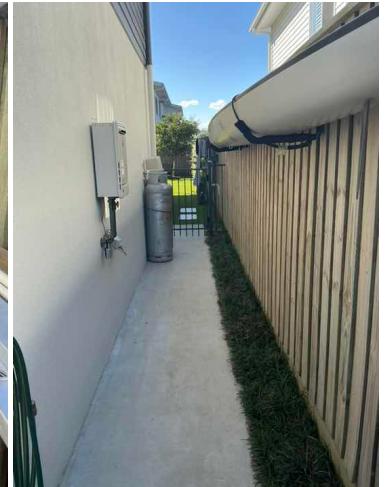
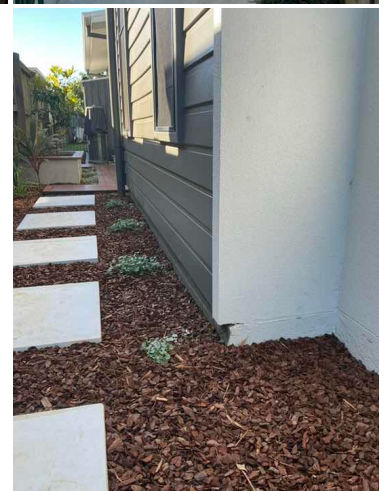
The paths around the home are in a serviceable condition for the age of this dwelling with no major defects visible.

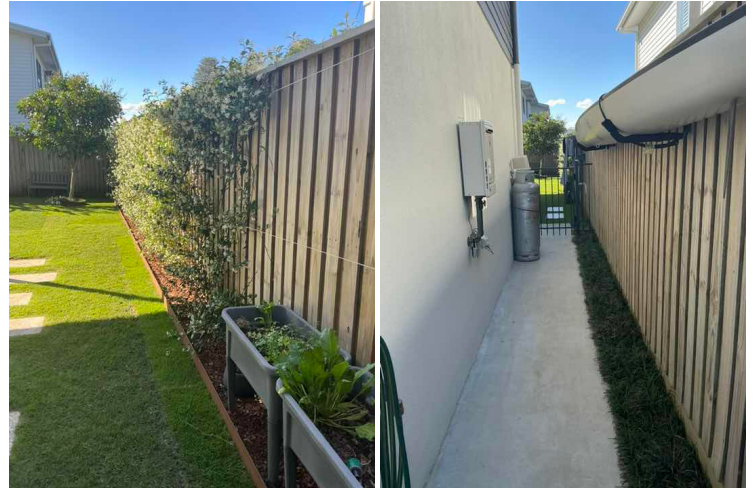
Of the visible areas, the general condition of the fences and gates is serviceable for the age of dwelling.

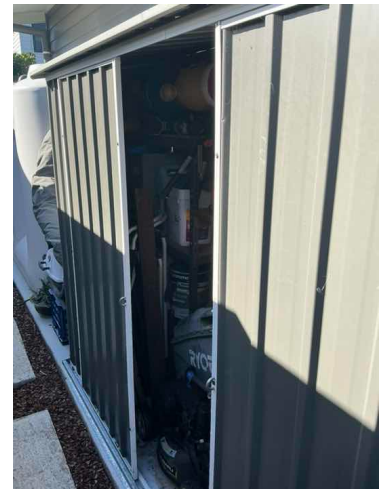
The shed is in fair usable condition.

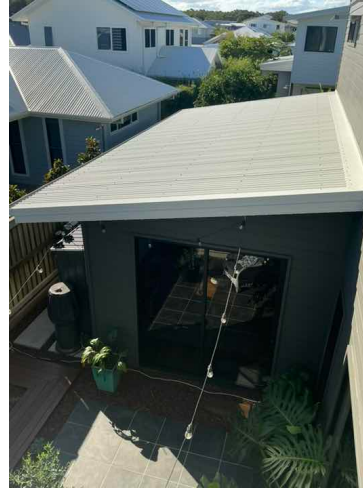
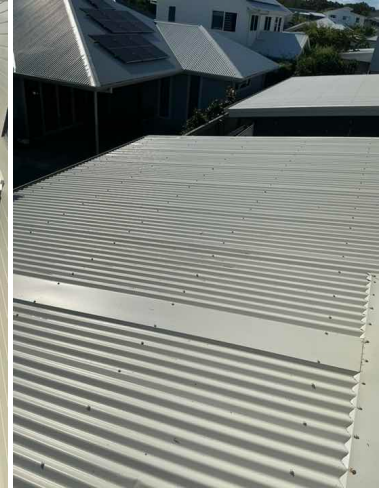
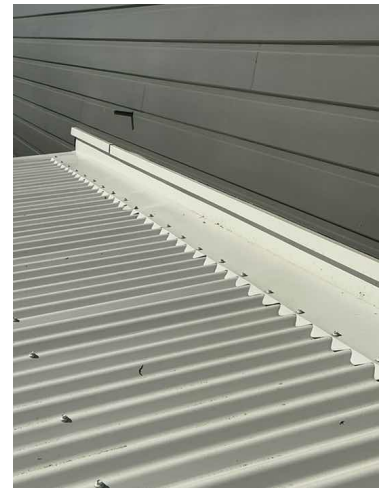
Of the visible areas, the general condition of the roof is in serviceable condition for the age.

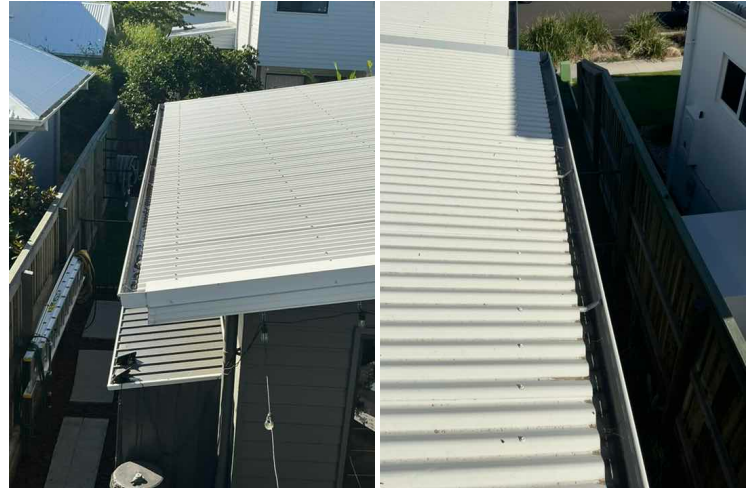
All visible and accessible of the physical nature of the guttering system appears to be in a serviceable condition with no apparent defects at the time of inspection. In the absence of prolonged rain fall efficiency of the guttering can not be assessed and you may find that further investigation or repairs maybe required. Note: Periodic maintenance checks should be carried out for rust penetrations and leaks.

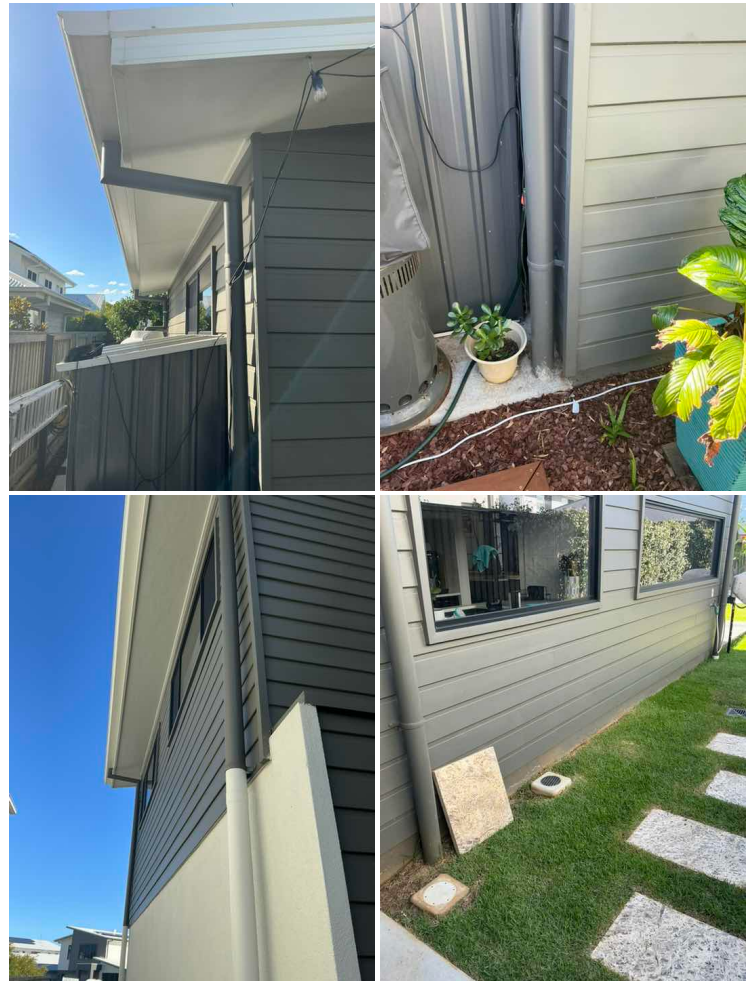
On visual inspection no apparent defects were noted to the down pipes and are considered serviceable, however no comment can be made with regard to blockages or connections to stormwater or functionality in the absence of rain. Note: Periodic maintenance checks should be carried out for rust penetrations and leaks.

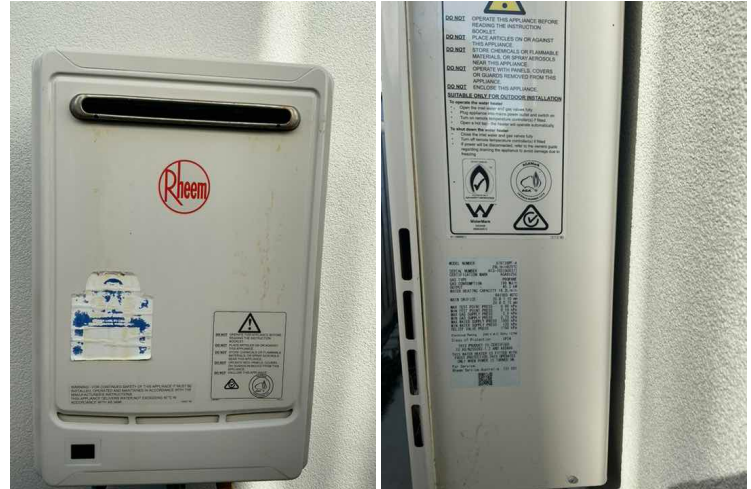
The hot water system appears to be in a serviceable condition. No specific tests other than running the hot water from a tap was carried out. No determination has been made as to the suitability or adequacy of the hot water system in relation to capacity or otherwise.

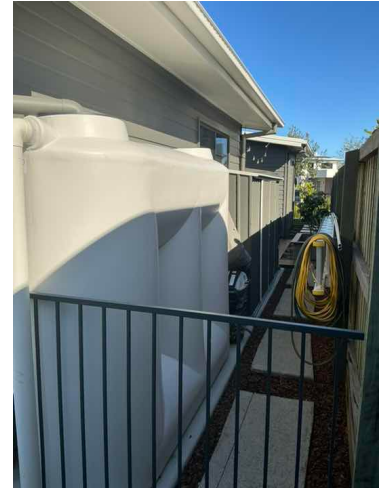
On Visual Inspection the water tank appears serviceable, but should be checked by a qualified plumber.

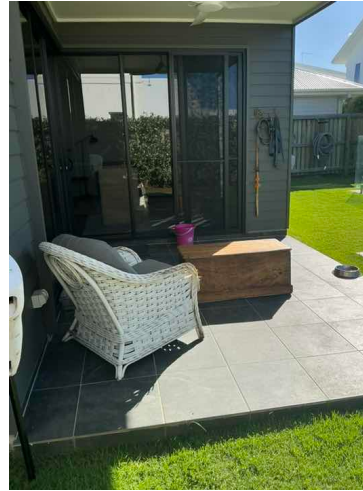
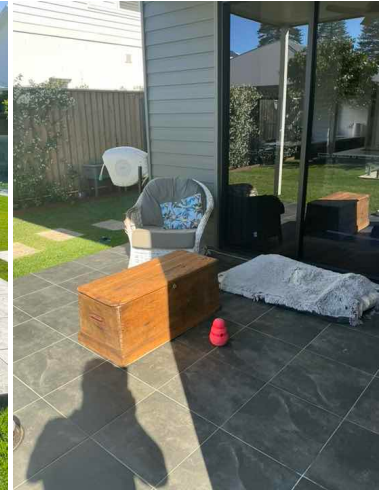
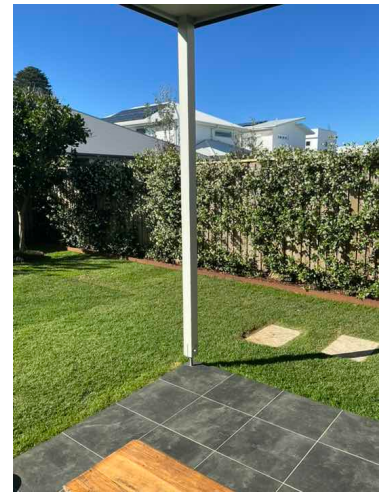
Visible sections of the Alfresco area are serviceable or in reasonable or condition for the age of this dwelling.

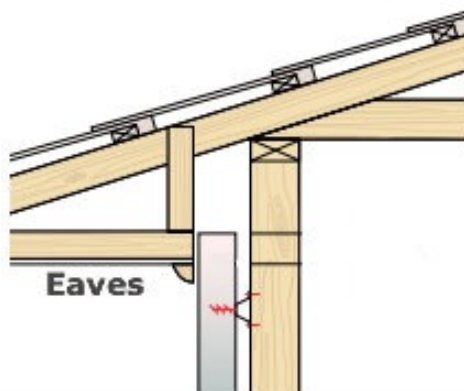
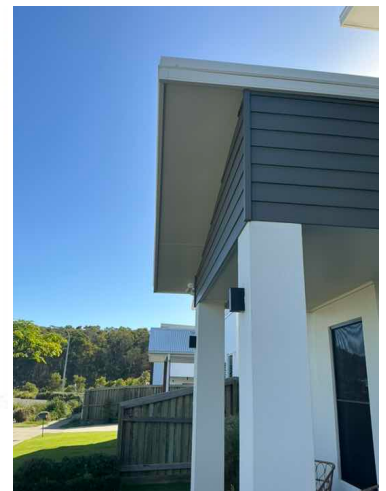
The soffit lining (eaves) are in a serviceable condition with no notable defects.

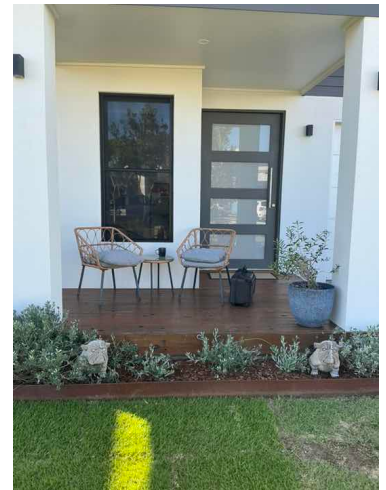
The entry porch serviceable or in reasonable or condition for the age of this dwelling.

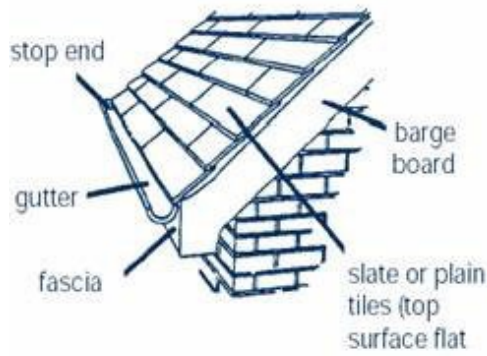
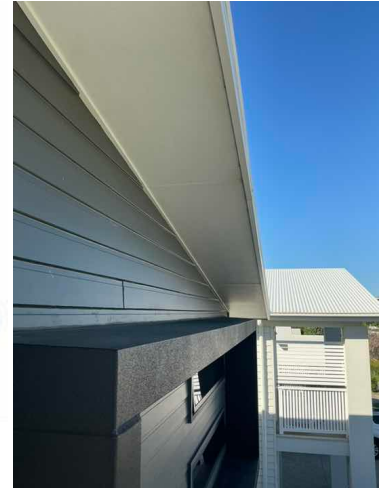
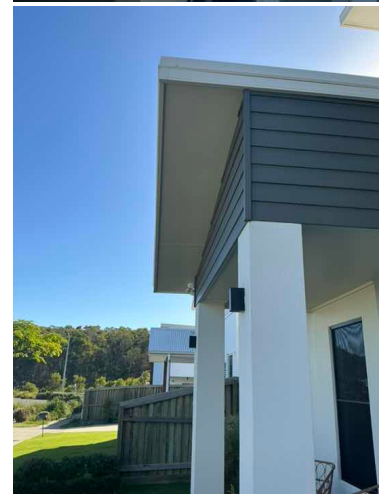
On visual inspection, the general condition of the fascia/barge boards is serviceable.

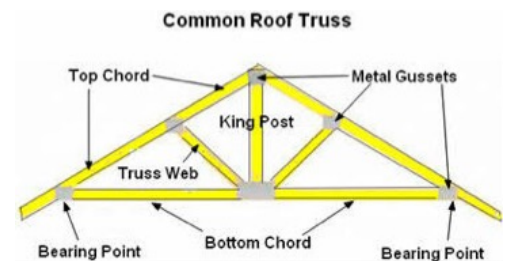
Viewed from out side due to restricted entry. No comment can be made regarding condition

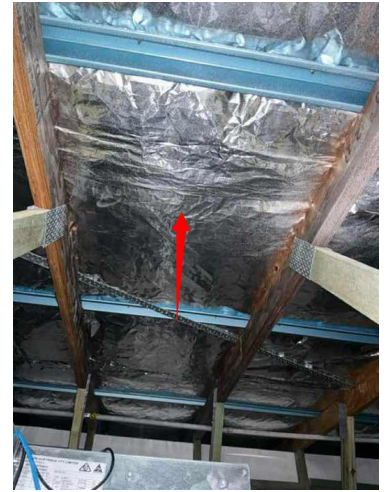
The sarking generally is in a serviceable condition.
