Inspection Report

Naraic Building & Pest Inspections Pty Ltd

Inspection Address

6 Cowrie St, Lennox Head, NSW, 2478

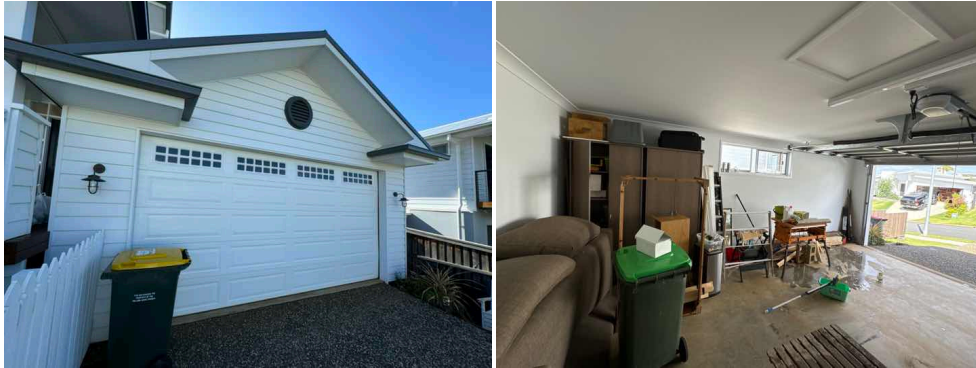
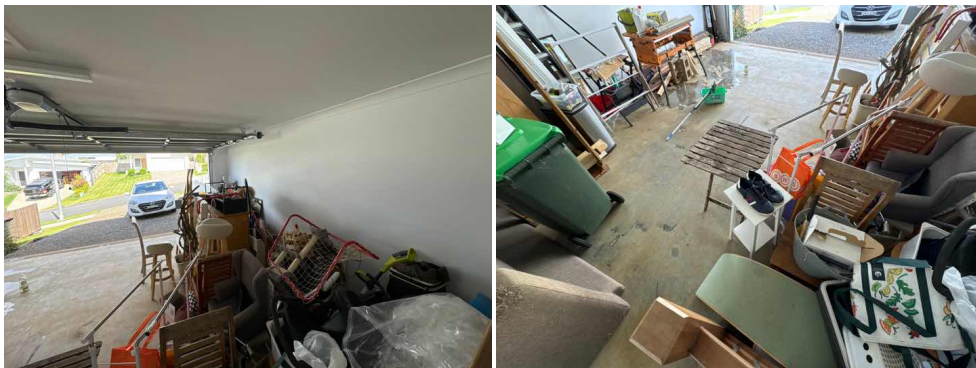
From the visible and accessible areas, the garage appears to be in a serviceable condition for the age of the property with no notable structural defects sighted.

Binding garage door - This can relate to differential settlement in the footings, frame movement, age and the like. It can also be seasonal where it may bind for some months and then open and close sufficiently. A qualified carpenter should be engaged for advice and recommendations.

Loose door handle

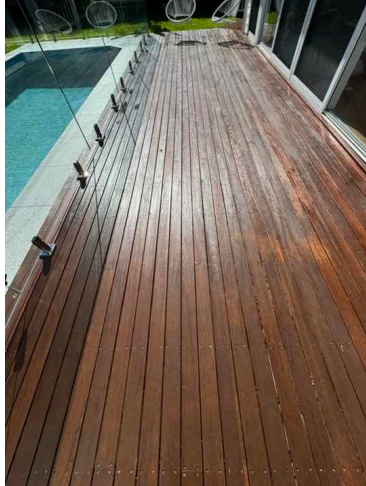
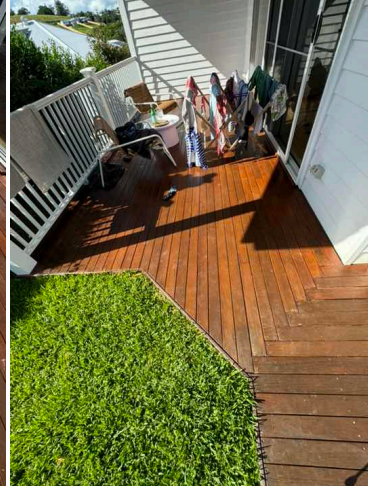
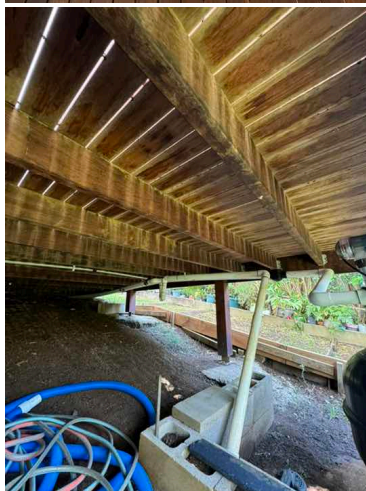
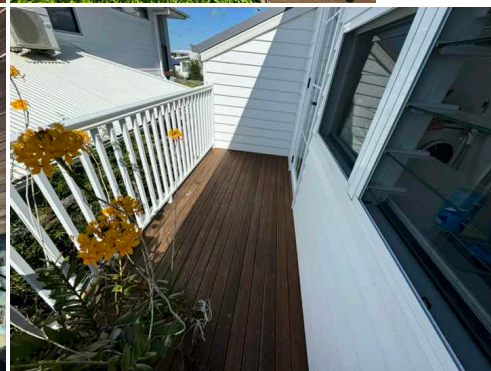
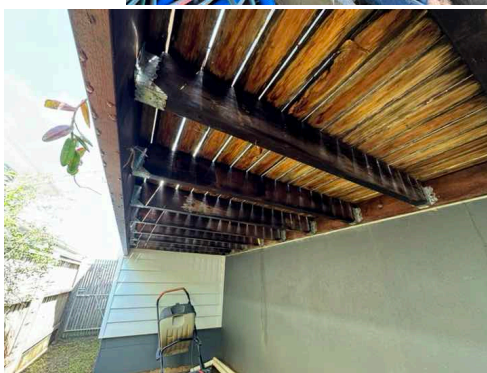
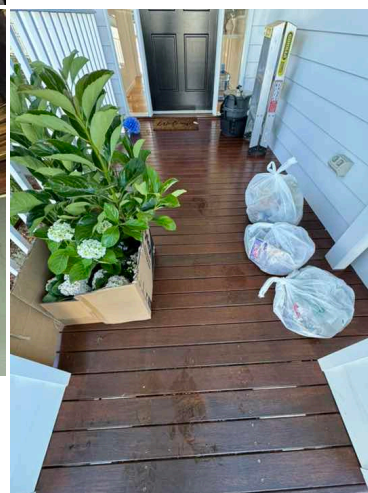
Of areas visible, minor defects and/or maintenance issues were visible. These will require assessment and subsequent repairs by a licensed tradesperson. Please read below for details. Please note that the inspector believes these to be of a minor nature relative to the age of the dwelling and or lack of proper and continual maintenance. Others, including other inspectors may differ in their opinions.

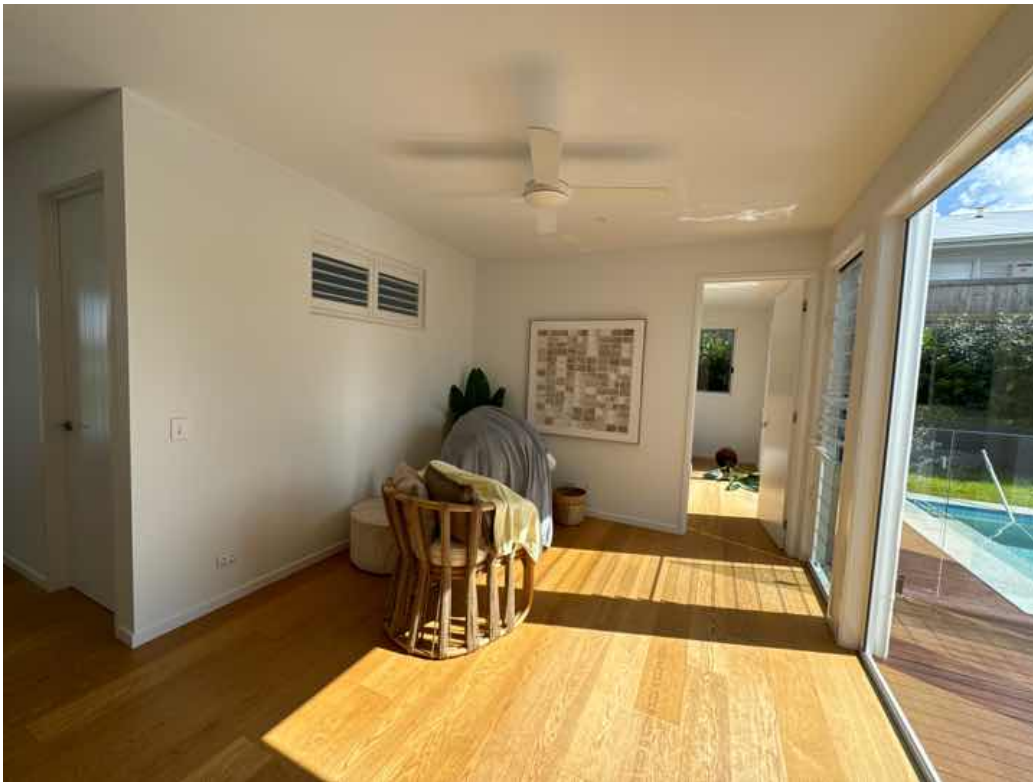
Settlement Cracks Noted. These are typical and generally patch and paint will suffice, however monitoring these cracks is advised for 12 months and if they become worse, further investigation by a suitably qualified professional is advised.

From the visible and accessible areas, this room appears to be in a serviceable condition for the age of the property with no notable structural defects sighted.

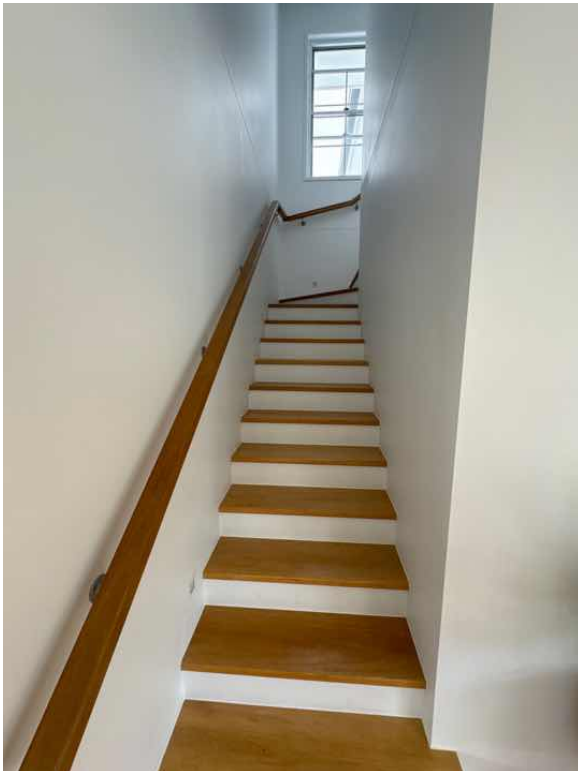
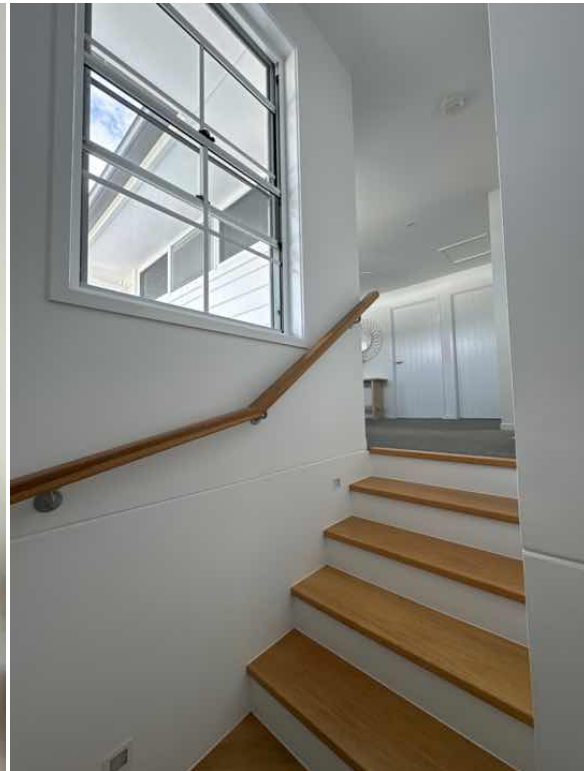
Internal Stair Case

The internal staircase and components appear to be in a serviceable condition for the age with no notable defects sighted.

The stair treads squeak and require maintenance.

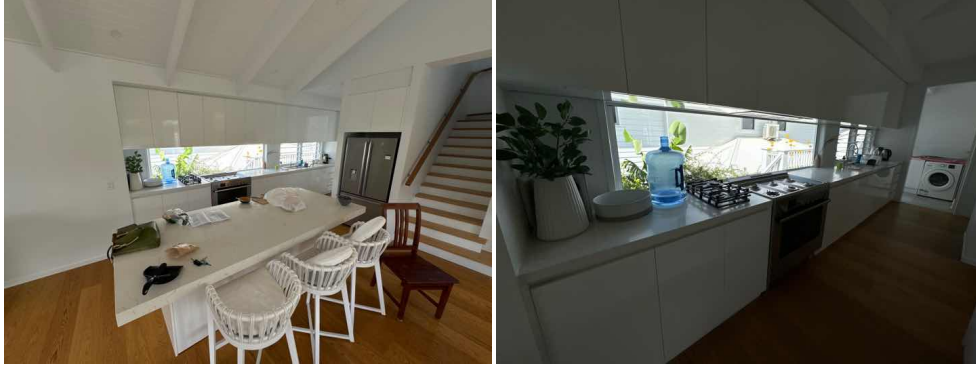
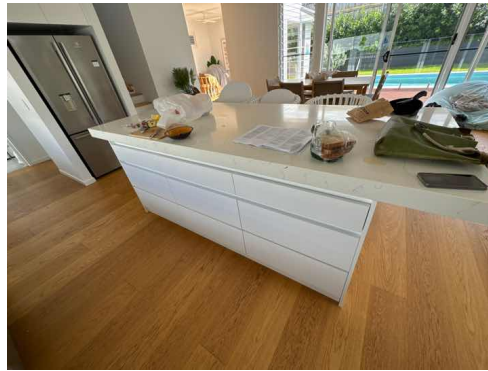
Of the visible areas, the general condition of the kitchen and pantry is serviceable or in reasonable condition for age of dwelling.

Adjustment to cabinet doors required, in some instance hinges may need to be replaced.

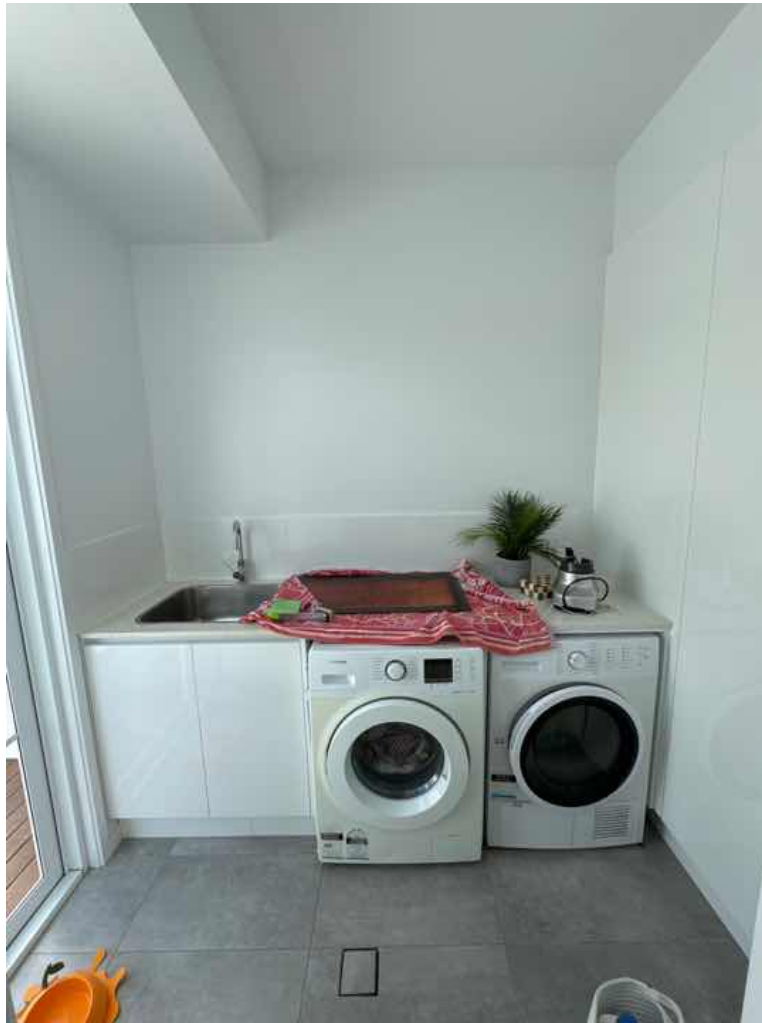
Of the visible areas, the general condition of the laundry is serviceable or in reasonable condition for age of dwelling.

Binding door - Doors that bind on the frame can relate to some differential settlement, frame movement, age, expansion, shrinkage or poor hanging. A qualified carpenter should be engaged for repairs.

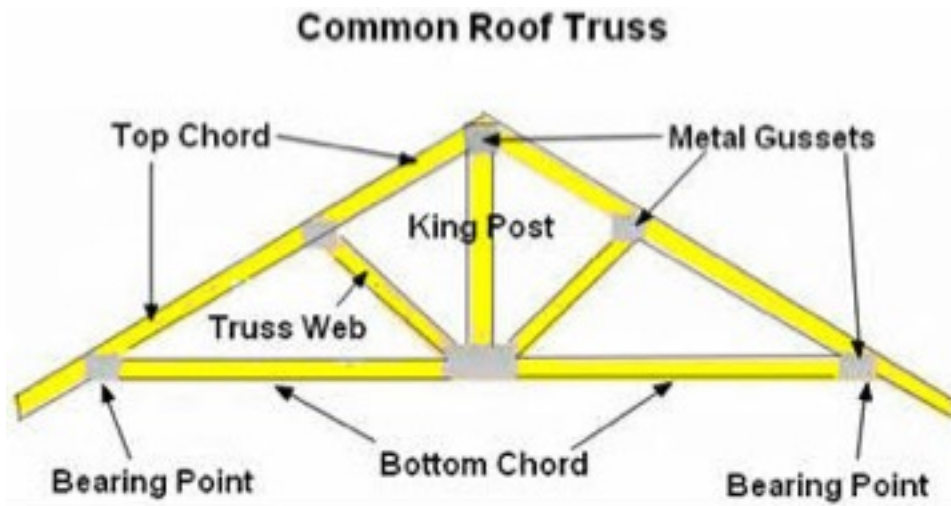
The roof frame is a truss timber frame.

Visible sections of the roof void is in a serviceable condition for age of this dwelling.
