Building and Pest Report

12 Bentwing Place Tintenbar

Inspection Report

12 Bentwing Place, Tintenbar , NSW , 2478

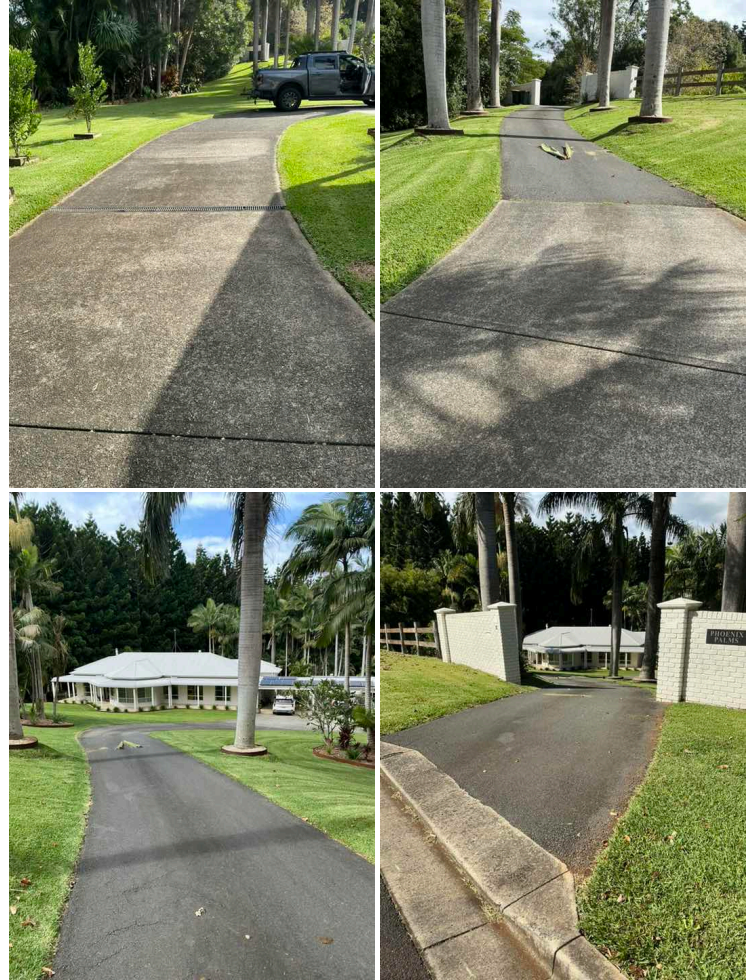
Driveway Condition

On visual inspection, the general condition of the driveway is serviceable.

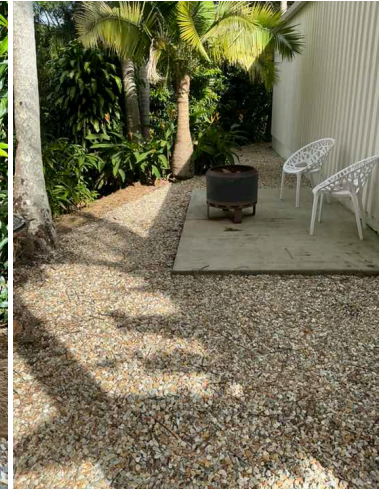
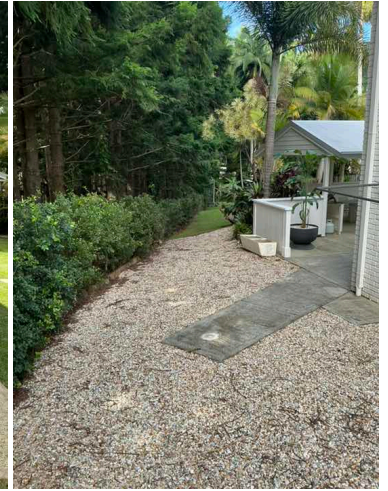
Pathways Condition

The paths around the home are in a serviceable condition for the age of this dwelling with no major defects visible.

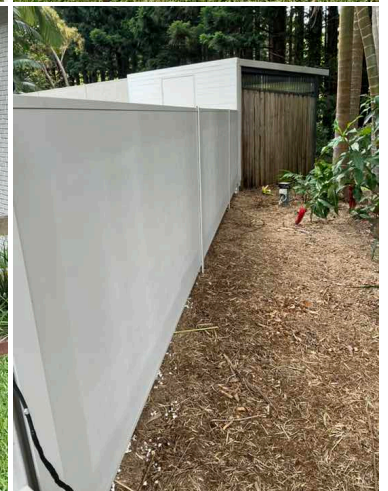
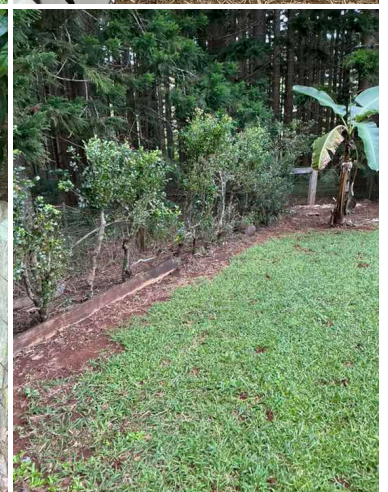
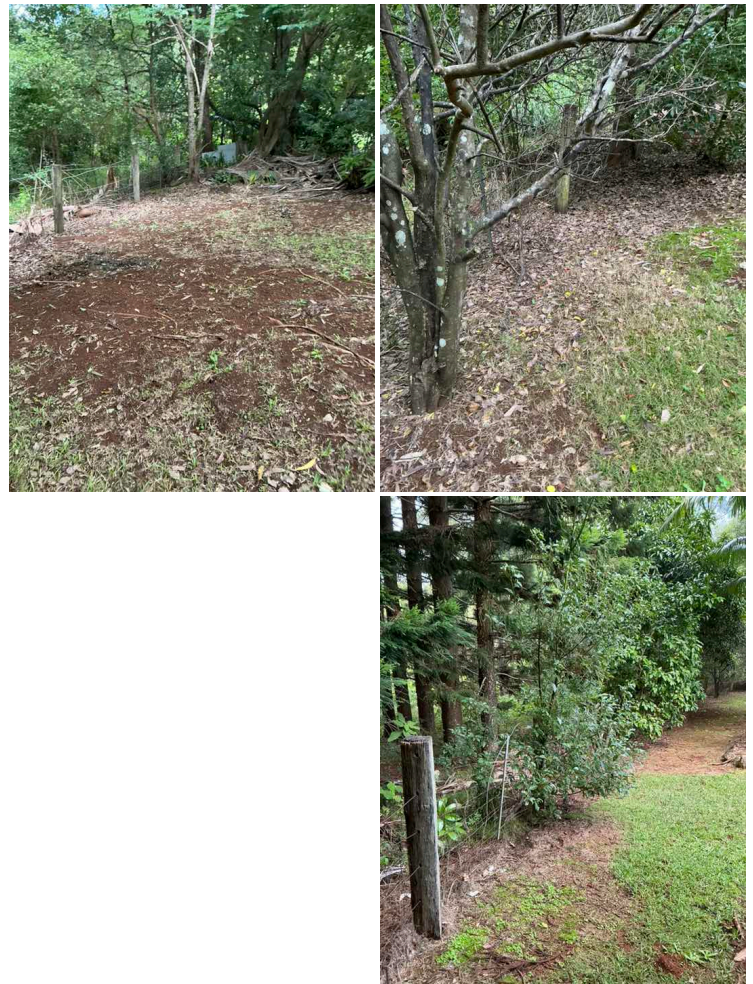
Overall Condition

Of the visible areas, the general condition of the fences and gates is serviceable for the age of dwelling.

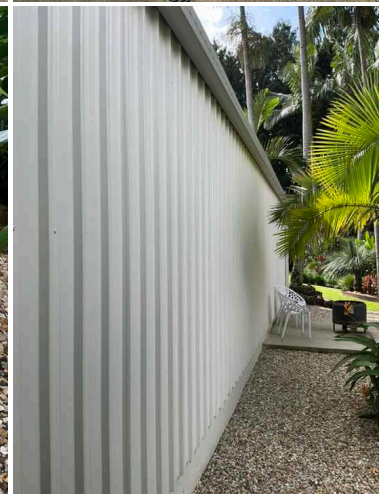
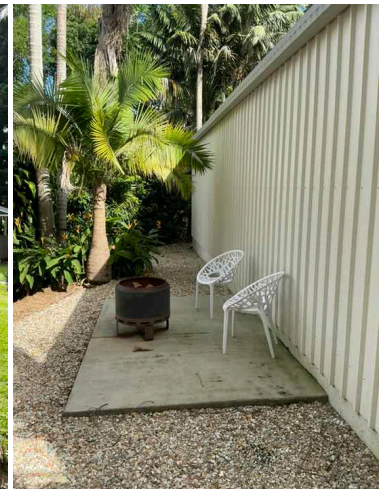
Shed Condition

The shed is in fair usable condition.

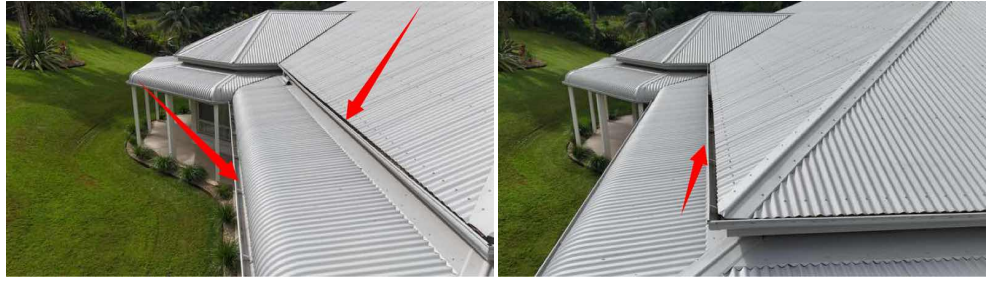
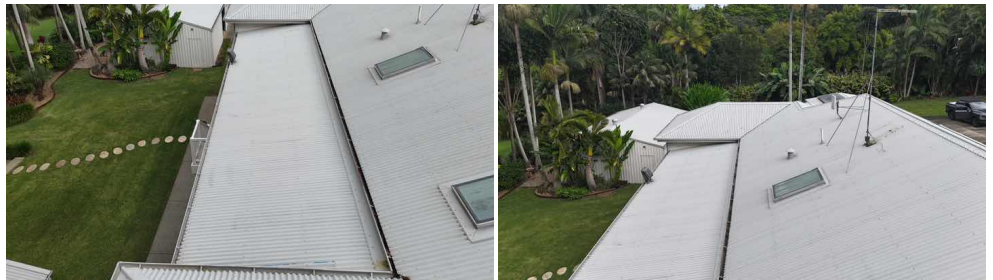
Gutter Findings

All visible and accessible of the physical nature of the guttering system appears to be in a serviceable condition with no apparent defects at the time of inspection. In the absence of prolonged rain fall efficiency of the guttering can not be assessed and you may find that further investigation or repairs maybe required. Note: Periodic maintenance checks should be carried out for rust penetrations and leaks.

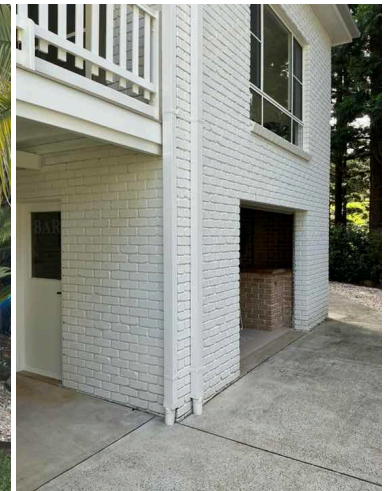
Downpipe Findings

On visual inspection no apparent defects were noted to the down pipes and are considered serviceable, however no comment can be made with regard to blockages or connections to stormwater or functionality in the absence of rain. Note: Periodic maintenance checks should be carried out for rust penetrations and leaks.

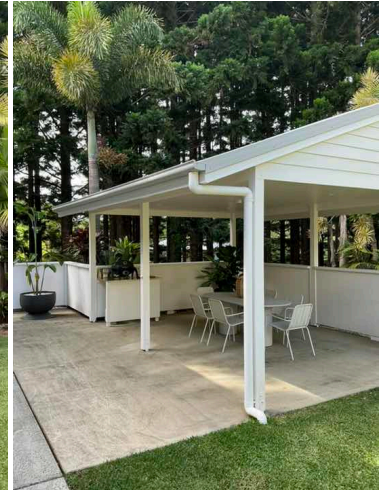
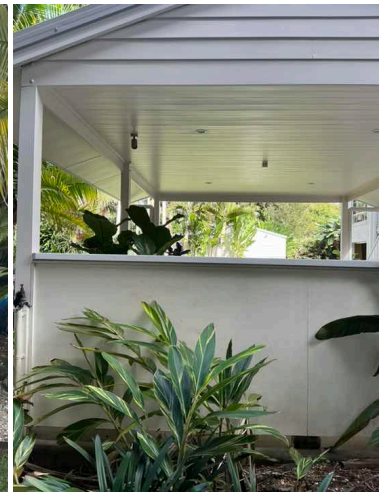
Overall Condition

Visible sections of the Alfresco area are serviceable or in reasonable or condition for the age of this dwelling.

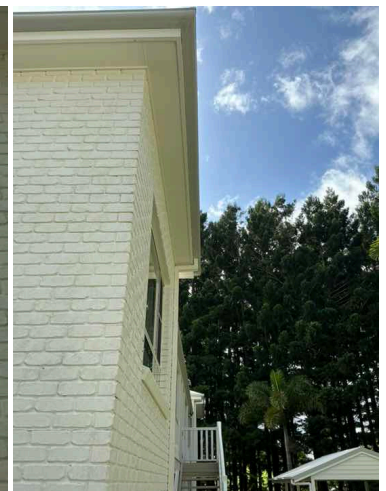
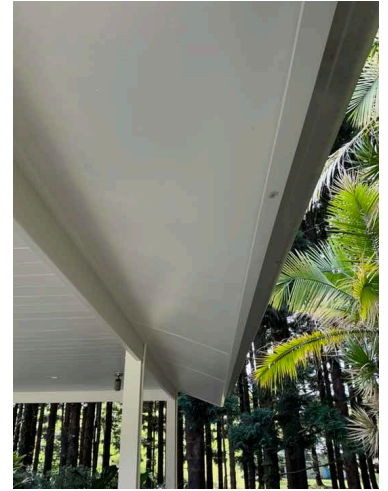
Eave Condition

The soffit lining (eaves) are in a serviceable condition with no notable defects.

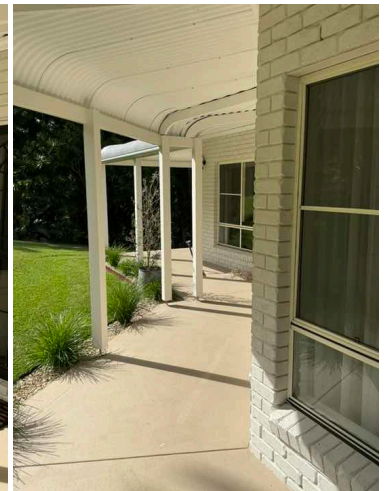
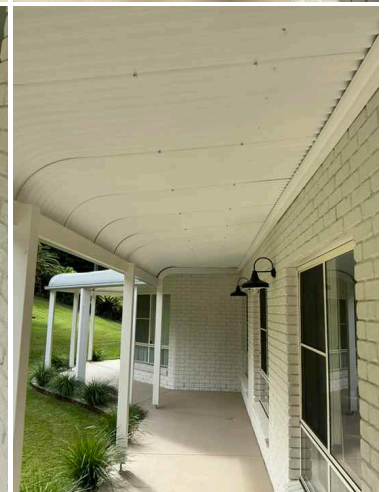
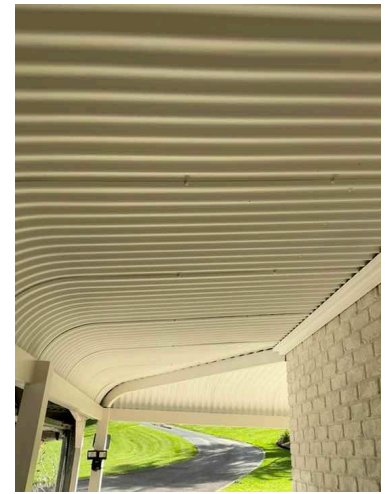
Overall Condition

The entry porch serviceable or in reasonable or condition for the age of this dwelling.

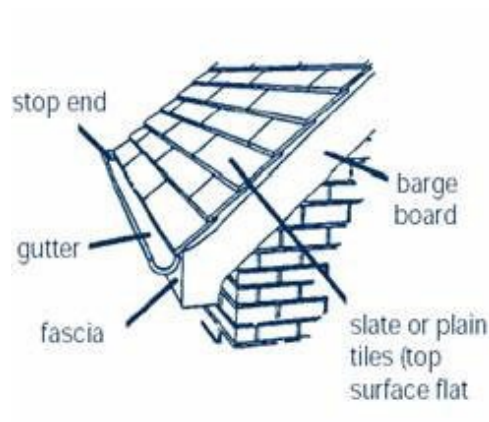
Condition

On visual inspection, the general condition of the fascia/barge boards is serviceable.

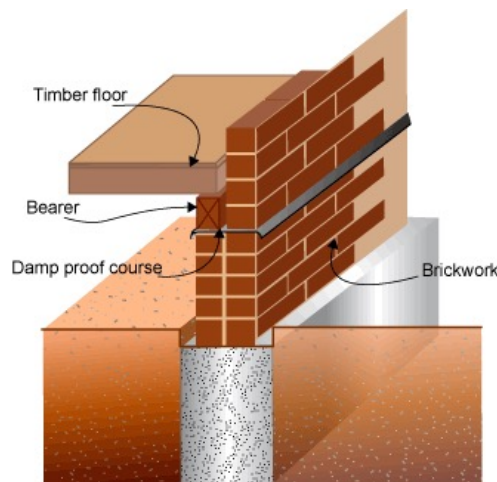
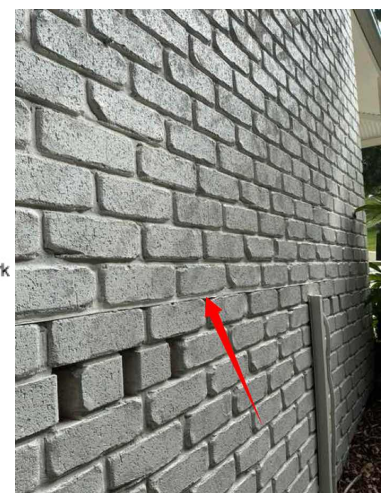
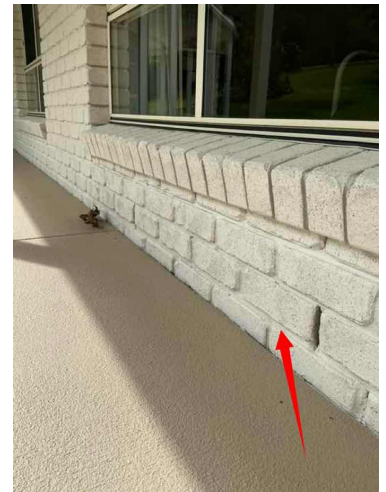
Damp Proof Course

A damp proof course (DPC) was noted.

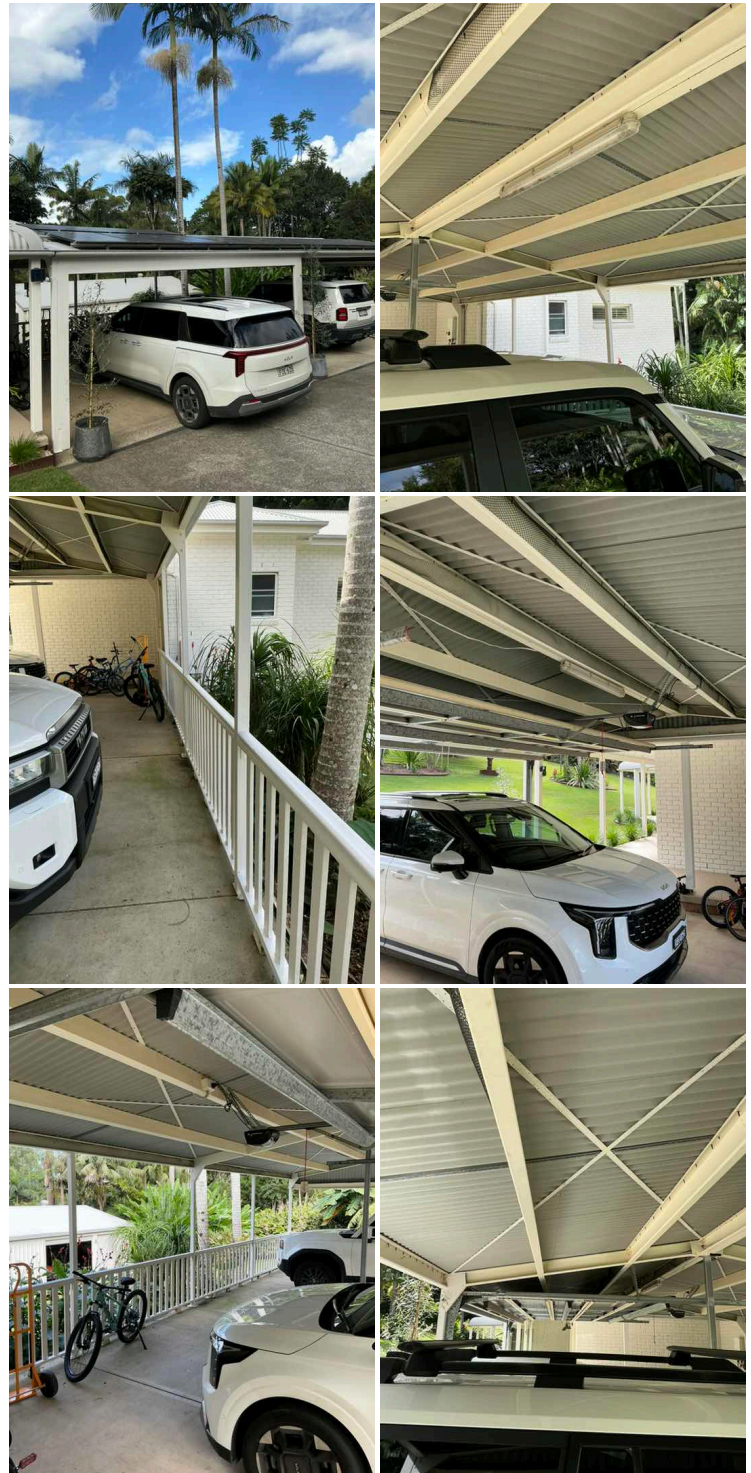
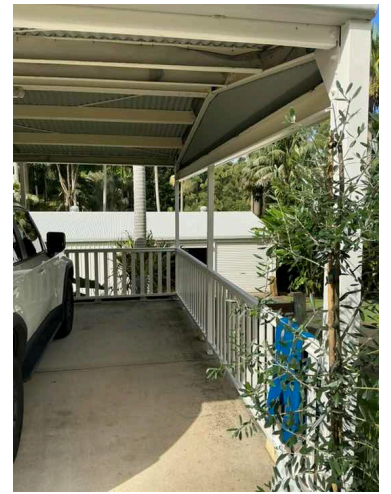
Overall Condition

The overall condition of the carport is serviceable for the age.

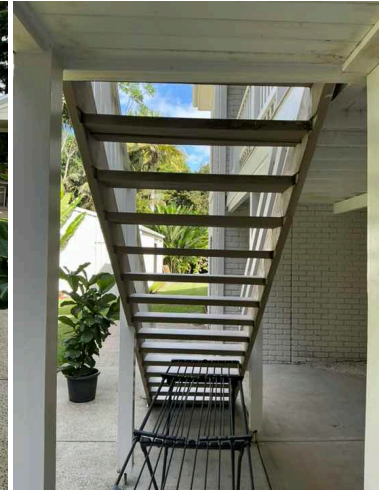
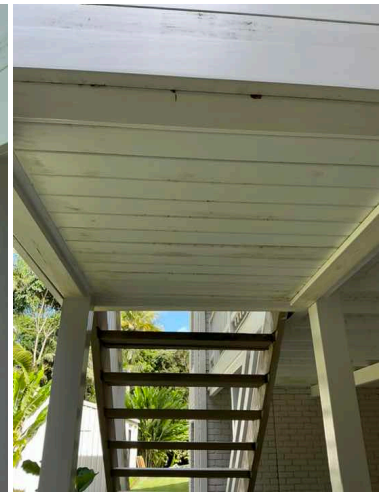
Overall Condition

The stairs/steps appear to be serviceable with no notable defects.

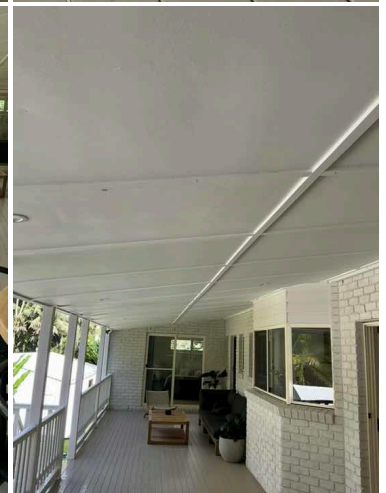
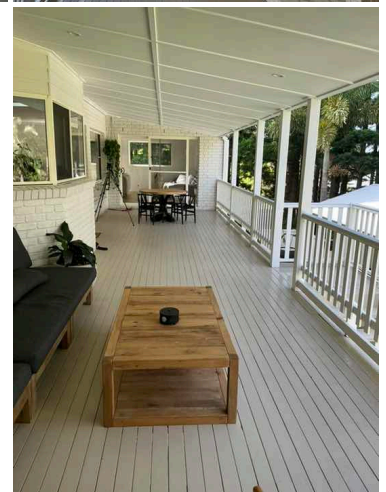
Overall Condition

Though we are not structural engineers the balcony/s appear to be in a serviceable condition.

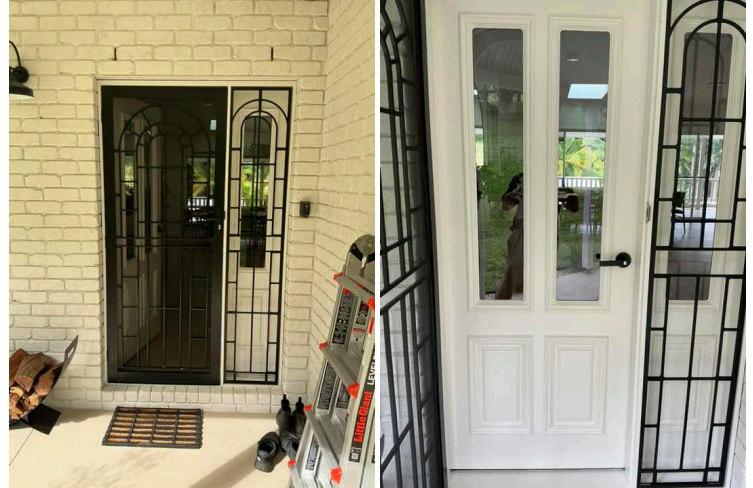
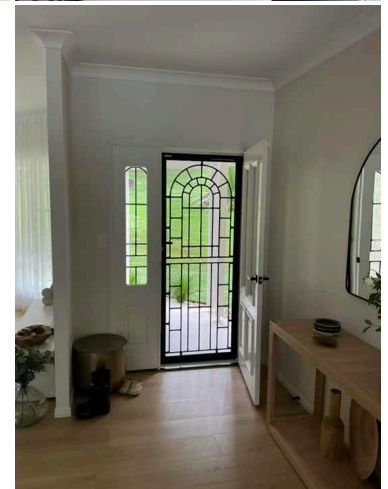
Front Entry Doors

The doors are in serviceable condition with no notable defects observed.

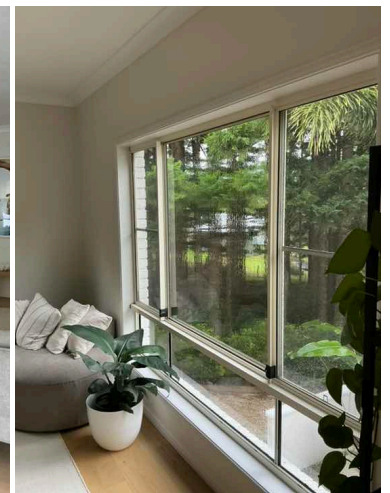
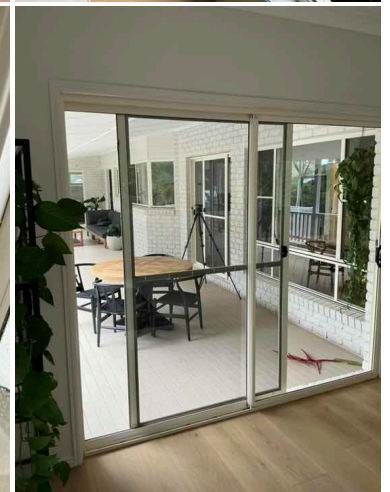
Combined Living & Dining

From the visible and accessible areas, this room appears to be in a serviceable condition for the age of the property with no notable structural defects sighted.

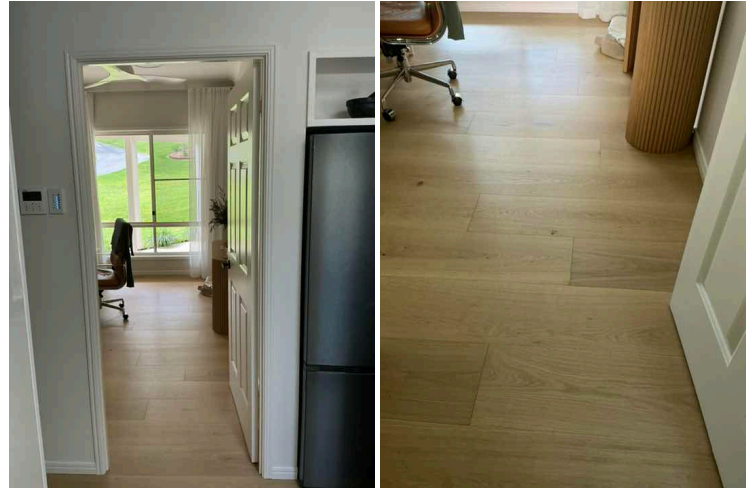
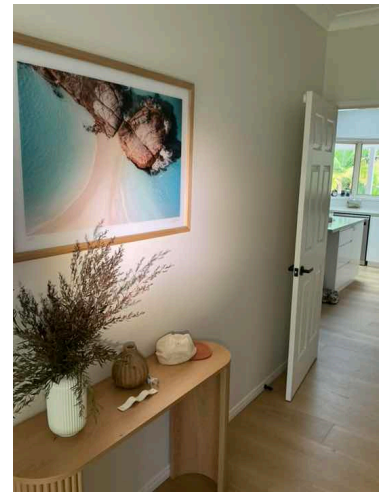
Study

From the visible and accessible areas, this room appears to be in a serviceable condition for the age of the property with no notable structural defects sighted.

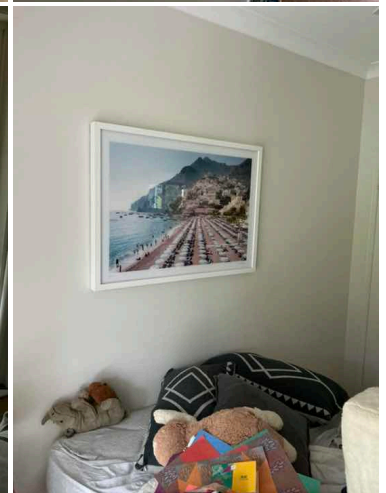
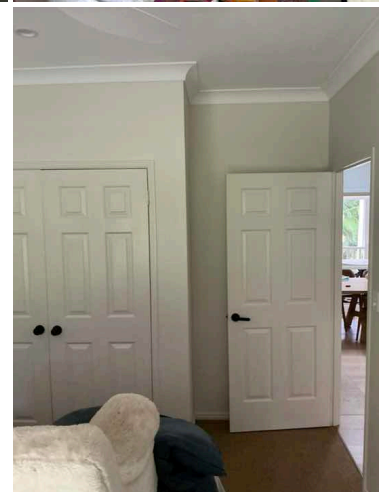
Bedroom 1

From the visible and accessible areas, this bedroom appears to be in a serviceable condition for the age of the property with no notable structural defects sighted.

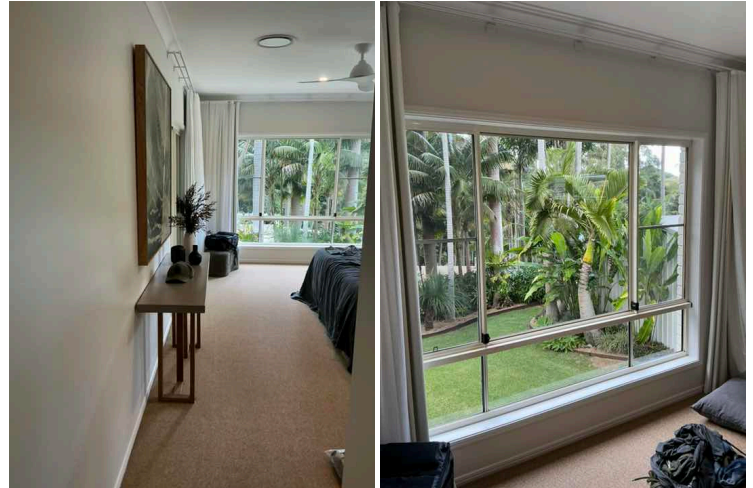
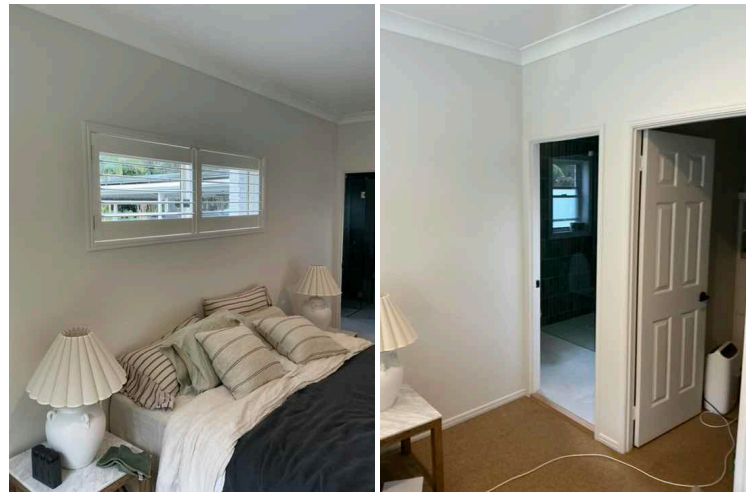
Bedroom 2

From the visible and accessible areas, this bedroom appears to be in a serviceable condition for the age of the property with no notable structural defects sighted.

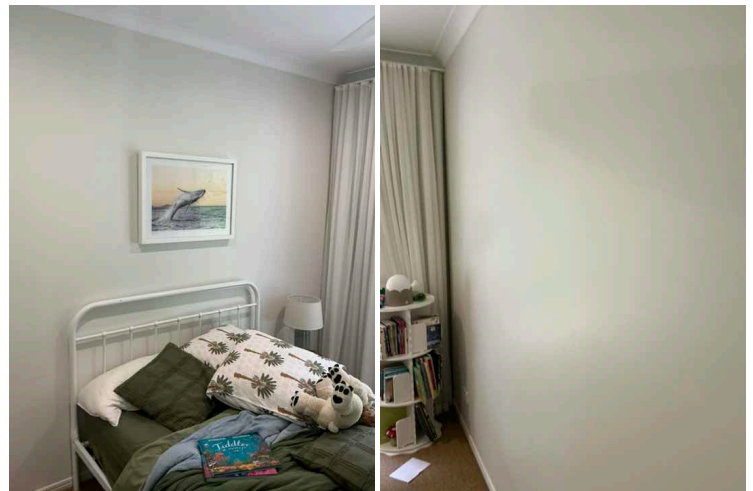
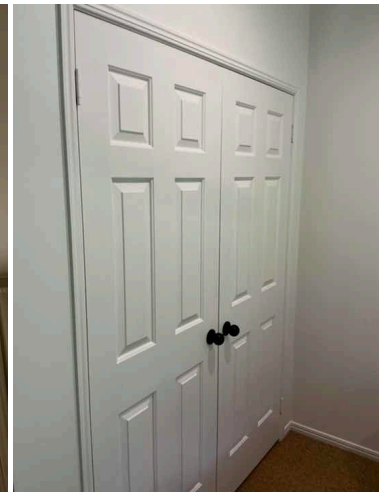
Bedroom 3

From the visible and accessible areas, this bedroom appears to be in a serviceable condition for the age of the property with no notable structural defects sighted.

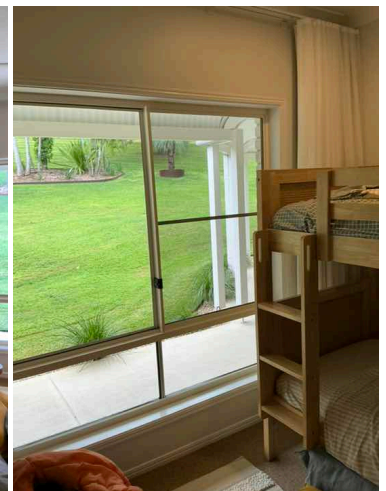
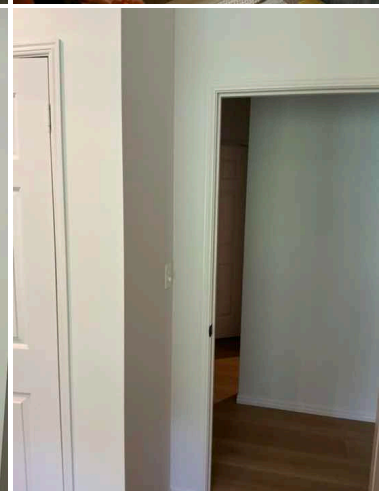
Bedroom 4

From the visible and accessible areas, this bedroom appears to be in a serviceable condition for the age of the property with no notable structural defects sighted.

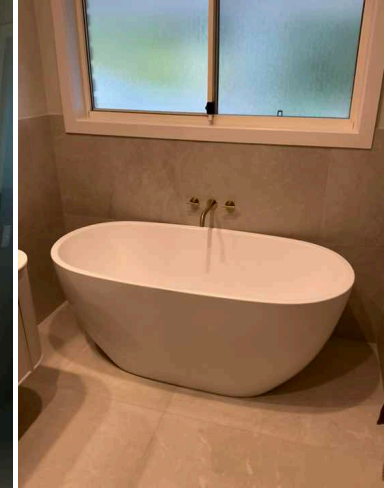
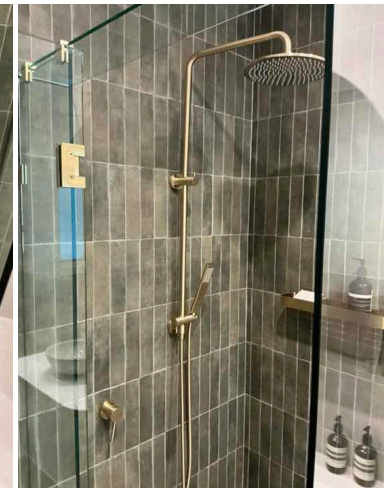
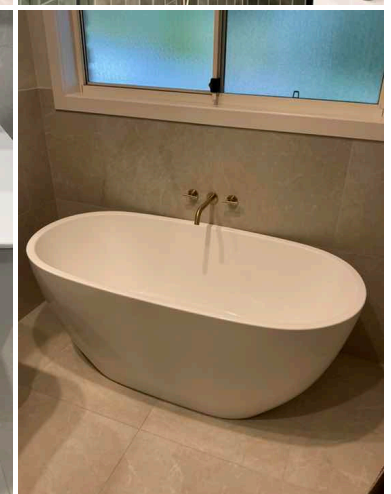
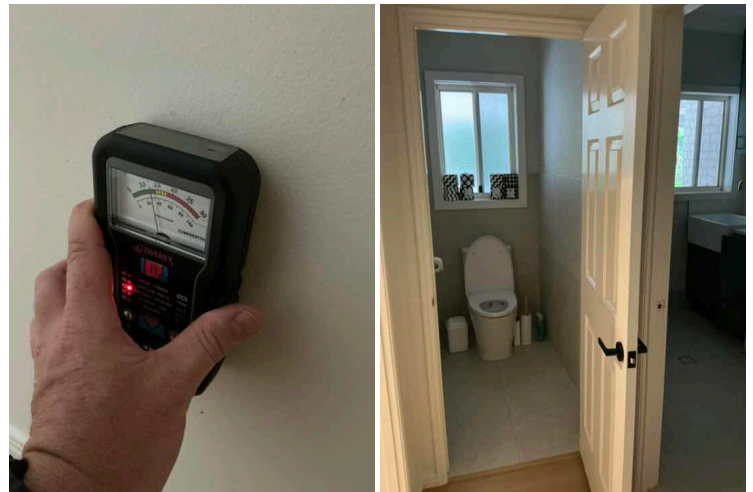
Overall Condition

Of the visible areas, the general condition of this bathroom is serviceable or in reasonable condition for age of dwelling.

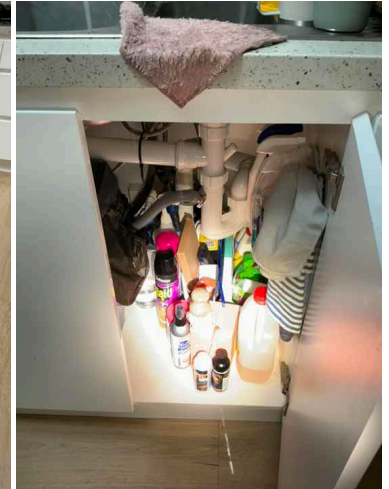
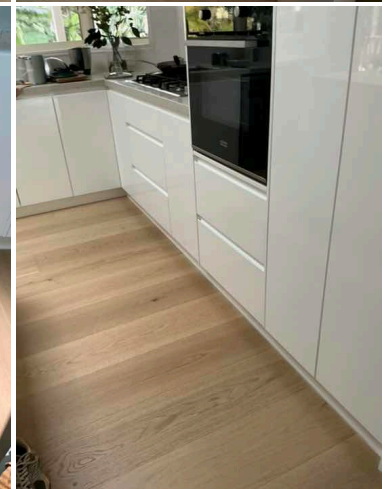
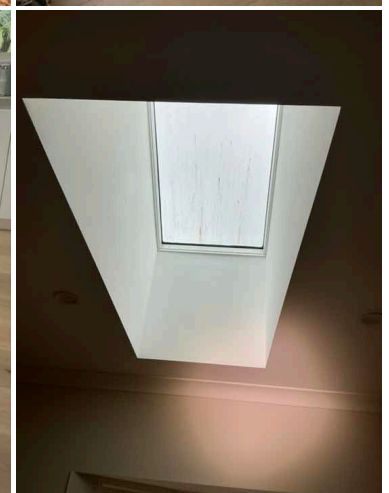
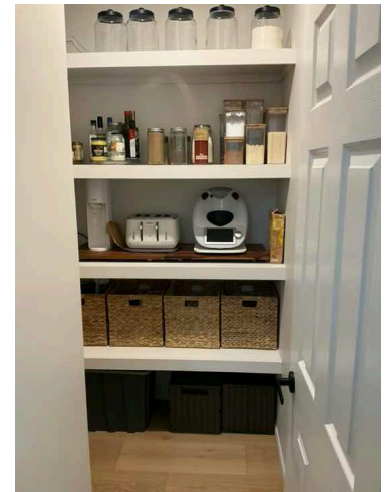
Overall Condition

Of the visible areas, the general condition of the kitchen and pantry is serviceable or in reasonable condition for age of dwelling.

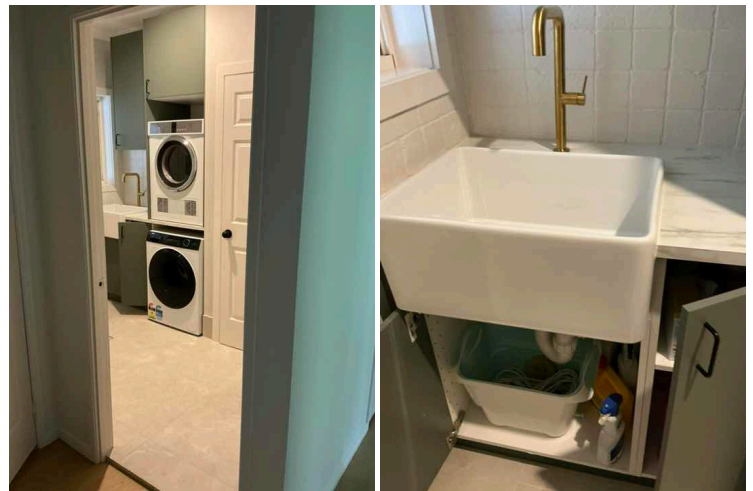
Overall Condition

Of the visible areas, the general condition of the laundry is serviceable or in reasonable condition for age of dwelling.

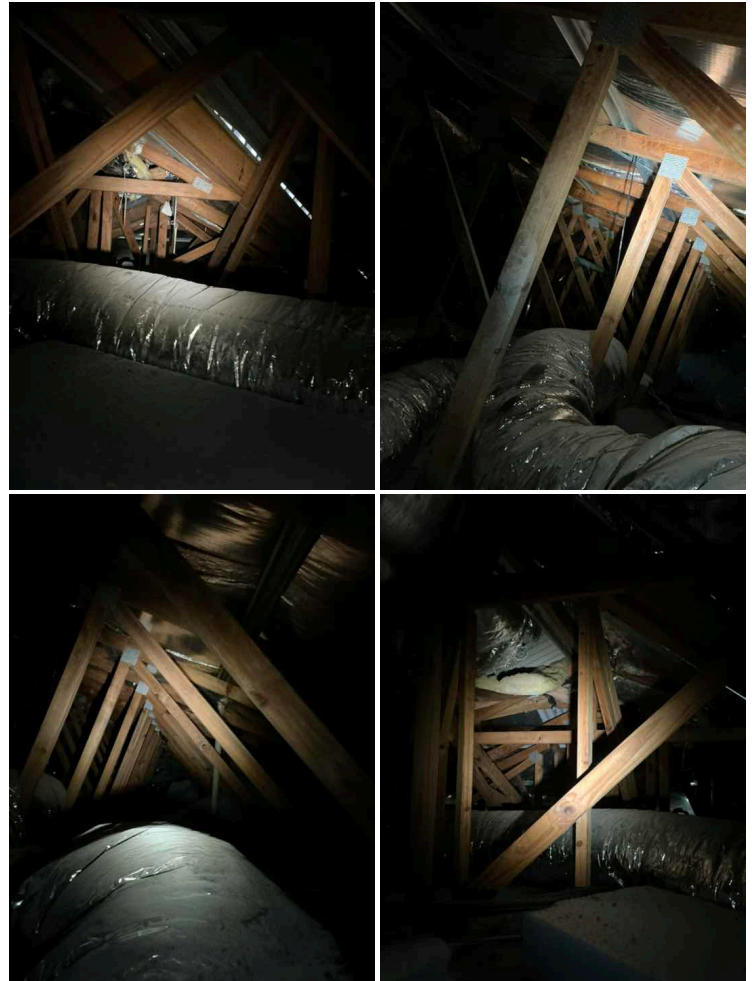
Overall Condition

Visible sections of the roof void is in a serviceable condition for age of this dwelling.

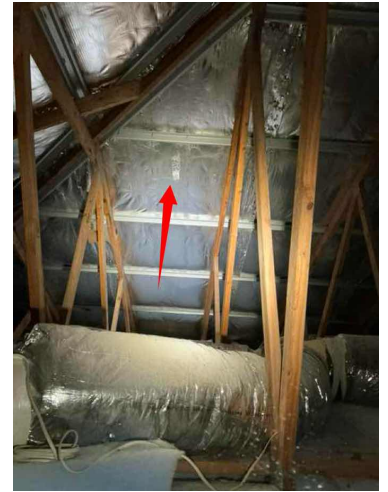
Sarking is installed.

The sarking generally is in a serviceable condition.

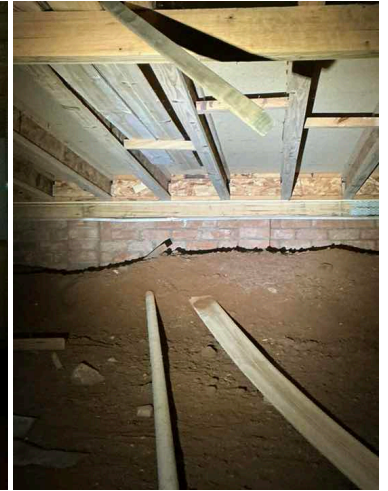
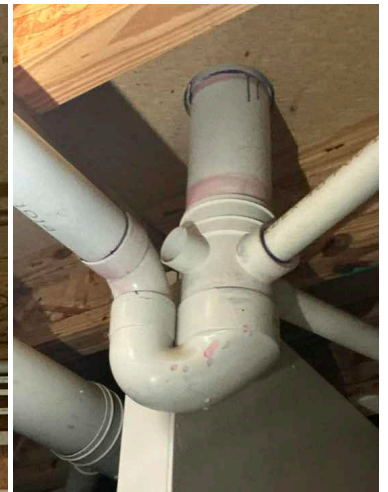
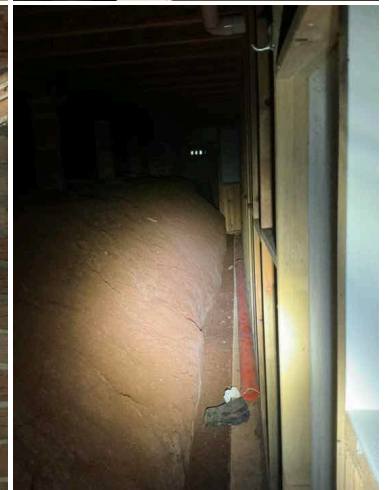
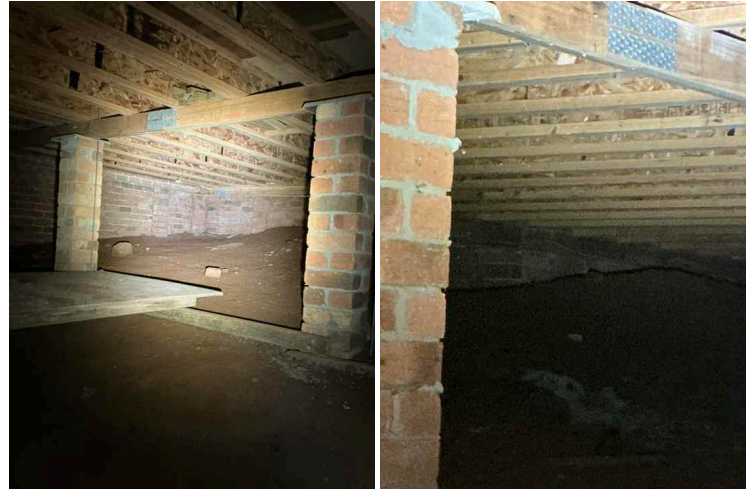
General Condition

Of areas accessible and visible, the subfloor and components appeared to be in a serviceable condition.

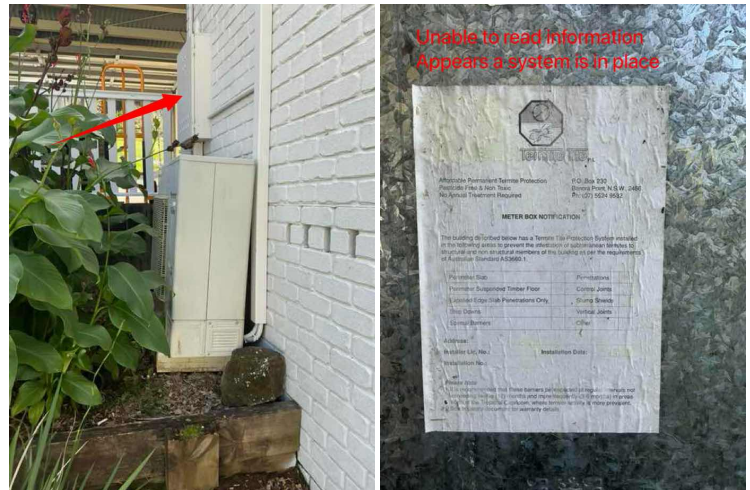
Was a Treatment Notice Found

Yes, a durable notice was found in the meter-box during the inspection.

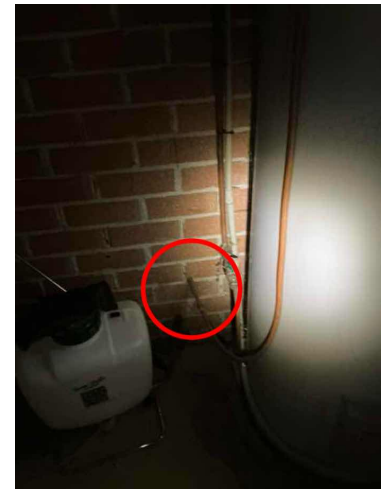
Was the overflow sufficiently drained

Yes. The hot water overflow does not drain to the perimeter of the building.

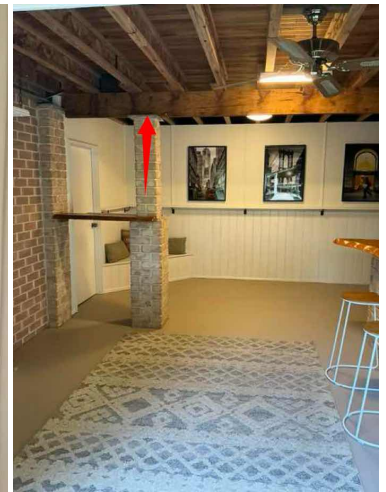
The ant capping is generally considered adequate.
