Building and Pest Report

8 Stonehenge Pl Lennox Head

Report/Agreement #	250225125443260
Inspection Date:	25 Feb 2025
Inspection Time:	12:54 pm

Pest And Building Inspection

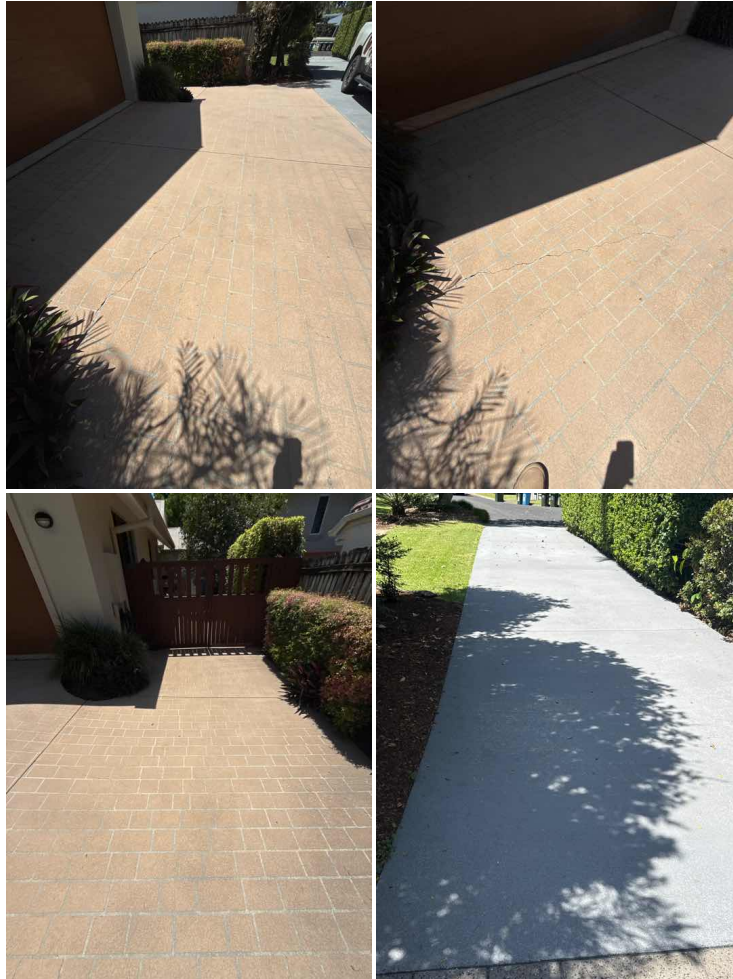
On visual inspection, the general condition of the driveway is serviceable.

Common cracks were observed on the driveway. Whilst these cracks appeared to be typical at the time of inspection, we strongly recommend you monitor these cracks and if worsening occurs contact a concreter for further advice.

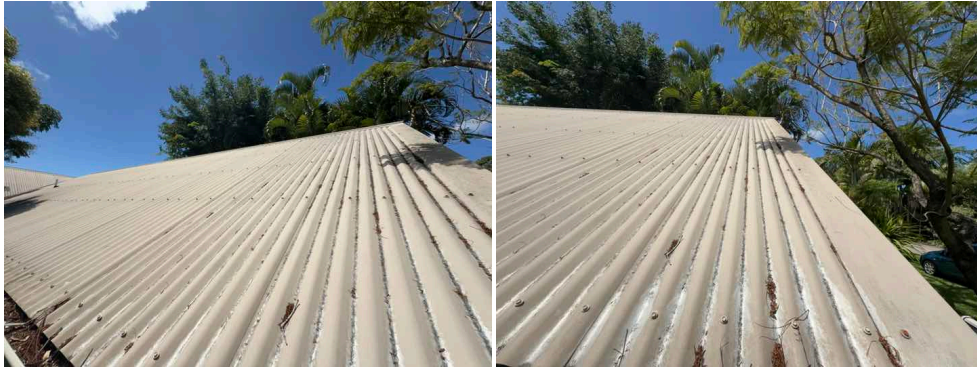
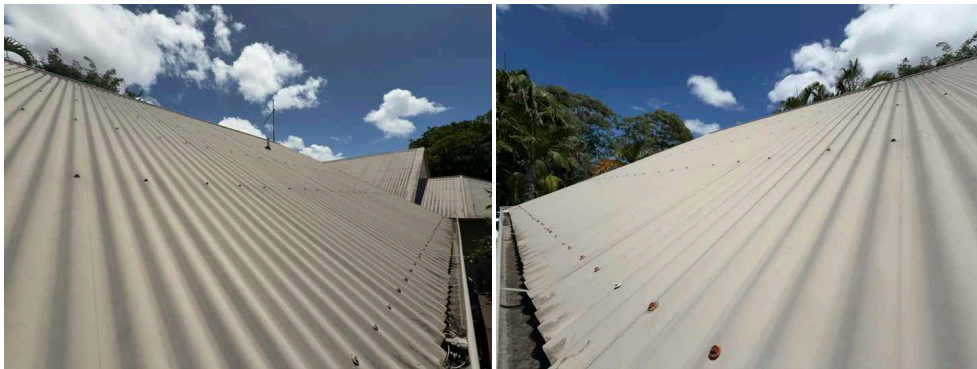
Of the visible areas, the general condition of the roof is in serviceable condition for the age.

Note: In the absence of rainfall there is no guarantee that the roof won't leak.

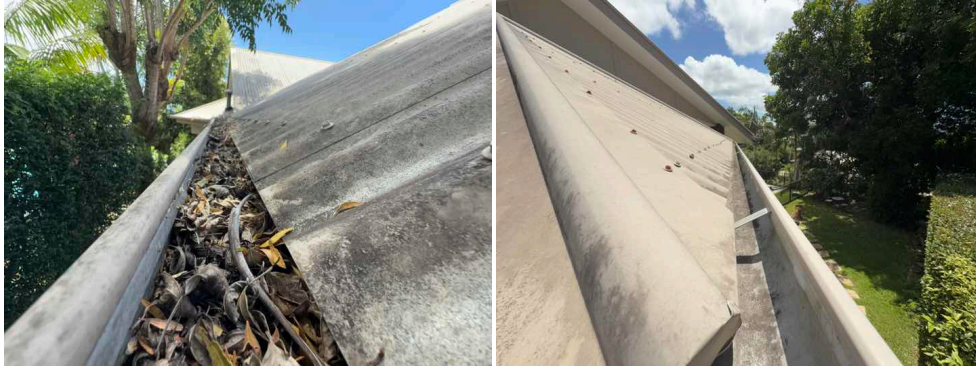
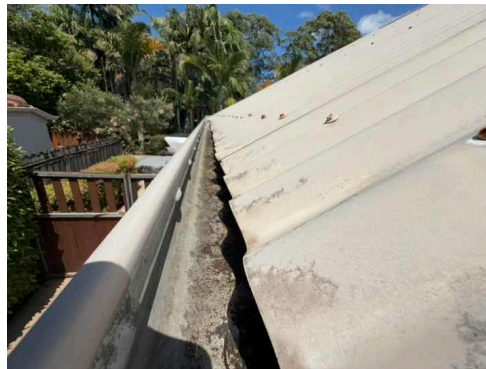
Corrosion noted to the screw fixings of the metal roof. Have these checked and replaced by qualified roofing contractor.

Debris in guttering areas- this requires cleaning out to prevent blocking of downpipes and leaking into eaves and fascia. Have gutters cleaned and assessed by a plumber for adequate fall. Regularly clean to prevent ponding. Ponding water will contribute to rust.

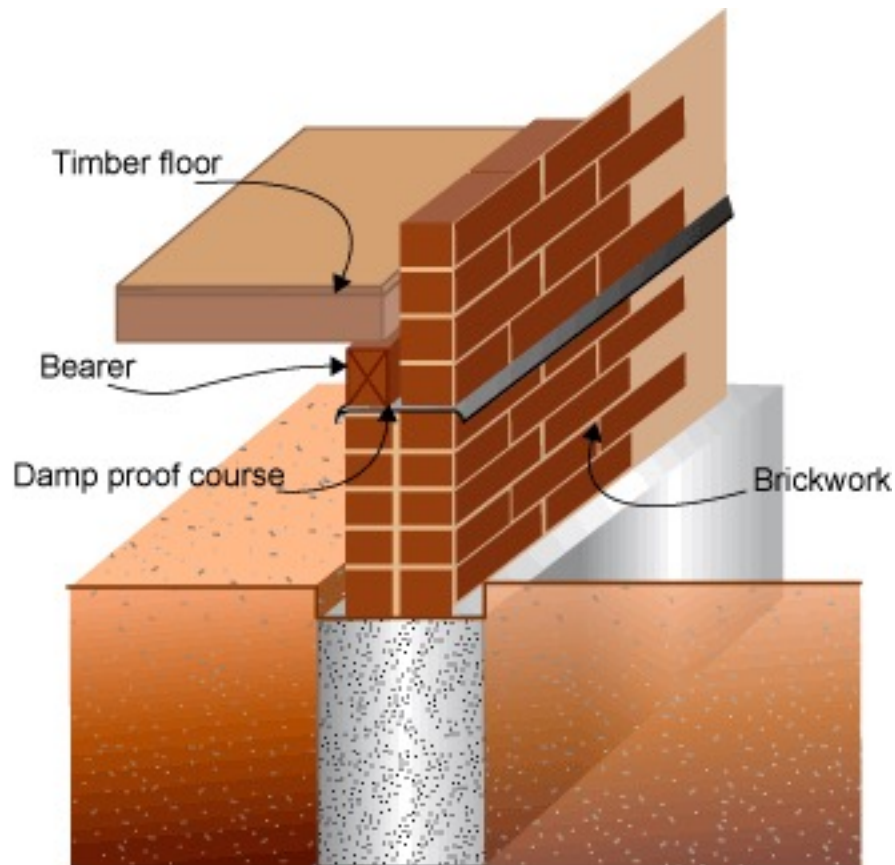
Salt residue on lower external wall visible - Salt residue can be associated with rising damp problems. Further investigation by a specialist in this field is recommended.

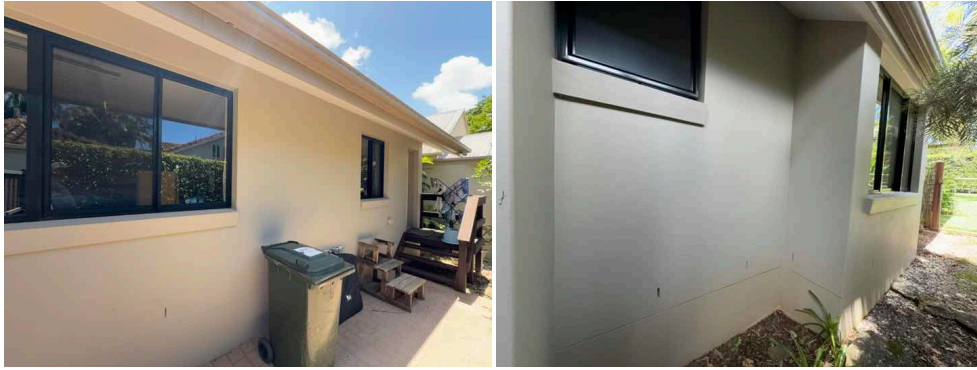
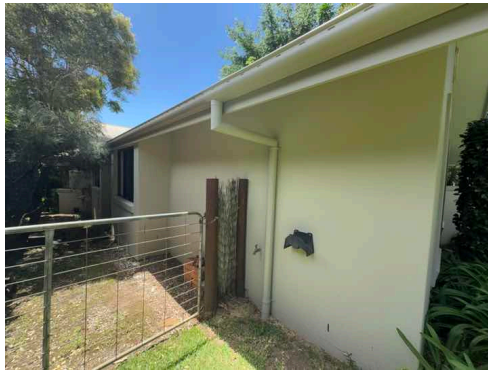
There appears to have been some settlement in the building which has caused some cracking to the walls. These cracks are categorized as 0 to 2. This can also cause some doors to bind or be out of square. In the inspector's opinion these cracks are due to settlement, usually due to ground movement and subsequent movement to building materials can be expected. Any cracks should be monitored and if cracks increase in size, further investigation should be carried out by a structural engineer.

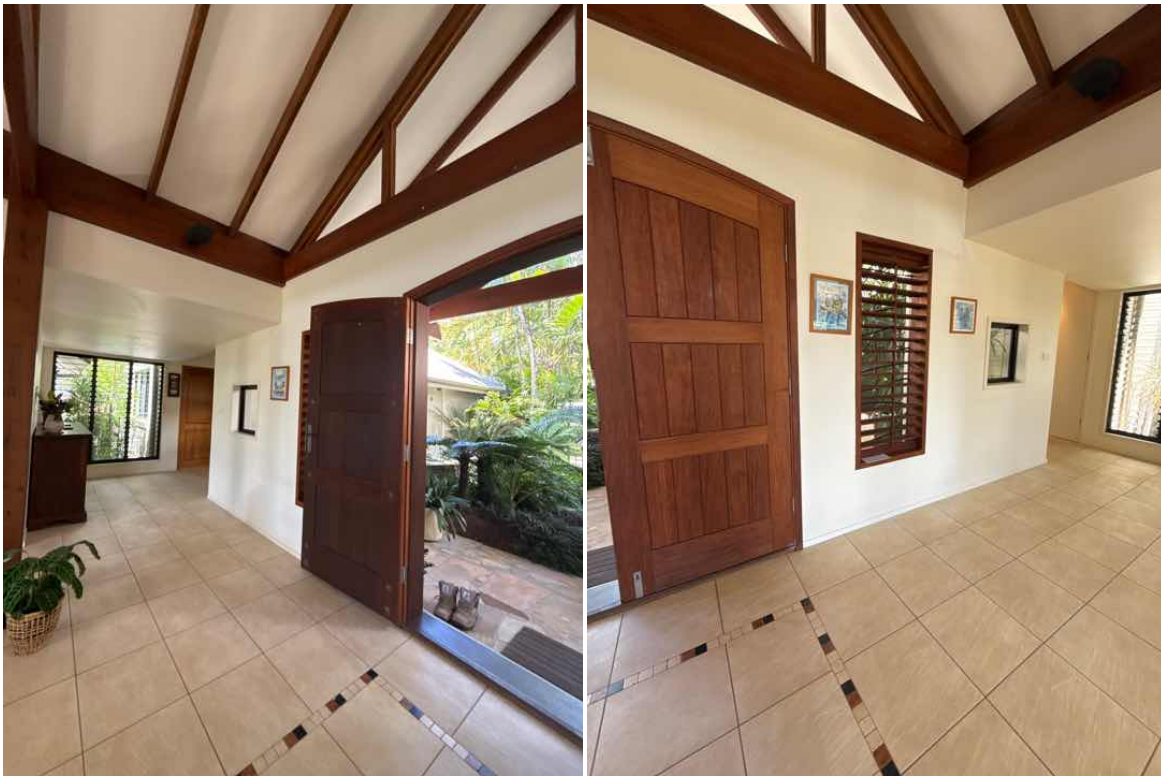
Settlement Cracks Noted. These are typical and generally patch and paint will suffice, however we recommend you monitor these cracks and if they become wider or longer, you will need to contact a structural engineers to assess.

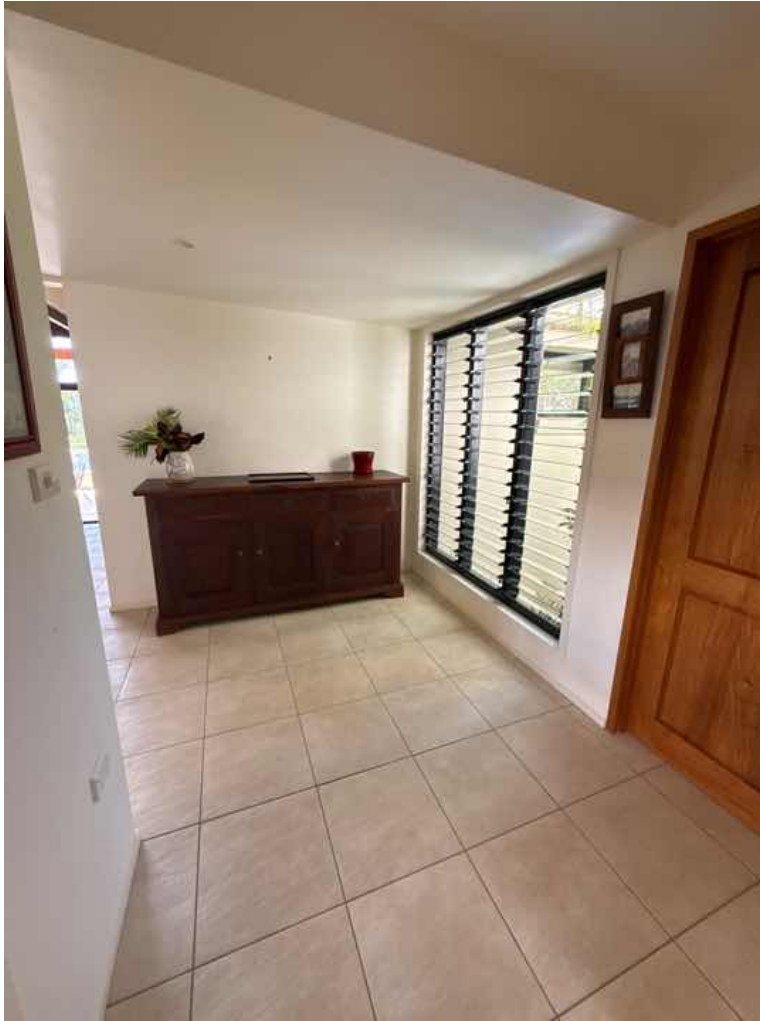
Settlement Cracks Noted. These are typical and generally patch and paint will suffice, however we recommend you monitor these cracks and if they become wider or longer, you will need to contact a structural engineers to assess.

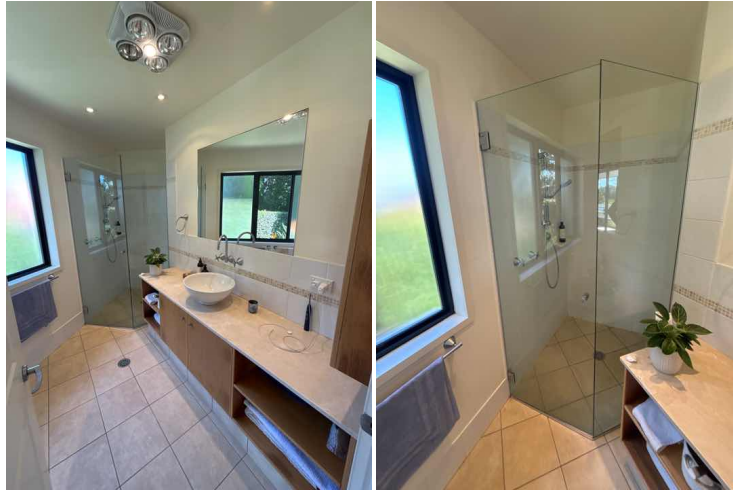
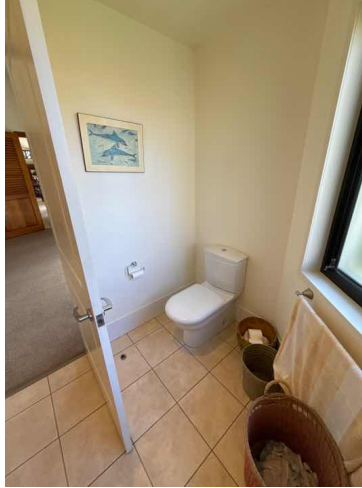
The vanity mirror is desilvering at edges. Replacement recommended.

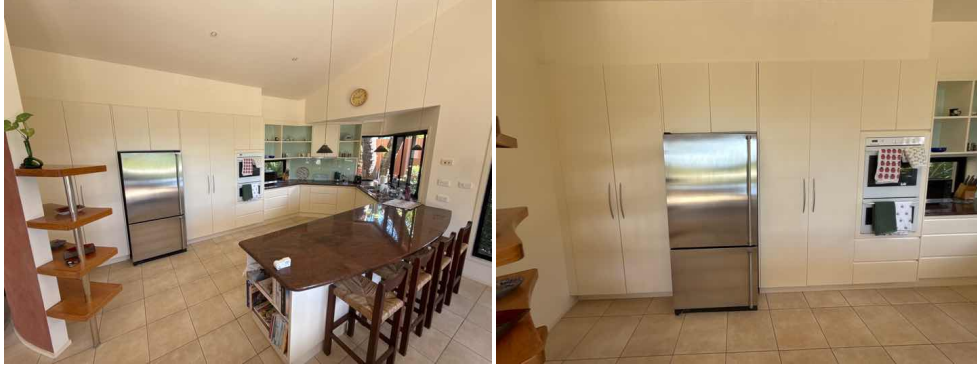
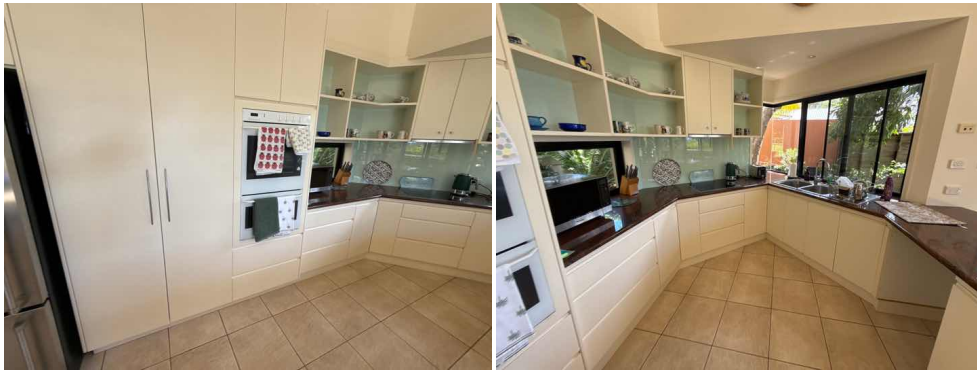
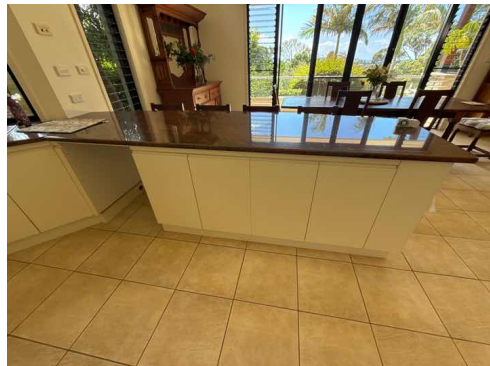
Adjustment to cabinet doors required, in some instance hinges may need to be replaced.

Damage was noted to the cabinets, contact a joinery company for repairs
