4/70 Cedar Crescent, East Ballina

Building & Pest Inspection Reports

Visual Timber Pest Inspection and Report in Accordance with AS 4349.3-2010

Inspections Residential Buildings - Appendix C

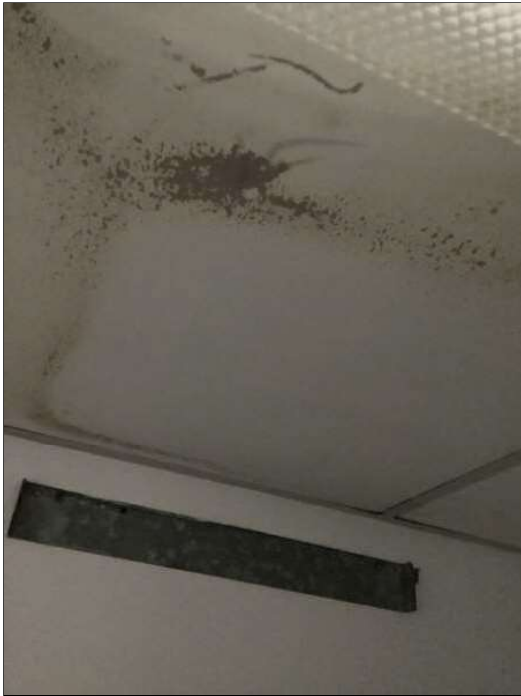
No
Location (Optional): Laundry
Details (Optional): Staining to ceiling evident. Possibly been caused from a clothes dryer previously installed and inadequate ventilation
Defect Rating: Minor Defect

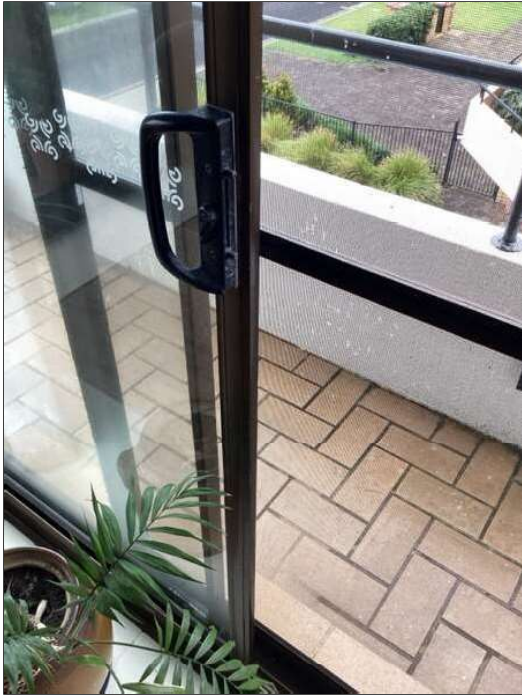
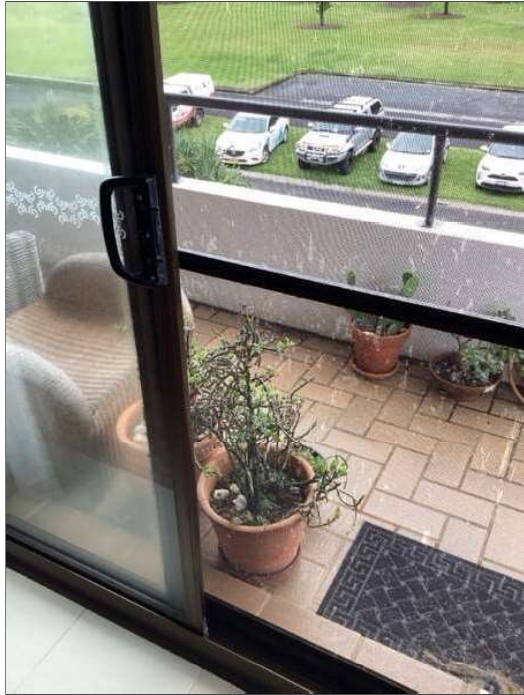
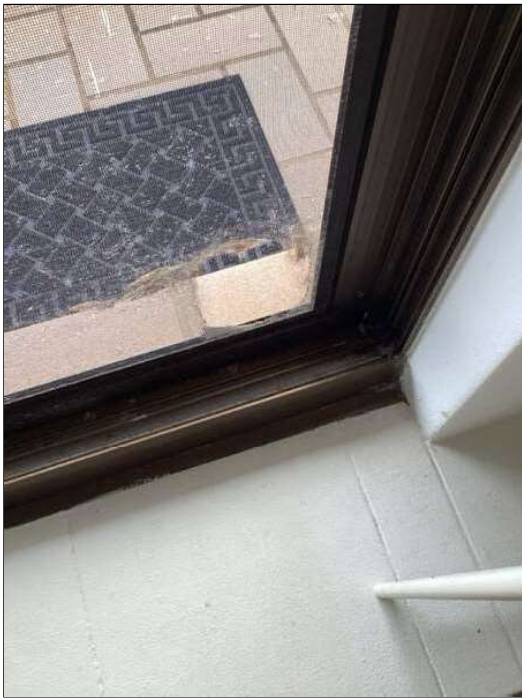
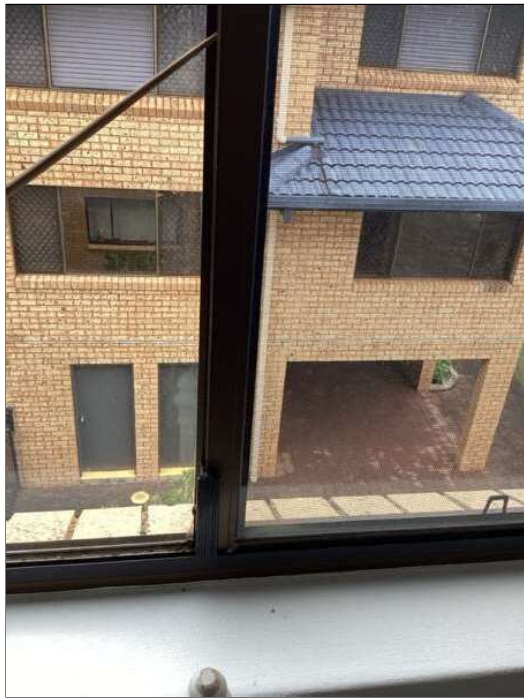
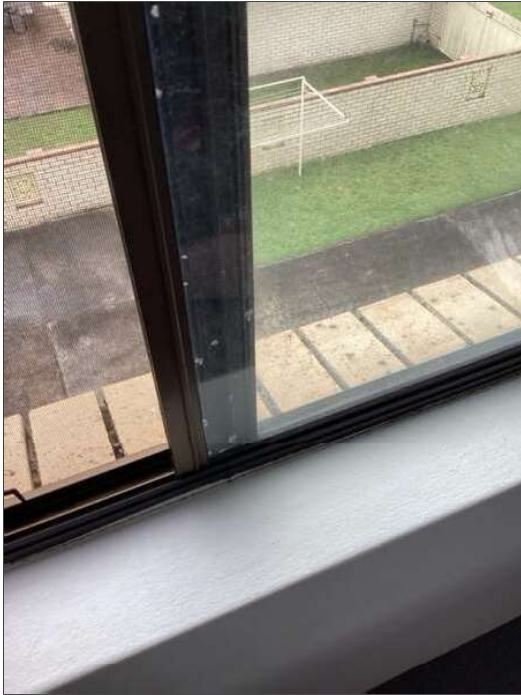
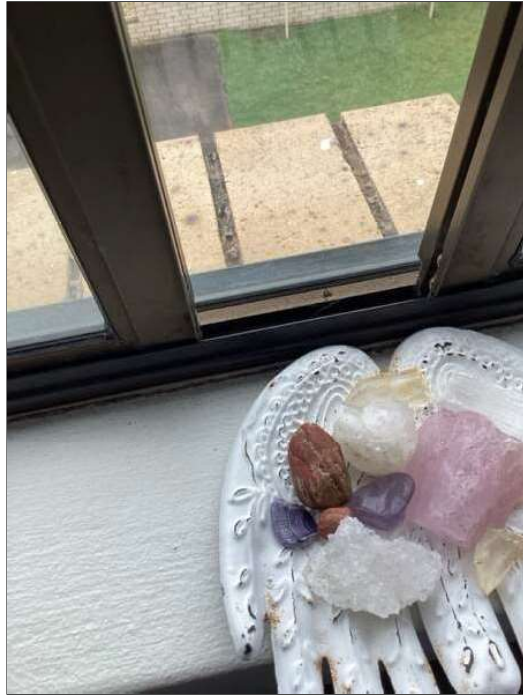
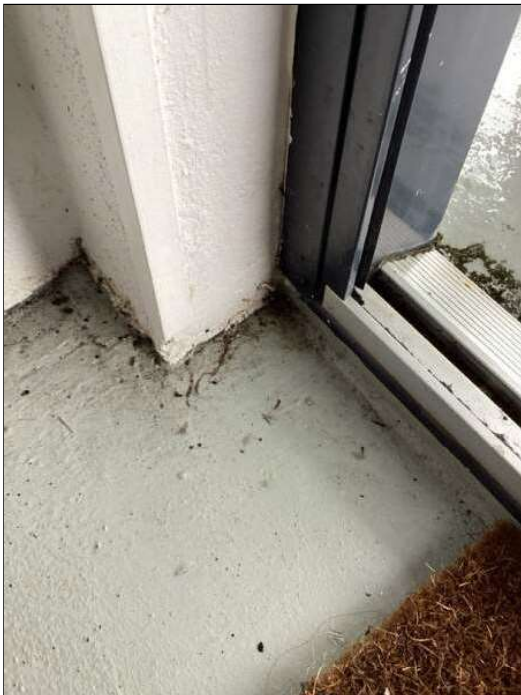
One or more windows require maintenance to the window rollers
Location (Optional): Generally all windows and sliding doors.
Details (Optional): Note It is a current Building Code to have window locks fitted to first floor windows allowing a maximum of 100mm opening. This is possibly a Body Corporate maintenance/upgrade
Photo 7- It is evident moisture is entering around sliding door of the Top Floor office
Defect Rating: Further Investigation

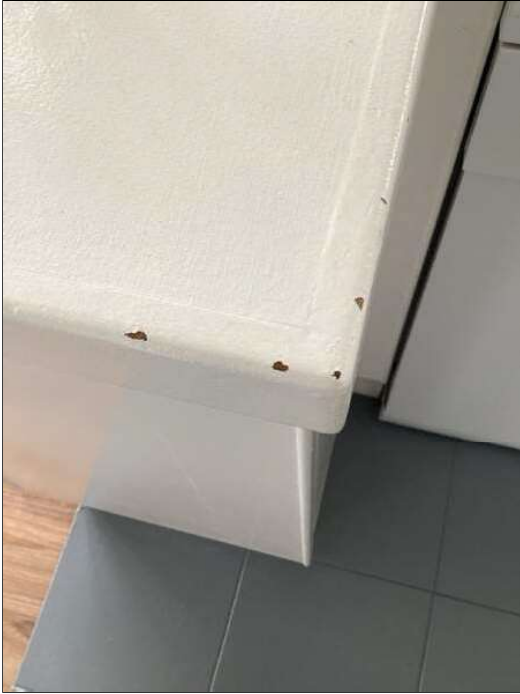
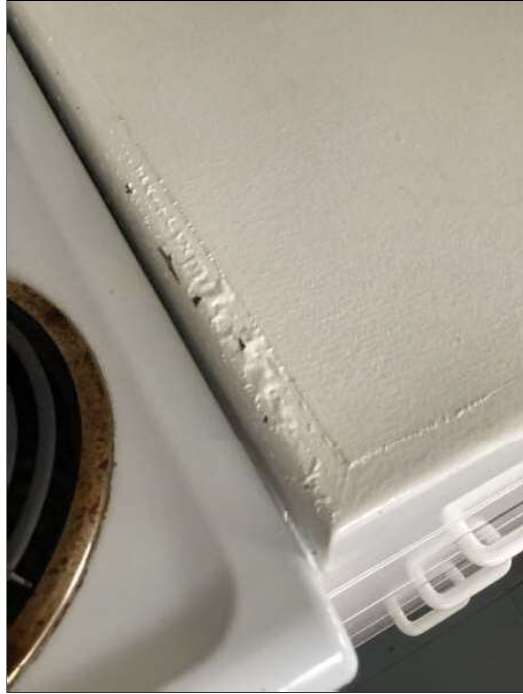
Location (Optional): Kitchen
Details (Optional): Benchtops have been painted and surfaces are affected by heat and moisture -Future maintenance will need consideration

Defect Rating: Minor Defect

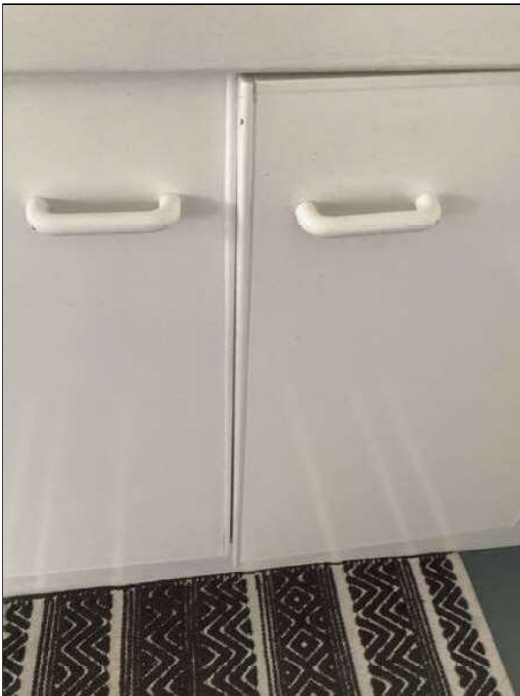
Recommend adjustment to the cupboard door hinges
Location (Optional): Kitchen
Defect Rating: Minor Defect

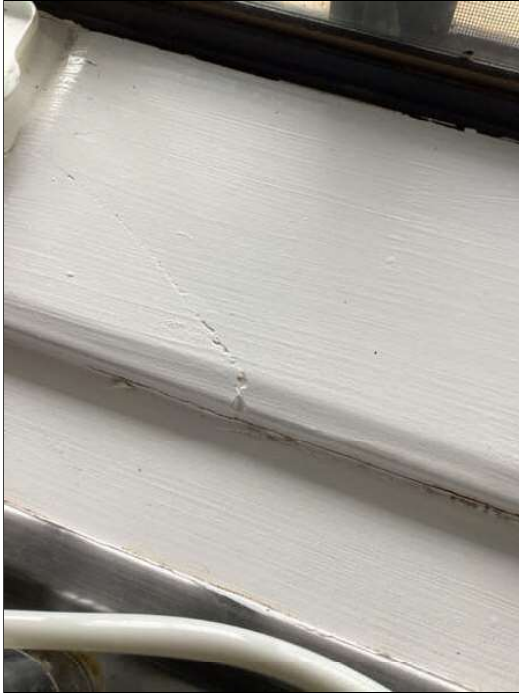
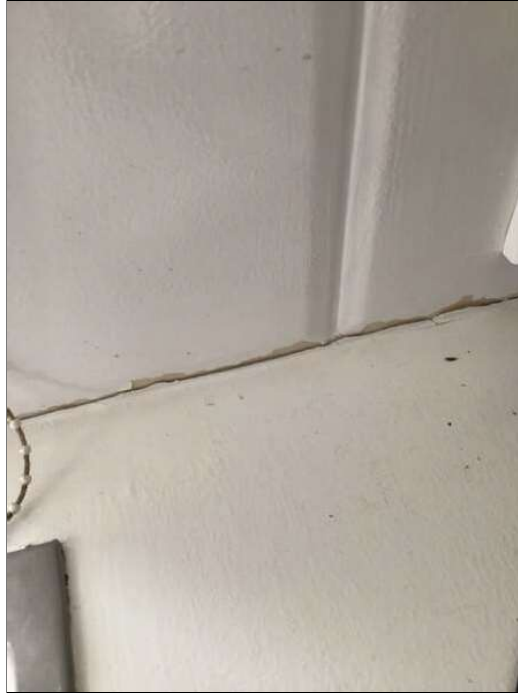
Kitchen; Are the tiles free of cracking, drumminess, or loose/missing grout/sealant? **Gaps in sealant**
Location (Optional): Kitchen
Defect Rating: Minor Defect

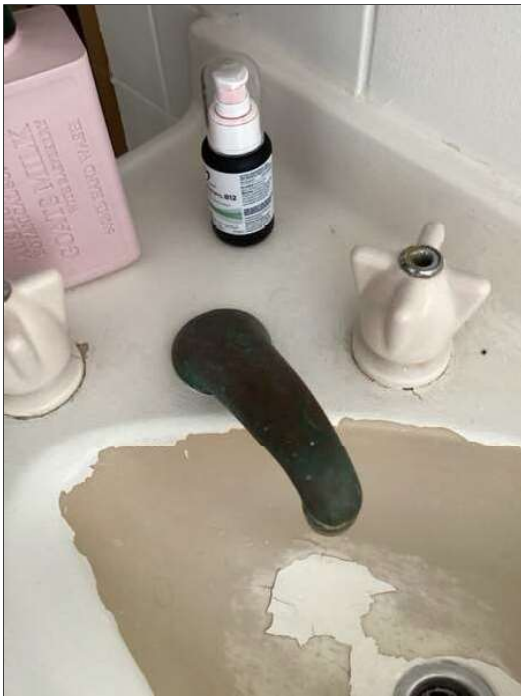
Bathrooms/WC; Are taps free of leaks, and does the water supply operate correctly? **No**
Location (Optional): Bathrooms
Details (Optional): The vanity tops have been painted and the surfaces are now peeling .
Future replacement will need consideration
Defect Rating: Further Investigation

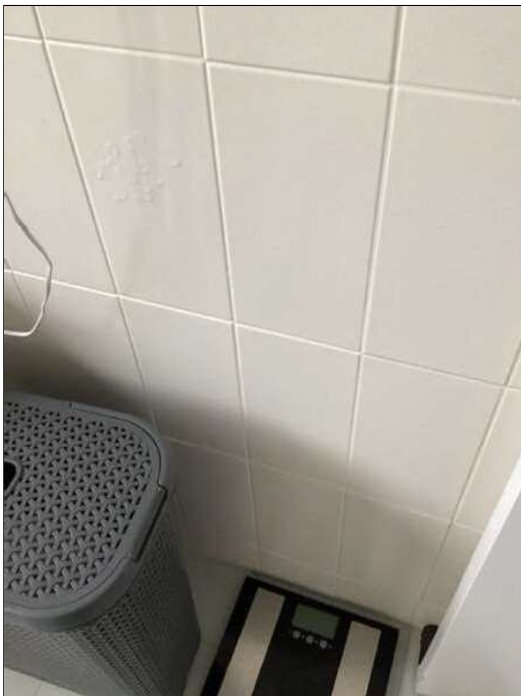
Drummy tiles

Details (Optional): Consideration will need to be given to fully upgrade bathroom tiling due to drummy tiles and age

Defect Rating: Further investigation

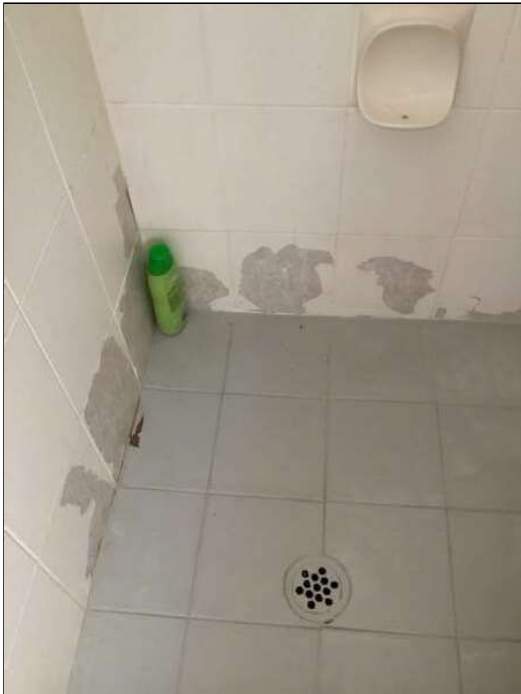
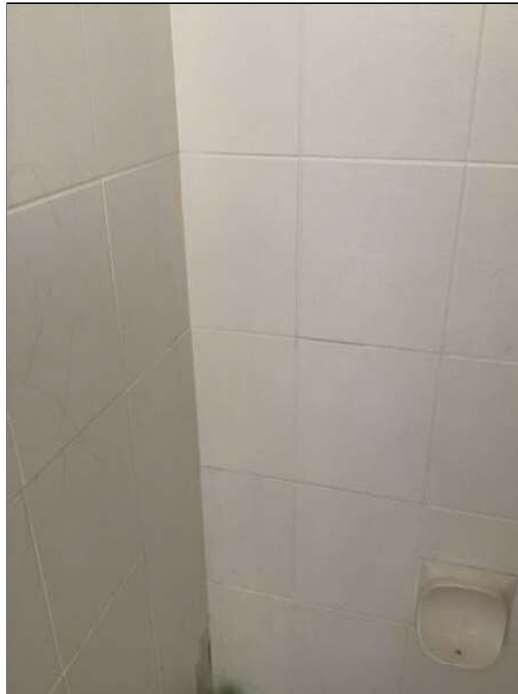
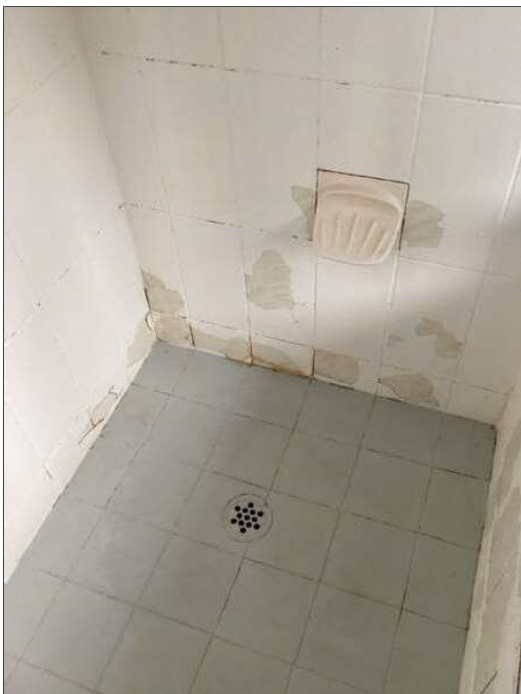
Location (Optional): Bathroom Showers
Details (Optional): Consideration will need to be given to fully upgrade bathroom tiling due to drummy tiles ,peeling paint surfaces and age

Defect Rating: Further investigation

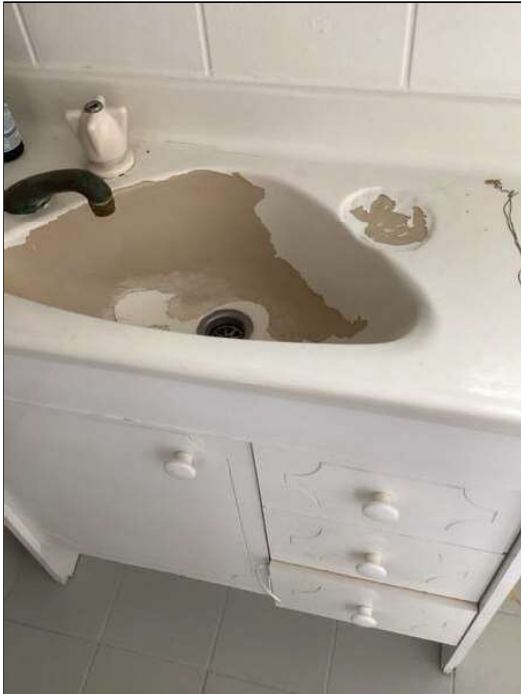
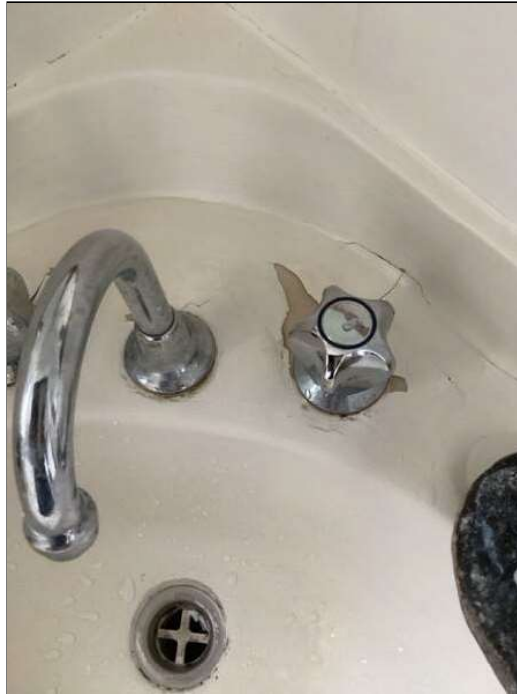
Future replacement will need consideration

General maintenance to tapware evident.

Defect Rating: Further investigation

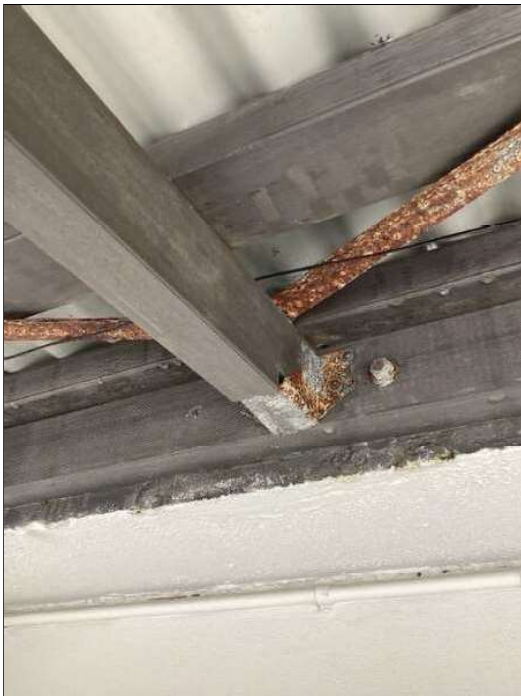
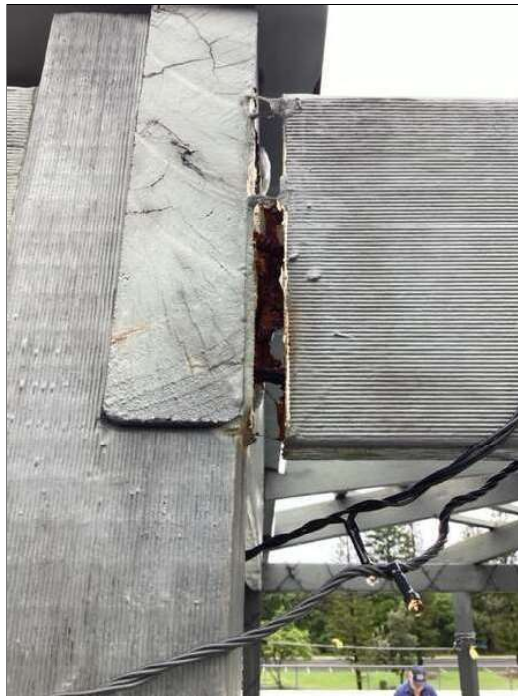
Balconies/verandahs/patios/decks/suspended floors/balustrades; Do they appear structurally sound, free of defects? **No**
Location (Optional): External
Details (Optional): Rusty tie down brackets and bracing to the external pergola timbers evident. Consideration will need to be given to further replacement of such . Engage a licensed builder to further liase with required repairs
Defect Rating: Further investigation

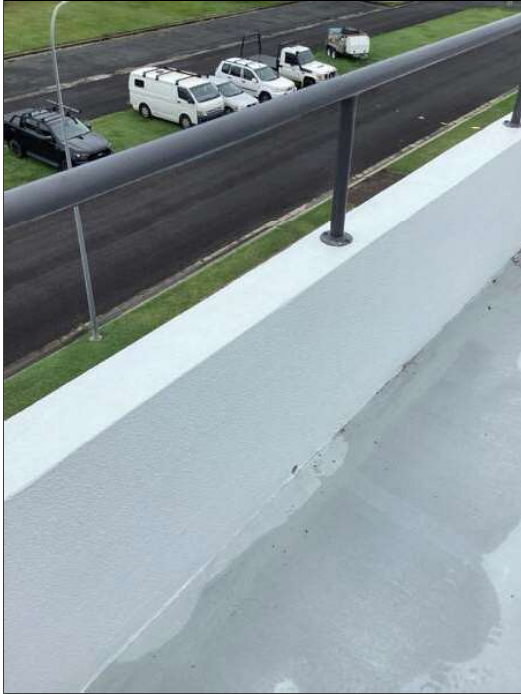
Handrail height under 1000mm and non-compliant

Details (Optional): External handrailing does not comply with the current Building Code - Body Corporate has a duty of care for safety and consideration should be forwarded for their review to make handrailing compliant

Defect Rating: Safety Hazard

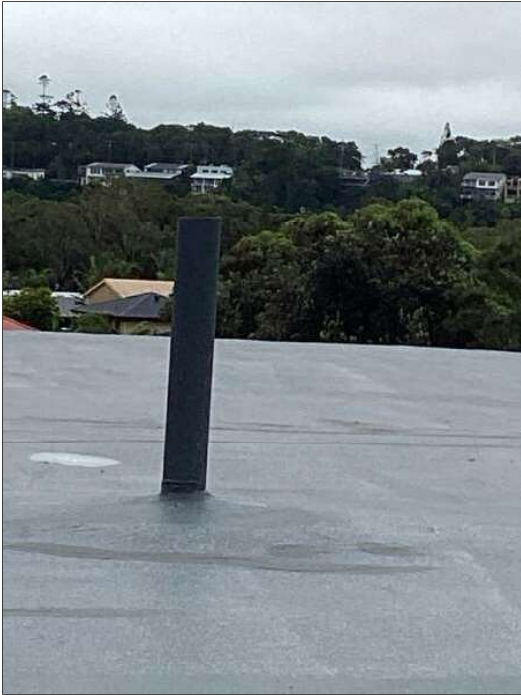
Details (Optional): Missing PVC cowl fittings to roof vents evident.

Defect Rating: Minor Defect

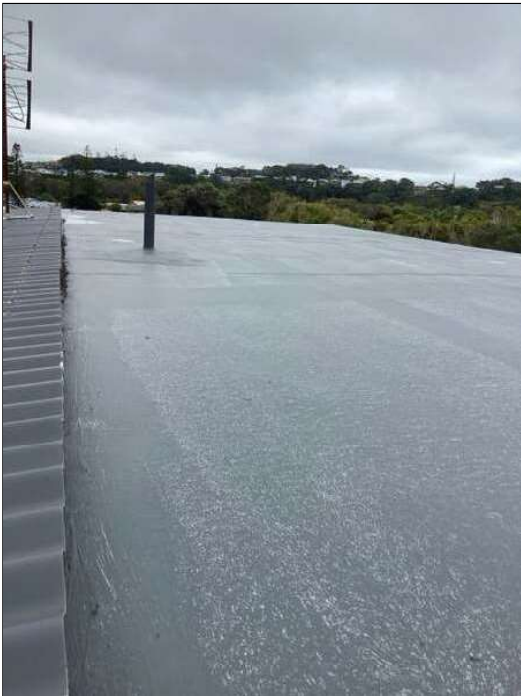
No
Location (Optional): Roof
Details (Optional): Roof is suspended concrete
Defect Rating: Nil Defect
