Building and Pest Report

9 Sand Street Skennars Head

Inspection Report

9 Sand St, Skennars Head, NSW, 2378

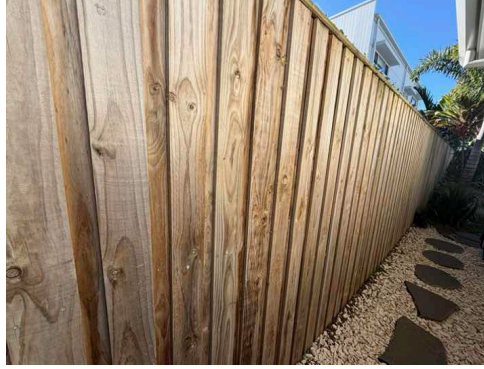
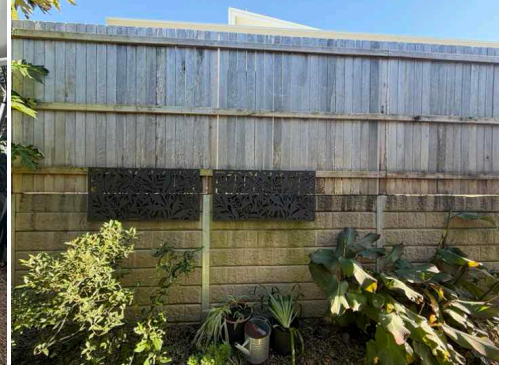
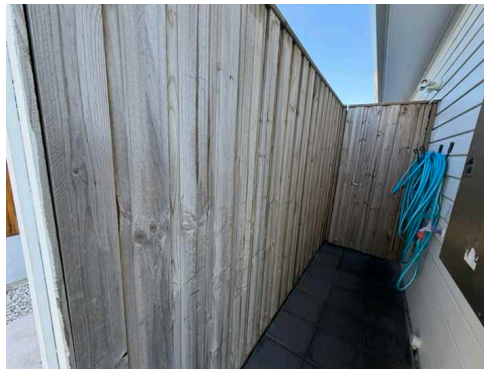
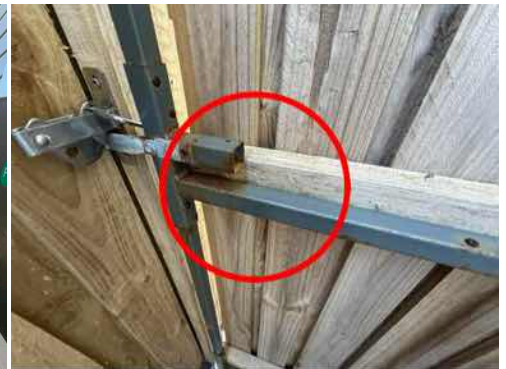
Of the visible areas, the general condition of the fences and gates is serviceable for the age of dwelling. Upon visual inspection, surface rust was noted on the gate frames. It is recommended to clean the affected areas using a wire brush to remove loose rust. Apply a rust converter to neutralize remaining rust, followed by a primer and rust-resistant paint. Regular maintenance checks should be scheduled to prevent recurrence and ensure the longevity of the gate frames.

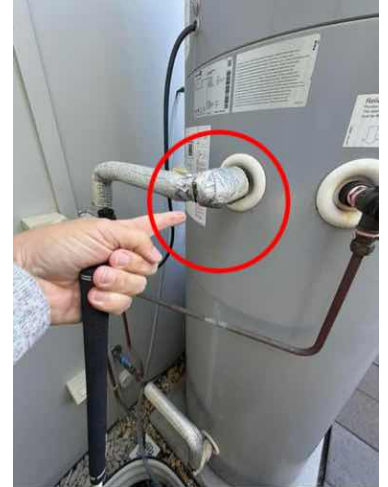
Leaking observed from hot water unit at time of inspection. Engage a licensed plumber to assess and rectify.

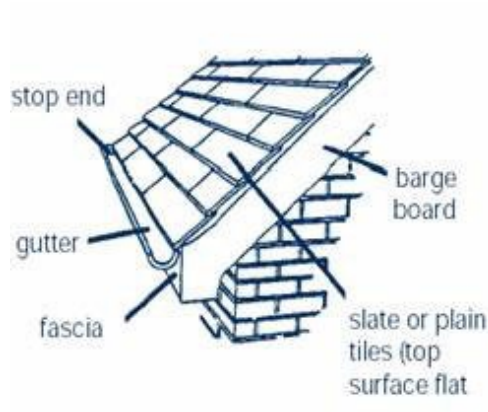
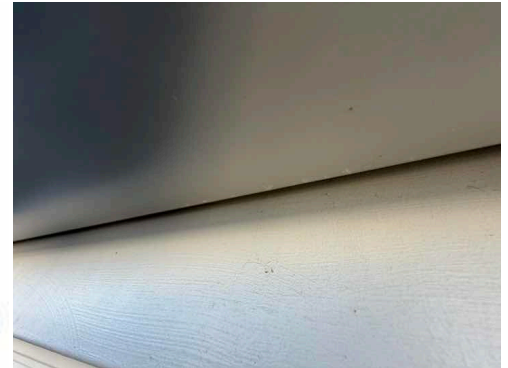
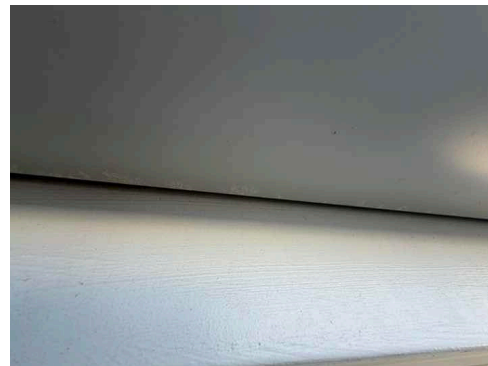
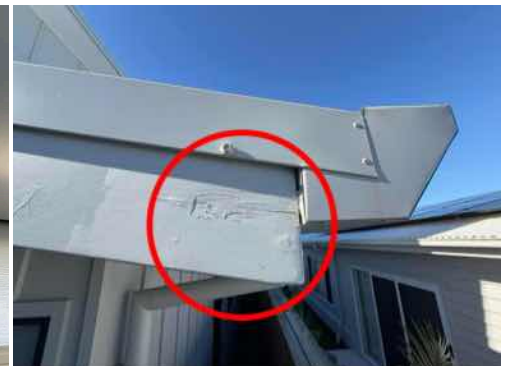
Paint / finish was deteriorated in areas and is in need of maintenance - Sanding back affected areas and painting required.

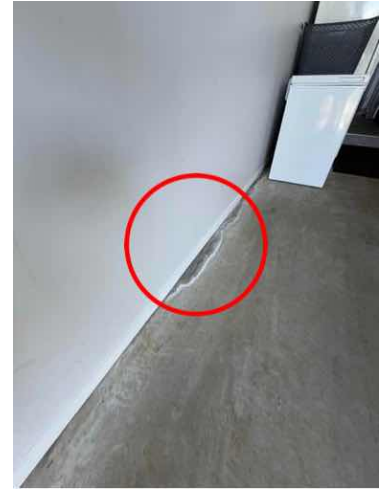
Minor hairline slab cracks - Note. Whilst these cracks appeared to be minor at the time of inspection, we strongly recommend you monitor these cracks and if worsening occurs contact a qualified concreter for further advice.

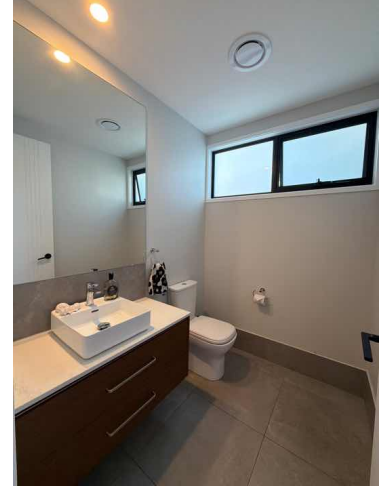
Silicone sealant has been applied to the interface of the floor and walls in the bathroom in an apparent attempt to prevent water penetration to surrounding areas. This method of repair can only be considered to be temporary. Further waterproofing may be necessary.

The vanity mirror is desilvering at edges. Replacement recommended.

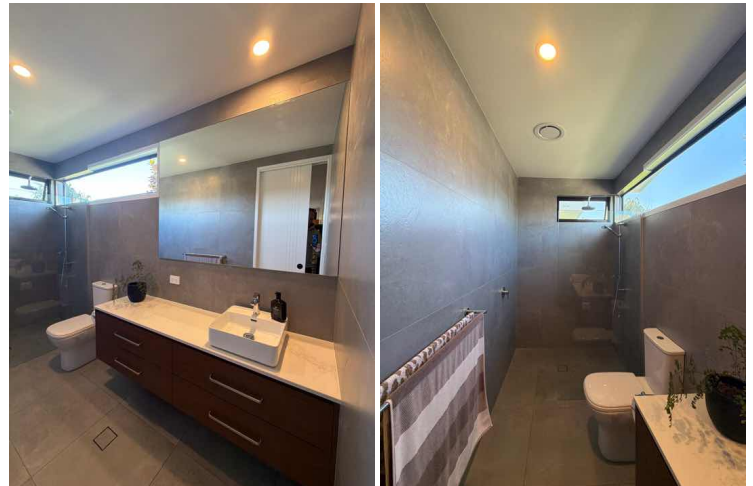
Silicone sealant has been applied to the interface of the floor and walls in the bathroom in an apparent attempt to prevent water penetration to surrounding areas. This method of repair can only be considered to be temporary. Further waterproofing may be necessary.

The vanity mirror is desilvering at edges. Replacement recommended.

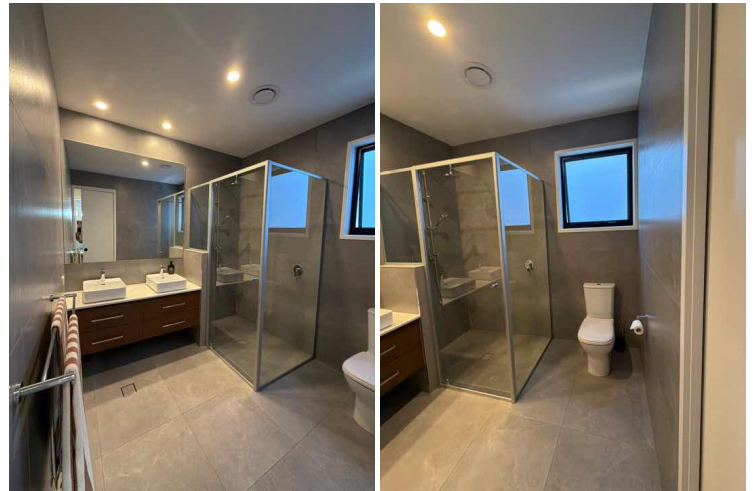
Silicone sealant has been applied to the interface of the floor and walls in the bathroom in an apparent attempt to prevent water penetration to surrounding areas. This method of repair can only be considered to be temporary. Further waterproofing may be necessary.

The vanity mirror is desilvering at edges. Replacement recommended.

Shower head is leaking. Replacement recommended.

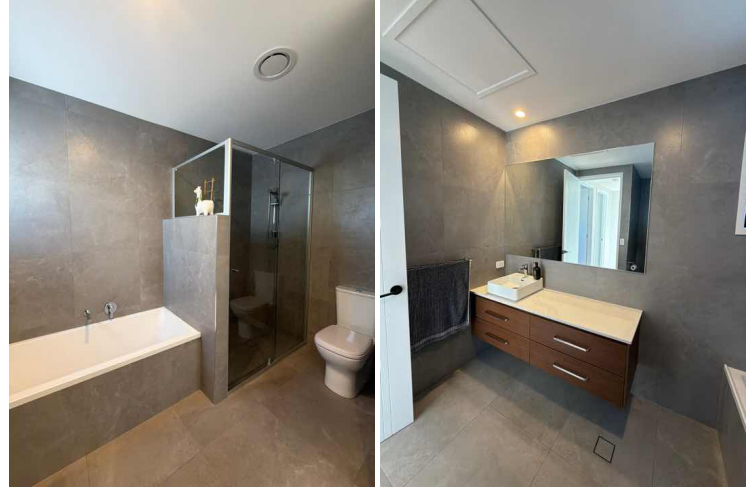
Silicone sealant has been applied to the interface of the floor and walls in the bathroom in an apparent attempt to prevent water penetration to surrounding areas. This method of repair can only be considered to be temporary. Further waterproofing may be necessary.

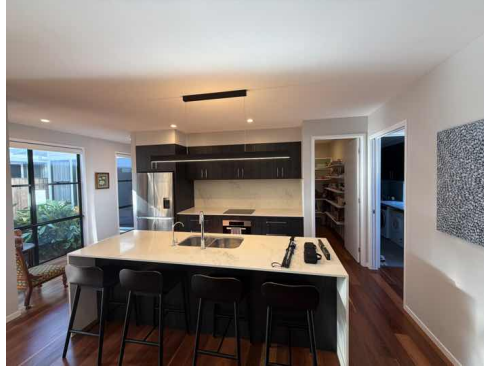
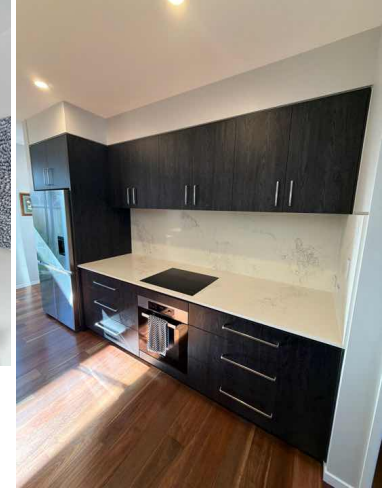
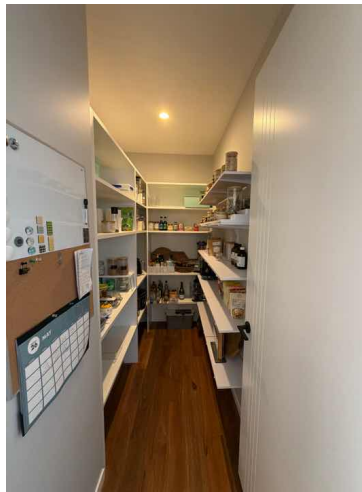
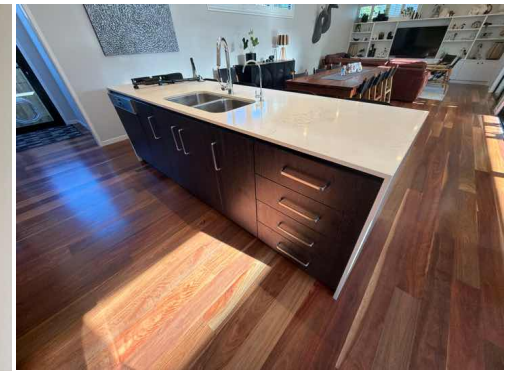
Adjustment to cabinet doors required, in some instance hinges may need to be replaced.
