PEST AND BUILDING PRE-PURCHASE REPORTS

Inspection Report

4 Seaside Av, Skennars Head, NSW, 2478

Pest And Building Inspection

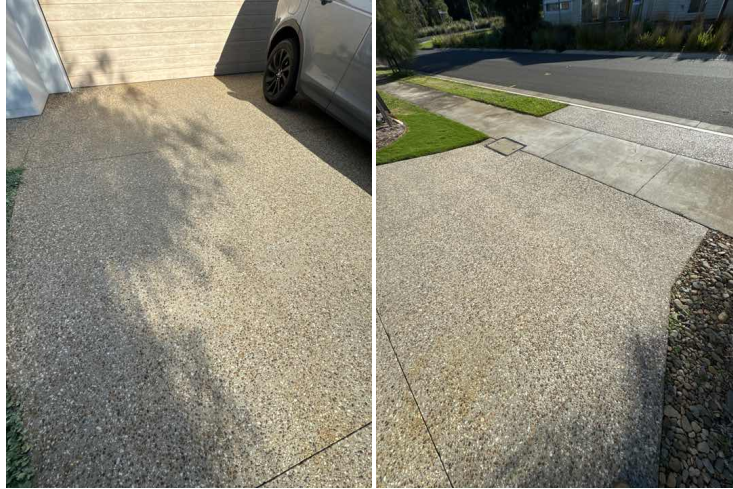
Driveway Condition

On visual inspection, the general condition of the driveway is serviceable.

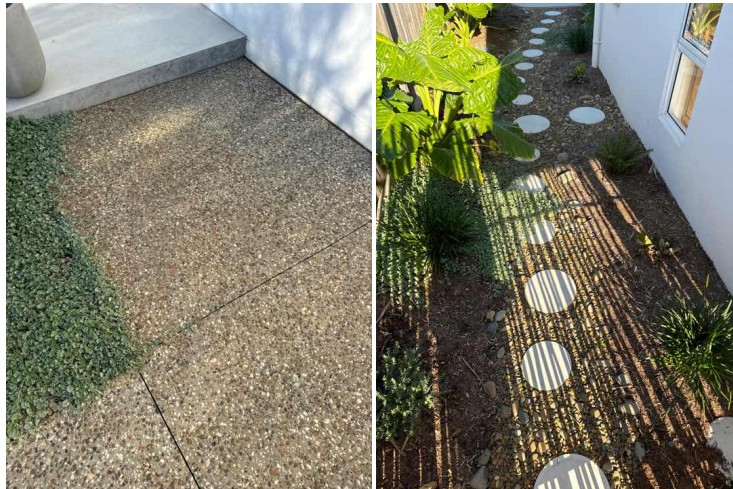
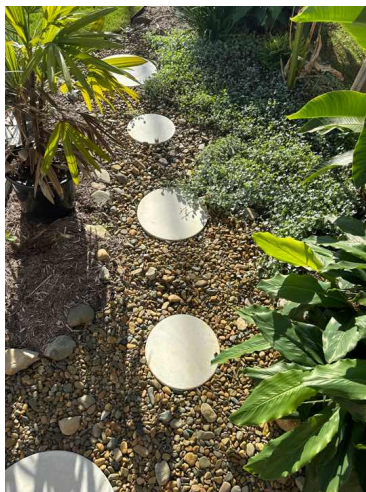
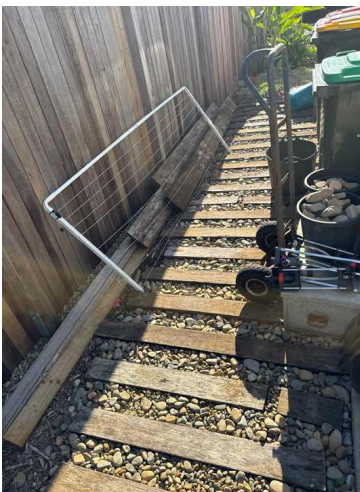
Pathways Condition

The paths around the home are in a serviceable condition for the age of this dwelling with no major defects visible.

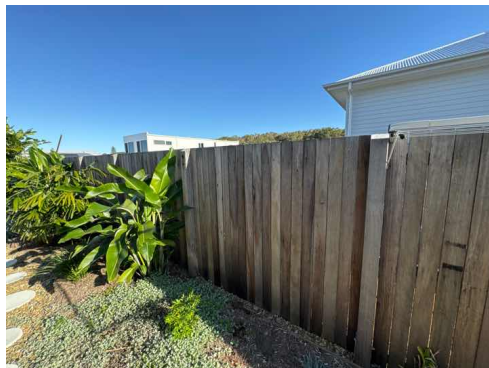
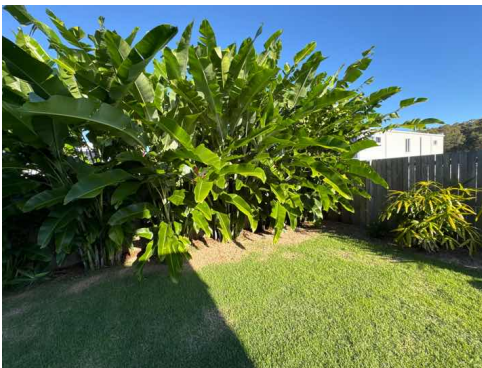
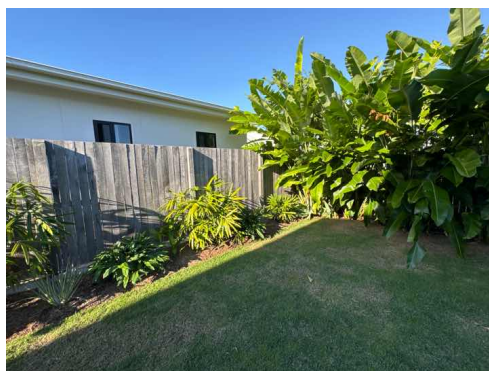
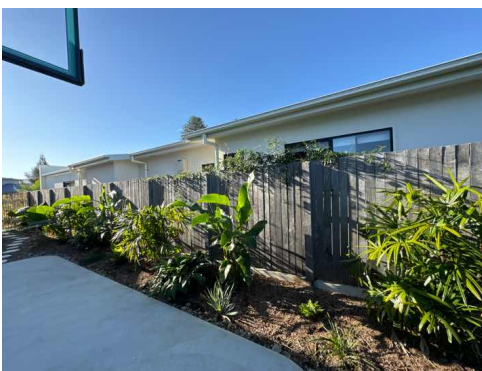
Fences & Gates

Of the visible areas, the general condition of the fences and gates is serviceable for the age of dwelling.

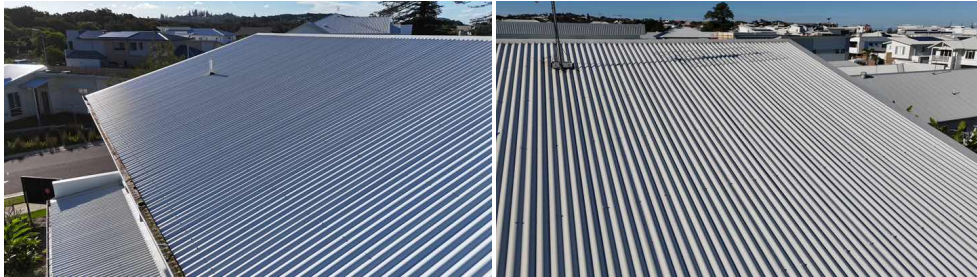
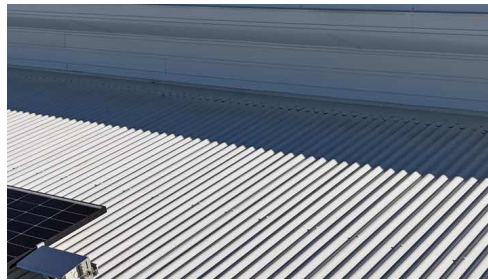
Of the visible areas, the general condition of the roof is in serviceable condition for the age.

Note: In the absence of rainfall there is no guarantee that the roof won't leak.

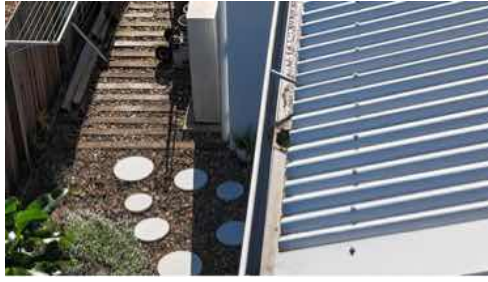
Gutter Findings

All visible and accessible of the physical nature of the guttering system appears to be in a serviceable condition with no apparent defects at the time of inspection. In the absence of prolonged rain fall efficiency of the guttering can not be assessed and you may find that further investigation or repairs maybe required. Note: Periodic maintenance checks should be carried out for rust penetrations and leaks.

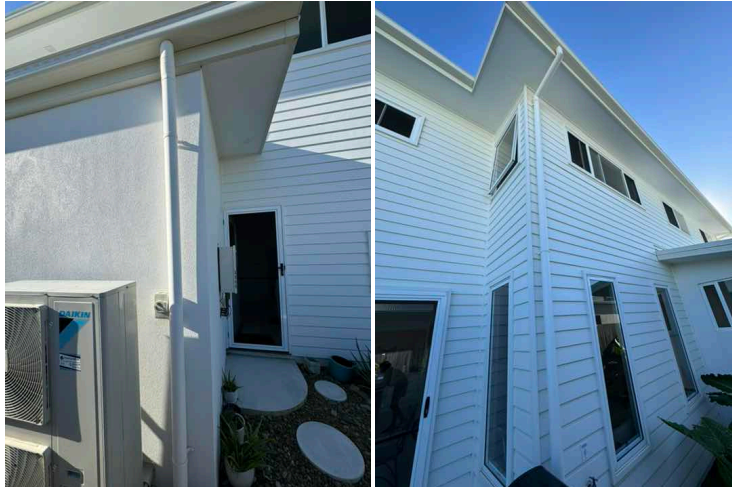
Downpipe Findings

On visual inspection no apparent defects were noted to the down pipes and are considered serviceable, however no comment can be made with regard to blockages or connections to stormwater or functionality in the absence of rain. Note: Periodic maintenance checks should be carried out for rust penetrations and leaks.

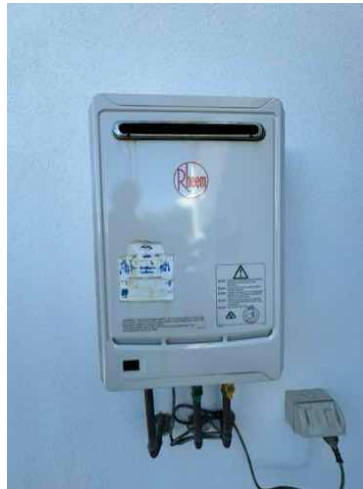
System Make

The make of the hot water unit is rheem.

Unable to determine , no label

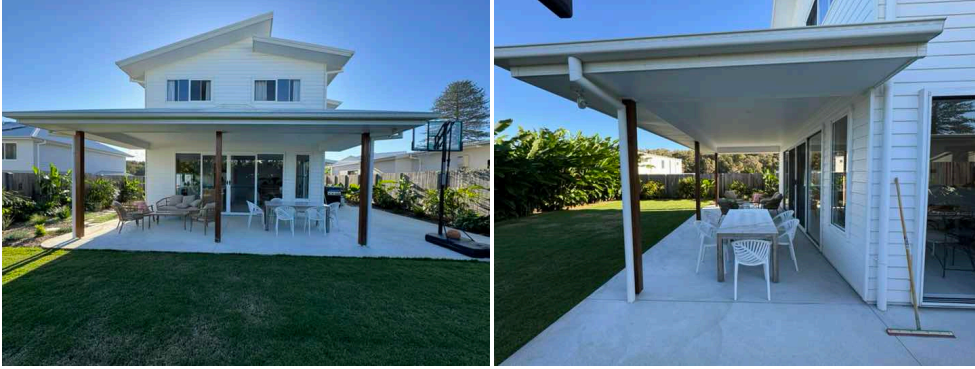
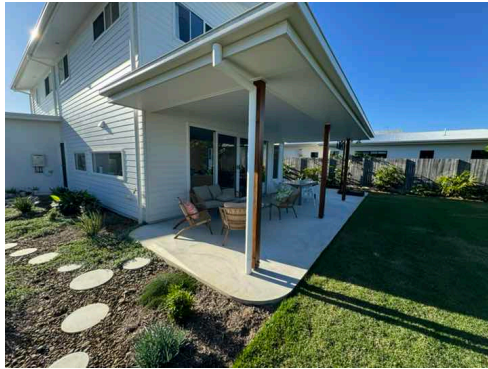
Visible sections of the Alfresco area are serviceable or in reasonable or condition for the age of this dwelling.

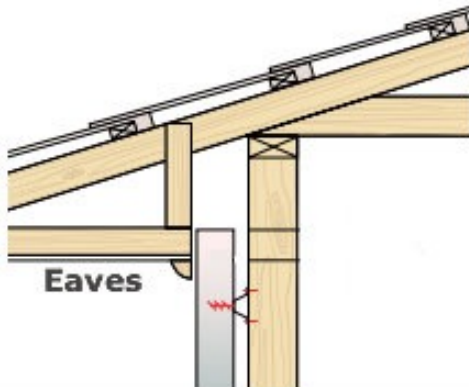
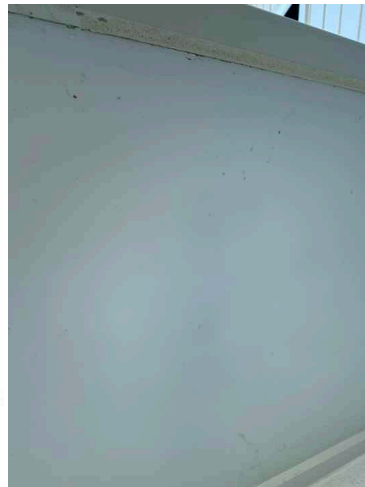
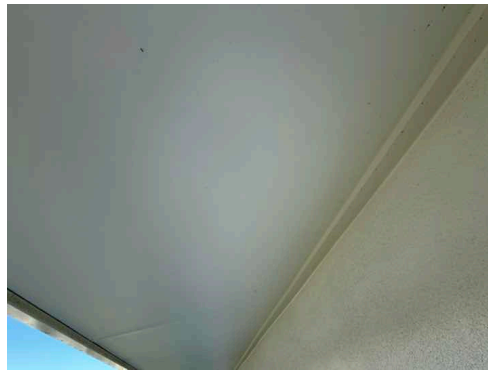
Eave Condition

The soffit lining (eaves) are in a serviceable condition with no notable defects.

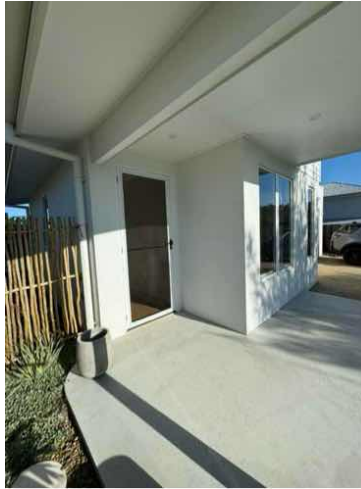
Entry Porch Area

The entry porch serviceable or in reasonable or condition for the age of this dwelling.

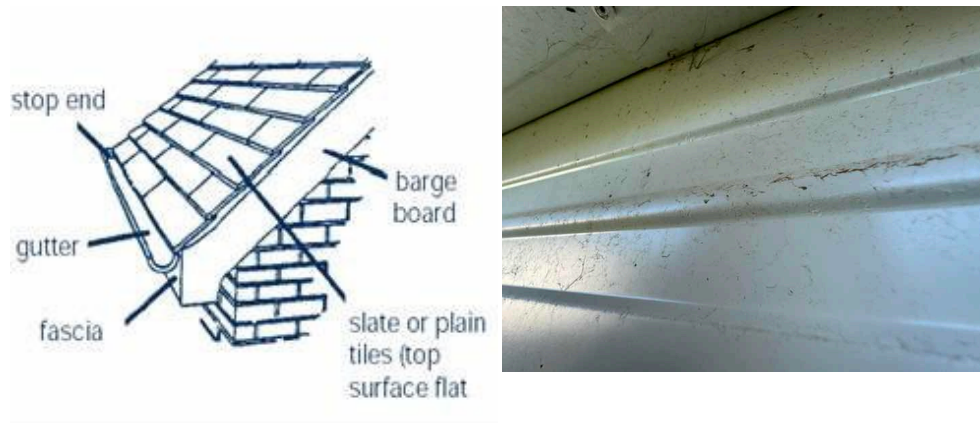
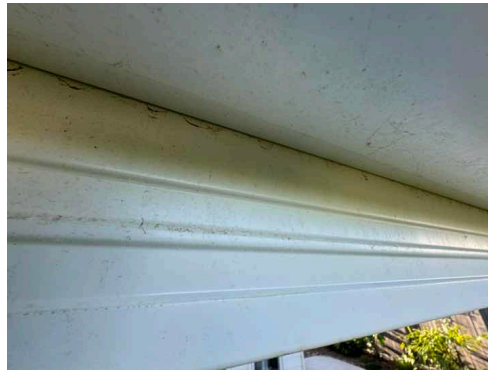
On visual inspection, the general condition of the fascia/barge boards is serviceable.

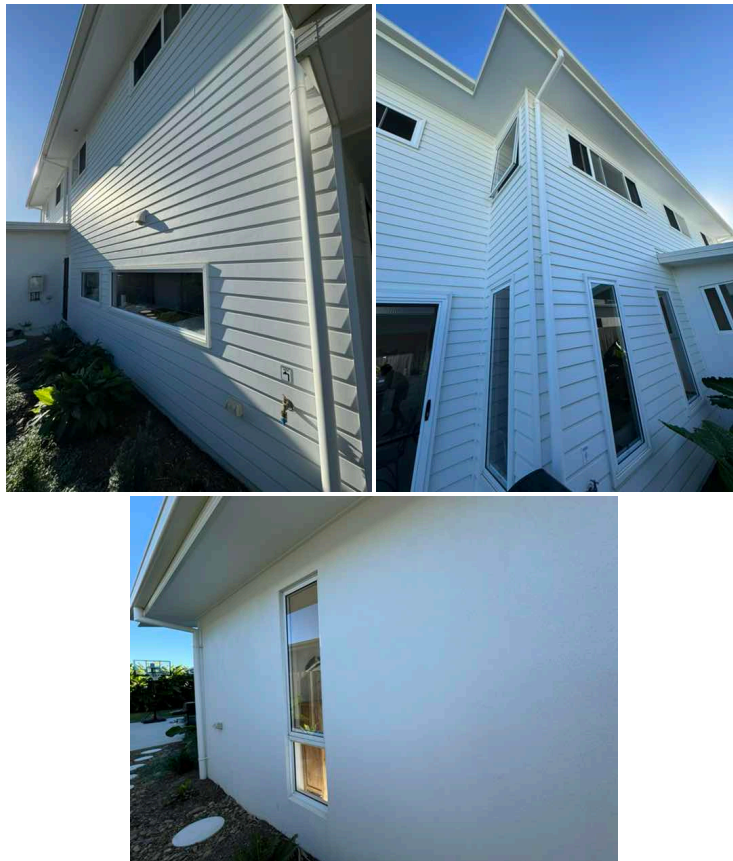
On visual inspection, the general condition of the exterior walls is serviceable for the age.

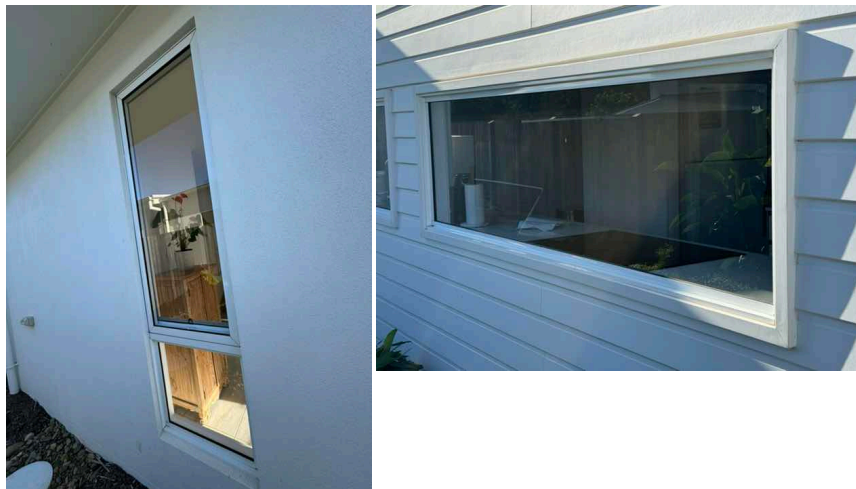
Windows

On visual inspection, the general condition of the windows is serviceable for the age.

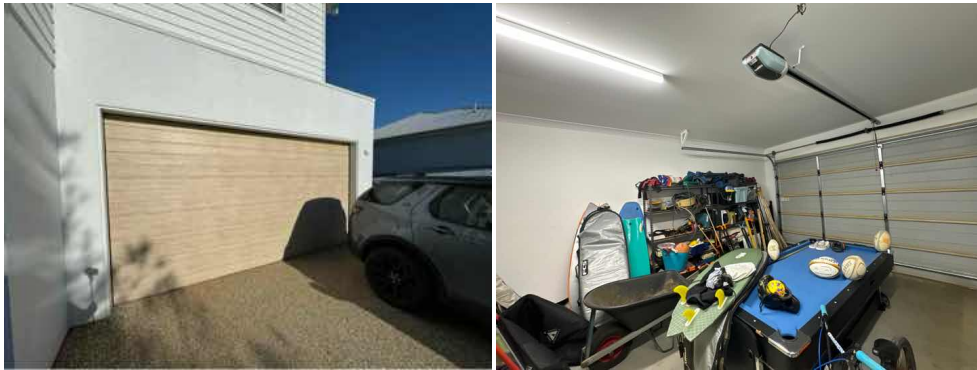
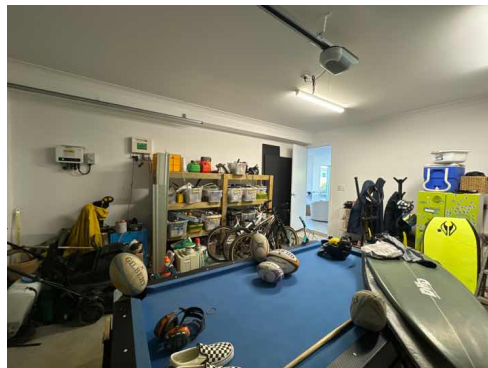
Stored items restricted a full and thorough inspection of this area. Defects may exist in the obstructed and inaccessible areas. It is strongly recommended that full access be granted to enable a thorough inspection as there may be timber pest activity, damage or defects. Note: Where vehicles and storage has restricted a full inspection it is advised that this area be cleared so a full and unobstructed inspection can be carried out.

From the visible and accessible areas, the garage appears to be in a serviceable condition for the age of the property with no notable structural defects sighted.

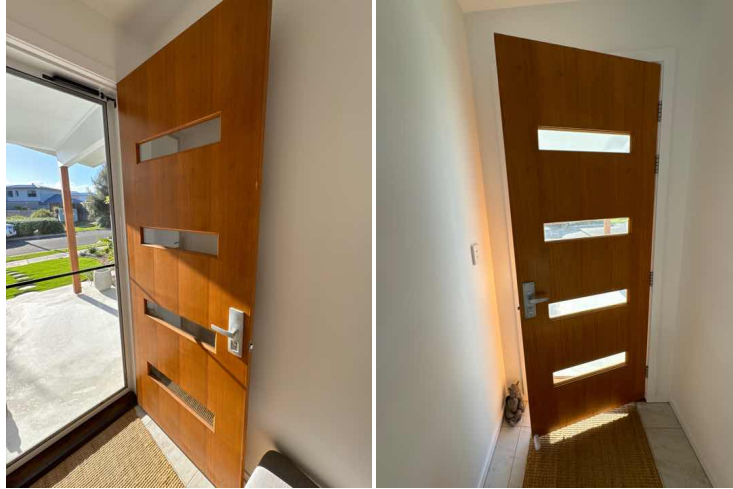
Front Entry Doors

The doors are in serviceable condition with no notable defects observed.

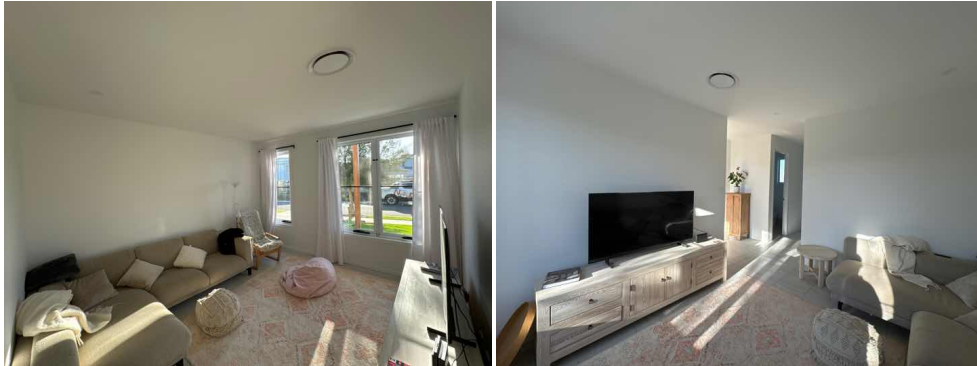
Living Room

From the visible and accessible areas, this room appears to be in a serviceable condition for the age of the property with no notable structural defects sighted.

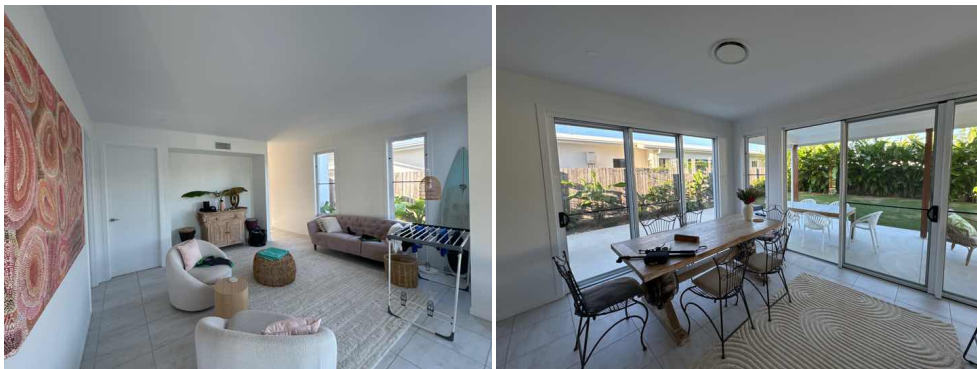
Combined Living & Dining

From the visible and accessible areas, this room appears to be in a serviceable condition for the age of the property with no notable structural defects sighted.

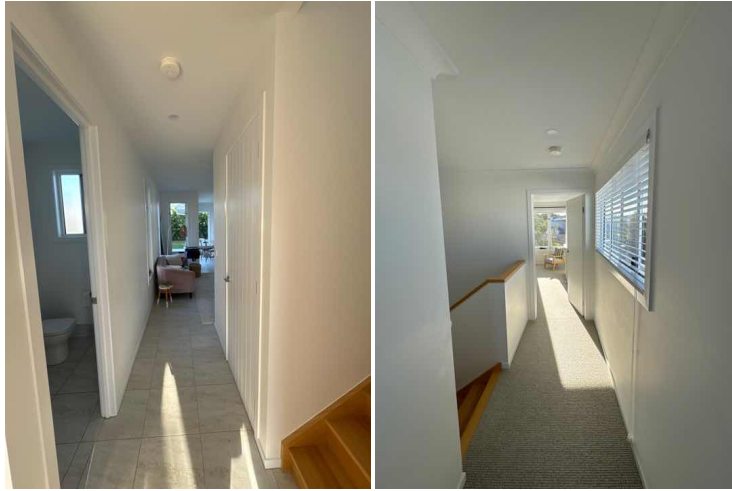
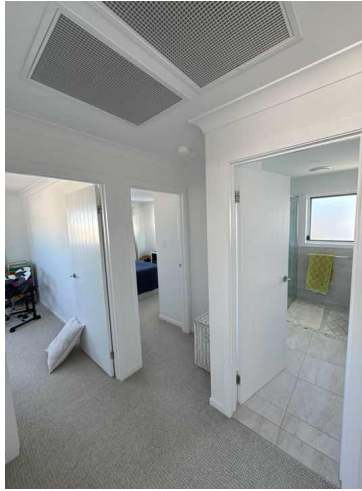
Hallway/s

From the visible and accessible areas, the hallway/ appears to be in a serviceable condition for the age of the property with no notable structural defects sighted.

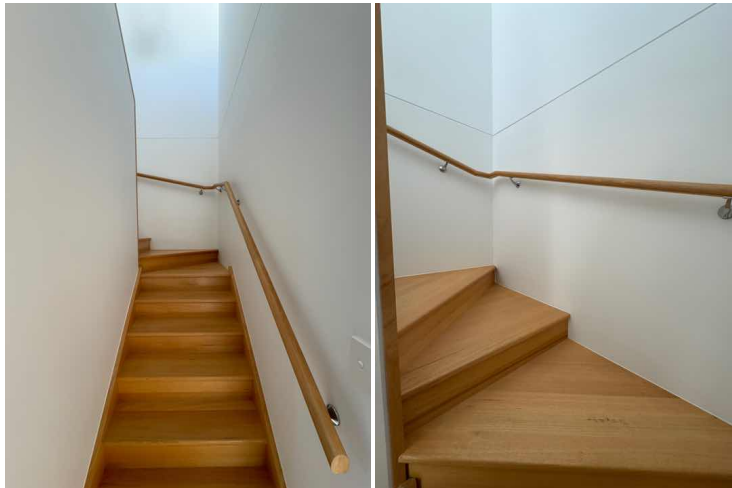
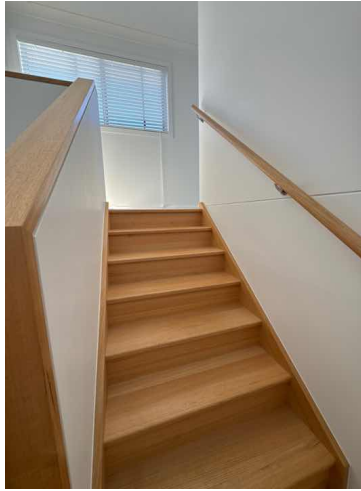
Internal Stair Case

The internal staircase and components appear to be in a serviceable condition for the age with no notable defects sighted.

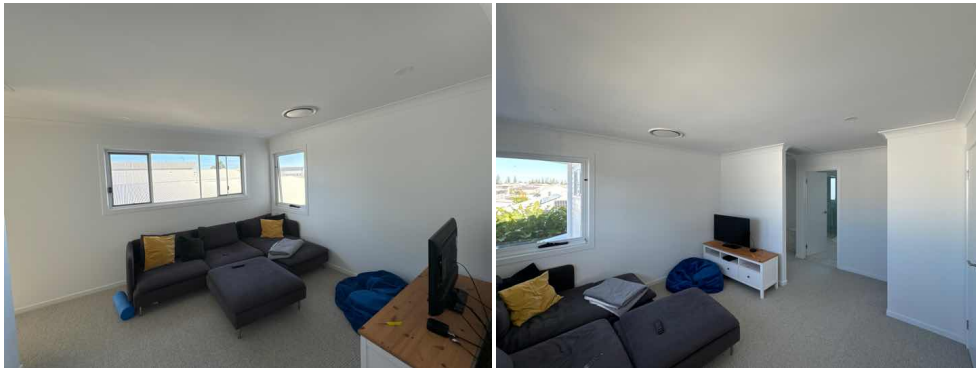
Upstairs Leisure Room

From the visible and accessible areas, this room appears to be in a serviceable condition for the age of the property with no notable structural defects sighted.

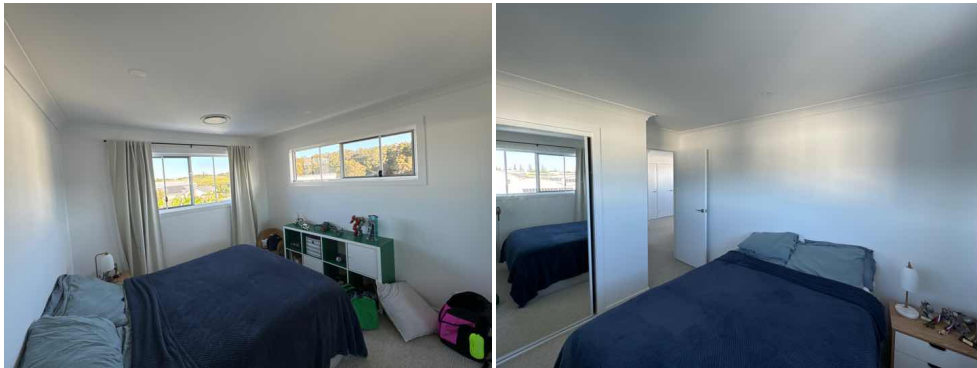
Bedroom 2

From the visible and accessible areas, this bedroom appears to be in a serviceable condition for the age of the property with no notable structural defects sighted.

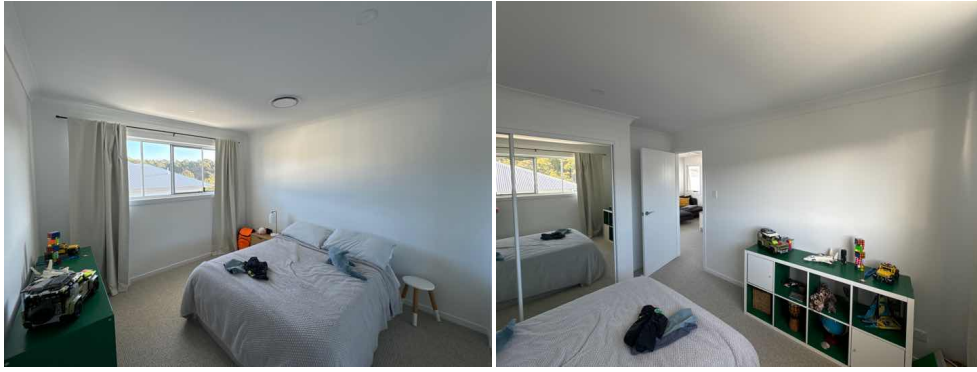
Bedroom 3

From the visible and accessible areas, this bedroom appears to be in a serviceable condition for the age of the property with no notable structural defects sighted.

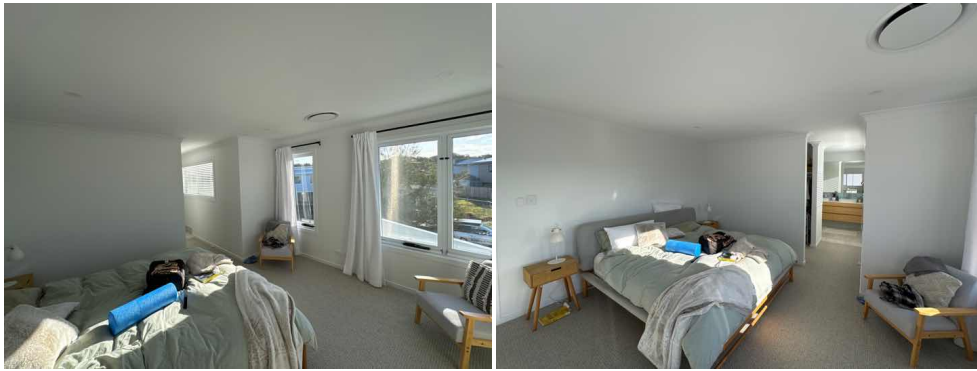
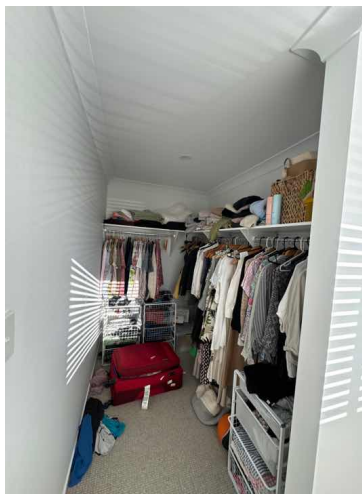
Bedroom 4

From the visible and accessible areas, this bedroom appears to be in a serviceable condition for the age of the property with no notable structural defects sighted.

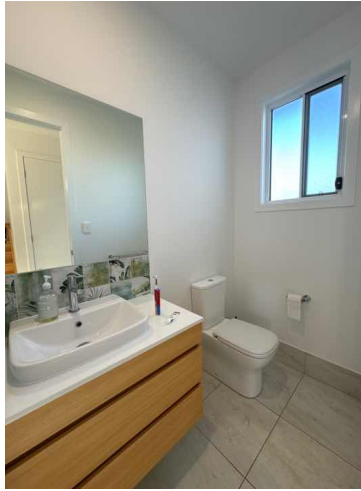
Of the visible areas, the general condition of this bathroom is serviceable or in reasonable condition for age of dwelling.

No exhaust fan is installed - Recommend having one installed.

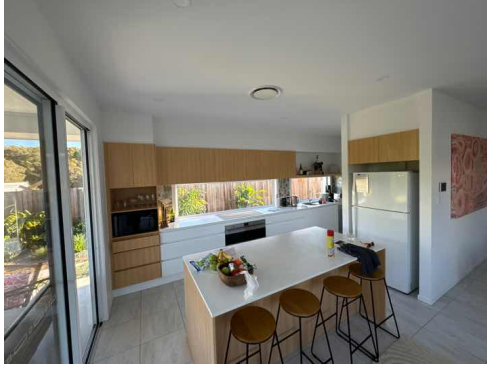
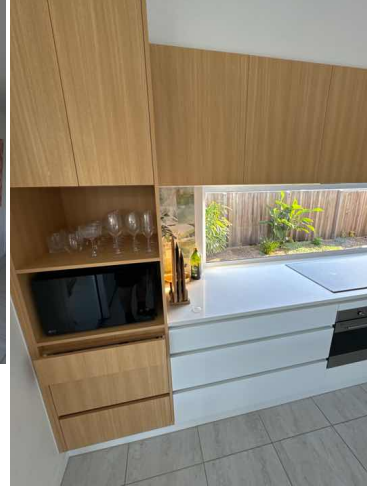
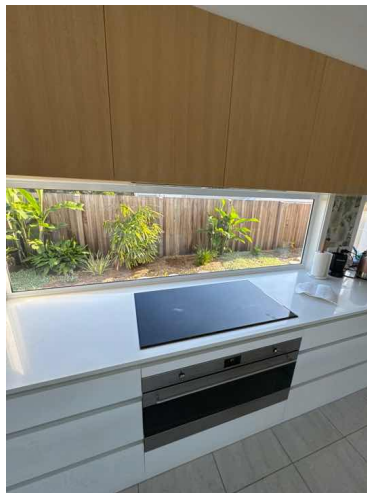
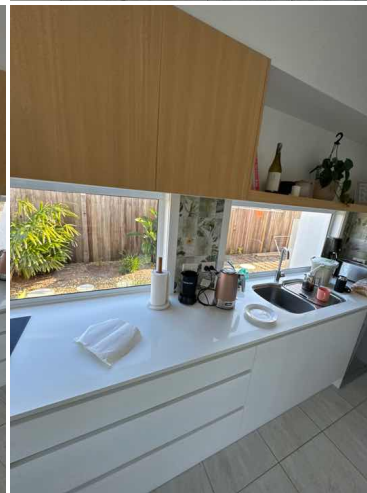
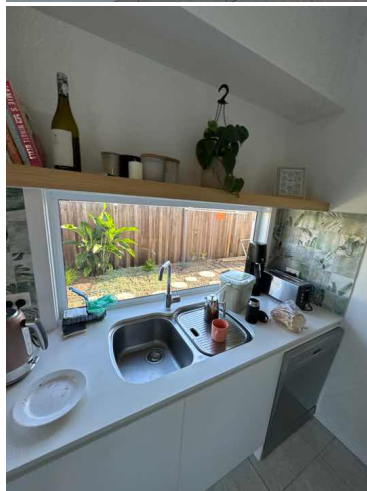
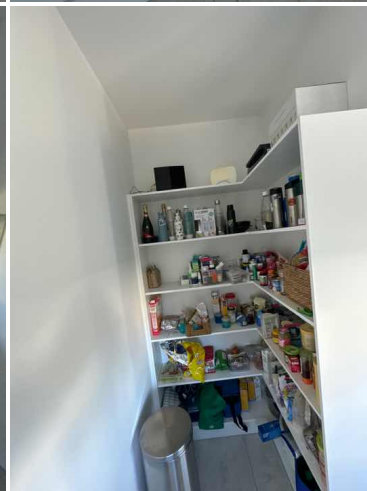
Of the visible areas, the general condition of the kitchen and pantry is serviceable or in reasonable condition for age of dwelling.

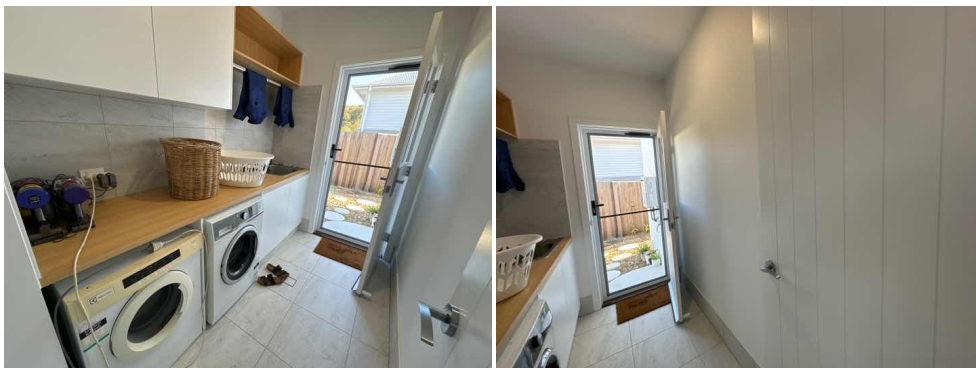
Of the visible areas, the general condition of the laundry is serviceable or in reasonable condition for age of dwelling.

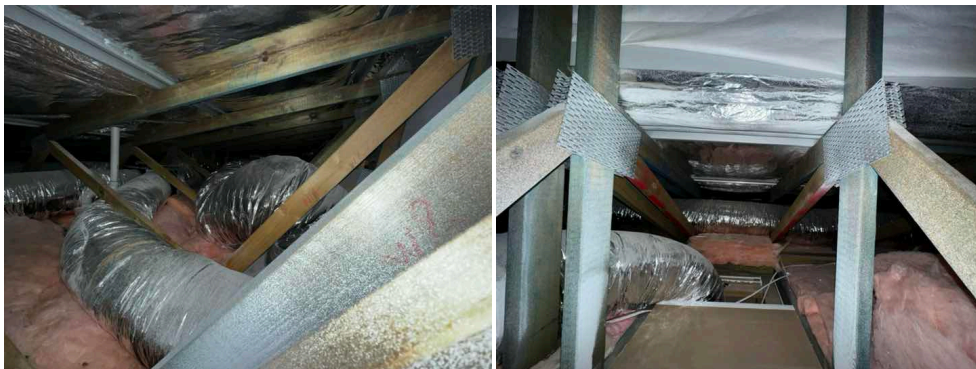
Visible sections of the roof void is in a serviceable condition for age of this dwelling.
